SOIL AND GROUNDWATER INVESTIGATION REPORT BRUNKER PROPERTY 1257 COUNTY BB DEERFIELD, WISCONSIN 53531

PECFA Identification number: #53531-9611-57 WDNR Reference number: #03-13-544797

FEBRUARY 2017

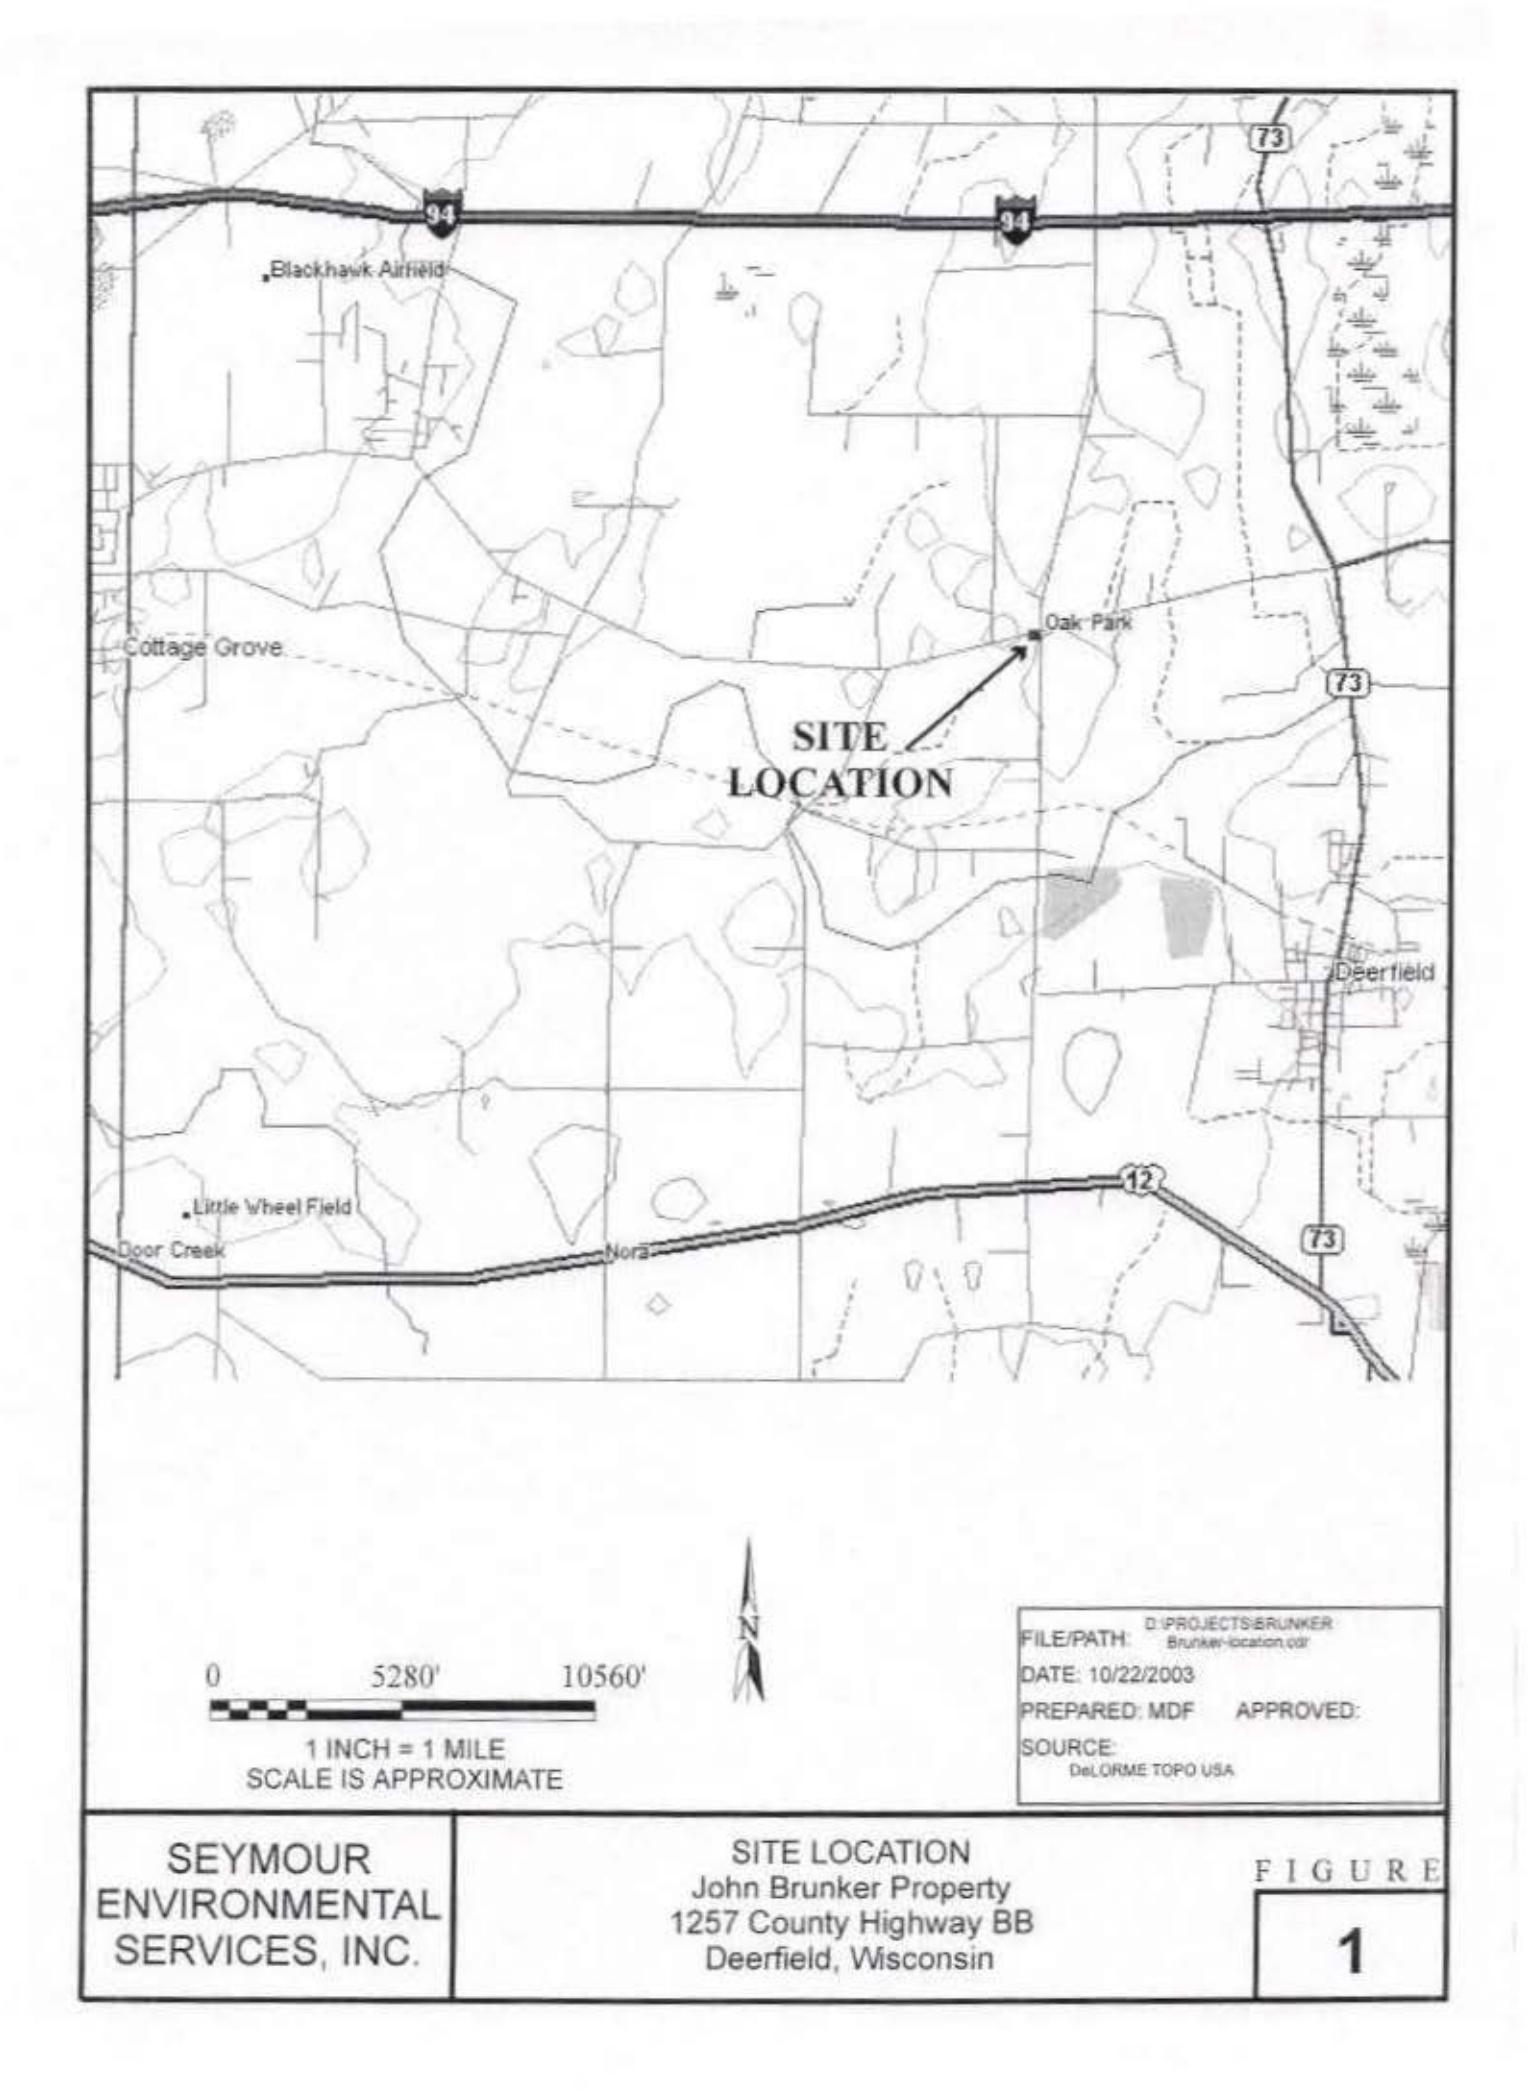
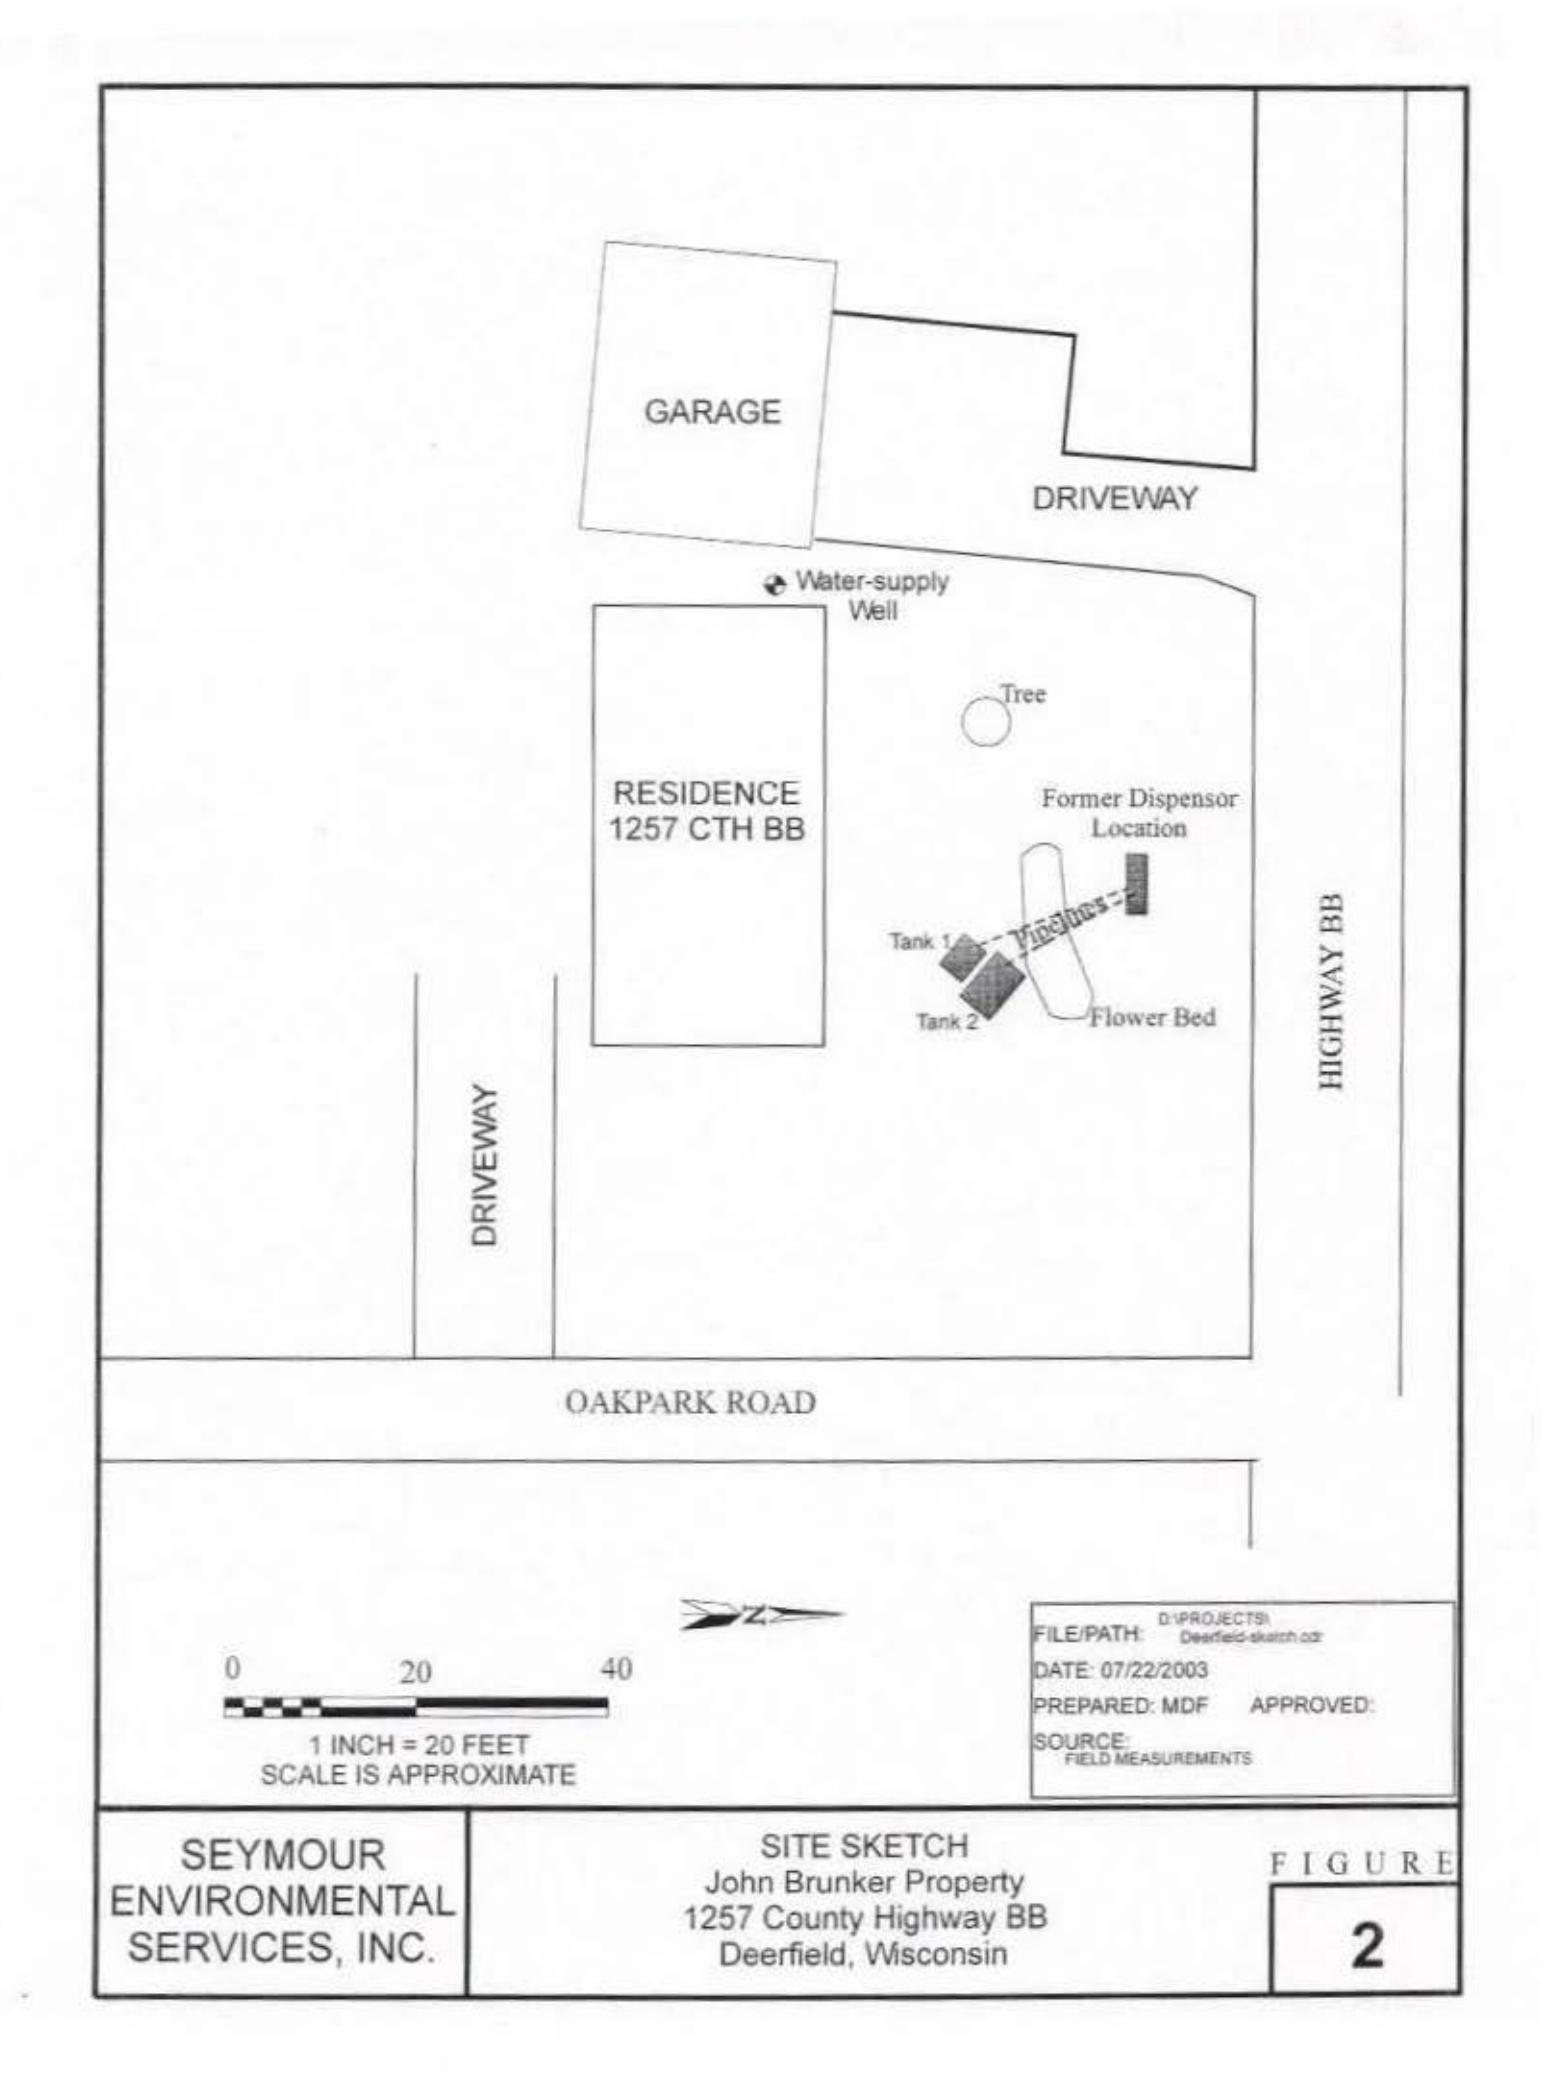
Figures

Two tanks were discovered at the site. The first tank was a 225-gallon gasoline tank which was rusted and had many holes. The second tank was a 550-gallon gasoline tank in good condition. Soil samples were collected beneath the center of the 225-gallon tank and from either end of the 550-gallon tank and beneath the piping. The sample results show that the soil does not contain any GRO above the allowable residual contaminant levels. Only one sample contained benzene above an RCL. We recommend closure and no further action.

Seymour and JEPA removed the tanks on September 16, 2003. We began excavating at the piping that Seymour had previously uncovered and followed the piping to the tanks. The first tank encountered was the 225-gallon tank which had several holes and a small amount of soil inside. The second tank was 550-gallons and was in excellent condition. The weather was in the 80's and clear. The tank location and sampling points are shown on Figure 2.

The pipeline sample #2 contained benzene above the RCL and should be reported to the Wisconsin Department of Natural Resources. The low level of contamination does not warrant additional information and we recommend unconditional closure. If there are any questions regarding this information, please call me at 608-838-9120. Any questions regarding the physical tank removal and disposal should be directed to JEPA, Inc.
