RE: **Public Bidding Deferred – Cost Cap Approved**

PECFA # 53937-7309-32-A DNR BRRTS # 03-53-554361 Robert & Teresa Rizzo Property, 33832 State HWY 154, Hillpoint

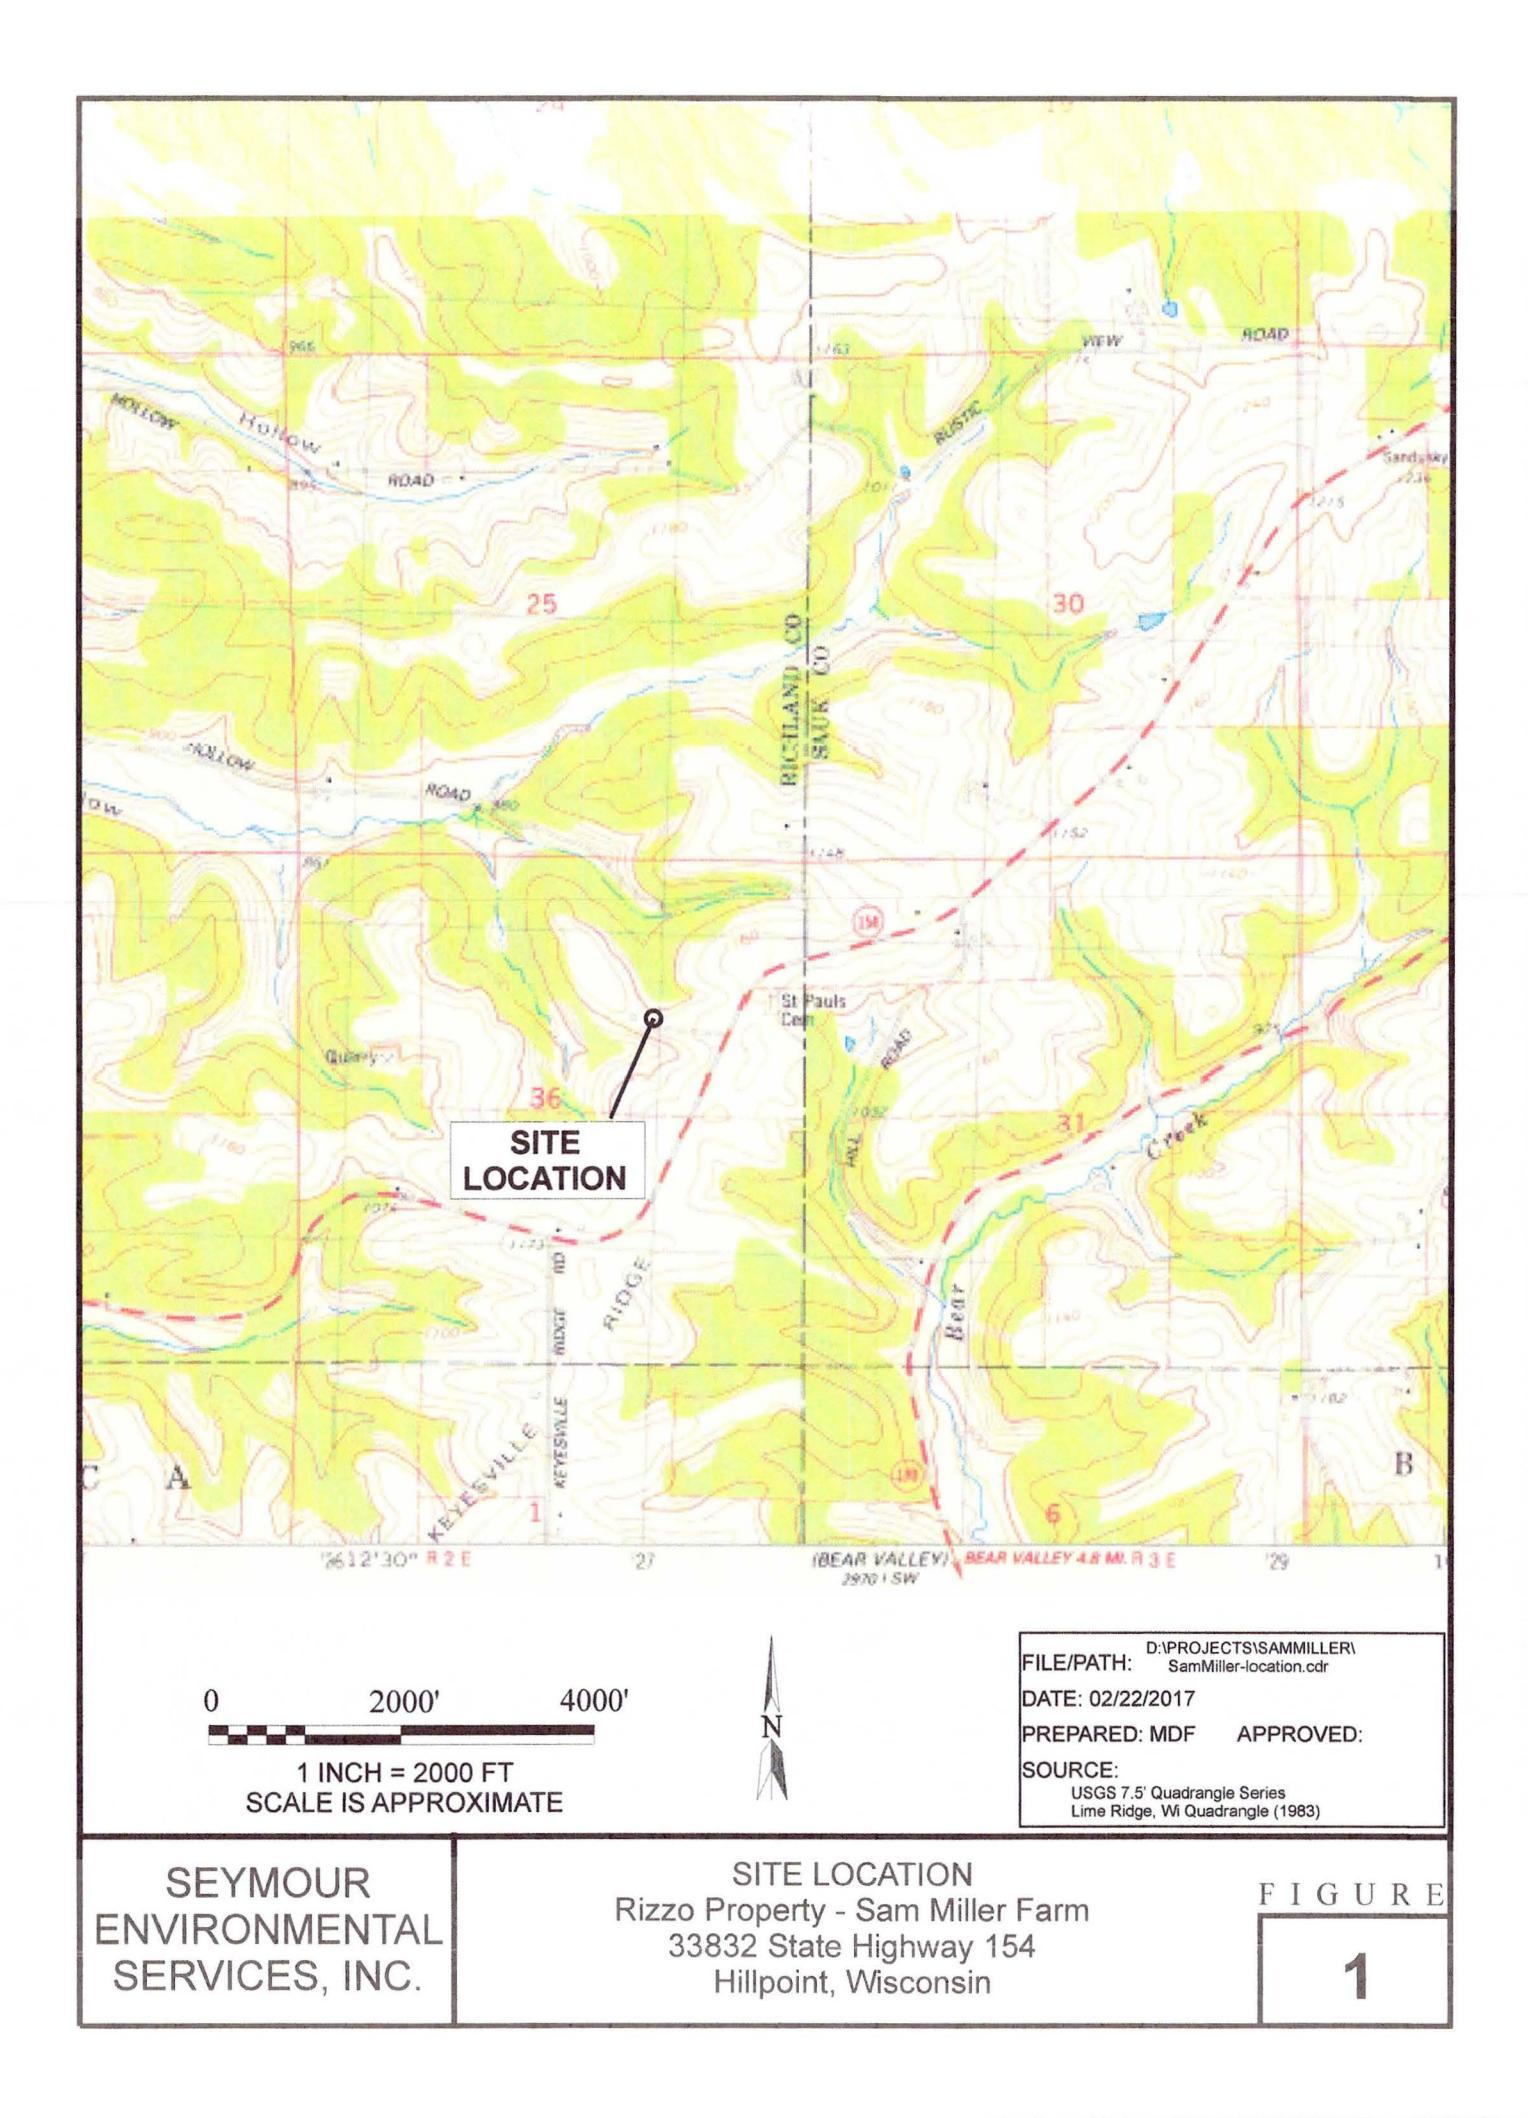
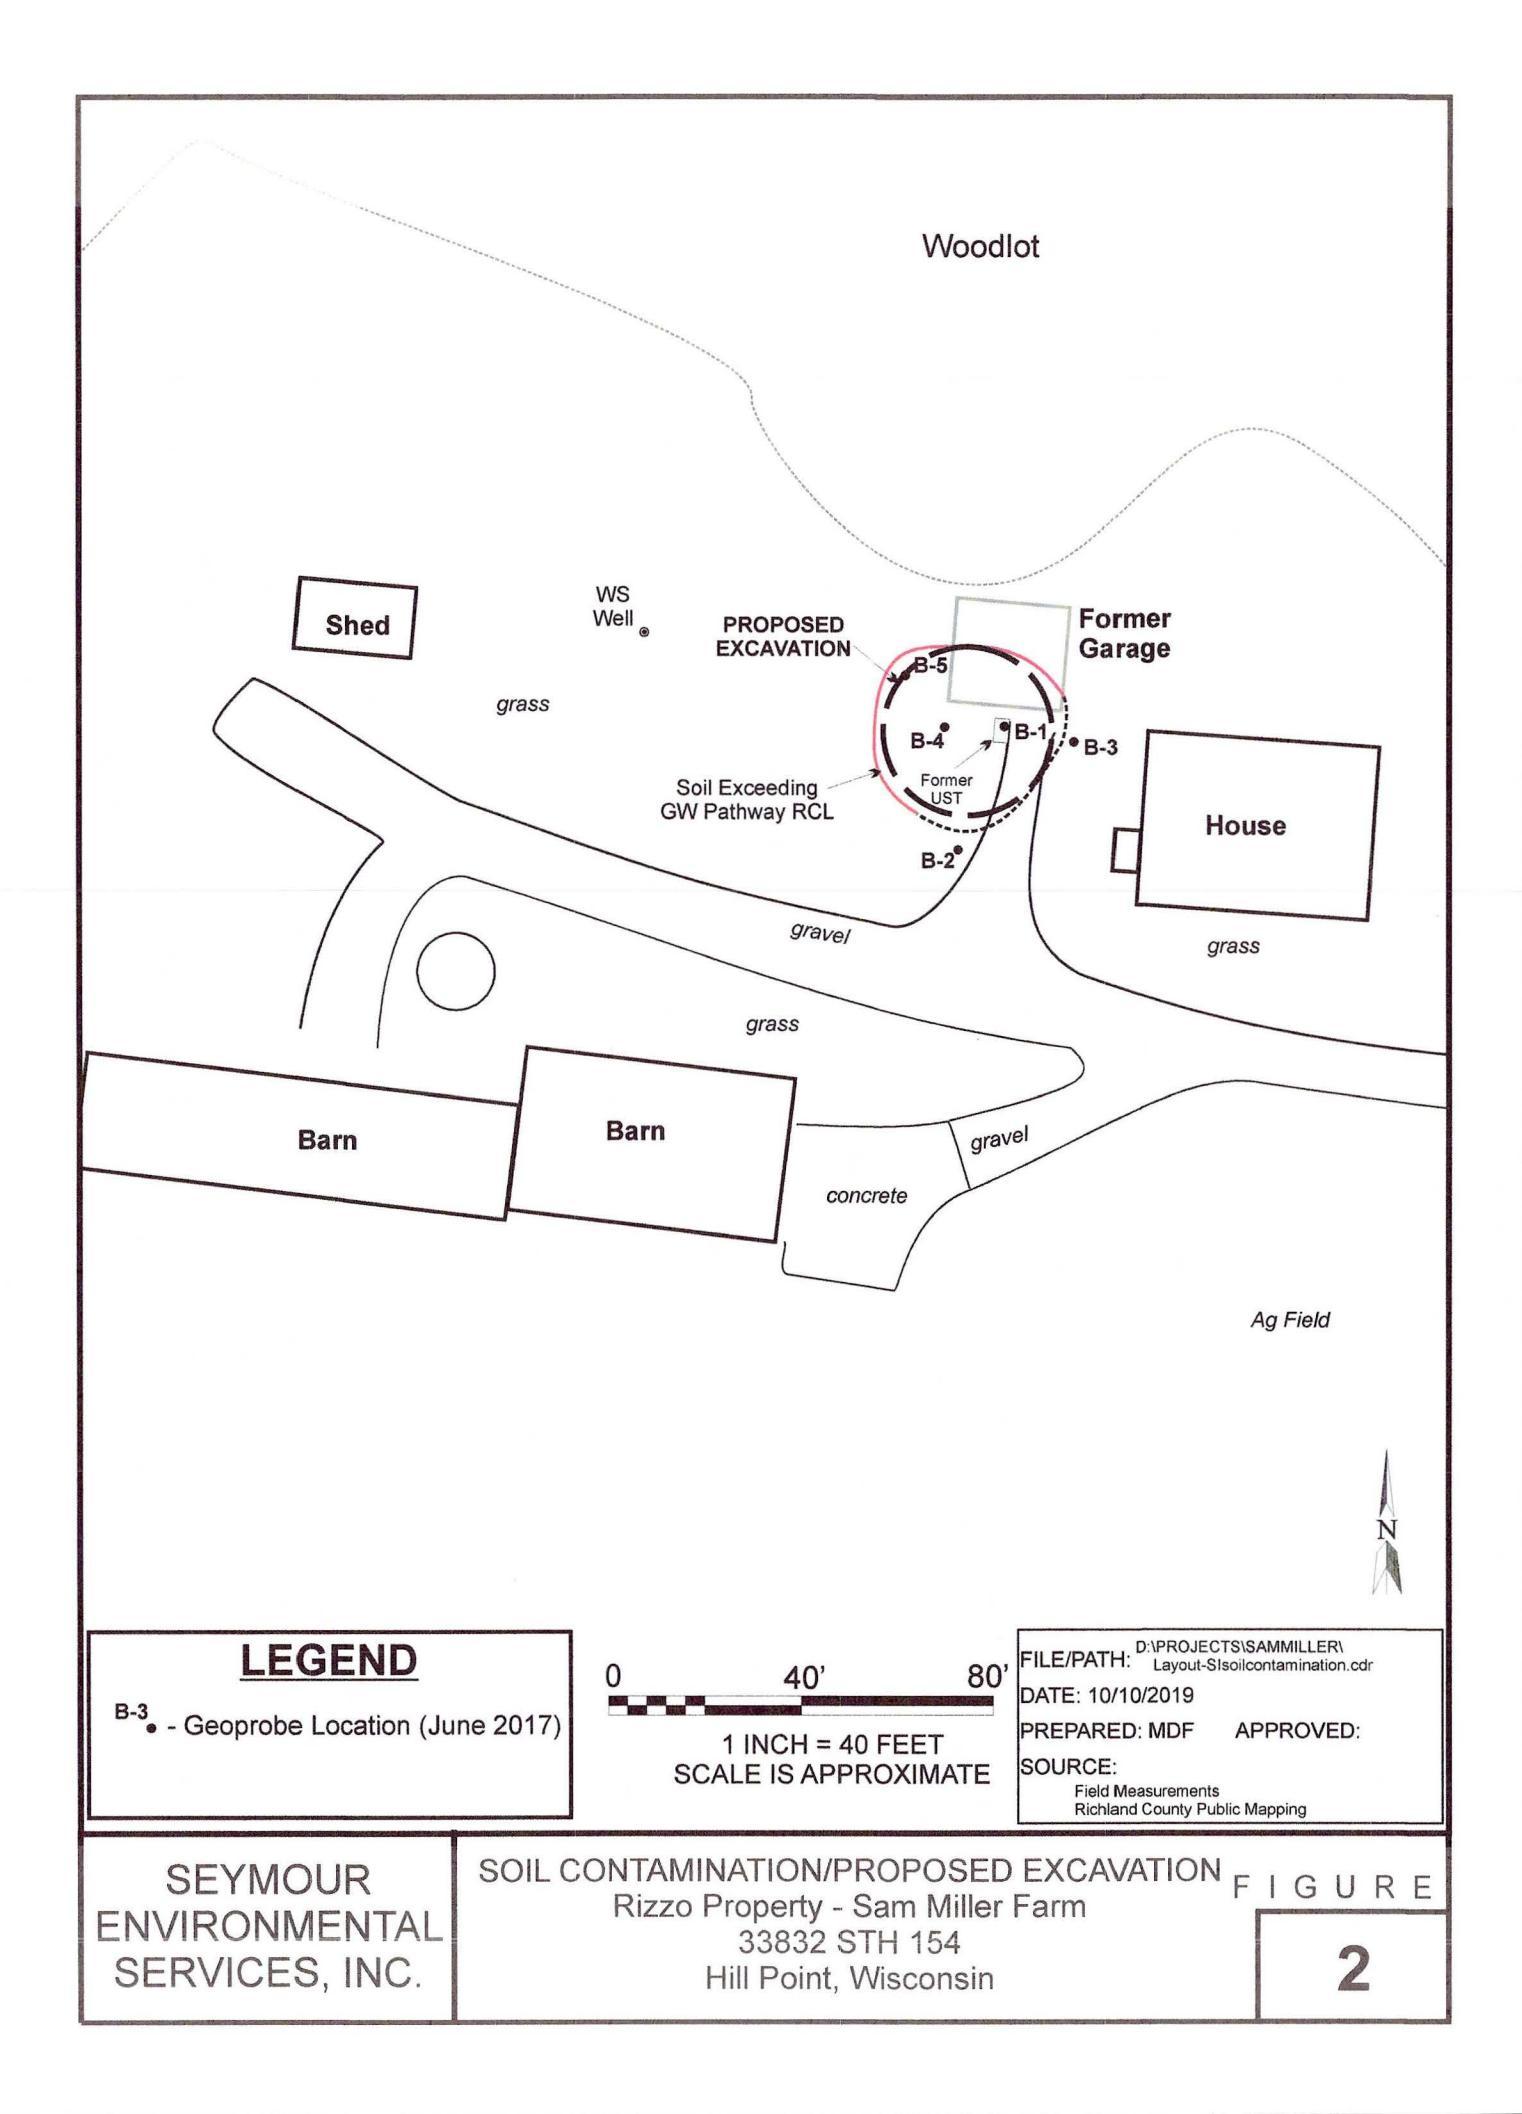
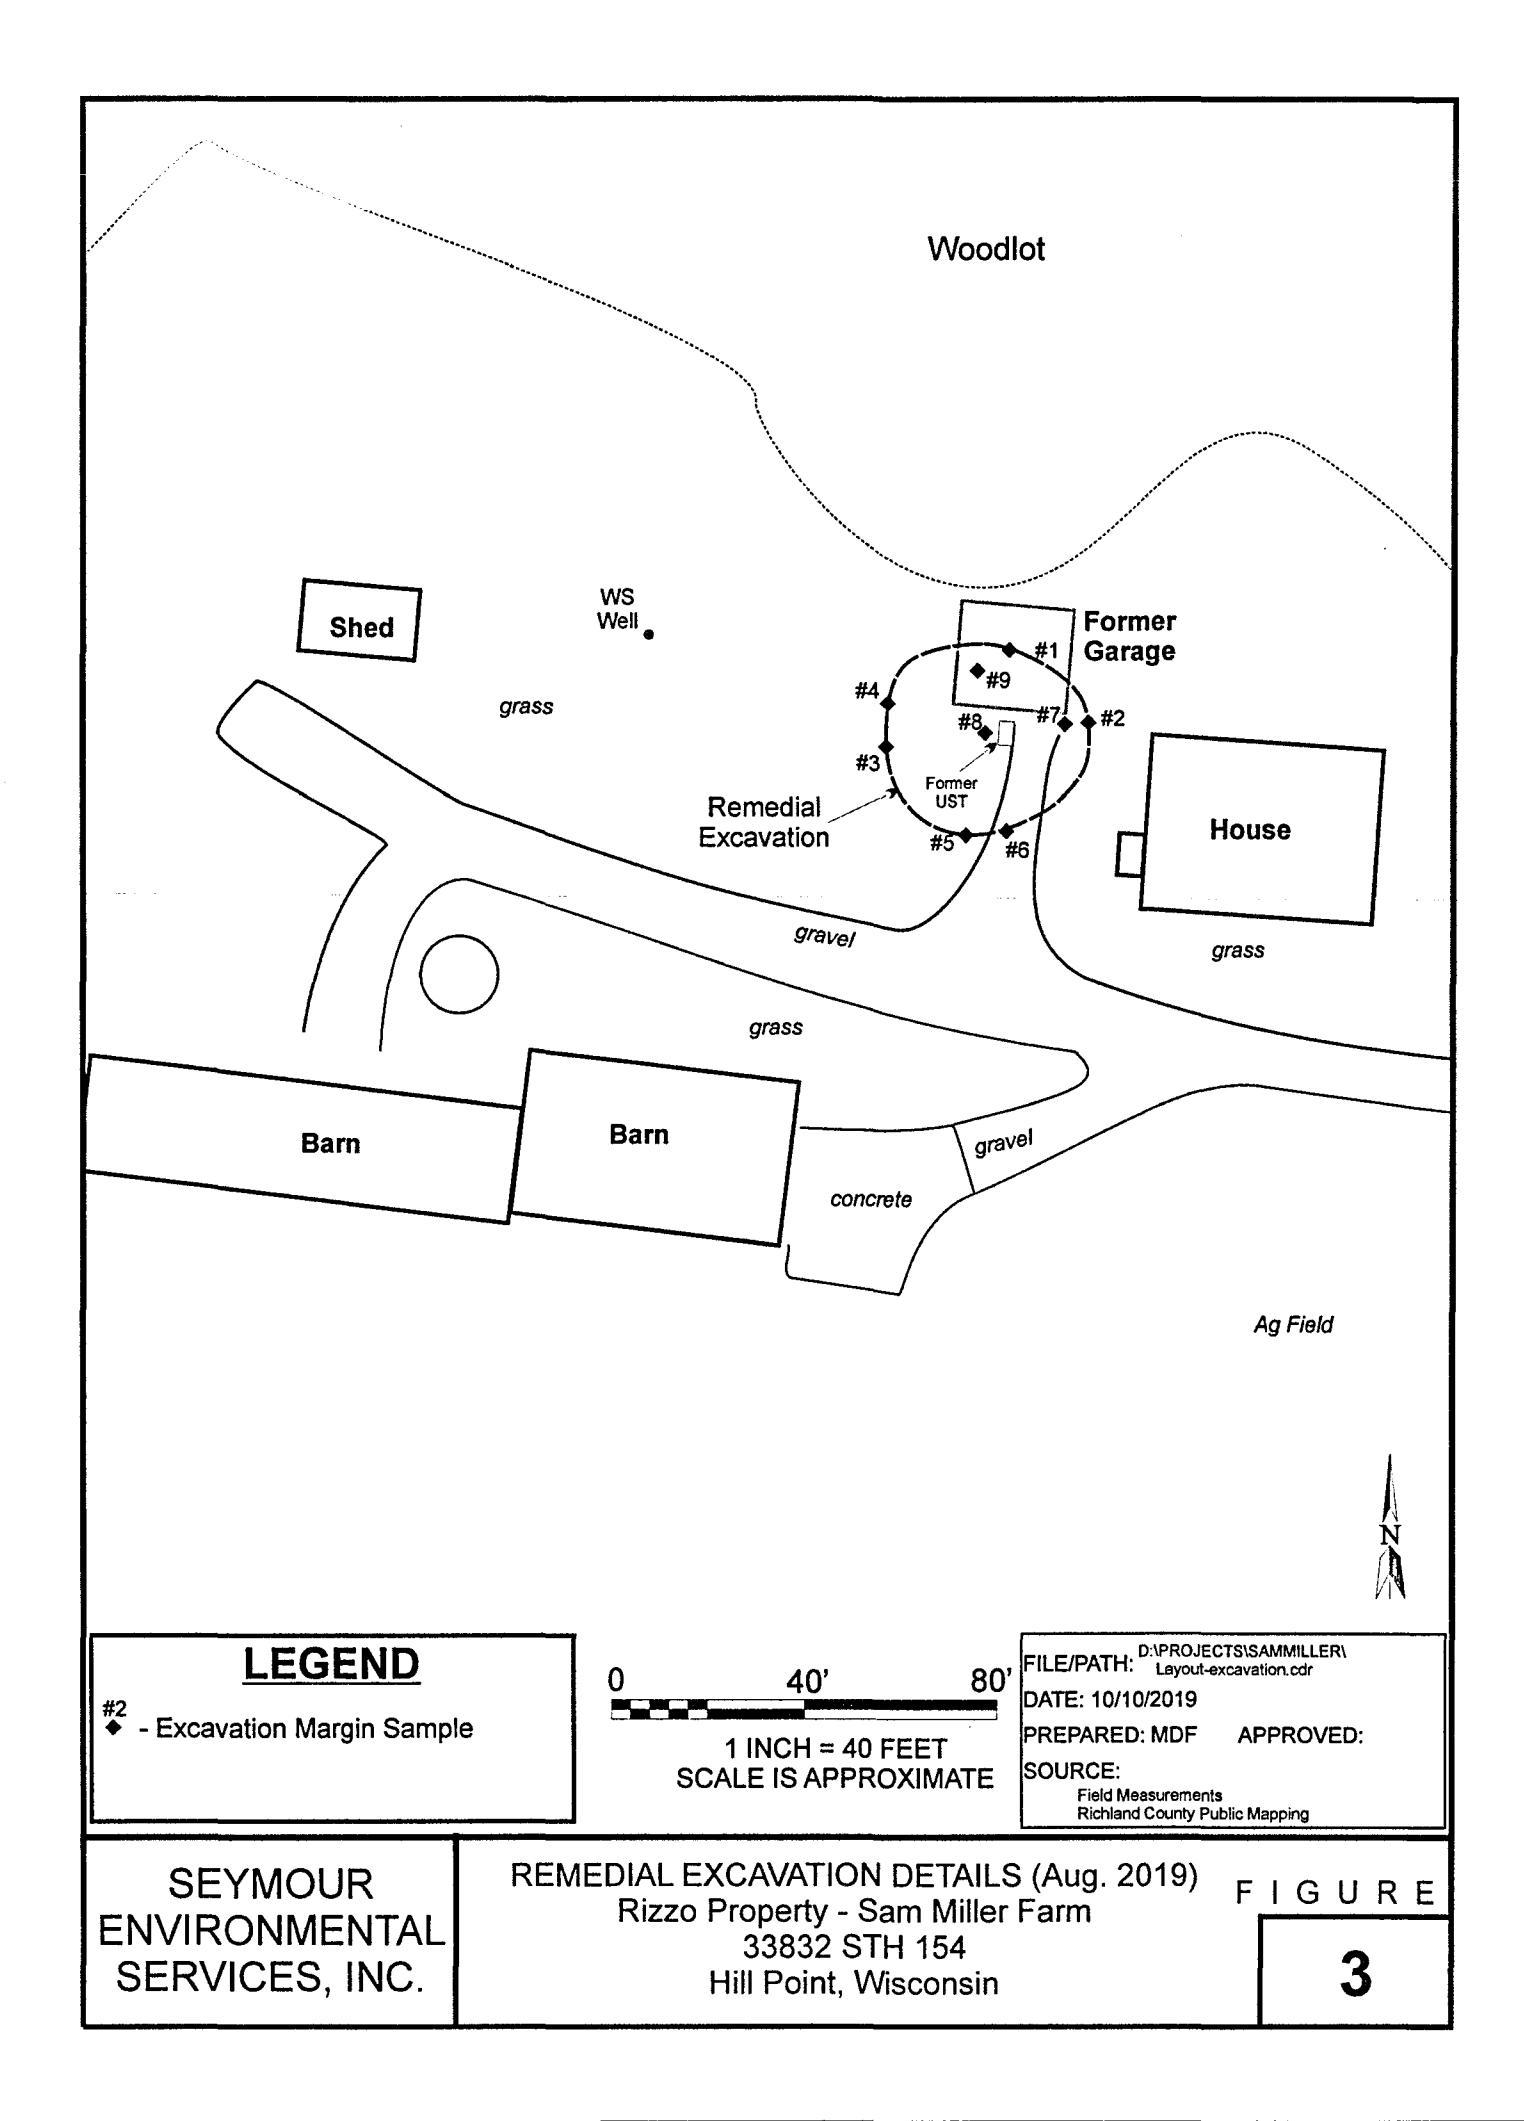
FIGURES

The excavation extended over a circular area 35-40 feet in diameter. Across the excavation soils were generally removed to top of weathered bedrock. Clean overburden soils that were excavated were stockpiled in the field north of the excavation. Sampling of the excavation margins showed that the contaminated soil was removed. The sample collected from the base of the excavation was below the limits of detection. Because of the depth to groundwater (~100 feet) and the limited groundwater impacts noted in the water-supply well samples, we believe that the site should be closed.

We began the work on the south portion of the proposed excavation. Overburden soils were removed until any evidence of petroleum contamination was noted. The shallowest soil contamination encountered was present in the area of B-1 and the former UST. Evidence of soil contamination in this area was noted at ~8 feet below grade. The upper surface of the soil contamination dropped off fairly steeply around the former tank bed and near the margins of the excavation soil contamination was only noted in soils deeper than ~18 feet below grade. The bentonite seals from the borings within the footprint of the excavation were noted during the excavation work.

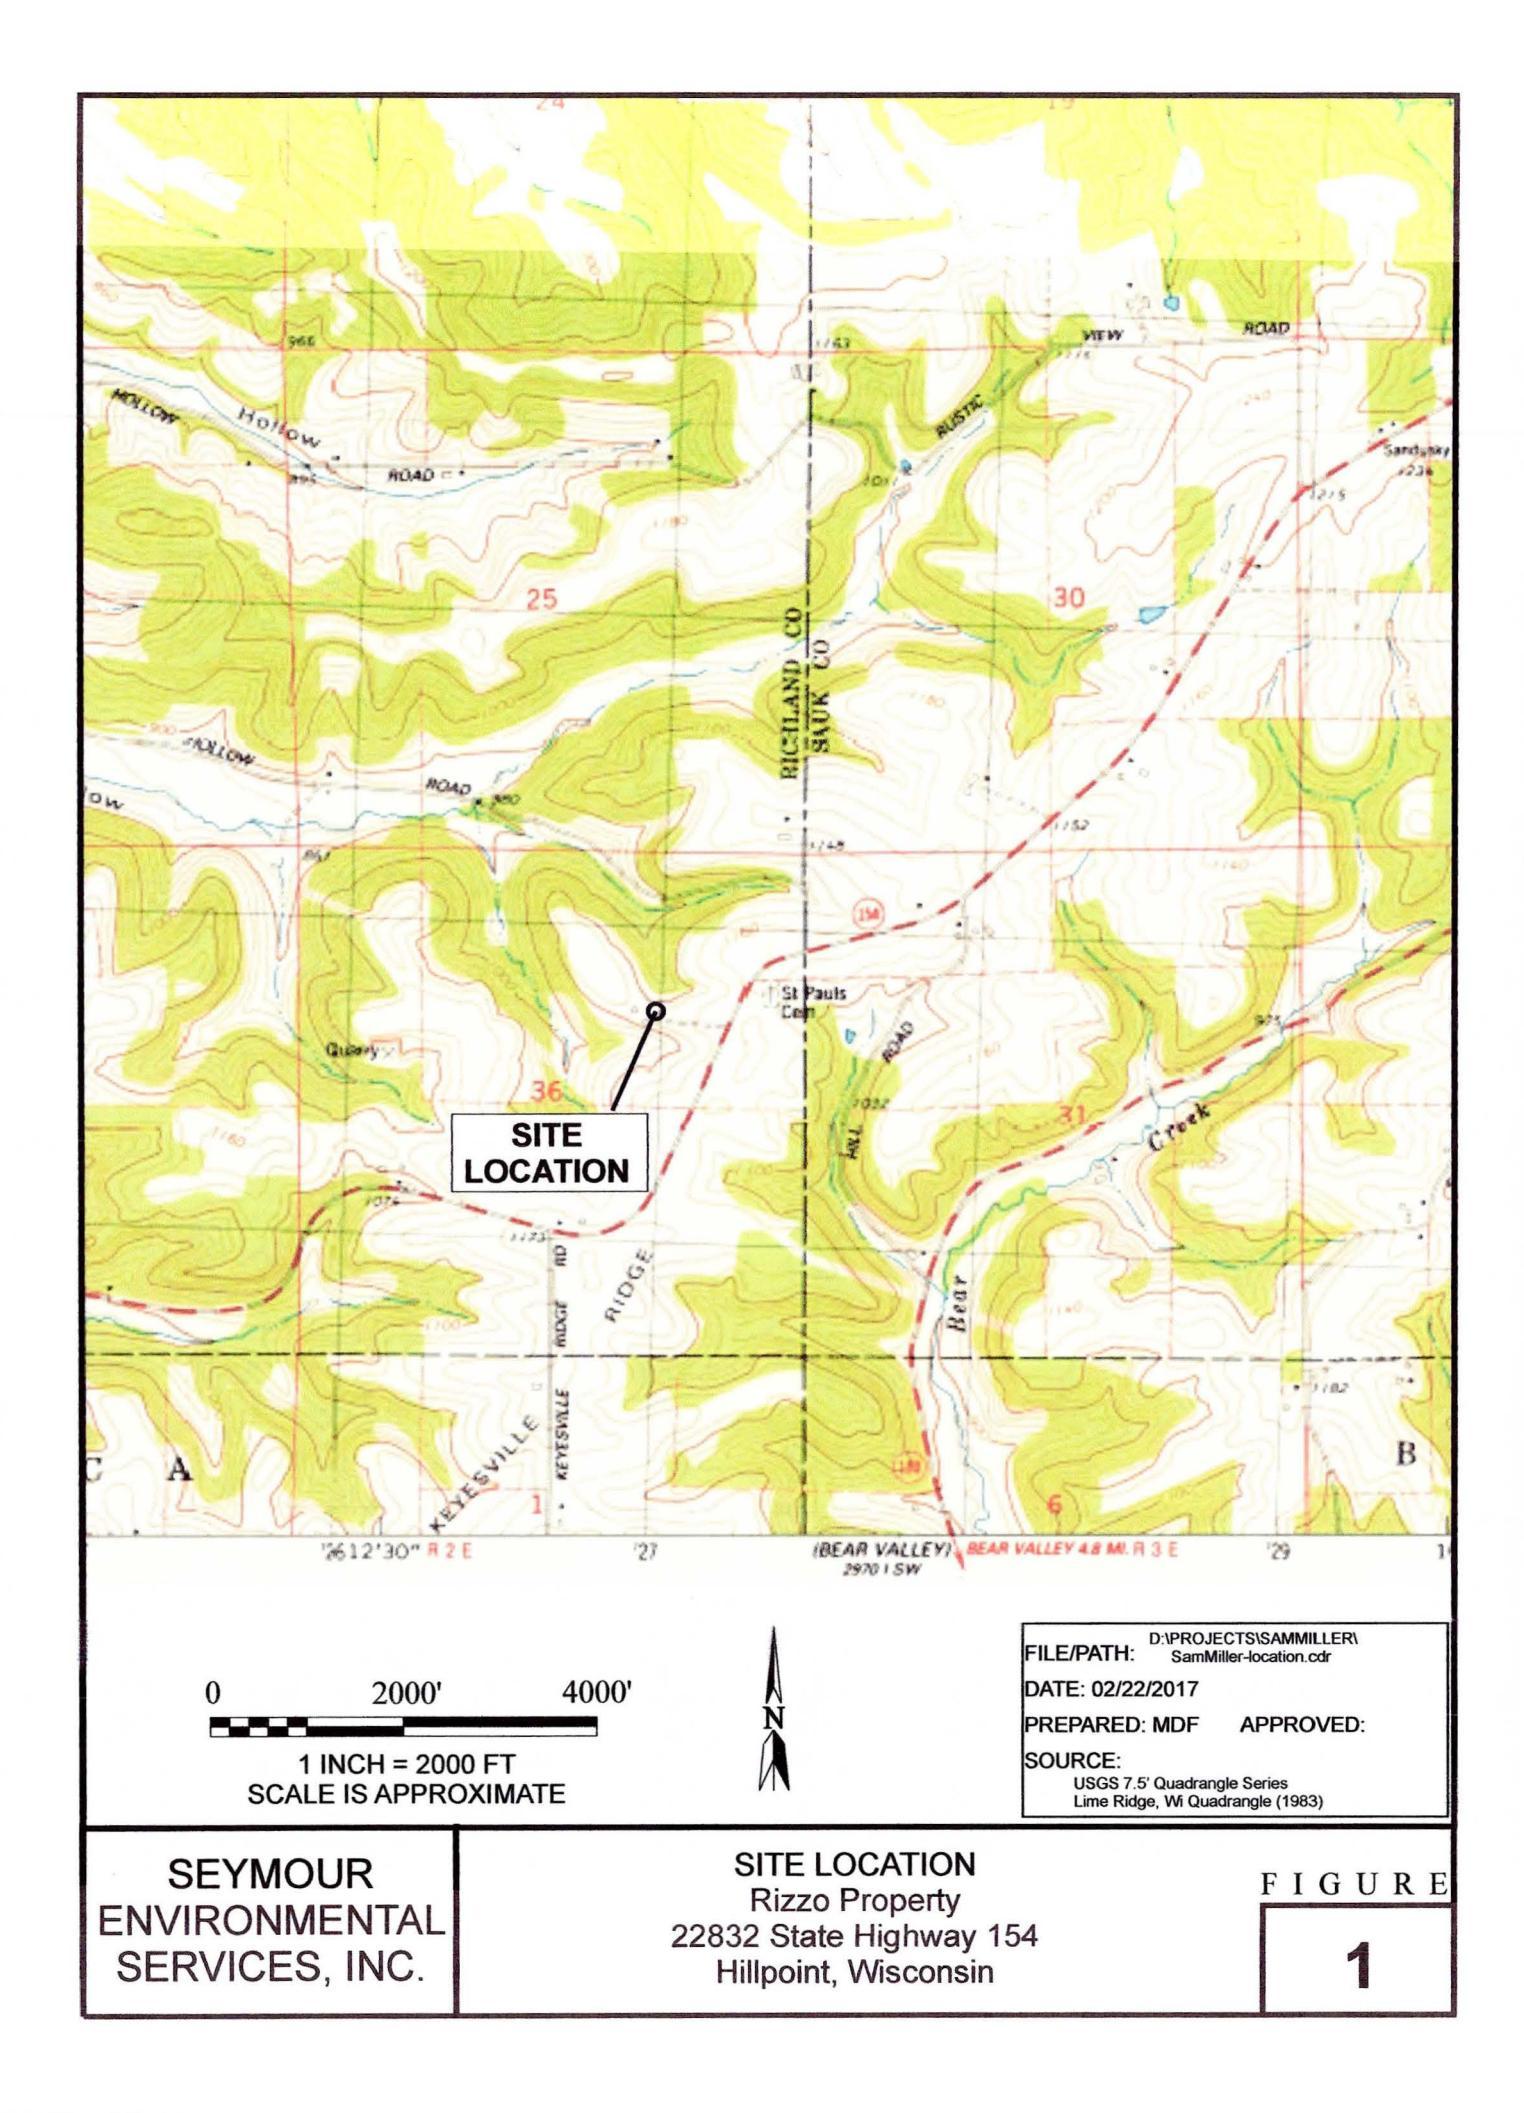
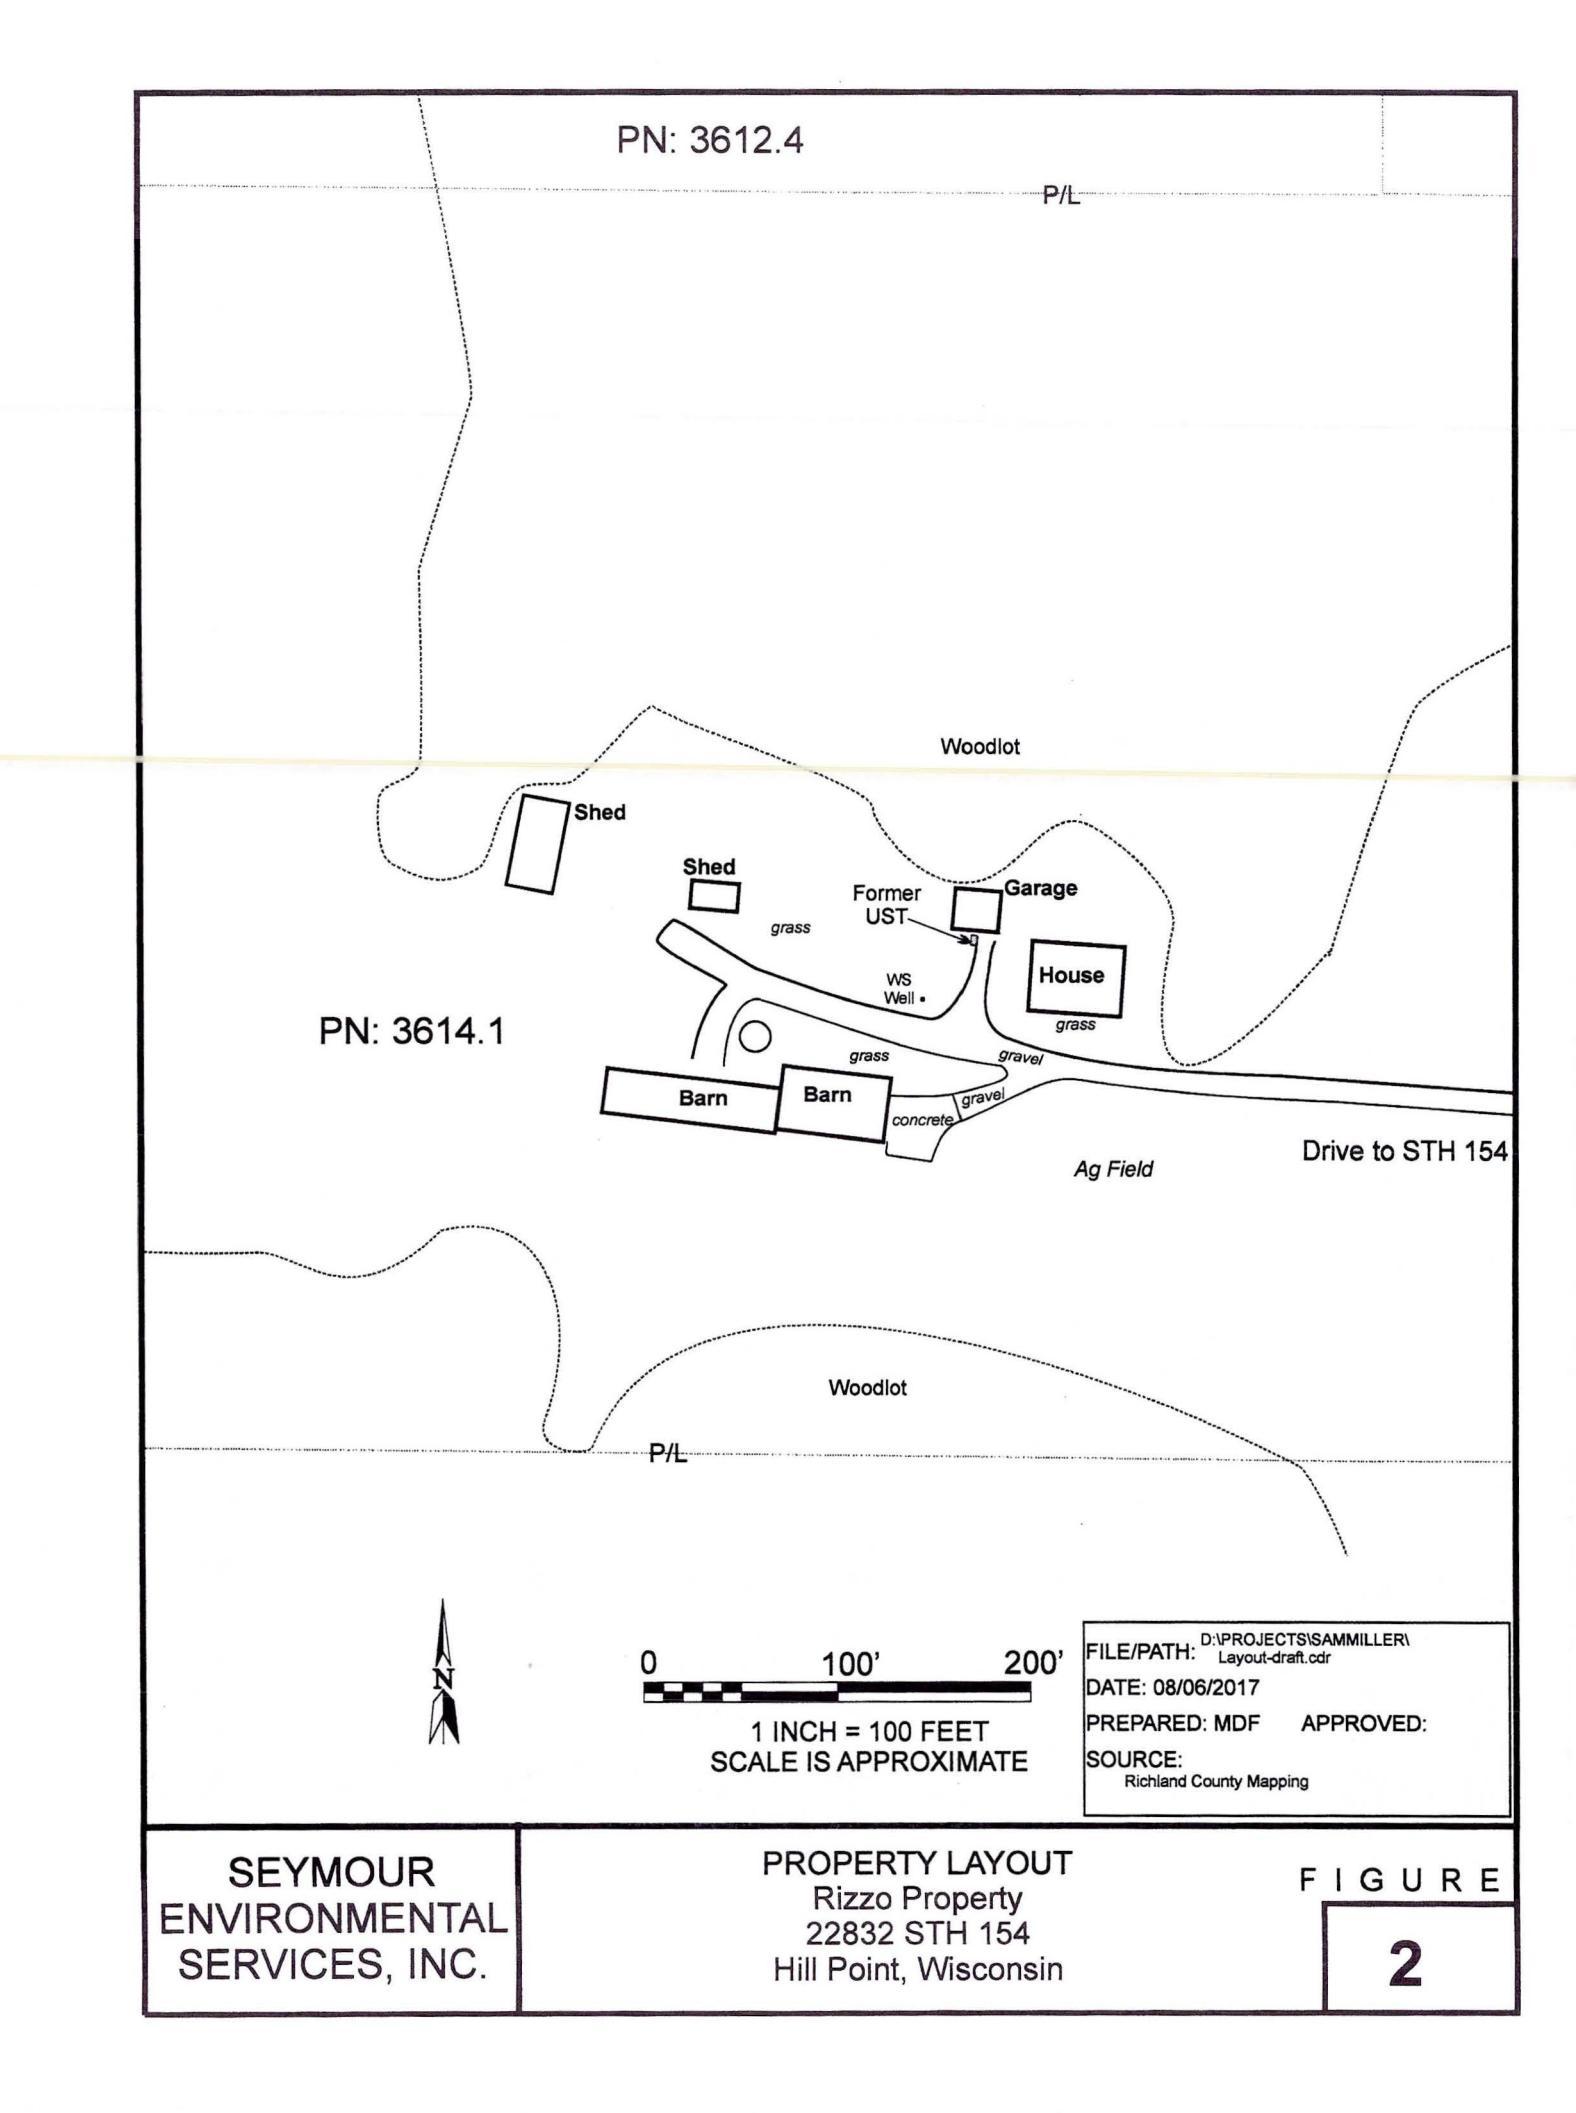
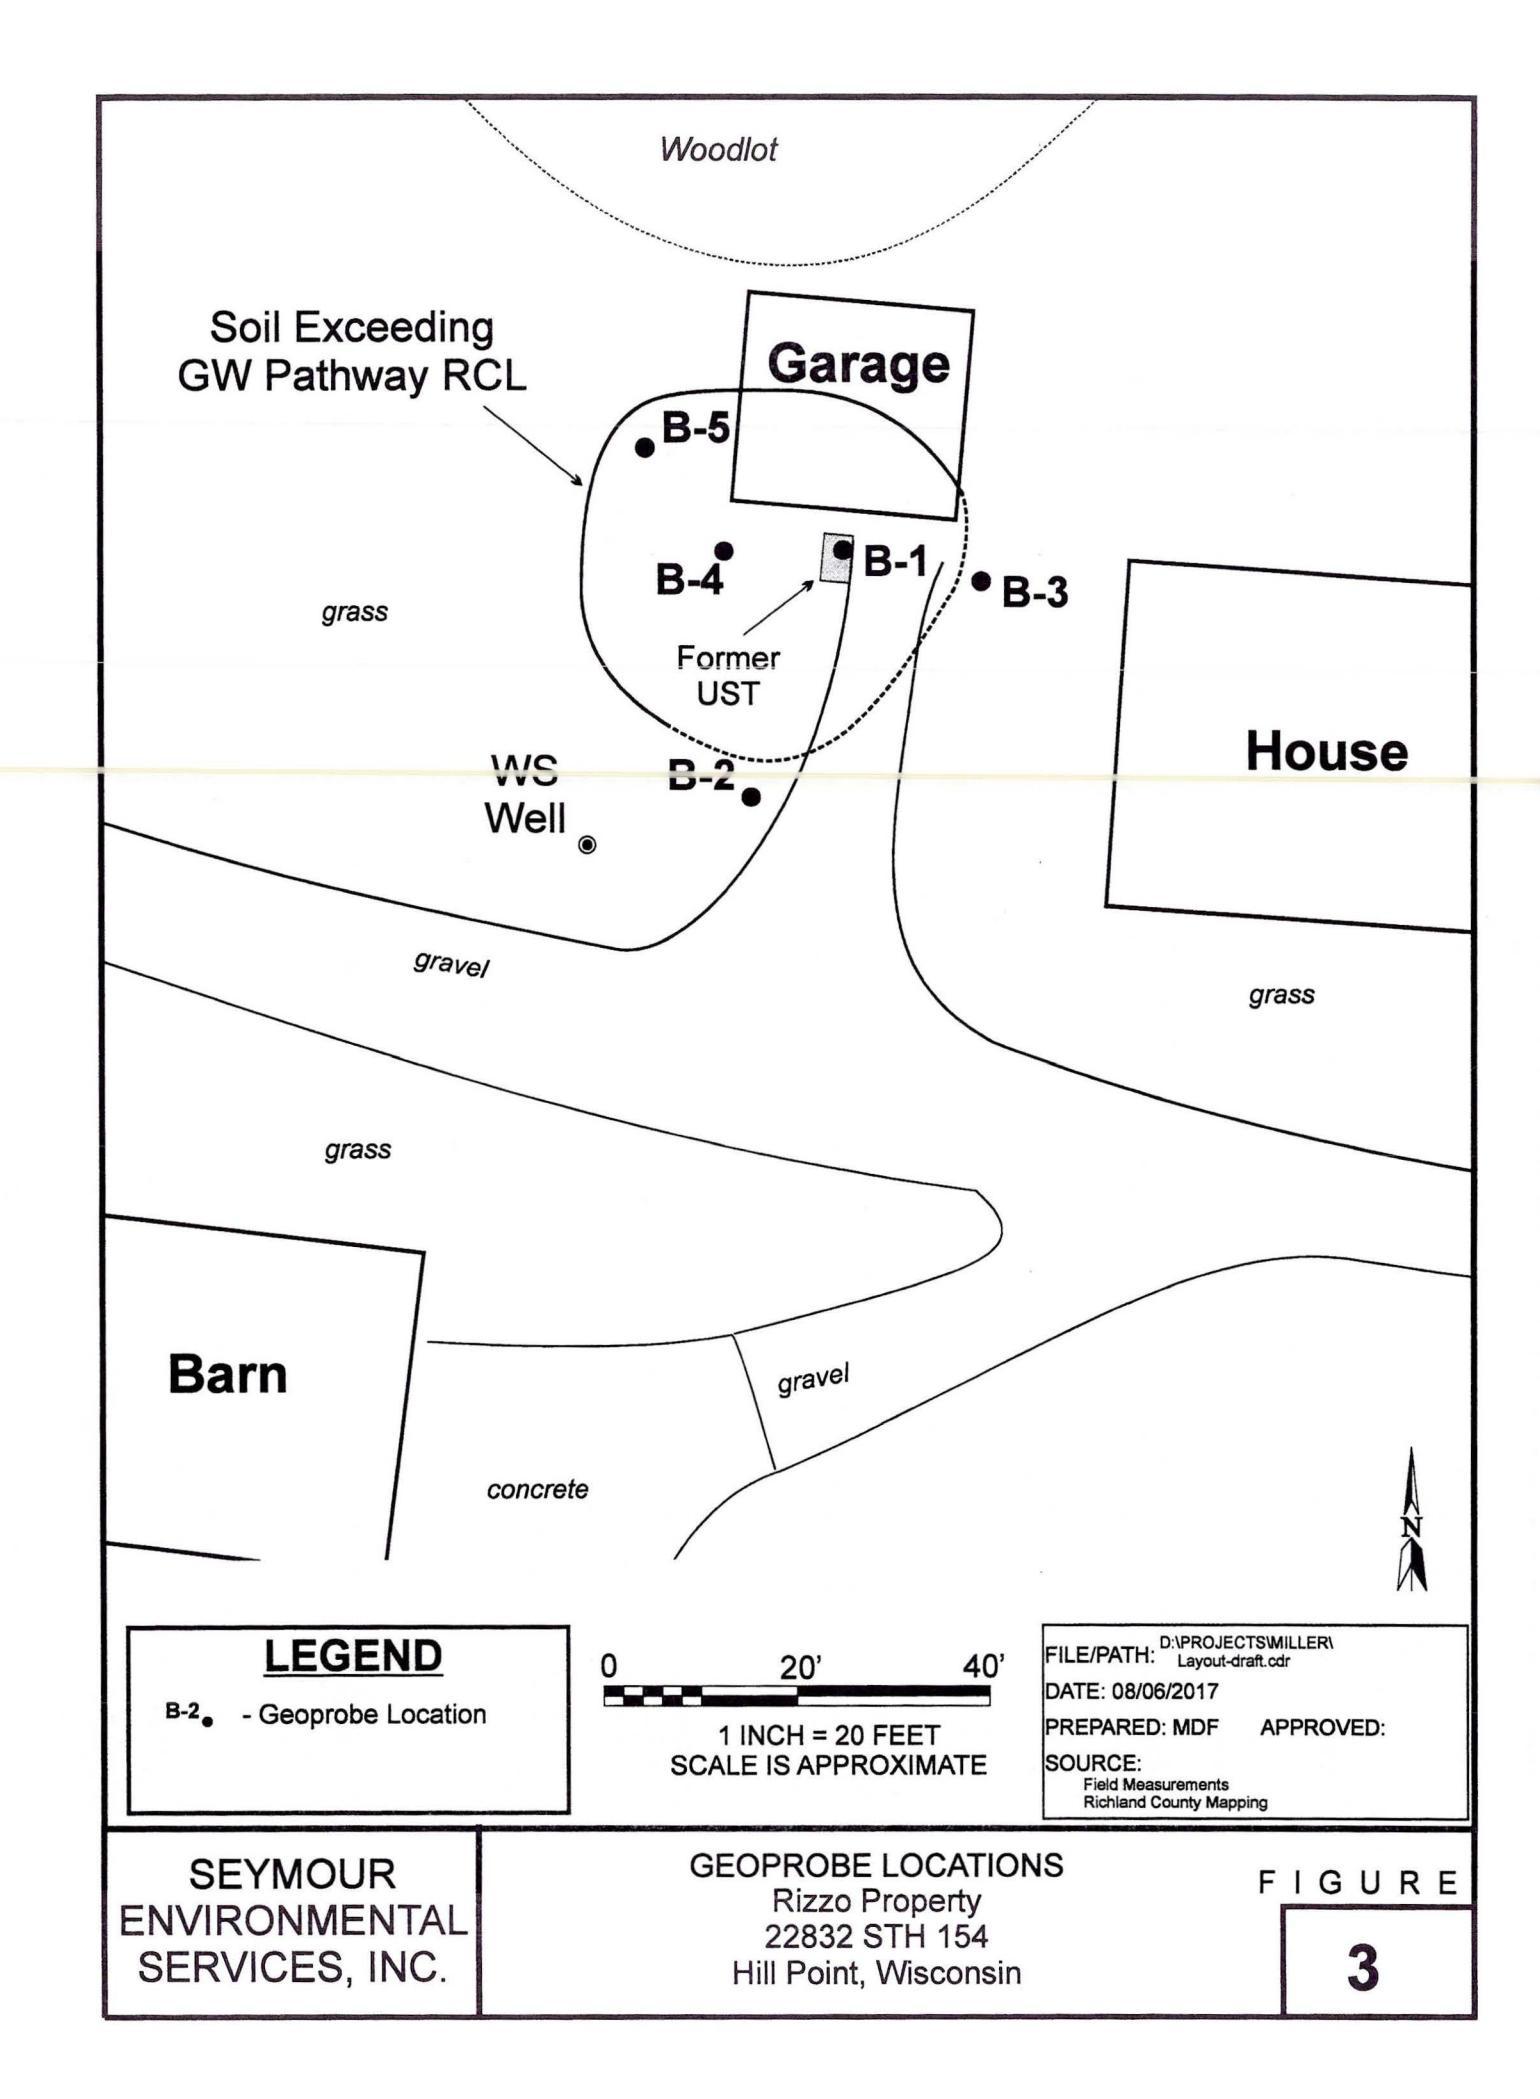
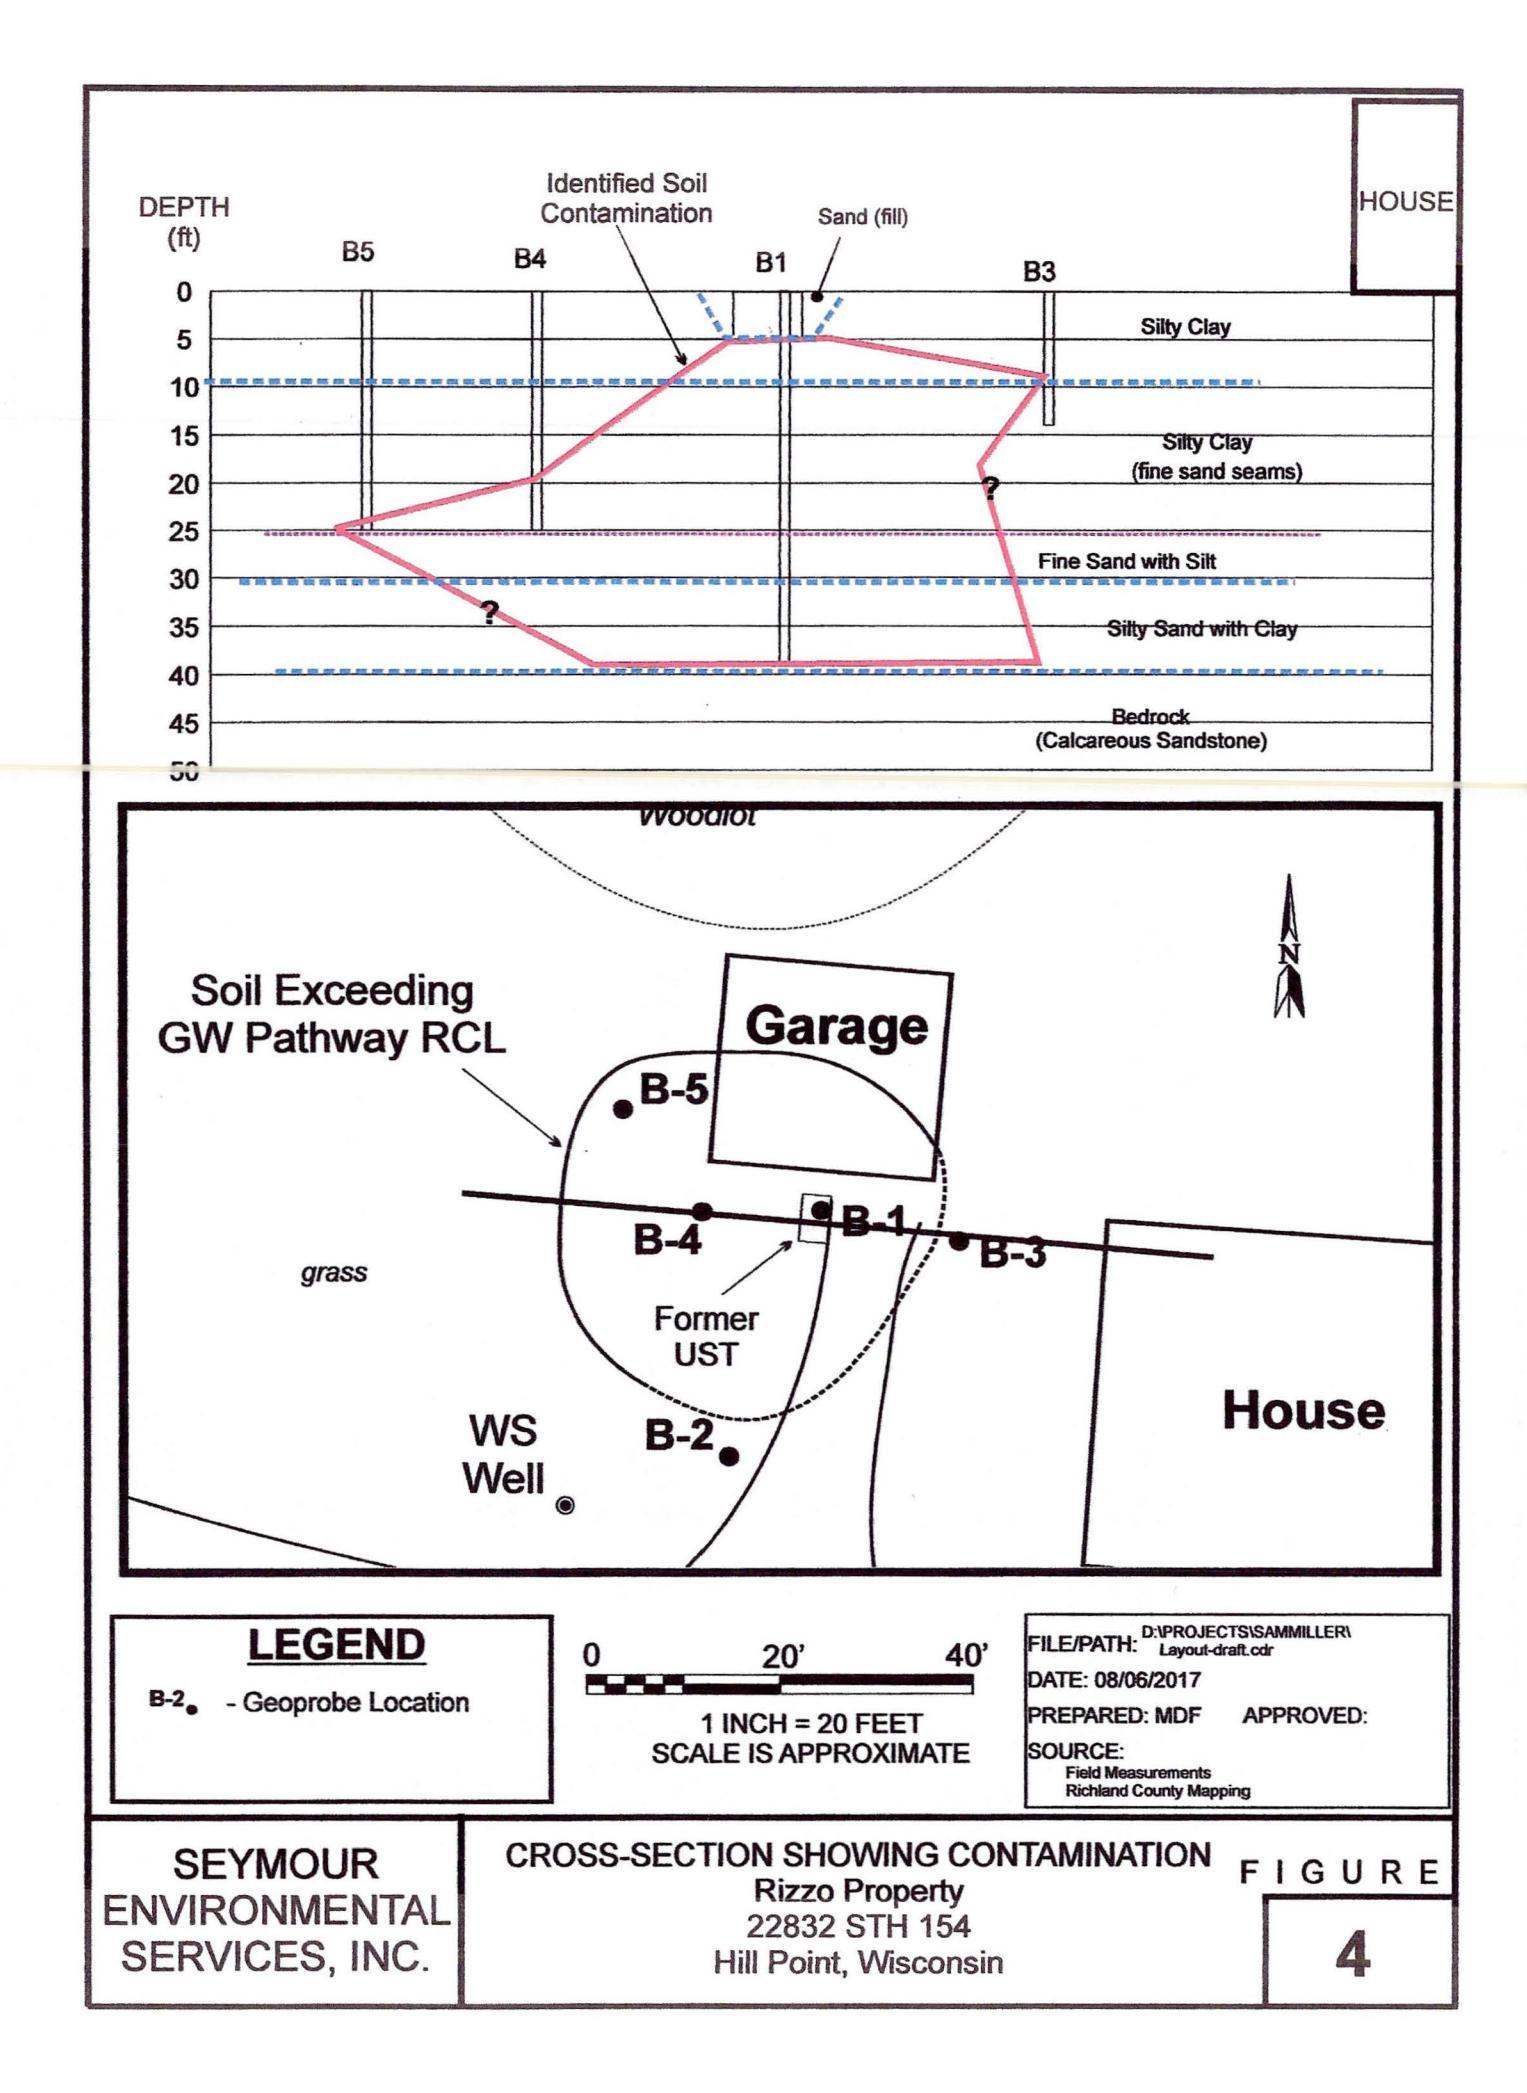
FIGURES

Seymour and On-site Environmental Services, Inc. (On-site) met at the site on June 30, 2017 to conduct the soil sampling. During the work five borings were installed at the site. Refusal was encountered in three of the borings which varied in depth from 14 to 39 feet below grade. Based on local water-supply well logs we believe that the refusal encountered at 39 feet was at the top of bedrock. Shallower refusal encountered at the other borings was likely caused by larger chert fragments within the colluvial deposits. The boring locations are shown on Figure 3.

The former UST and soil contamination is very near the private water supply well. We recommend excavation of the accessible contaminated soil to prevent future migration of the release to the groundwater and the water supply well. Because of the depth of the contamination it may not be possible to remove all of the contamination exceeding groundwater pathway RCLs. An estimated 800-1,000 yards of soil contamination is present. We would likely only be able to remove 400-500 yards due to the total depth of the contamination.
