RE: Change Order Request #2 for the Former Fox Auto Salvage (a/k/a Standard Oil) Property Located at 2423 Racine Street in the Village of Mount Pleasant, Wisconsin; ReadyEarth Project No. 13-0603; BRRTS No. 03-52-554541; PECFA No. 53403-3348-23

A.1 Groundwater Analytical Table (Pg 1 of 2) Fmr. Fox Auto Salvage (a/k/a Fmr. Standard Oil) 2423 Racine Street, Mt. Pleasant

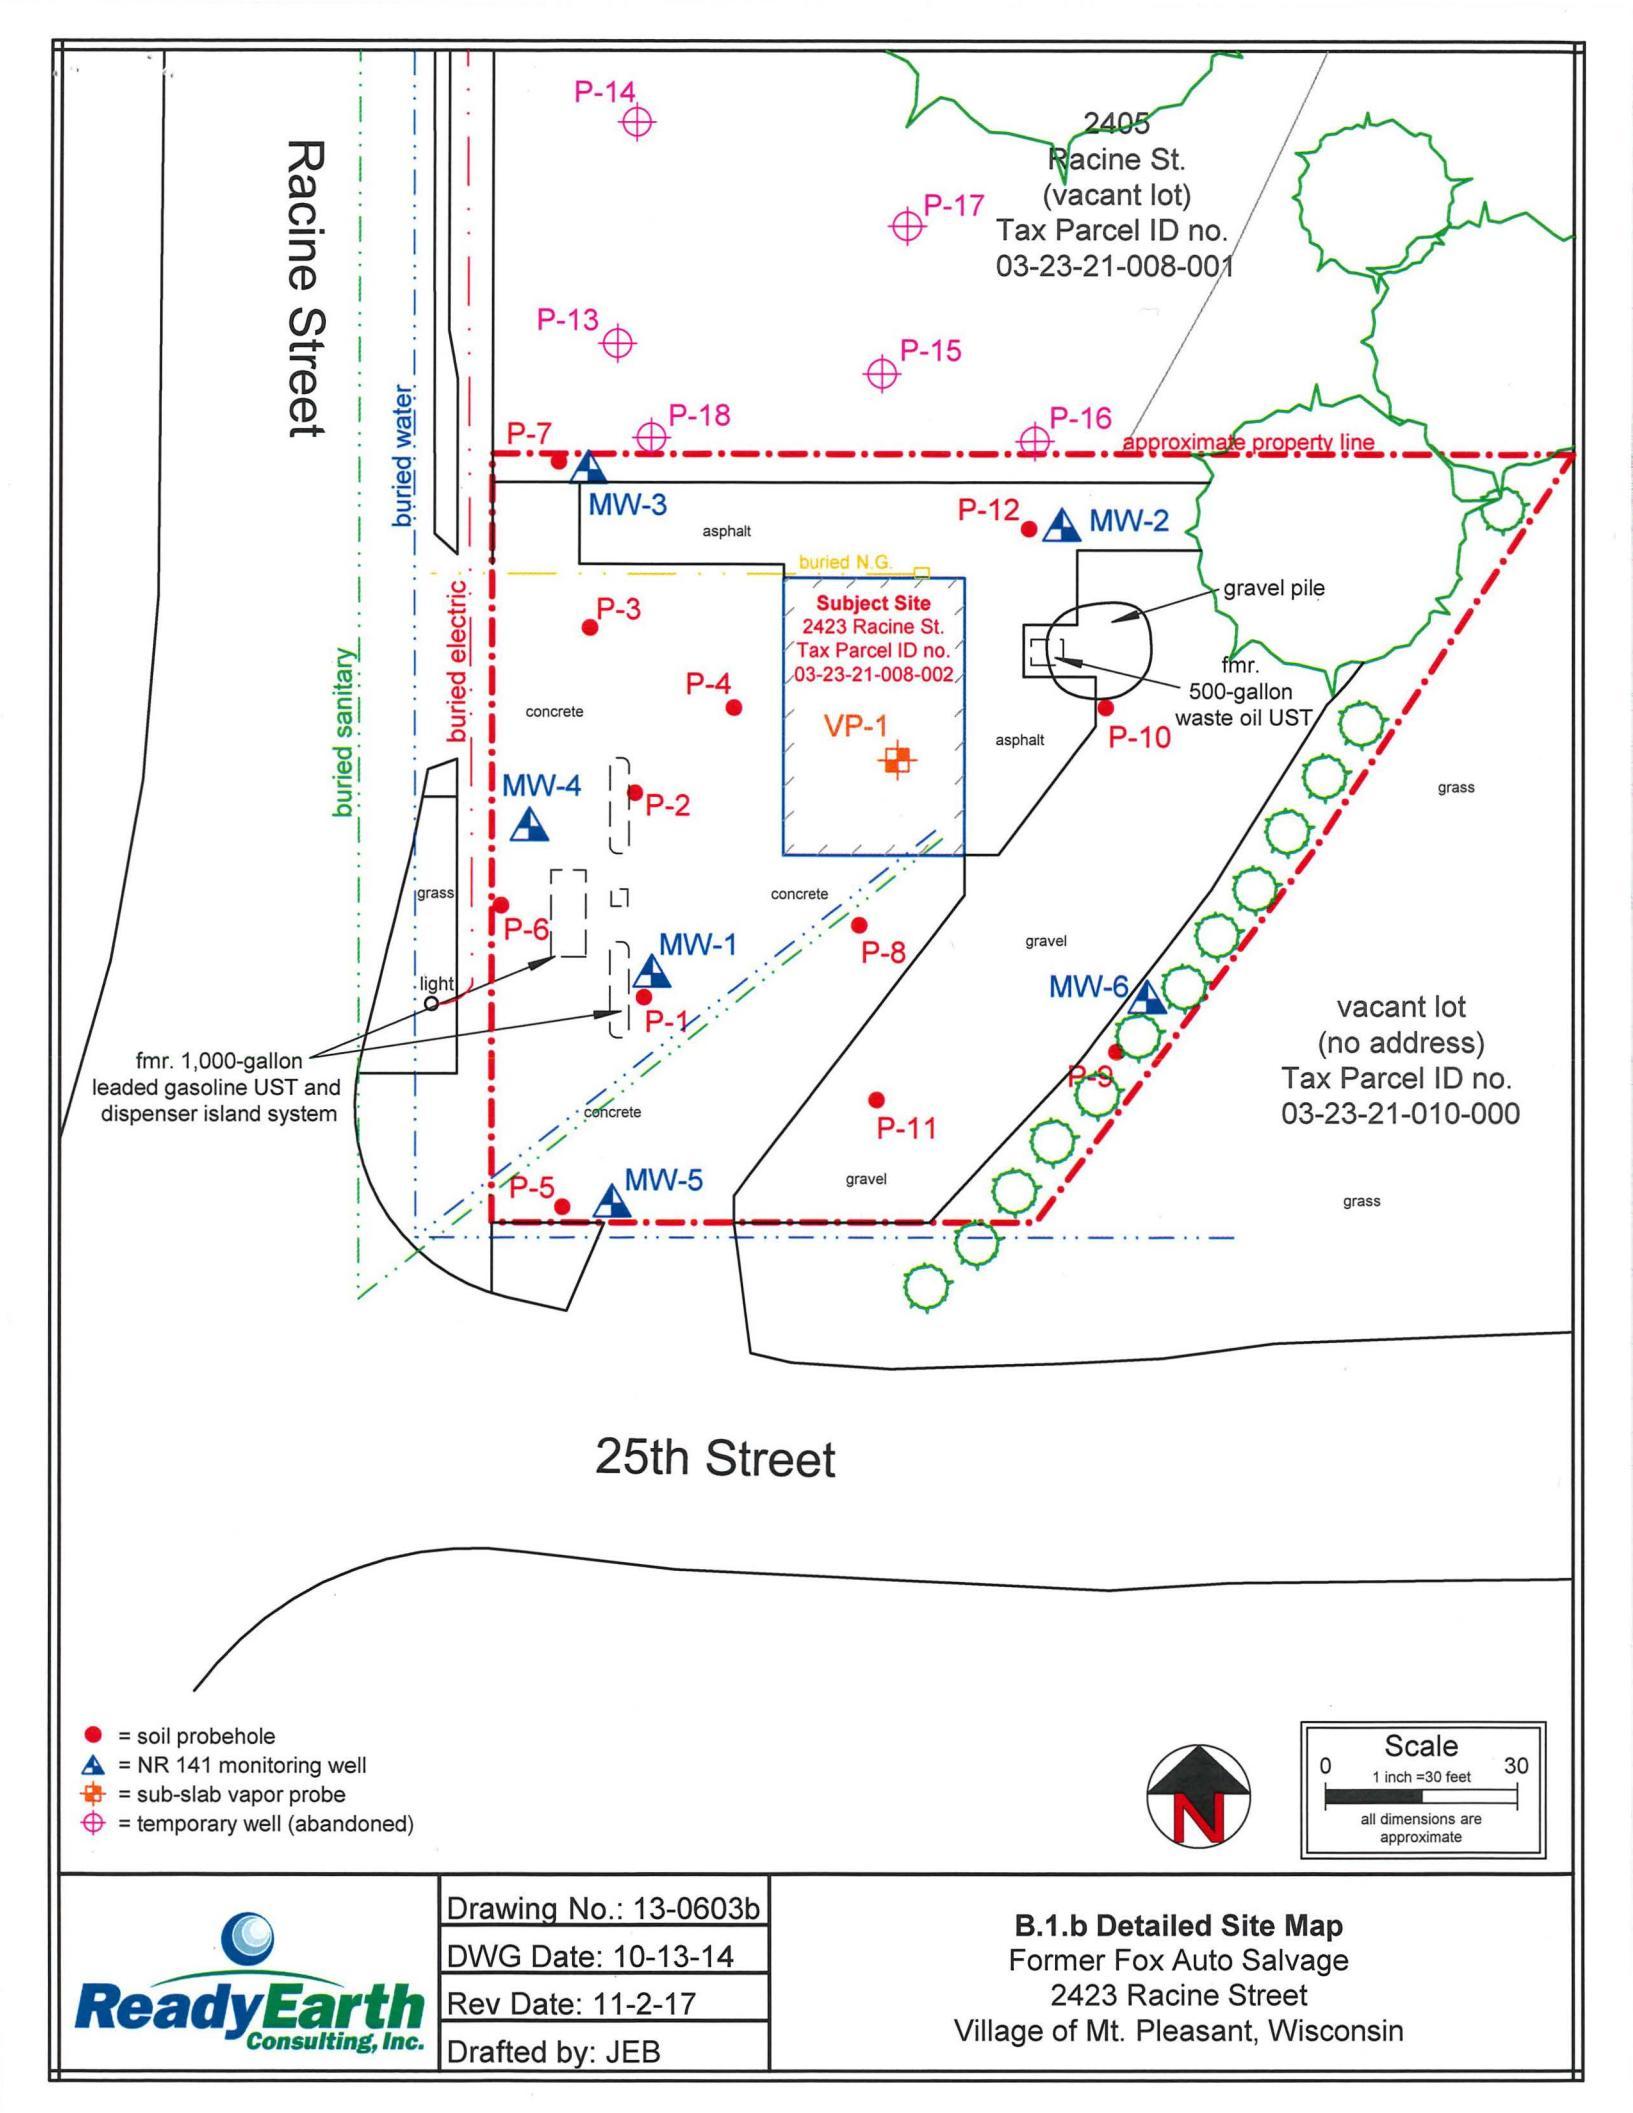
ReadyEarth documented the Site Investigation (SI) activities in our report dated December 23, 2016. The SI included advancing twelve probeholes, installing six NR 141 monitoring wells, and installing one sub-slab vapor sampling port. The attached Figure B.2.b illustrates the site features and sampling locations.

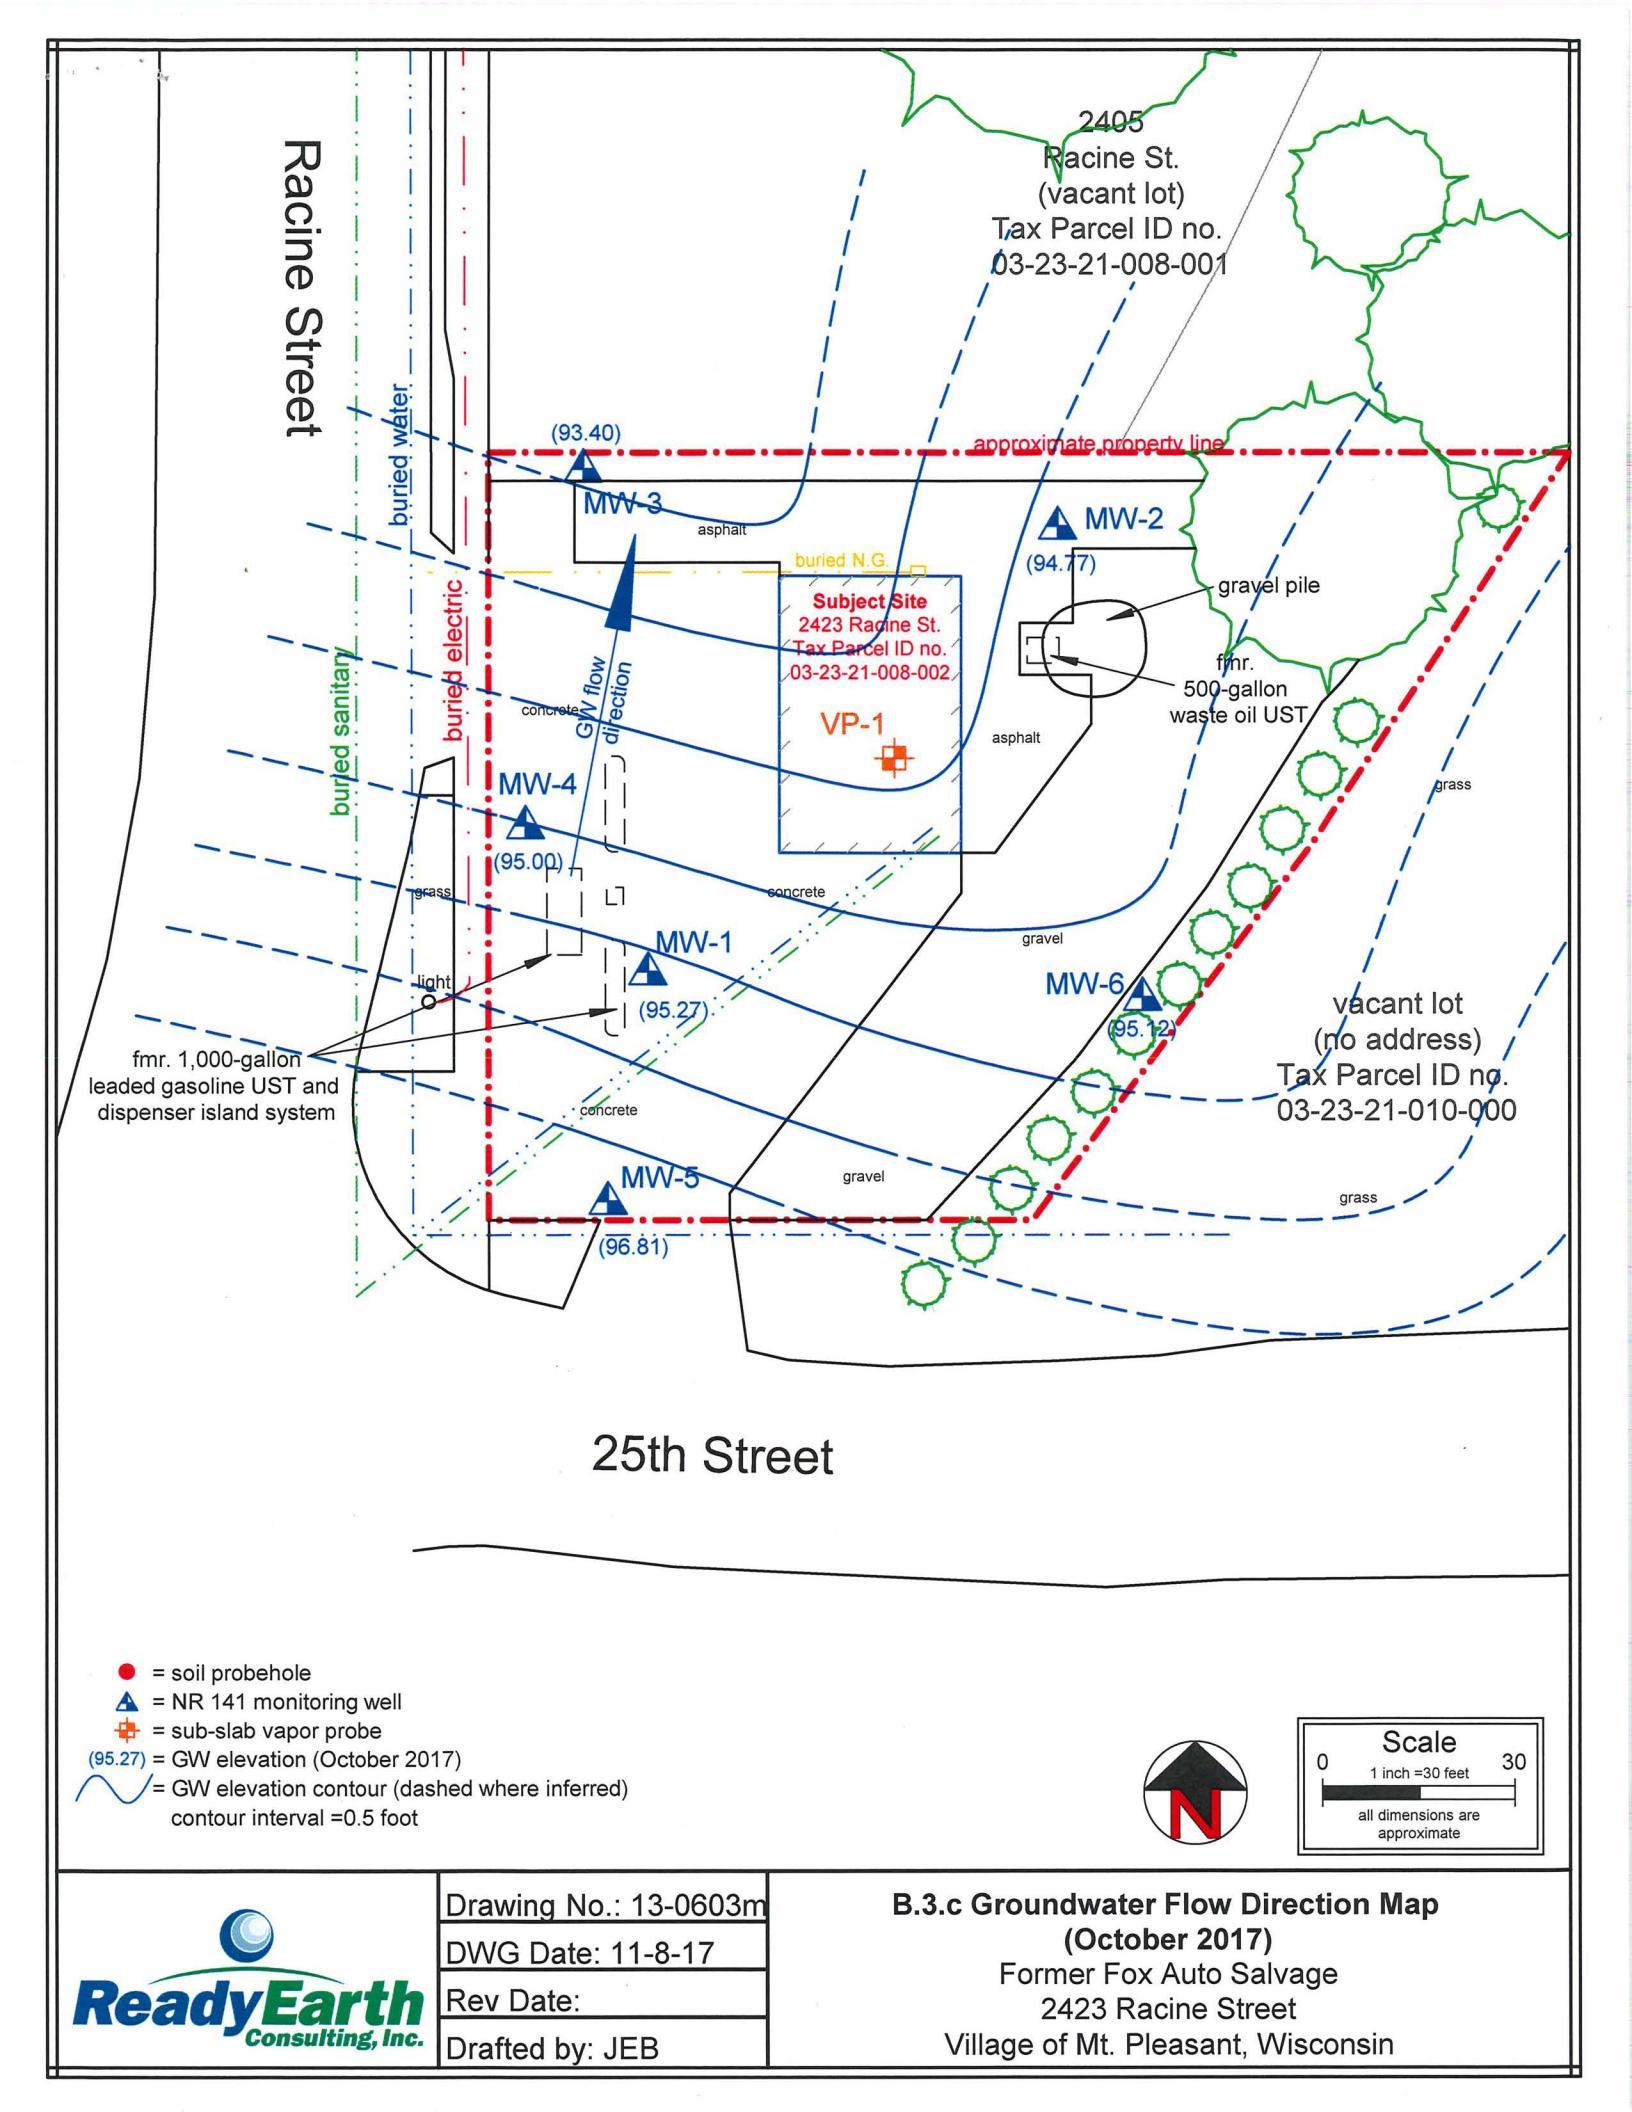
On October 20, 2017, ReadyEarth collected the final round of approved groundwater sampling at the site. The sampling included the six on-site NR 141 wells as well as the six off-site temporary wells. ReadyEarth abandoned each of the temporary wells immediately after sampling. Prior to sampling, ReadyEarth measured the depth to water in each well and temporary well to determine groundwater elevations (note that ReadyEarth did not survey the temporary wells). The attached Tables A.1 and A.6 summarize the groundwater data collected to date, and the attached Figure B.3.c illustrates the groundwater elevation contours for the October 2017 event.
