AQUATIC PLANT MANAGEMENT PLAN

**LYNX LAKE
VILAS COUNTY, WISCONSIN**

June 27, 2007
Revised August 6, 2007

Northern Environmental Technologies, Incorporated
1203 Storbeck Drive
Waupun, Wisconsin 53963

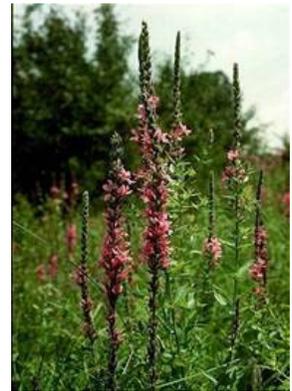
Purple Loosestrife (*Lythrum salicaria*)

Purple loosestrife is a perennial herb 3-7 feet tall with a dense bushy growth of 1-50 stems. The stems, which range from green to purple, die back each year. Showy flowers vary from purple to magenta, possess 5-6 petals aggregated into numerous long spikes, and bloom from July to September. Leaves are opposite, nearly linear, and attached to four-sided stems without stalks. It has a large, woody taproot with fibrous rhizomes that form a dense mat

Purple loosestrife was first detected in Wisconsin in the early 1930's, but remained uncommon until the 1970's. It is now widely dispersed in the state, and has been recorded in 70 of Wisconsin's 72 counties. Low densities in most areas of the state suggest that the plant is still in the pioneering stage of establishment. Areas of heaviest infestation are sections of the Wisconsin River, the extreme southeastern part of the state, and the Wolf and Fox River drainage systems.

This plant's optimal habitat includes marshes, stream margins, alluvial flood plains, sedge meadows, and wet prairies. It is tolerant of moist soil and shallow water sites such as pastures and meadows, although established plants can tolerate drier conditions. Purple loosestrife has also been planted in lawns and gardens, which is often how it has been introduced to many of our wetlands, lakes, and rivers. Purple loosestrife spreads mainly by seed, but it can also spread vegetatively from root or stem segments. A single stalk can produce from 100,000 to 300,000 seeds per year. Seed survival is up to 60-70%, resulting in an extensive seed bank. Mature plants with up to 50 shoots grow over 2 meters high and produce more than two million seeds a year. Germination is restricted to open, wet soils and requires high temperatures, but seeds remain viable in the soil for many years. Even seeds submerged in water can live for approximately 20 months (WDNR website, 2006).

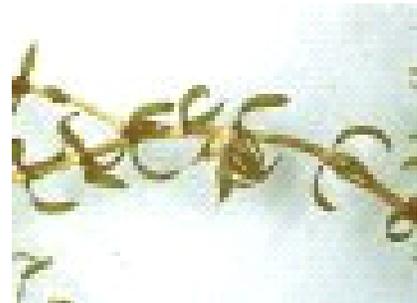
Elodea
Source: UW Herbarium Website

Elodea canadensis (Elodea or common waterweed) is an abundant native plant species that is distributed statewide. It prefers soft substrate and water depths to 15 feet (Nichols, 1999). Elodea reproduces by seed and sprigs (USDA, 2002). The stems of elodea offer shelter and grazing to fish, but very dense elodea can interfere with fish movement. Elodea can be considered invasive at times and out-competes other more desirable plants.

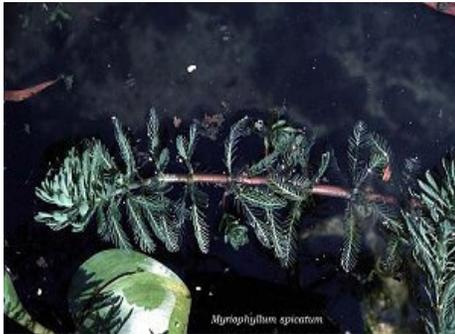
Eurasian watermilfoil
Source: UW Herbarium Website

Myriophyllum spicatum (Eurasian watermilfoil or EWM) is a submersed aquatic plant native to Europe, Asia and northern Africa. It was introduced to the United States by early European settlers. EWM was first detected in Wisconsin lakes during the 1960's. In the past three decades, this AIS has significantly expanded its range to about 61 of Wisconsin's 72 counties and continues to infest new water bodies every year. Because of its potential for explosive growth and its incredible ability to regenerate, EWM can successfully out-compete most native aquatic plants, especially in disturbed areas.

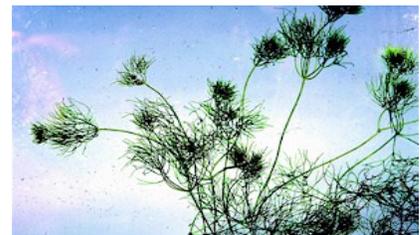
Nitella sp.
Source: UW Herbarium Website

Nitella sp. (Nitella) is a macroalgae that looks like a vascular plant. Nitella is similar in appearance to muskgrass and is often found in similar habitats. However, Nitella can be distinguished from muskgrass by its smooth stems and branches, which are smooth (Borman, et al., 1997).

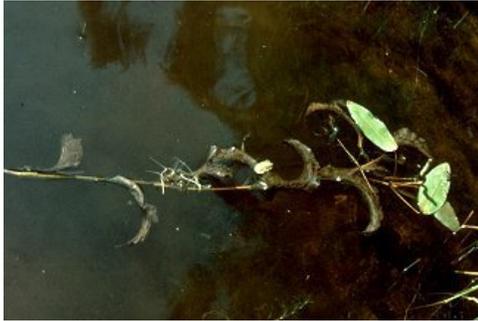
Large-leaf Pondweed
Source: UW Herbarium Website

Potamogeton amplifolius (Large-leaf Pondweed) is also often referred to as musky weed or cabbage by anglers. Large leaf pondweed has robust stems and broad submersed leaves, which are slightly folded and lined with many veins. Floating leaves are oval and on long stalks. It is found mainly in soft sediments in water one to several feet deep and is sensitive to increased turbidity. The plant is commonly grazed by waterfowl, offers habitat for invertebrates, and foraging opportunities for fish (Borman, e al., 1997).

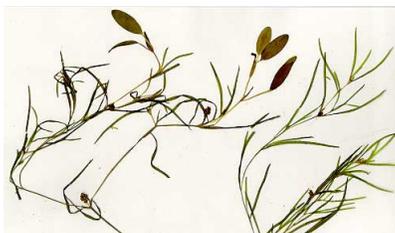
Spiral-Fruited Pondweed
Source: UW-Green Bay website

Potamogeton spirillus (Spiral-Fruited Pondweed) is another pondweed with frequently branched stems and narrow, submersed leaves. When present, the floating leaves are elliptical in shape. This can be easily distinguished from other narrow-leaved pondweeds by its spiral-shaped fruit. Spiral-fruited pondweed grows abundantly when present and is important in stabilizing the sediment in shallow water. It also provides a food source for waterfowl, habitat for invertebrates, and foraging opportunities for fish (Borman, et al., 1997).

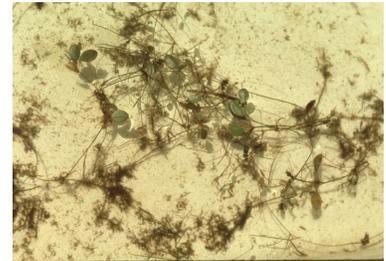
Vasey’s Pondweed
Source: UW Herbarium Website

Potamogeton vaseyi (Vasey’s Pondweed) is a rare aquatic plant in Wisconsin. Its fine, hair-like leaves may be confused with Water-Thread Pondweed (*Potamogeton diversifolius*) and/or Small Pondweed (Borman, et al., 1997). It is generally found in water 6 feet deep or less and produces small, elliptical floating leaves (Nichols, 1999). Vasey’s pondweed provides food for waterfowl, invertebrate habitat, and foraging opportunities for fish (Borman, et al., 1997).

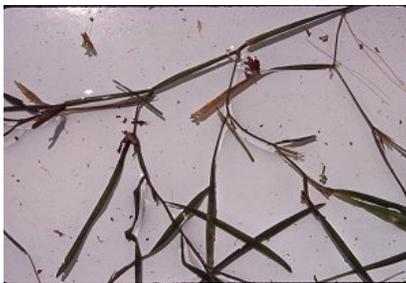
Flat- Stem Pondweed
Source: UW Herbarium Website

Potamogeton zosteriformis (Flat-Stem Pondweed) is a submergent pondweed with freely-branched flattened stems. Flat stem pondweed is commonly confused with water stargrass (*Heteranthera dubia*) but Flat-stem Pondweed can be distinguished by its prominent mid-vein and many fine, parallel veins.

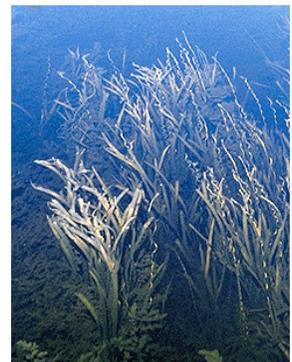
Wild Celery
Source: UW Herbarium Website

Valisneria americana (Wild Celery) also known as eel-grass or tape-grass, and has ribbon-like leaves that tend to grow until they emerge in clusters along the water surface. Wild celery is a premiere source of food for waterfowl. All portions of the plant are consumed. Beds of wild celery are also considered good fish habitat providing shade, shelter and feeding opportunities (Borman, et al., 1997).
