AQUATIC PLANT MANAGEMENT PLAN

**DUCK LAKE
VILAS COUNTY, WISCONSIN**

June 22, 2007
Revised August 6, 2007

Northern Environmental Technologies, Incorporated
1203 Storbeck Drive
Waupun, Wisconsin 53963

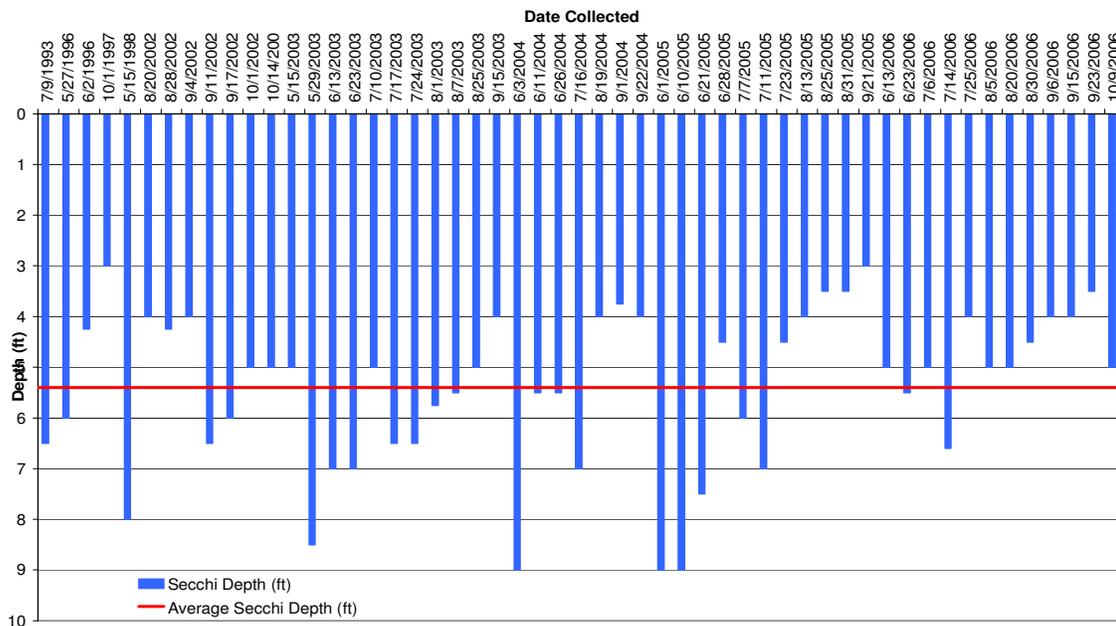
Duck Lake Secchi Readings

The historical water clarity average is 5.4 feet (1.6 meters). The following graph illustrates historical and current water clarity measurements on Duck Lake.

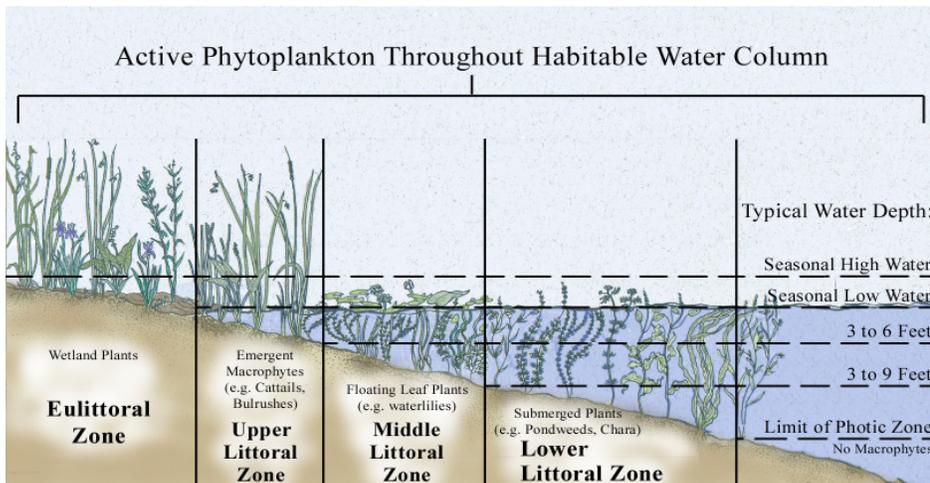
Aquatic Plant Communities Schematic

In contrast, macrophytes are predominantly found in distinct habitats located in the littoral (i.e., shallow near shore) zone where light sufficient for photosynthesis can penetrate to the lake bottom. The littoral zone is subdivided into four distinct transitional zones: the eulittoral, upper littoral, middle littoral, and lower littoral (Wetzel, 1983).

- Eulittoral Zone:** Includes the area between the highest and lowest seasonal water levels, and often contains many wetland plants.
- Upper Littoral Zone:** Dominated by emergent macrophytes and extends from the shoreline edge to water depths between 3 and 6 feet.
- Middle Littoral Zone:** Occupies water depths of 3 to 9 feet, extending deeper from the upper littoral zone. The middle littoral zone is often dominated by floating-leaf plants.
- Lower Littoral Zone:** Extends to a depth equivalent to the limit of the photic zone, which is the maximum depth that sufficient light can support photosynthesis. This area is dominated by submergent aquatic plant types.

The following illustration depicts these particular zones and aquatic plant communities.

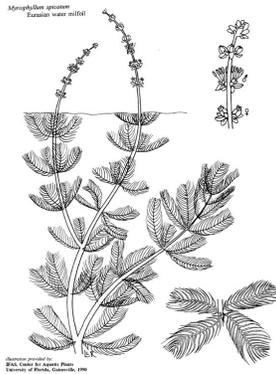
Eurasian Watermilfoil (*Myriophyllum spicatum*)

EWM is the most common AIS found in Wisconsin lakes. EWM was first discovered in southeast Wisconsin in the 1960's. During the 1980's, EWM began to spread to other lakes in southern Wisconsin and by 1993 it was common in 39 Wisconsin counties. EWM continues to spread across Wisconsin and is now found in the far northern portion of the state including Vilas and Oneida Counties.

Unlike many other plants, EWM does not rely on seed for reproduction. Its seeds germinate poorly under natural conditions. It reproduces vegetatively by fragmentation, allowing it to disperse over long distances. The plant produces fragments after fruiting once or twice during the summer. These shoots may then be carried downstream by water currents or inadvertently picked up by boaters. EWM is readily dispersed by boats, motors, trailers, bilges, live wells, or bait buckets, and can stay alive for weeks if kept moist (WDNR website, 2006).

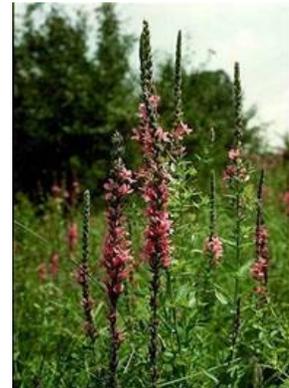
Purple Loosestrife (*Lythrum salicaria*)

Purple loosestrife is a perennial herb 3-7 feet tall with a dense bushy growth of 1-50 stems. The stems, which range from green to purple, die back each year. Showy flowers vary from purple to magenta, possess 5-6 petals aggregated into numerous long spikes, and bloom from July to September. Leaves are opposite, nearly linear, and attached to four-sided stems without stalks. It has a large, woody taproot with fibrous rhizomes that form a dense mat

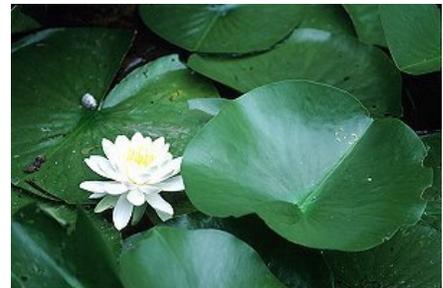
White Water Lily
Source: UW Herbarium Website

Nymphaea odorata (White Water Lily) has a flexible stalk with a round floating leaf. White Water Lily can be found growing in a variety of sediment types in less than 6 feet of water. Fragrant white flowers occur throughout the summer. The floating leaves provide shelter and shade for fish as well as habitat for invertebrates (Borman, et al., 1997).

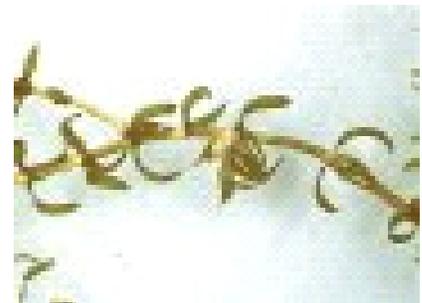
Elodea
Source: UW Herbarium Website

Elodea canadensis (Elodea or common waterweed) is an abundant native plant species that is distributed statewide. It prefers soft substrate and water depths to 15 feet (Nichols, 1999). Elodea reproduces by seed and sprigs (USDA, 2002). The stems of elodea offer shelter and grazing to fish, but very dense elodea can interfere with fish movement. Elodea can be considered invasive at times and out-competes other more desirable plants.

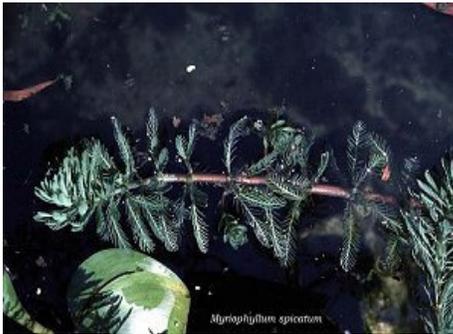
Eurasian watermilfoil
Source: UW Herbarium Website

Myriophyllum spicatum (Eurasian watermilfoil or EWM) is a submersed aquatic plant native to Europe, Asia and northern Africa. It was introduced to the United States by early European settlers. EWM was first detected in Wisconsin lakes during the 1960's. In the past three decades, this AIS has significantly expanded its range to about 61 of Wisconsin's 72 counties and continues to infest new water bodies every year. Because of its potential for explosive growth and its incredible ability to regenerate, EWM can successfully out-compete most native aquatic plants, especially in disturbed areas.

Eurasian watermilfoil shows no substrate preference in most instances and can grow in water depths greater than 4 meters (Nichols, 1999). Dense beds of EWM are usually identified in soft/organic rich sediments in many lakes. Eurasian watermilfoil can reproduce by seeds, but its main form of reproduction is vegetatively by fragmentation, allowing it to disperse over long distances. The plant produces fragments after fruiting once or twice during the summer. These shoots may then be carried by water currents or inadvertently picked up by boaters. EWM is readily dispersed by boats, motors, trailers, bilges, live wells, or bait buckets, and can stay alive for weeks if kept moist. Once established in an aquatic community, EWM reproduces from shoot fragments and stolons (runners that creep along the substrate).

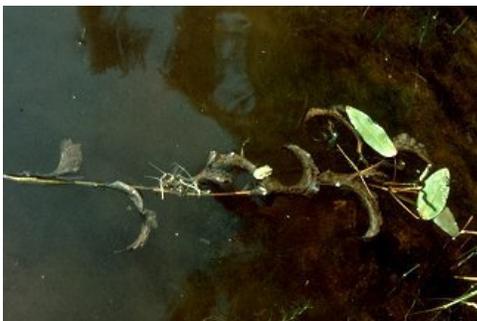
Large-leaf Pondweed
Source: UW Herbarium Website

Potamogeton amplifolius (Large-leaf Pondweed) is also often referred to as musky weed or cabbage by anglers. Large leaf pondweed has robust stems and broad submersed leaves, which are slightly folded and lined with many veins. Floating leaves are oval and on long stalks. It is found mainly in soft sediments in water one to several feet deep and is sensitive to increased turbidity. The plant is commonly grazed by waterfowl, offers habitat for invertebrates, and foraging opportunities for fish (Borman, et al., 1997).

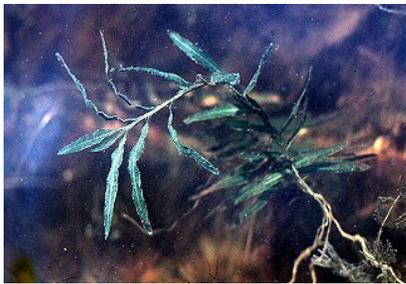
Fern Pondweed
Source: UW Herbarium Website

Potamogeton robbinsii (Fern Pondweed) is a submergent pondweed with robust stems and strongly two-ranked leaves, creating a feather or fern-like appearance while in the water. Fern pondweed sprouts in the spring and thrive in deeper water. Fern pondweed provides habitat for invertebrates that are grazed by waterfowl and also offers good cover for fish, particularly northern pike (Borman, et al., 1997).

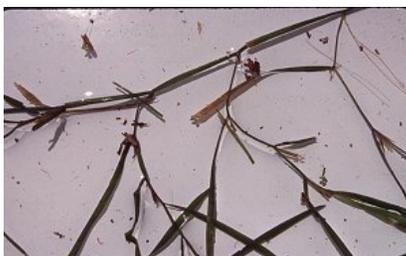
Flat- Stem Pondweed
Source: UW Herbarium Website

Potamogeton zosteriformis (Flat-Stem Pondweed) is a submergent pondweed with freely-branched flattened stems. Flat stem pondweed is commonly confused with water stargrass (*Zosterella dubia*) but Flat-stem Pondweed can be distinguished by its prominent mid-vein and many fine, parallel veins.
