Re: Rhinelander Hydroelectric Project, FERC Project No. 2161  
Invasive Species Survey Report 2010 and Request for Extension to file  
Comprehensive Report

2010  
INVASIVE SPECIES REPORT  
FOR THE  
RHINELANDER HYDROELECTRIC PROJECT  
ONEIDA COUNTY, WISCONSIN  
FERC Project No. 2161

October 2010

Prepared By  
North American Hydro, Inc.  
P.O. Box 167  
116 State Street  
Neshkoro, Wisconsin 54960  
(920) 293-4628

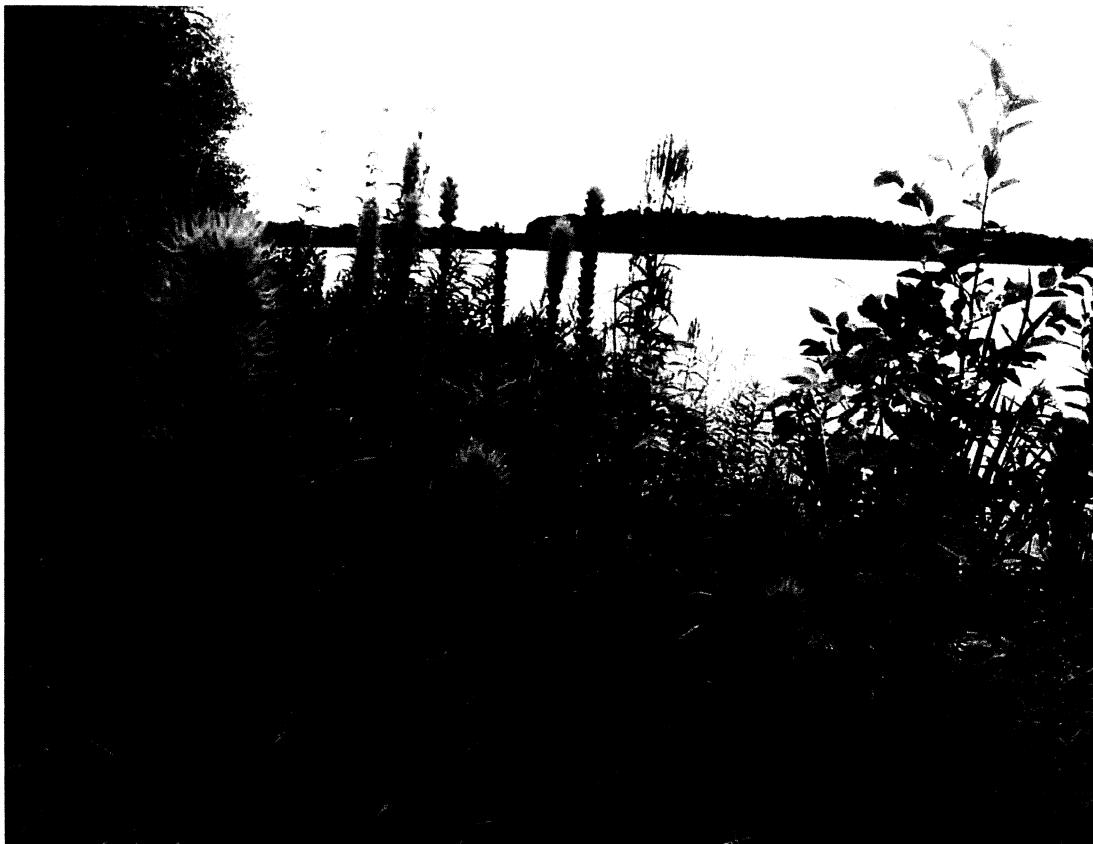
**BLAZING STAR/GAYFEATHER PLANTS IN PLANTING AREA OF HODAG PARK NEAR FISHING PIER OBSERVED IN 2010**

Comments received from the Wisconsin Department of Natural Resources regarding the survey performed in 2009 stated that information had been received indicating that PL plants may exist in the area of the Hodag Park fishing pier. In 2010, the survey crew increased efforts in this area by performing a pedestrian survey from the boat launch on the west end of the park to the east side of the swimming beach on the east end of the park. Although a number of plants that resemble PL were found in the planting areas of this location, no PL plants were found.
