MARENGO RIVER WATERSHED PARTNERSHIP PROJECT WATERSHED ACTION PLAN

**Bad River Watershed Association
P.O. Box 875
Ashland, WI 54806**

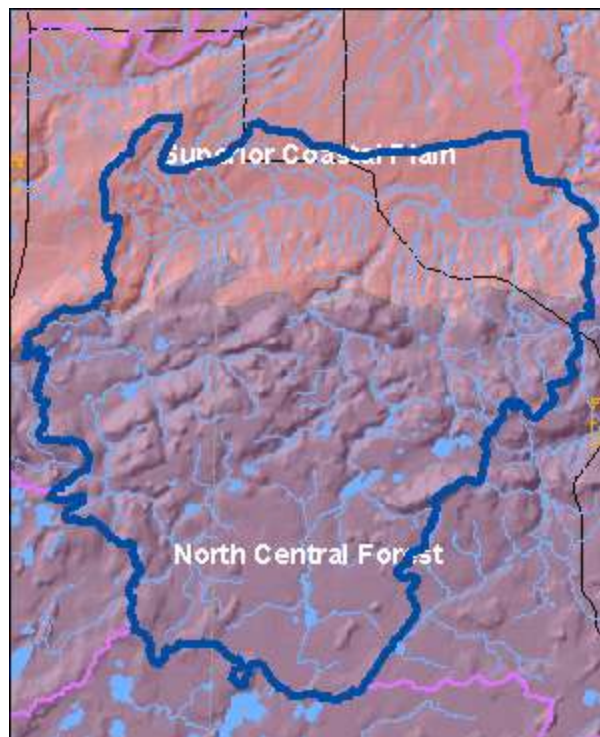
Figure 2.9. Ecological Landscapes in the Marengo River Watershed (WDNR 2010a).

Two Ecological Landscapes occur within the Marengo River Watershed, the Superior Coastal Plain Landscape covering the northern third; and the North Central Forest Landscape covering the southern two thirds of the watershed (Figure 2.9).

The Superior Coastal Plain is Wisconsin's northernmost Ecological Landscape. Its major landform is a nearly level plain of lacustrine clays that slopes gently northward toward Lake Superior. Historically the Superior Coastal Plain was almost entirely forested and included a distinctive mixture of white pine, white spruce, balsam fir, paper birch, balsam poplar, trembling aspen, and white cedar (Figure 2.3).

The North Central Forest has landforms characterized by end and ground moraines with some pitted outwash and bedrock controlled areas. Kettle depressions and steep ridges are found in the northern portion. Soils consist of sandy loam, sand, and silts. The historic vegetation was primarily hemlock-hardwood forest dominated by hemlock, sugar maple, and yellow birch (Figure 2.3).

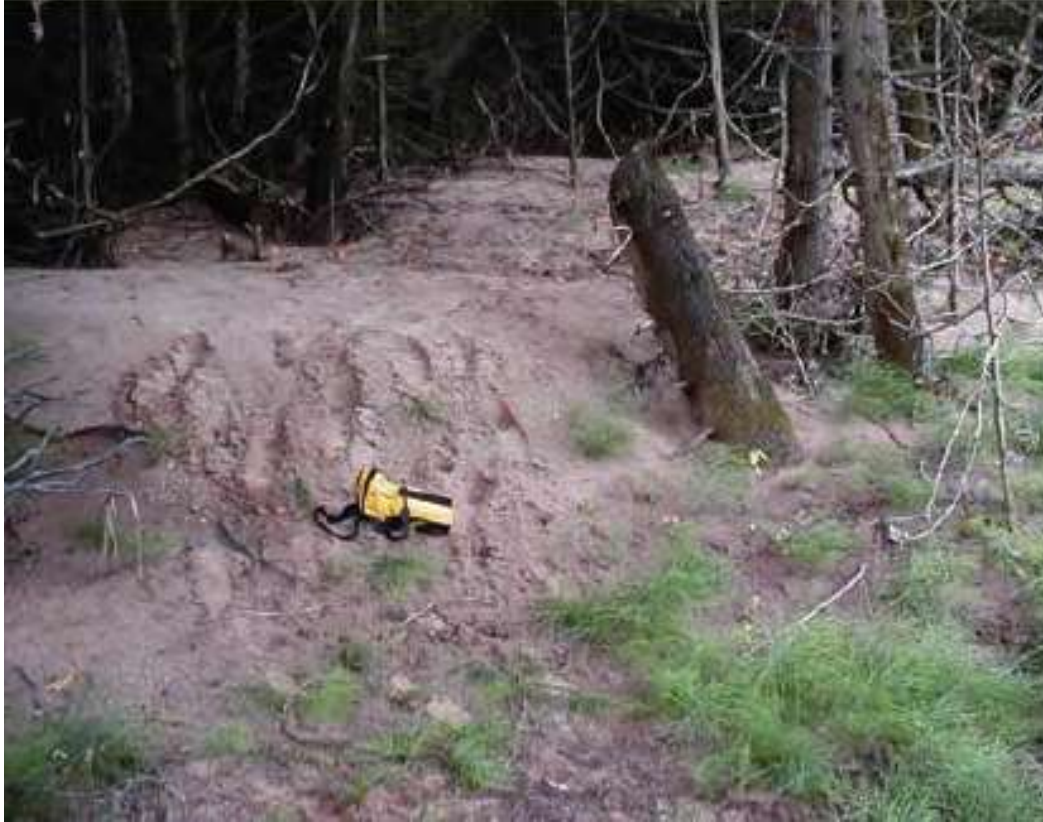
Figure 2.13. Levee building as a result of sand deposition near the mouth of the Marengo River (photo courtesy of Bad River Natural Resources Department).

Excessive lateral migration and channel instability exist at the confluence of the Marengo and Bad Rivers. Increased overbank sedimentation (levee building) disconnects the river from its floodplain and increases flood power to downstream reaches (Fitzpatrick 2005). The overbank sedimentation is primarily sand, presumably eroded from the wave-planned topography in the soil transition zone (Figure 2.13).

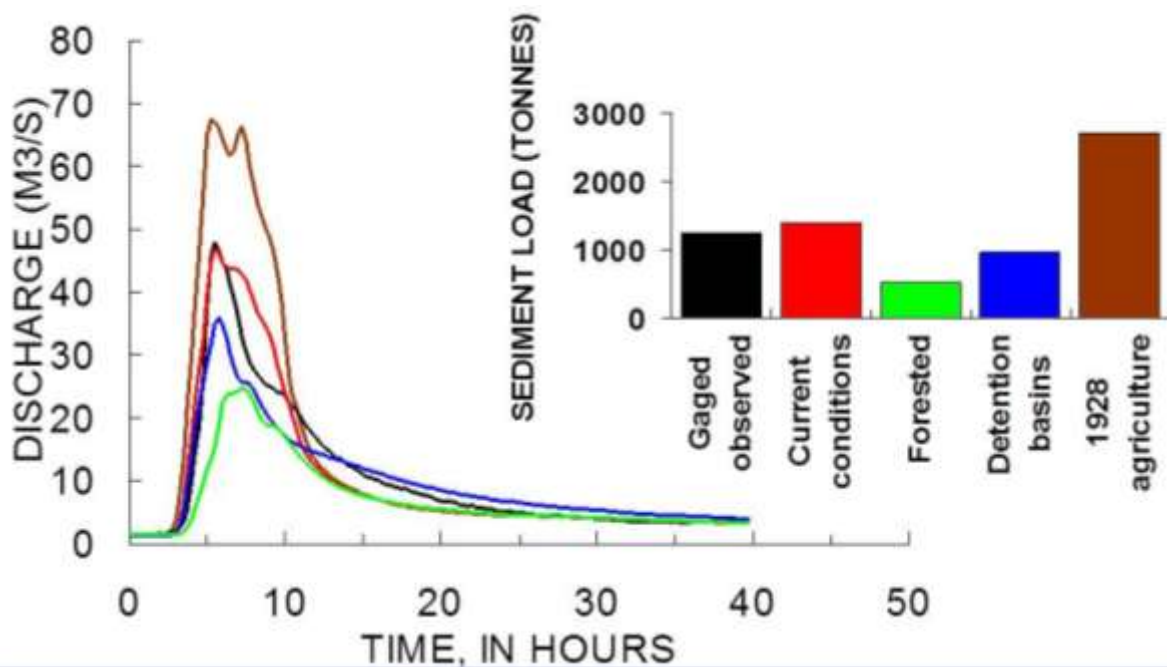
Figure 2.16. Storm hydrographs and sediment loads for North Fish Creek near Moquah, WI, for a historical storm on September 3, 1991, under four land-cover conditions (Fitzpatrick et al. 1999).

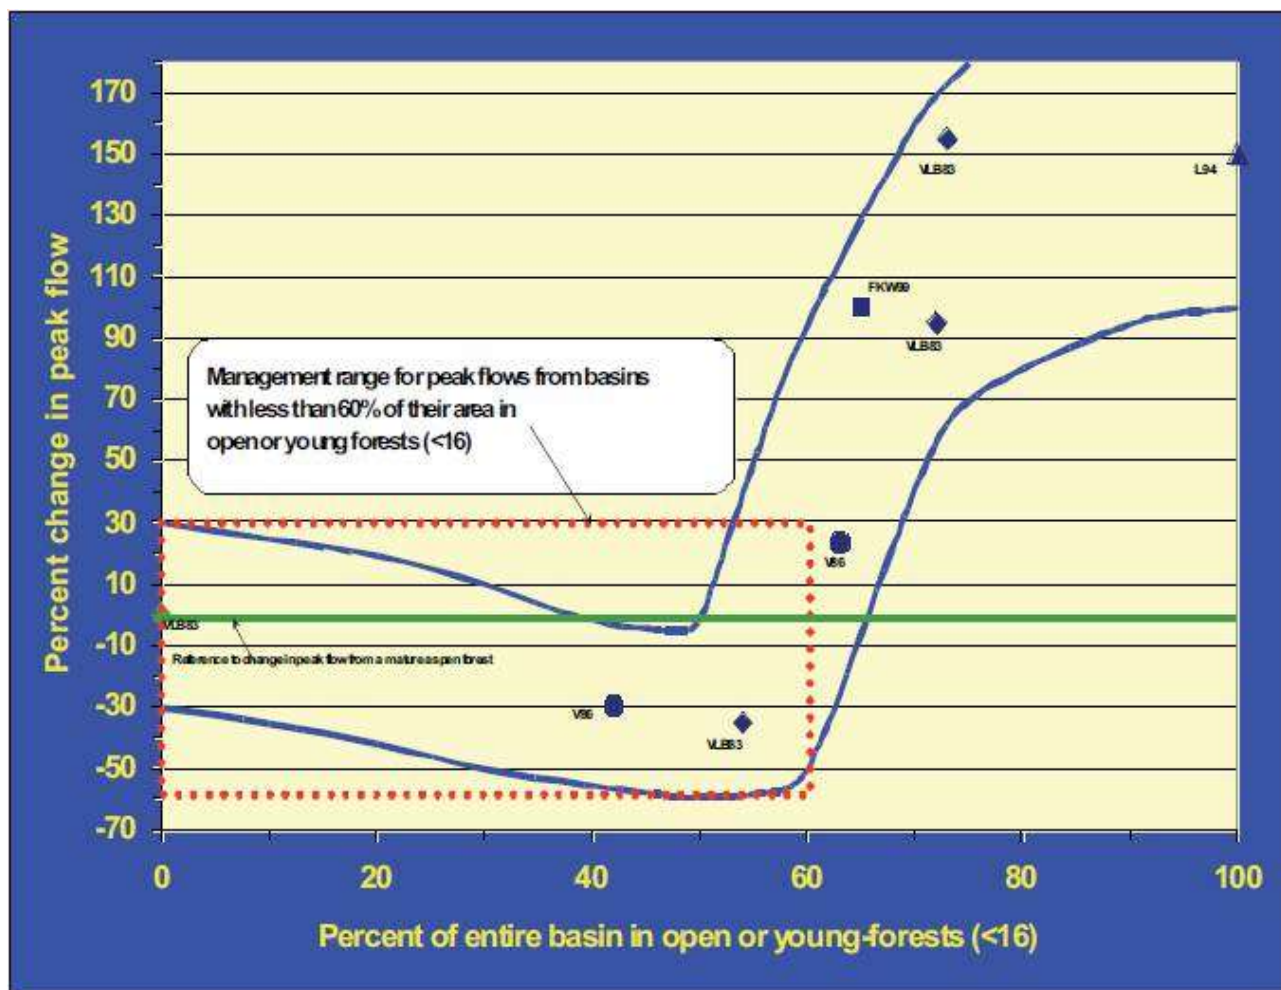
Figure 2.17. Relationship of the amount of open land in a subwatershed to the change in peak flow (Verry, 2001).

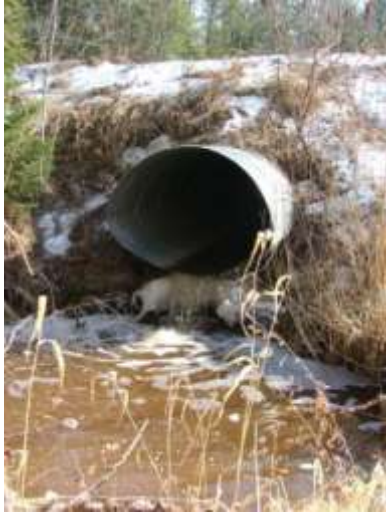
Figure 2.25. Example of a typical perched culvert in the Marengo River Watershed.

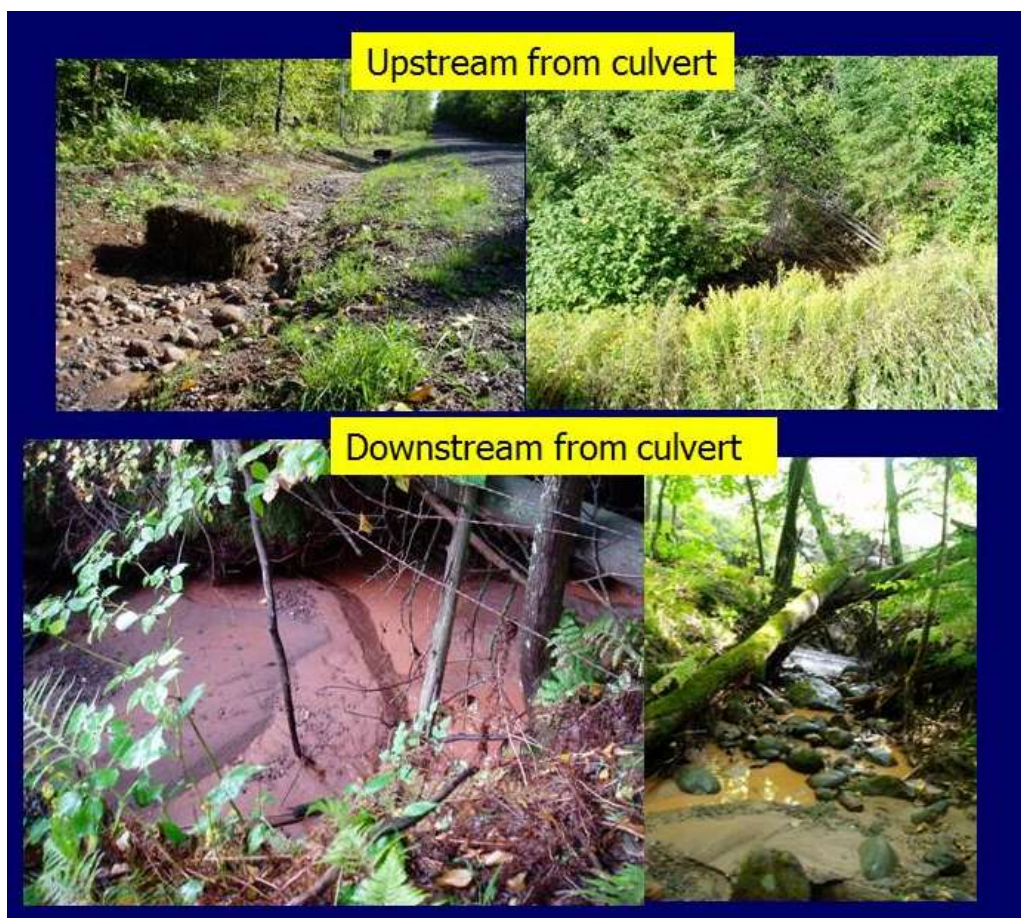
Figure 2.26. Examples of typical road/stream interaction at culverts in the soil transition zone of the Marengo River Watershed (courtesy of F. Fitzpatrick). Sediment accumulation upstream and erosion downstream.

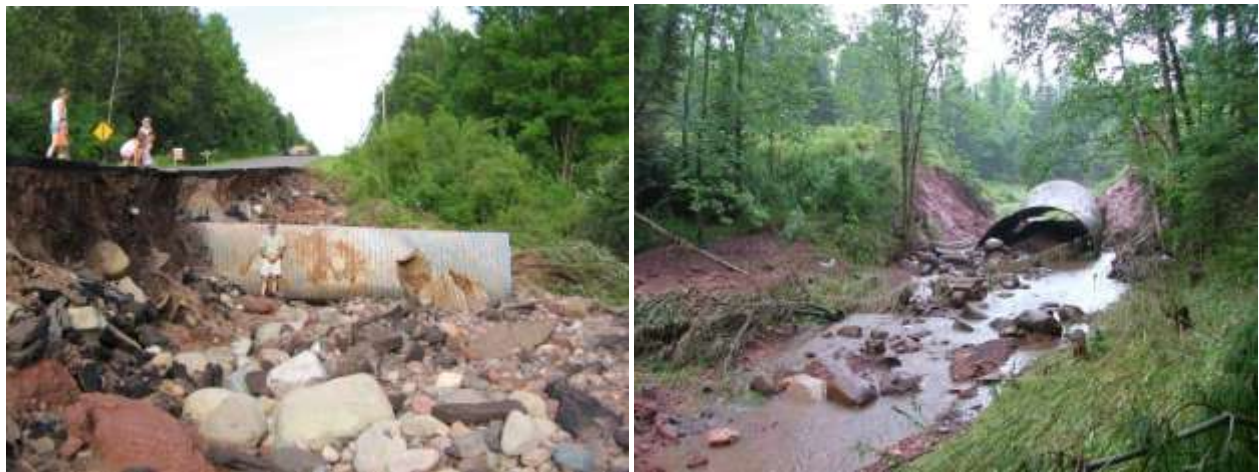
Figure 2.27. Examples of failed culverts in the Marengo River Watershed.

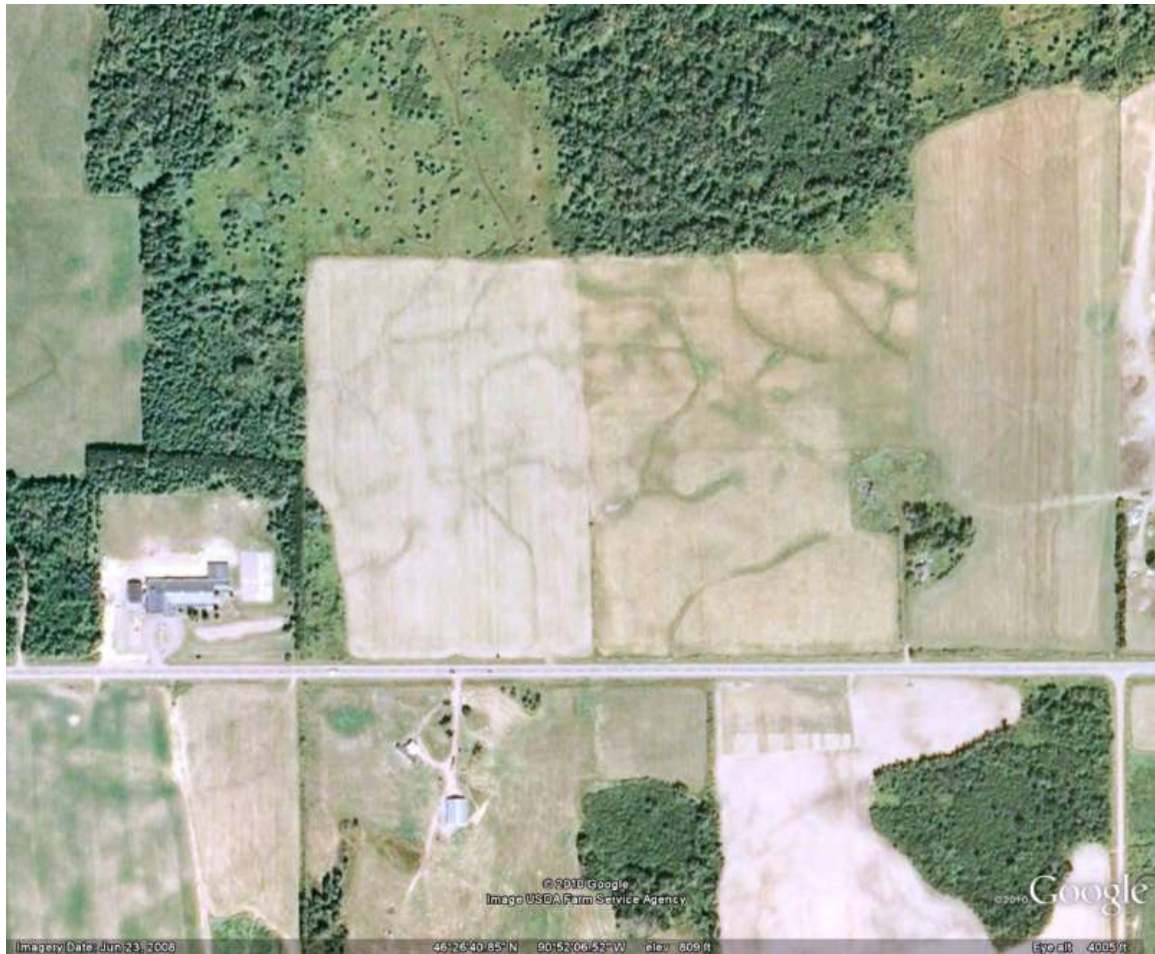
Figure 2.28. Aerial photo showing an example of an existing agricultural drainage network in the Marengo River Watershed (photo – USDA Farm Service Agency 2008, from Google Earth).

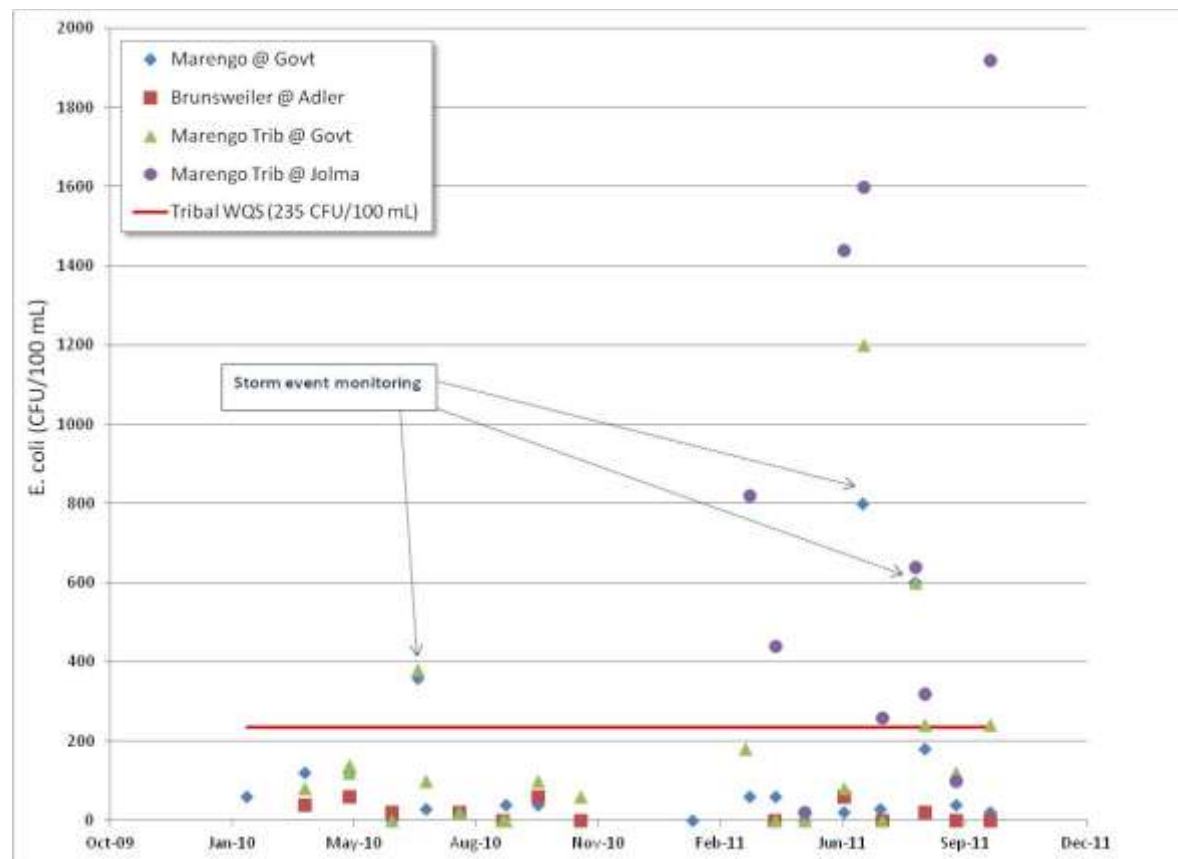
Figure 2.36. Bad River Natural Resources Department *E. coli* data collected from 2010-2011 at four monitoring locations within the Reservation boundaries. The Tribal *E. coli* criterion for a single sample is shown (235 CFU/100 mL). Three monitoring events associated with storm events are highlighted.
