Eurasian water milfoil (*Myriophyllum spicatum*) Meandering Littoral Zone Survey North Twin Lake - WBIC: 2485900 Minong Township - Washburn County, Wisconsin

Survey Conducted by and Report Prepared by: Endangered Resource Services, LLC Matthew S. Berg, Research Biologist St. Croix Falls, Wisconsin August 3, 2011

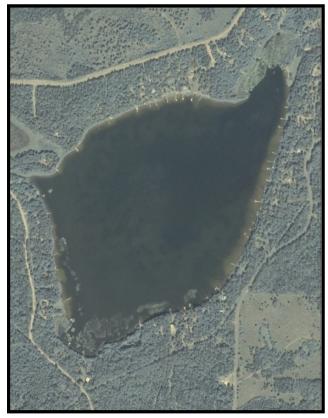
Figure 1: North Twin Lake Aerial Photo

North Twin Lake (WBIC 2485900) is a 113 acre seepage lake in north-central Washburn County, Wisconsin in the Town of Minong (T41N R13W S2 NE NE) (Figure 1). It reaches a maximum depth of 20ft in the northeast corner of the central basin, and has an average depth of approximately 6ft. Historical Secchi disc data suggests a significant loss of water clarity over the past 18 years at the rate of about 1/3<sup>rd</sup> of a foot/year. The lake was oligotrophic in 1993, but is now mesotrophic bordering on eutrophic (WDNR 2011). At the time of the survey, we could see the bottom clearly in only about 4ft of water, and Secchi readings on the day of the survey were in the 5ft range with the littoral zone extending to only 8ft. The bottom substrate is predominately sand and sandy muck with some organic muck occurring in the boggy northeast and southwest bays (Bush et al. 1967).

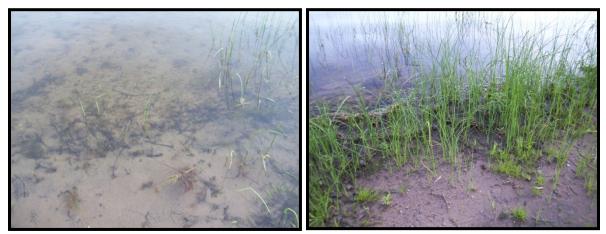
Figure 4: Typical Limited Shoreline Plant Community

In general, North Twin Lake has a very limited plant community because the low nutrient sand and sandy muck doesn't support excessive plant growth (Figure 4). Based on our shoreline survey and the random rake samples beyond the visible littoral zone, it appears that plants also don't extend far from shore as most species quickly disappeared in areas deeper than 5ft due to low light penetration. Interestingly, we found evidence that large amounts of Fern pondweed (*Potamogeton robbinsii*), another high habitat value native species, used to be found much deeper than it was in 2011. Partially decomposed stems and leaves of the plant were found to depths of 15ft. Perhaps the plants were able to colonize these depths during the drought of the past few years when lake levels were low but have now died off due to lack of light, or they may just be relics of a time not too long ago when the lake had much better water clarity and quality.

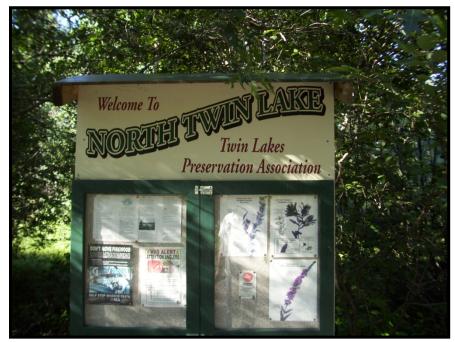
Figure 5: Sign at North Twin Lake Landing

Aquatic Invasive Species (AIS) such as Eurasian water milfoil are an increasing problem in the lakes of northern Wisconsin in general, and several nearby lakes in the Minong area in particular. Preventing their introduction into North Twin Lake with proactive measures is strongly encouraged. Especially around the boat landing, lakeshore owners should minimize the removal of native plants from the lake unless absolutely necessary as these patches of barren substrate can provide an easy place for invasive plants to take root and become established. Maintaining the lake's large noticeable sign at the boat landing will continue to offer a layer of protection against AIS by providing education, reeducation, and continual reminders of the dangers/impacts of aquatic invasive species to lake owners and visitors alike (Figure 5).

Training volunteers to recognize EWM and CLP is another low cost management strategy that we strongly encourage. Monthly volunteer transect surveys at the lake's boat landing and at least biannual meandering shoreline surveys of the whole lake could result in early detection if an AIS is introduced into North Twin Lake. The sooner an infestation is detected, the greater the chances it can be successfully and economically controlled.

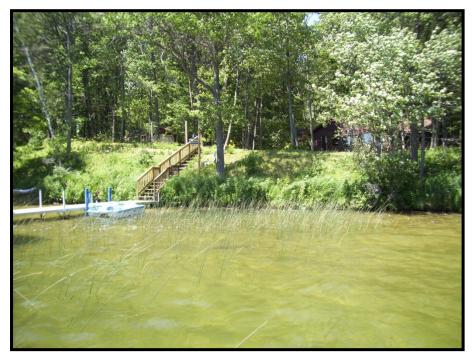
Figure 6: Model Natural Shoreline on a Nearby Washburn Co. Lake

Currently, North Twin's poor clarity is causing a lack of light penetration which means that few "big plants" or macrophytes are growing much past 5ft. Without these plants to absorb nutrients, algae proliferate which further reduces clarity and quality. Such things as internal loading from sediments/decomposing plants, failed septic systems, and lawn and field fertilizer runoff are common causes of excess nutrients in surface water. Because the lake's plant community is so limited, even a small increase in macrophyte plants or a small decrease in nutrient input could tip the lake's current balance away from algae and back towards macrophytes with resulting improvements in both water clarity and quality. Regardless of where nutrients are coming from, educating lake residents about reducing nutrient input directly along the lake is one of the easiest ways to limit algal growth and maintain or even improve water clarity. Not mowing down to the lakeshore, bagging grass clippings, switching to a phosphorus-free fertilizer or eliminating fertilizer altogether, and avoiding motor start-ups in shallow water would all be positive steps to this end. Wherever possible, restoring shorelines, building rain gardens, and establishing buffer strips of native vegetation would enhance water clarity and quality by preventing erosion and runoff. Stabilizing the lake's water quality/clarity with proactive measures should he a high priority for everyone on the lake. Hopefully, with a greater understanding of how better conservation practices by even a few people can have lakewide impacts, more people with be encouraged to make positive changes (Figure 6).

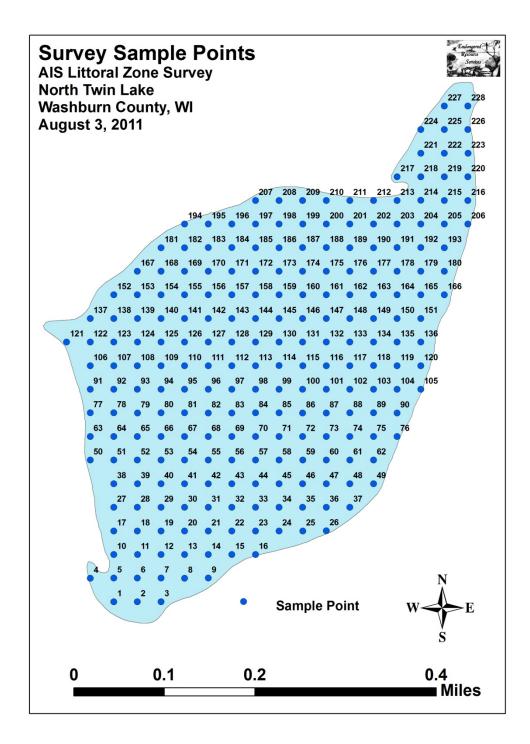
Appendix I: North Twin Lake Map with Survey Sample Points

Using a standard formula that takes into account the shoreline shape, distance, and total lake acres, Michelle Nault (WDNR – lake biologist) generated a sampling grid of 228 points that covered the entire lake (Appendix I). This grid will be used for any future full lake plant surveys and serves as a location reference in case any new exotic species are located.

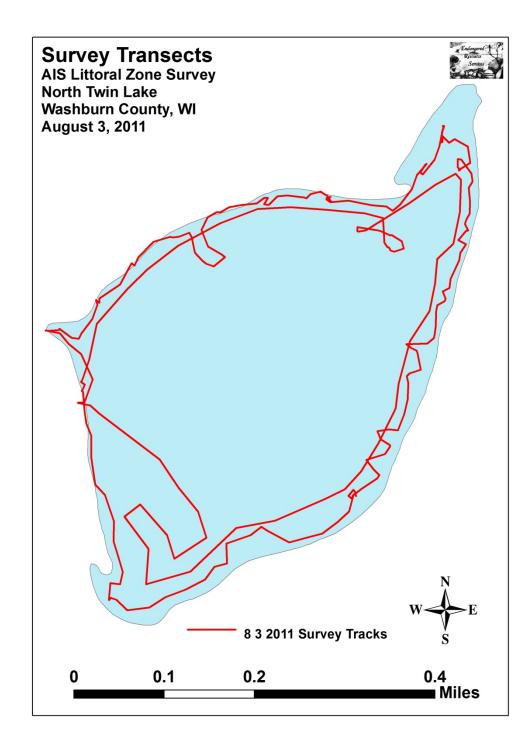
Appendix II: North Twin Lake Map with Survey Transects

On August 3<sup>rd</sup>, we surveyed 3.7 transect miles through and adjacent to the littoral zone of North Twin Lake (Figure 3) (Appendix II). No Eurasian water milfoil, Curly-leaf pondweed, or any other exotic plants were found. Interestingly, we also did not locate any Coontail (*Ceratophyllum demersum*), Northern water milfoil (*Myriophyllum sibiricum*) or Whorled water milfoil (*Myriophyllum verticillatum*). These species are common to abundant in most northern Wisconsin lakes, and are frequently confused with EWM. Dwarf water milfoil (*Myriophyllum tenellum*) is the only species of milfoil we found in the lake. This highly desirable, sensitive native species provides habitat for young fish and insect larvae. It is common in sandy shoreline areas of the lake, but it has no leaflets, and is not easily recognizable as a water milfoil. (For more information on Milfoil identification, see Appendix III).
