Subject: Dougs Tire update re: paving and wells

As you know, Dougs Tire is getting re-paved. We prepared a Cap Maintenance Plan and will rely on this re-paving as a remedial cap for the diesel LNAPL area.

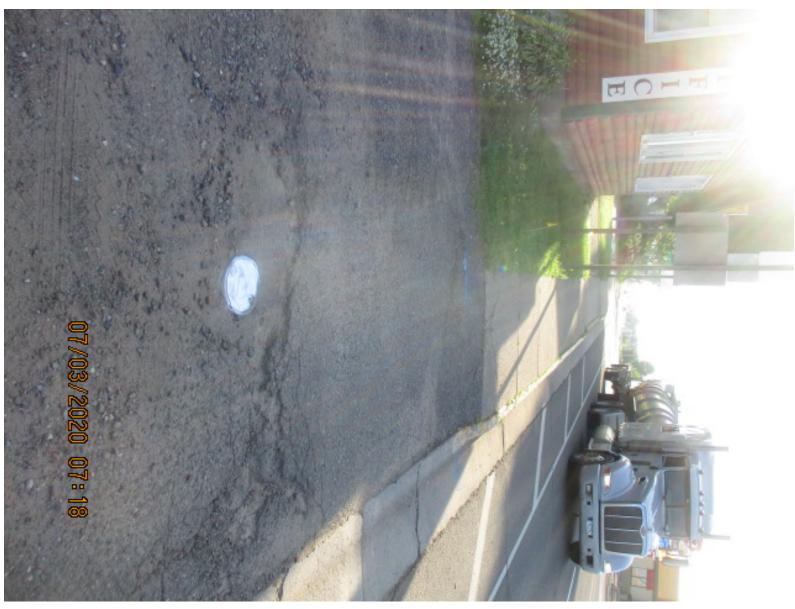
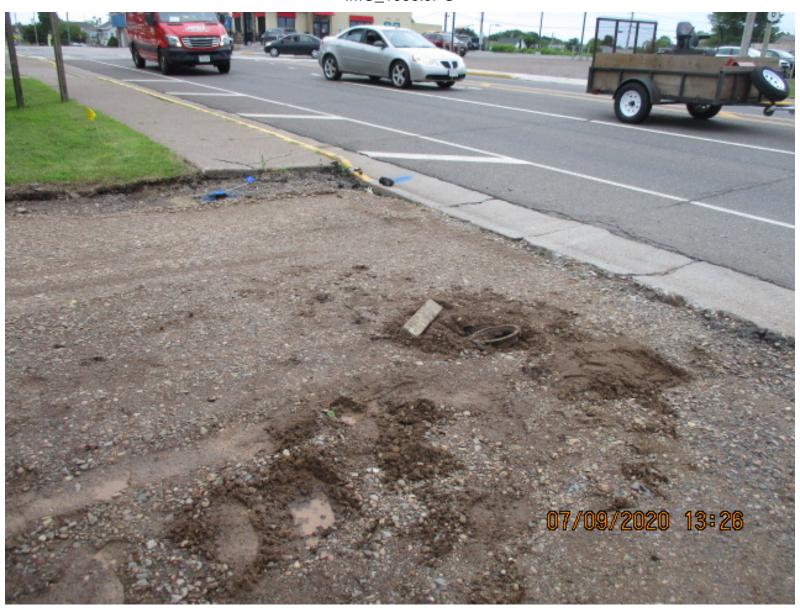
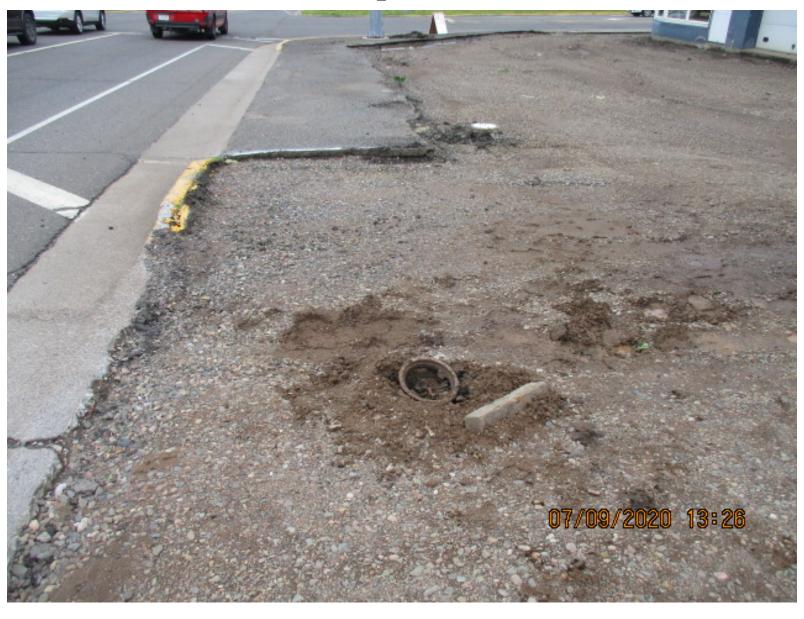
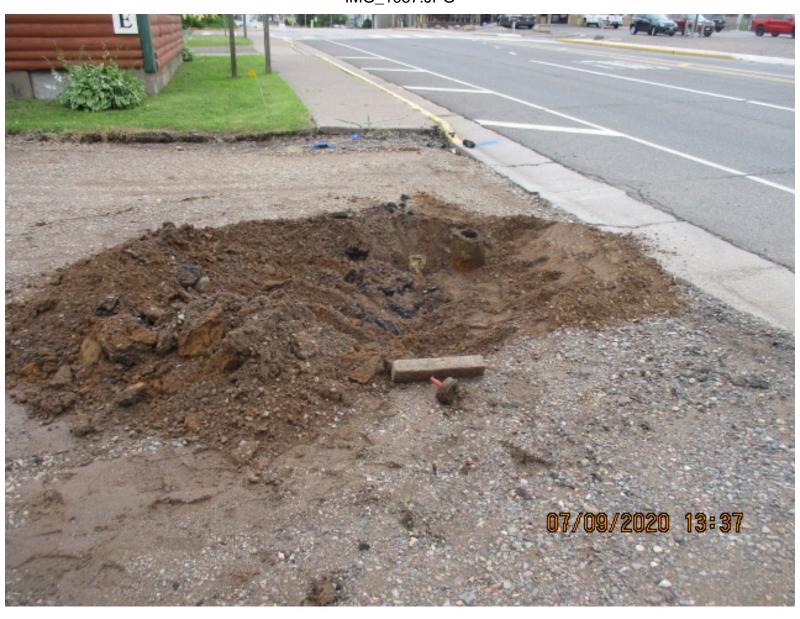
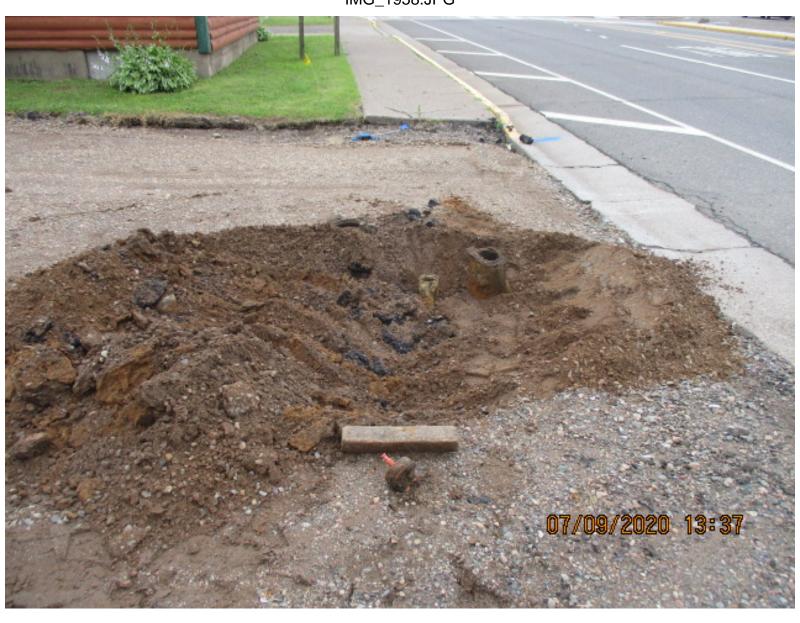
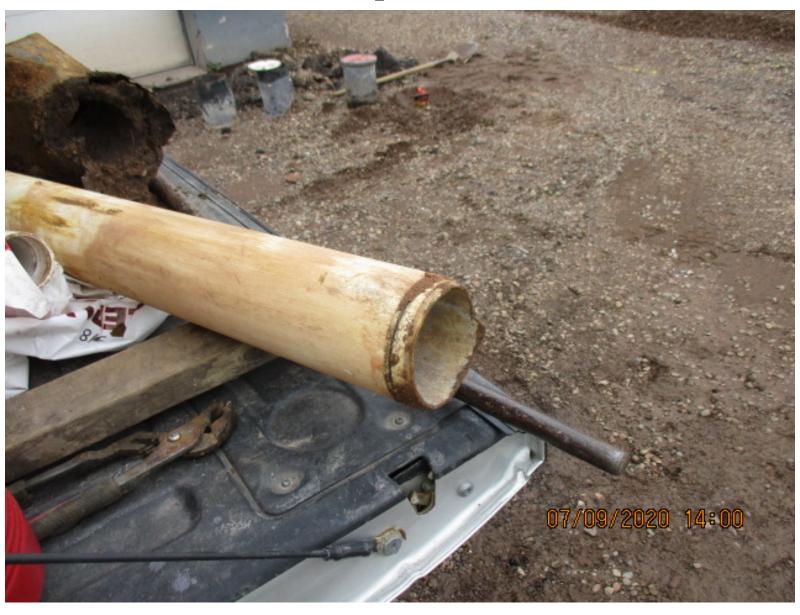
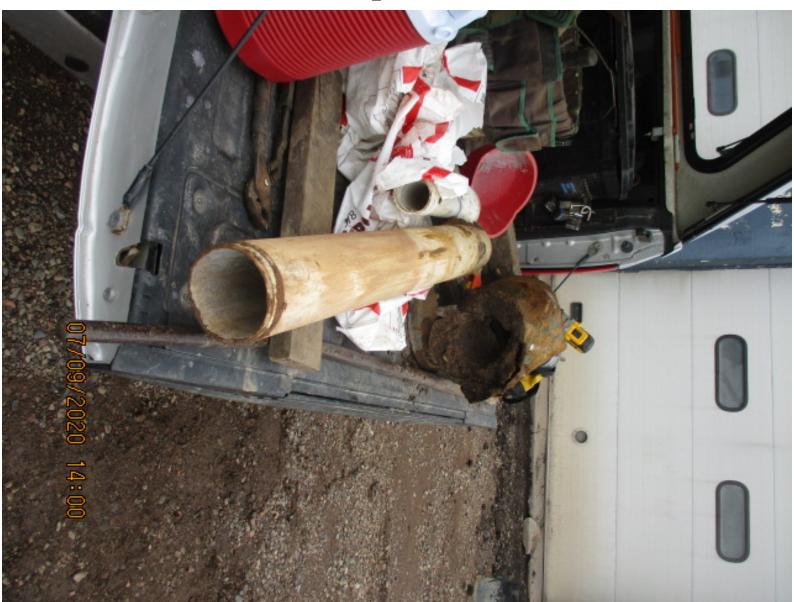
See attached pictures of EX-4 for reference.

EX-4 manway had to be removed/replaced. However, when I went to cut down the PVC riser, I discovered it was broken about 3 feet down (see pictures). This extraction well was installed in the alleyway and endured heavy traffic and frost-heaving (see pictures). I suspect it has been broken for awhile because it kept coming up on us. Due to its location in the City's alley, we abandoned this extraction well to allow the alley to be excavated and repaved.

I am worried about EX-10. It is located in the center of the entrance ramp to the entire lot and sees a lot of traffic. I worry it will be a problem down the road. It is probably best to abandon it and if more work is needed in the future, a new well can be installed there. We are saving the nearby MW-4 which will provide all of the information needed from that area.
