Remediation & Redevelopment Continuing Obligation Review

BRRTS ID No. 02-13-227101 _____

Review Date: 09/13/2023

Site Name: Paul's Classic Cleaners

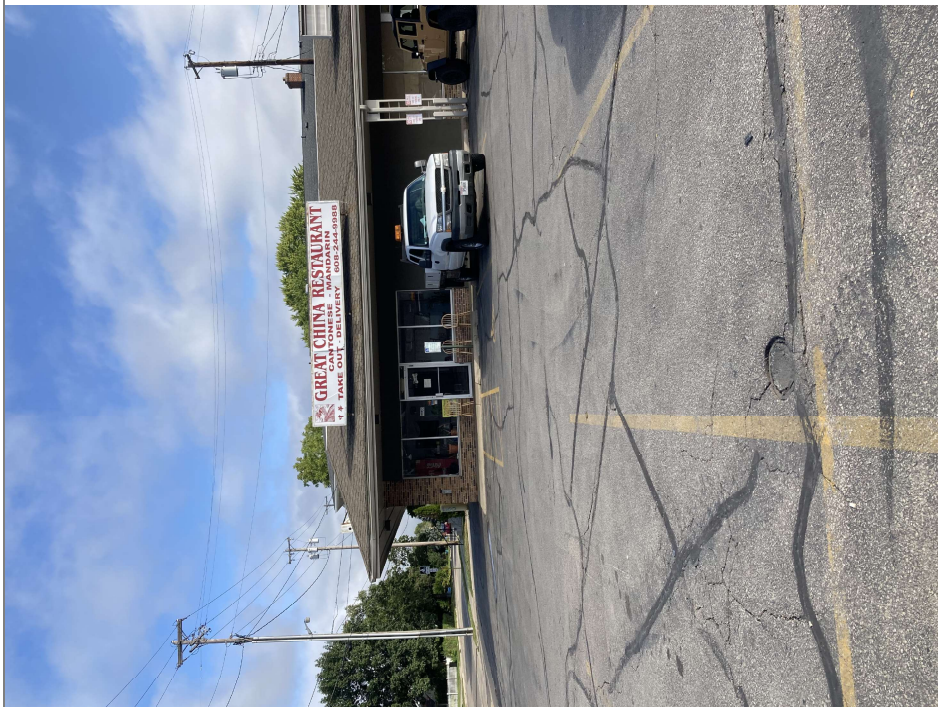
Title: Paul's Classic Cleaners, 02-13-227101: Looking at cap (building and asphalt) 09/13/2023

The asphalt in front of the building and the building itself are serving as the cap. The maintenance plan details the activities which are prohibited on the property without DNR approval. Please reach out with any questions. From our inspection today the asphalt seems to be in ok condition. The asphalt should be inspected annually.

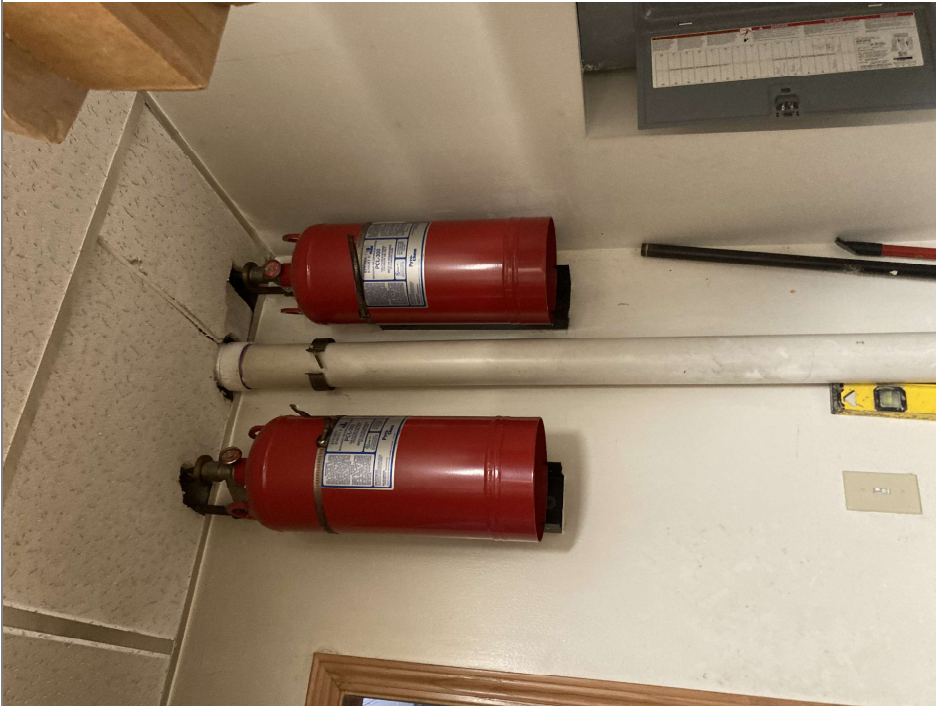
Manometer needs to be replaced

- Yes
- No – Describe what's not in compliance and the reasons for noncompliance:
Manometer is missing

Title: Paul's Classic Cleaners, 02-13-227101: Riser pipe & location of former manometer 09/13/2023

As we discussed, there is also a vapor mitigation system installed. From our inspection today, the fan seems to be running, but the manometer could not be located. This needs to be fixed as soon as practical. Moving forward the vapor mitigation system should be inspected by the property owner or tenant at least weekly. A daily inspection is better.

- No
- Yes – Summarize the actions needed to return the site to compliance and identify who is responsible:
Vapor mitigation system needs to be repaired. Manometer needs to be replaced

Please let me know when you have this maintenance work scheduled. I will need confirmation that the work was completed. The maintenance plan includes contact information for Acura Services and SCS Engineers.

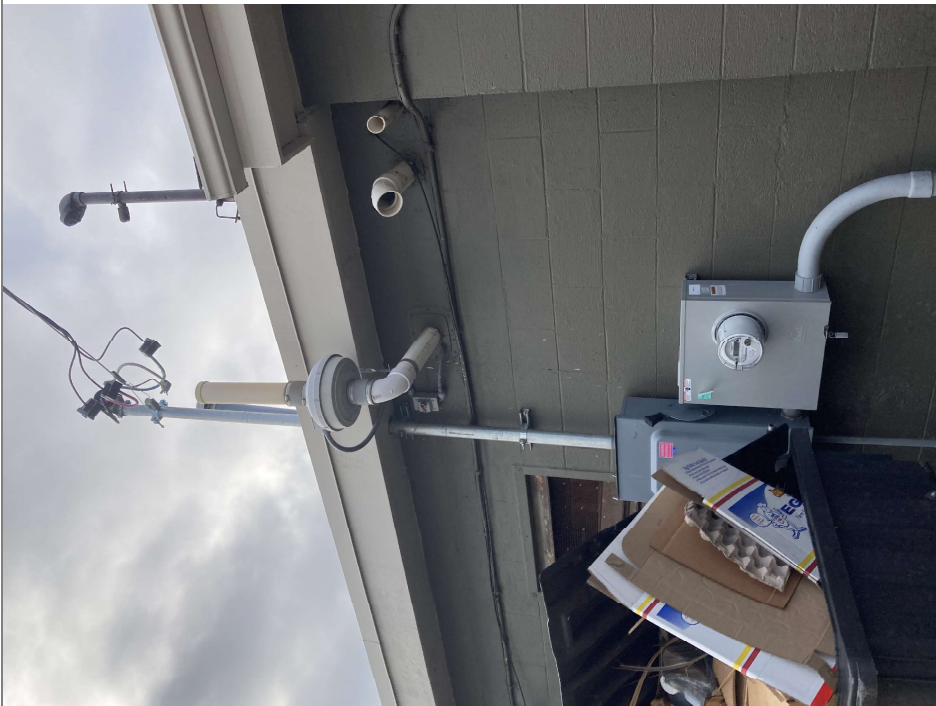
Title: Paul's Classic Cleaners, 02-13-227101: Fan & discharge pipe 09/13/2023
