**UNDERGROUND STORAGE TANK REMOVAL/
SUBSURFACE SITE ASSESSMENT**

**PENNZOIL PIT STOP 24
152 E. HURON STREET
BERLIN, WI**

REI PROJECT #6623

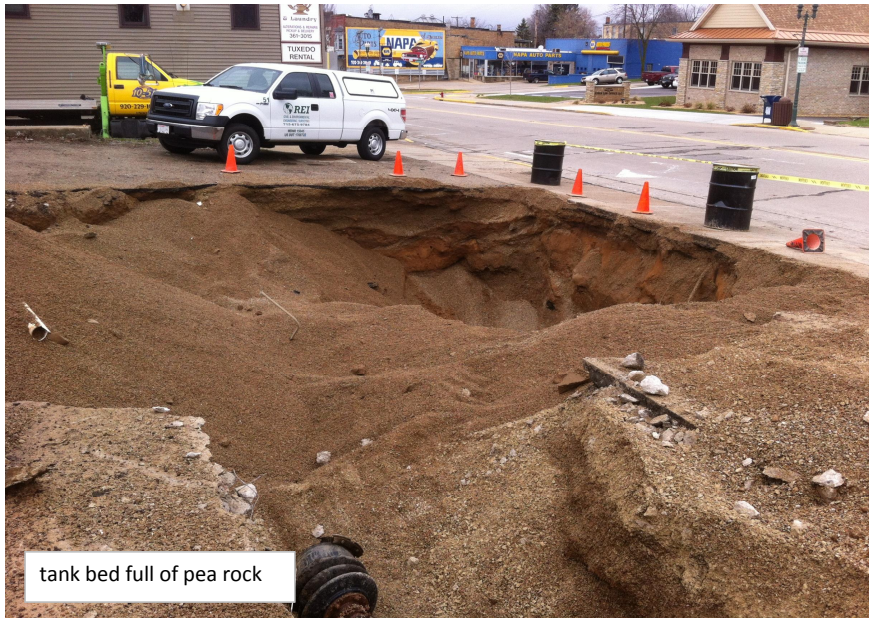
The UST's appeared to be in very good condition. With the exception of the abandoned UST, the three (3) known tanks were all set in the pea rock backfill. Site specific soil conditions were mainly medium to fine grained sands, silts and clays.

tank bed full of pea rock

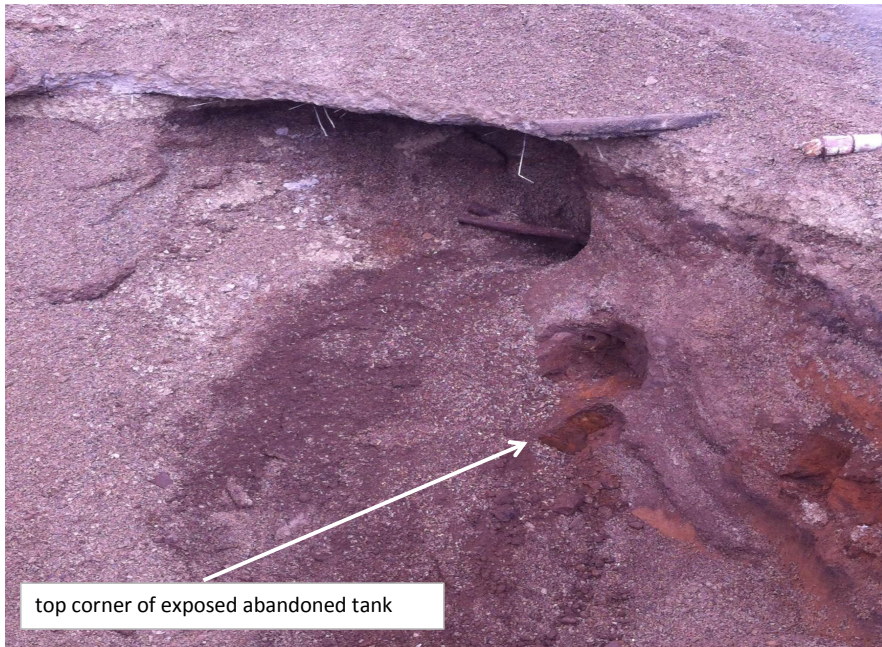
An abandoned UST was discovered during the tank closure assessment and was subsequently removed. The unknown tank was a single wall steel constructed 1,000 gallon tank that appeared to have contained gasoline. The tank was water tight and held approximately thirty-two (32) inches of liquid. Once the top of the tank was removed it became apparent that a fine grained sand material had been added to the tank.

top corner of exposed abandoned tank

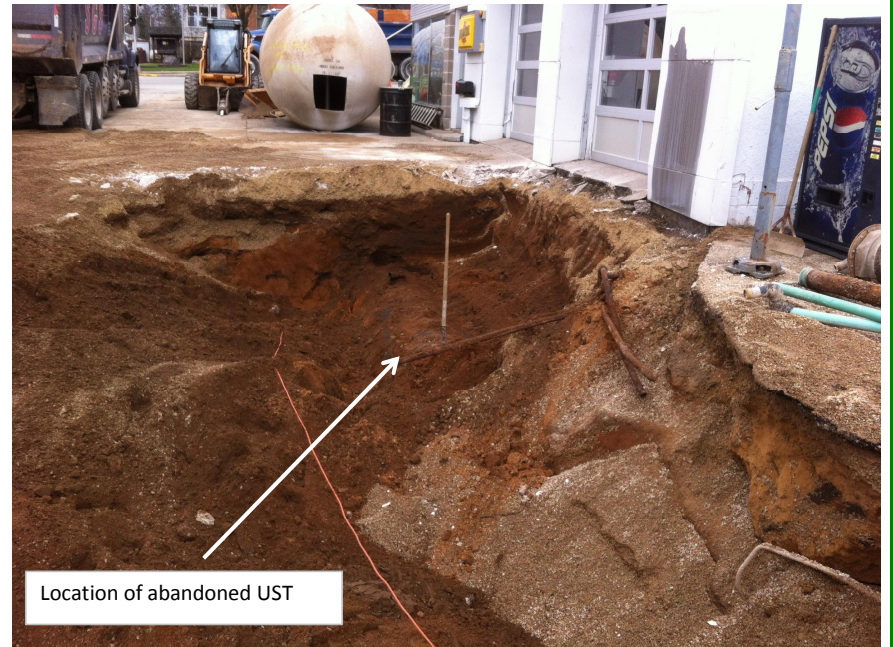
Location of abandoned UST

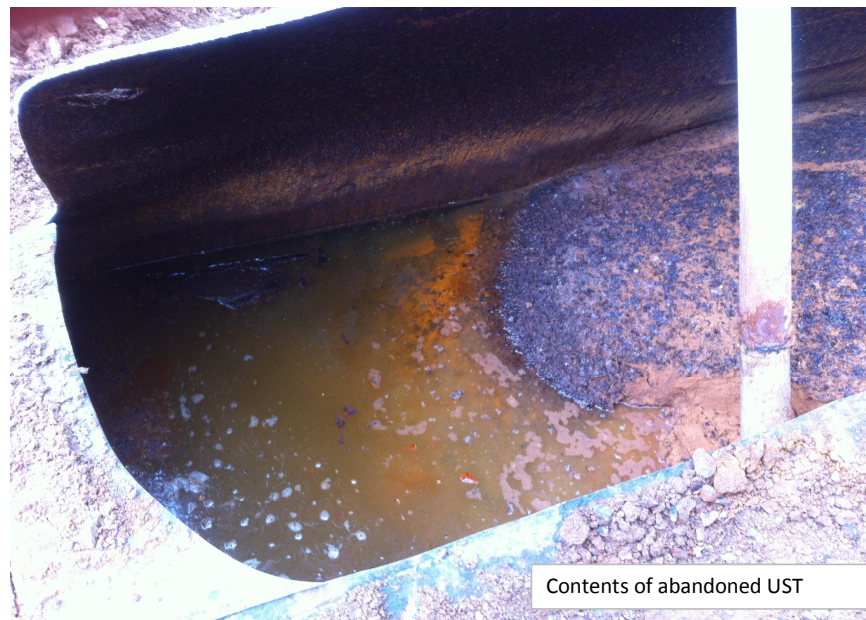
Contents of abandoned UST
