Subject: Milwaukee Plating, Inc.  
1434 North 4<sup>th</sup> Street  
Milwaukee, WI 53212  
BRRTS No. 03-41-000762  
PECFA No. 53212-3888-34

ATTACHMENT A - PHOTO

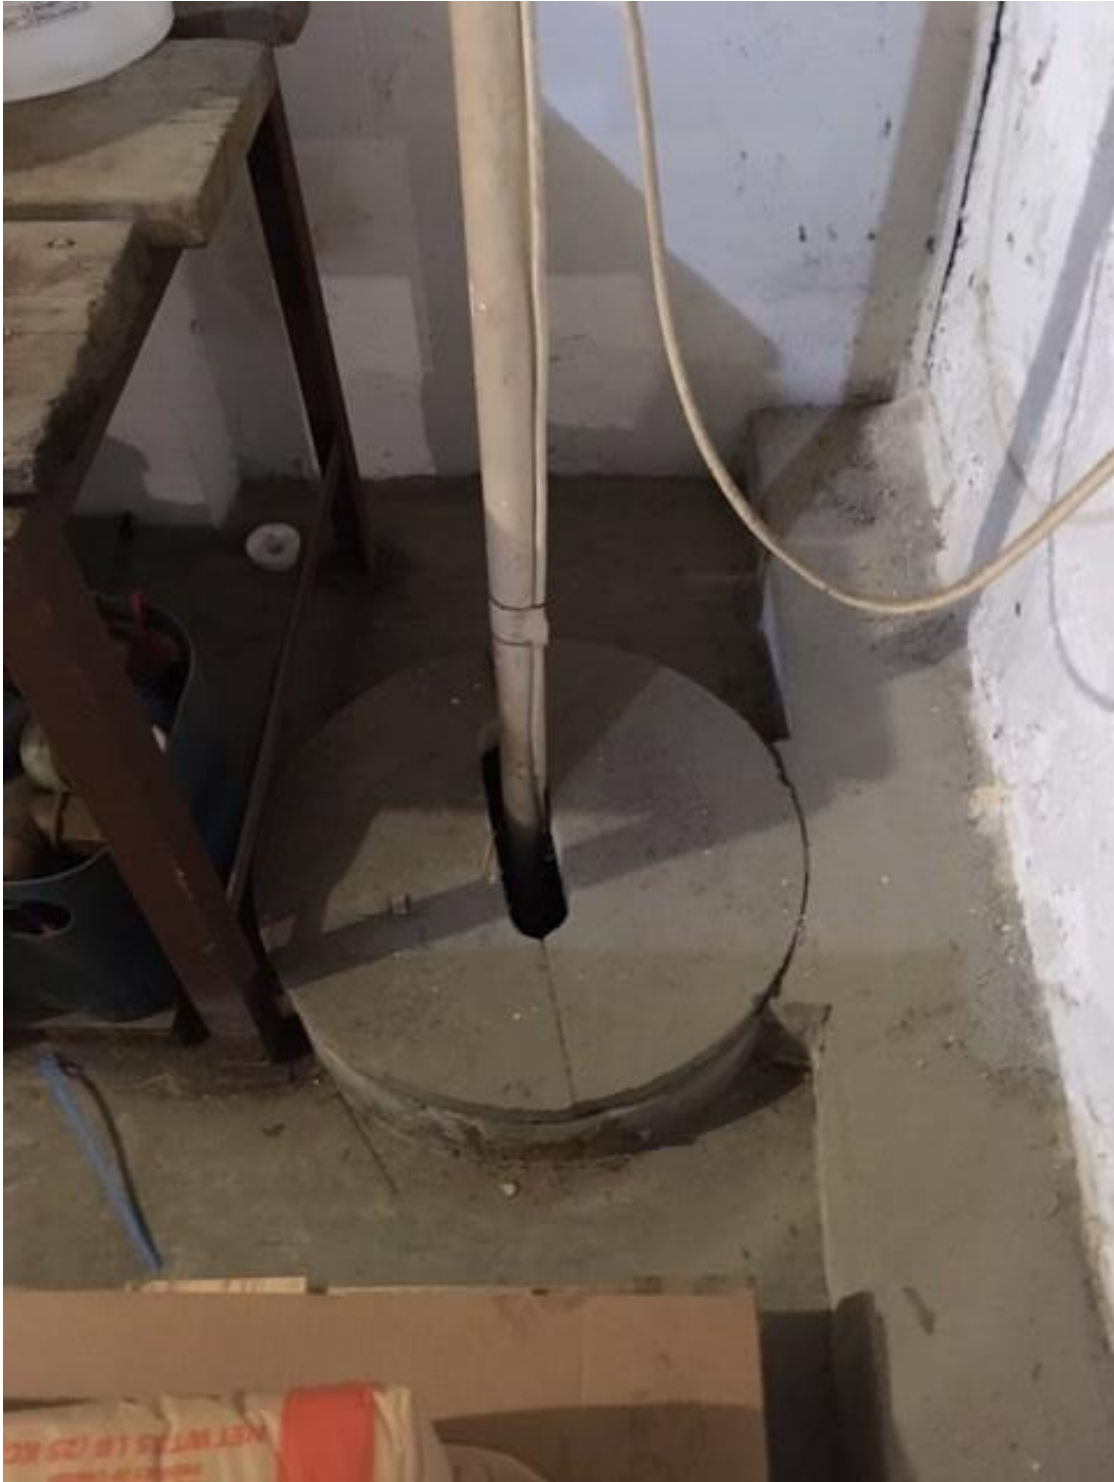
Photo 1: Sump Pump – Milwaukee Plating

Attached is a photo of the sump located in the lowest level of the Milwaukee Plating Facility at the above mentioned address. The photo was taken on June 11, 2019.

The sump is surrounded by the concrete floor with a lip that extends about 2 inches above the surrounding floor slab. The sump crock is constructed of concrete. The sump is covered with two pieces of concrete that fit together and fit inside the top of the sump crock.

I was told by the plant manager, that the sump is often if not always dry as water does not accumulate in the crock. At the time of the visit it was dry to the bottom which is about 24 inches below the lowest floor slab elevation.
