Technical Assistance, Environmental Liability Clarification or Post-Closure Modification Request

Property Name Former Superior Health Linen	FID No. (if known) 113147100
BRRTS No. (if known) 02-13-256630	Parcel Identification Number 070934402060
Street Address 1509 Emil Street	City Madison
	State WI
County Dane	Municipality where the Property is located <input checked="" type="radio"/> City <input type="radio"/> Town <input type="radio"/> Village of Madison
	Property is composed of: <input checked="" type="radio"/> Single tax parcel <input type="radio"/> Multiple tax parcels
	Property Size Acres 1

VAPOR MITIGATION SYSTEM LAYOUT
Former Superior Health Linen
1509 Emil Street
Madison, Wisconsin

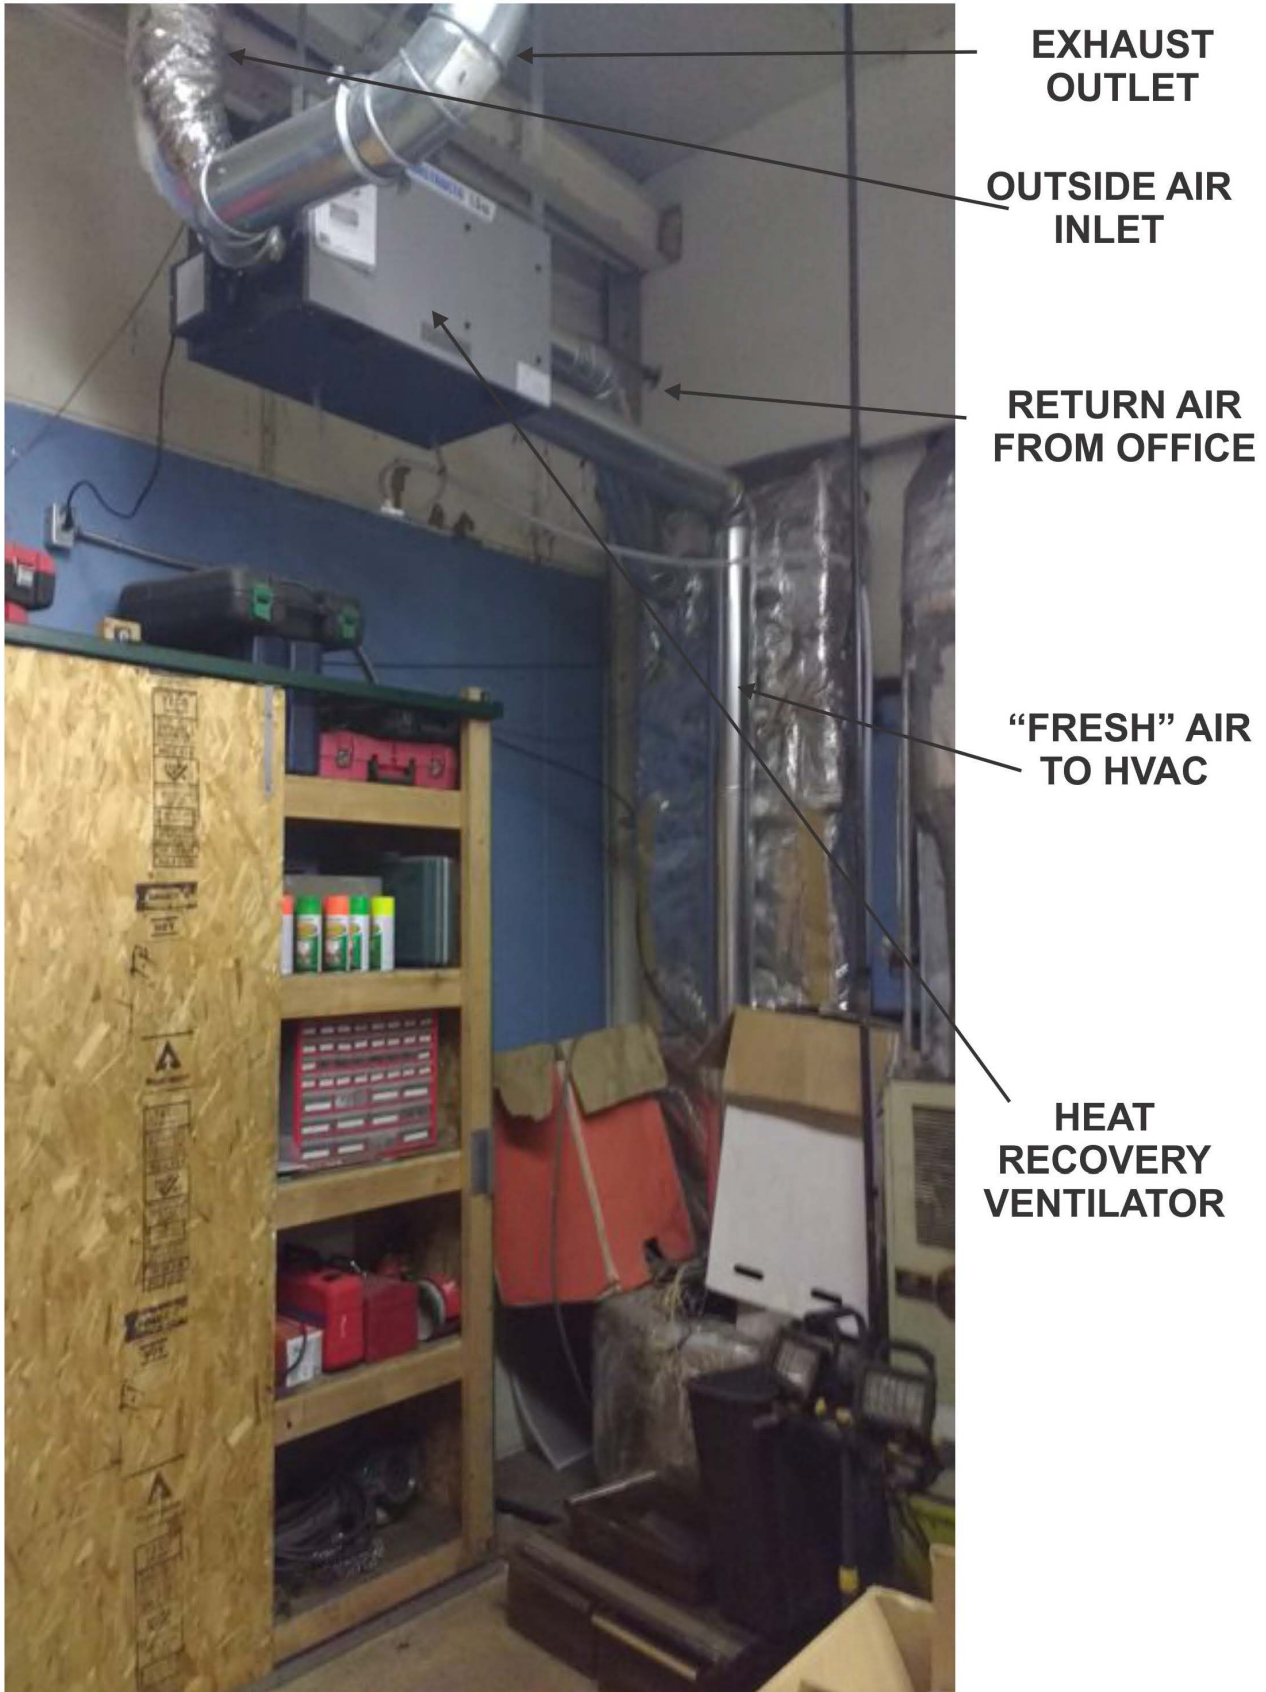
PHOTO 1 - Heat Exchange Ventilator and ducting components. In northwest corner of shop.

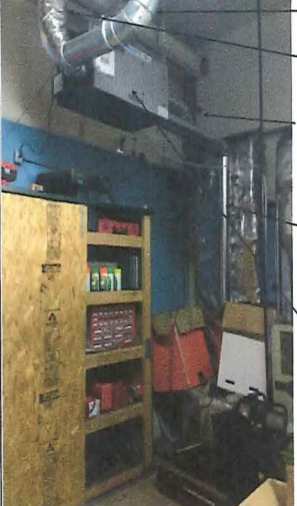
EXHAUST OUTLET
OUTSIDE AIR INLET
RETURN AIR FROM OFFICE
"FRESH" AIR TO HVAC
HEAT RECOVERY VENTILATOR

Title: AIR EXCHANGER AND DUCTING

Detailed description: A photograph showing a room with a heat recovery ventilator (HRV) unit mounted on the wall. Ductwork is visible on the ceiling, connecting the HRV to various parts of the room. Labels point to the exhaust outlet, outside air inlet, return air from the office, fresh air to the HVAC, and the HRV unit itself.

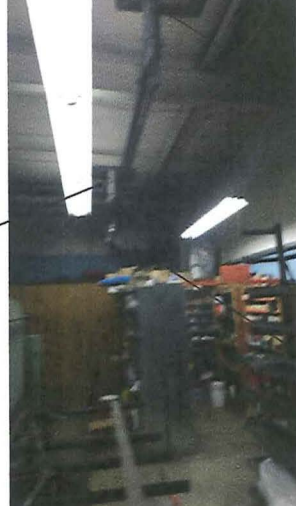
EXHAUST AIR
OUTSIDE AIR INLET
HEAT RECOVERY VENTILATOR

Title: OUTSIDE AIR INTAKE AND EXHAUST (note separation)

Detailed description: A photograph showing the separation of outside air intake and exhaust air. Labels point to the exhaust air, outside air inlet, and the heat recovery ventilator.

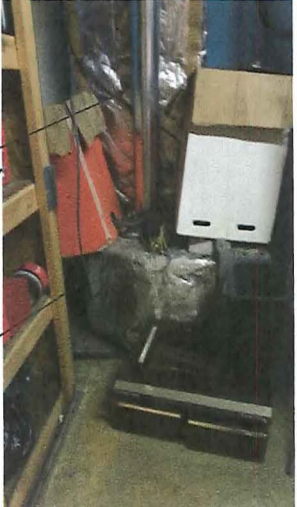
FRESH AIR FROM HEAT RECOVERY VENTILATOR
HVAC INTAKE

Title: FRESH OUTSIDE AIR INTO HVAC SYSTEM
