SUBJECT: Final Case Closure with Continuing Obligations  
Dicks Car Care, 620 Broadway St., Baraboo, WI  
DNR BRRTS Activity #: 03-57-258614, PECFA #: 53913-2101-20

## DETAILED SITE MAP

### CAP MAINTENANCE PLAN

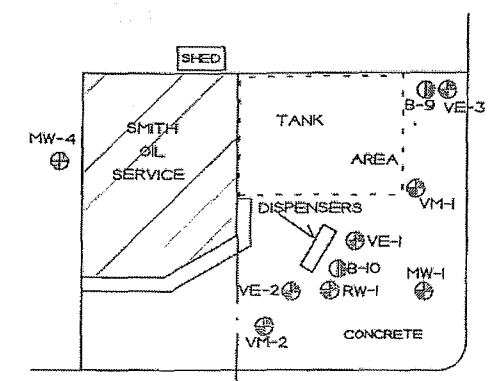
**WELLS BEING TRANSFERRED TO  
THE CITY OF BARABOO**

ESTIMATED EXTENT OF PETROLEUM  
CONTAMINATION IN GROUNDWATER  
EXCEEDING THE NR140 ES AND/OR PAL.

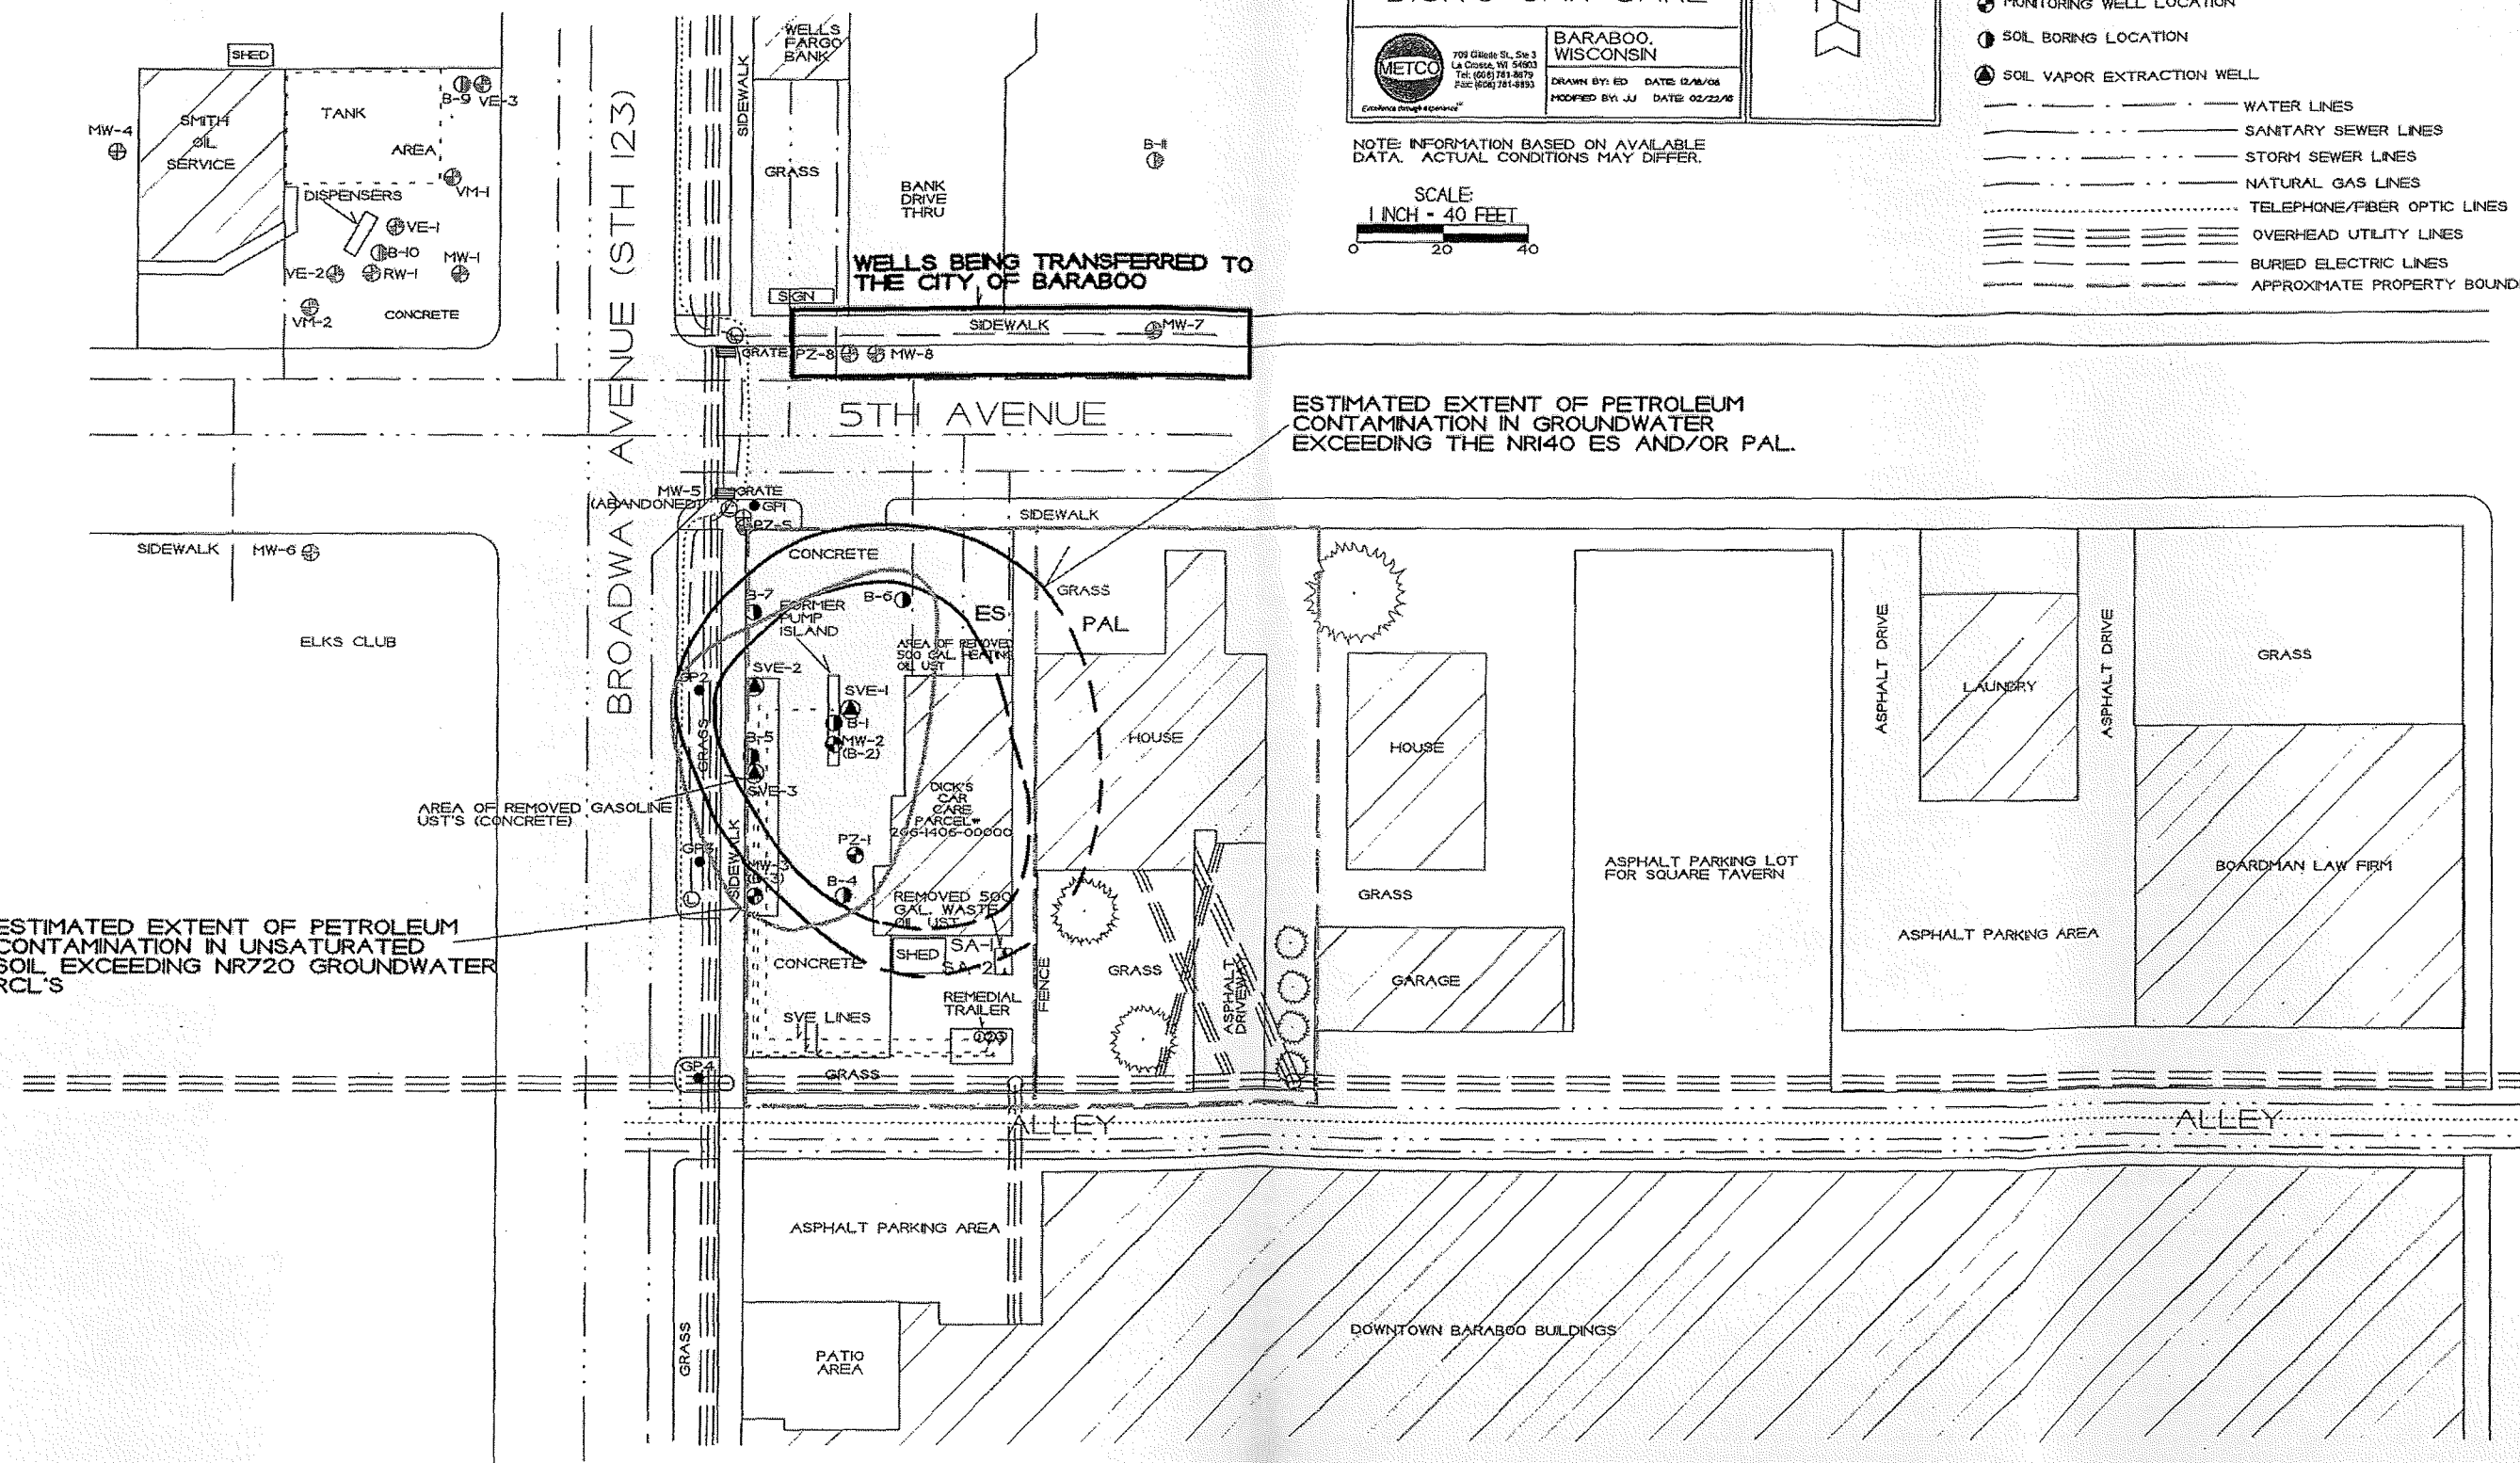
ESTIMATED EXTENT OF PETROLEUM  
CONTAMINATION IN UNSATURATED  
SOIL EXCEEDING NR720 GROUNDWATER  
RCL'S

AREA OF REMOVED GASOLINE  
UST'S (CONCRETE)

Monitoring wells MW-7, MW-8, and PZ-8 will be used on another project (Circus City Cleaners, BRRTS # 02-57-551681). Presently there is no one to transfer the wells to because there is not a responsible party for the Circus City Cleaners. The City of Baraboo has agreed to inform the DNR of possible roadwork that could damage the wells. You are no longer responsible for the wells and the proper abandonment of the wells. Do NOT fill and seal these wells at this time. Well filling and sealing will be required for closure, upon conclusion of the cleanup of that site. These wells are identified on the **attached map** (Detailed Site Map, February 22, 2016).

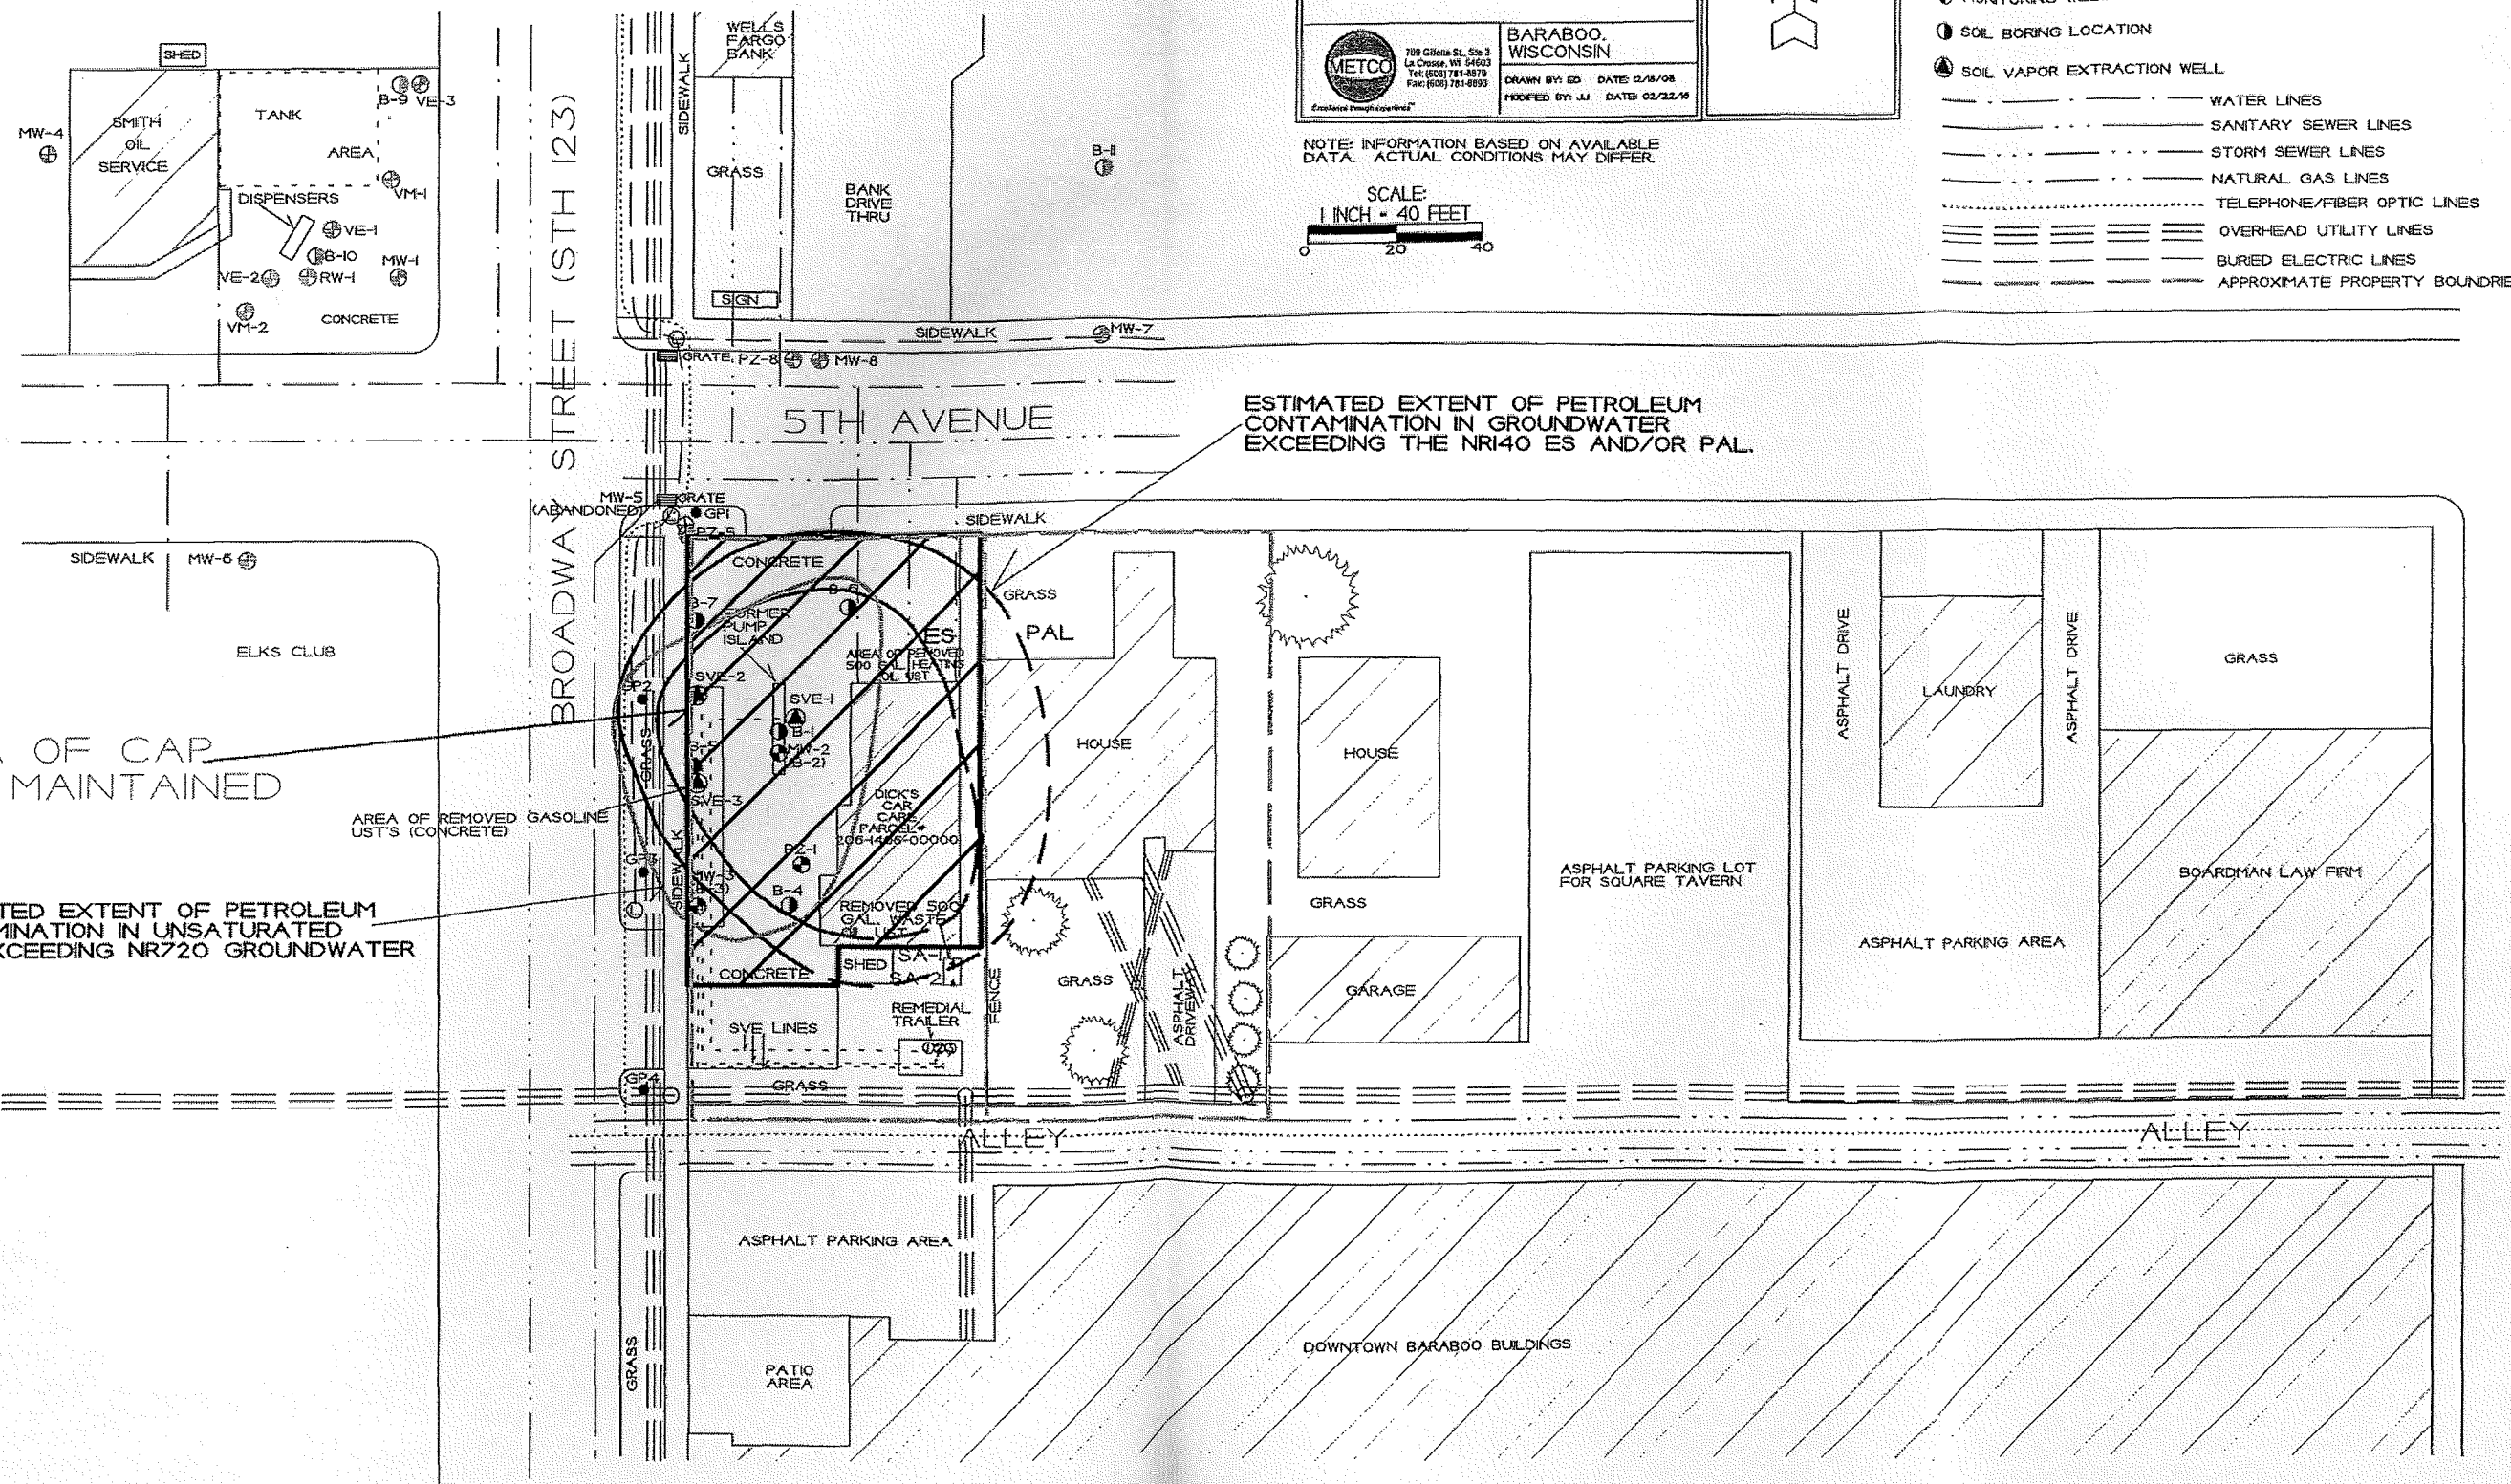
D.2. LOCATION MAP  
DICK'S CAR CARE

AREA OF CAP TO BE MAINTAINED

ESTIMATED EXTENT OF PETROLEUM CONTAMINATION IN UNSATURATED SOIL EXCEEDING NR720 GROUNDWATER RCL'S

ESTIMATED EXTENT OF PETROLEUM CONTAMINATION IN GROUNDWATER EXCEEDING THE NR140 ES AND/OR PAL.

The pavement and building or other impervious cover that exists in the location shown on the **attached map** (Location Map, Attachment D.2, February 22, 2012) shall be maintained in compliance with the **attached maintenance plan** in order to minimize the infiltration of water and prevent additional groundwater contamination that would violate the groundwater quality standards in ch. NR 140, Wis. Adm. Code.

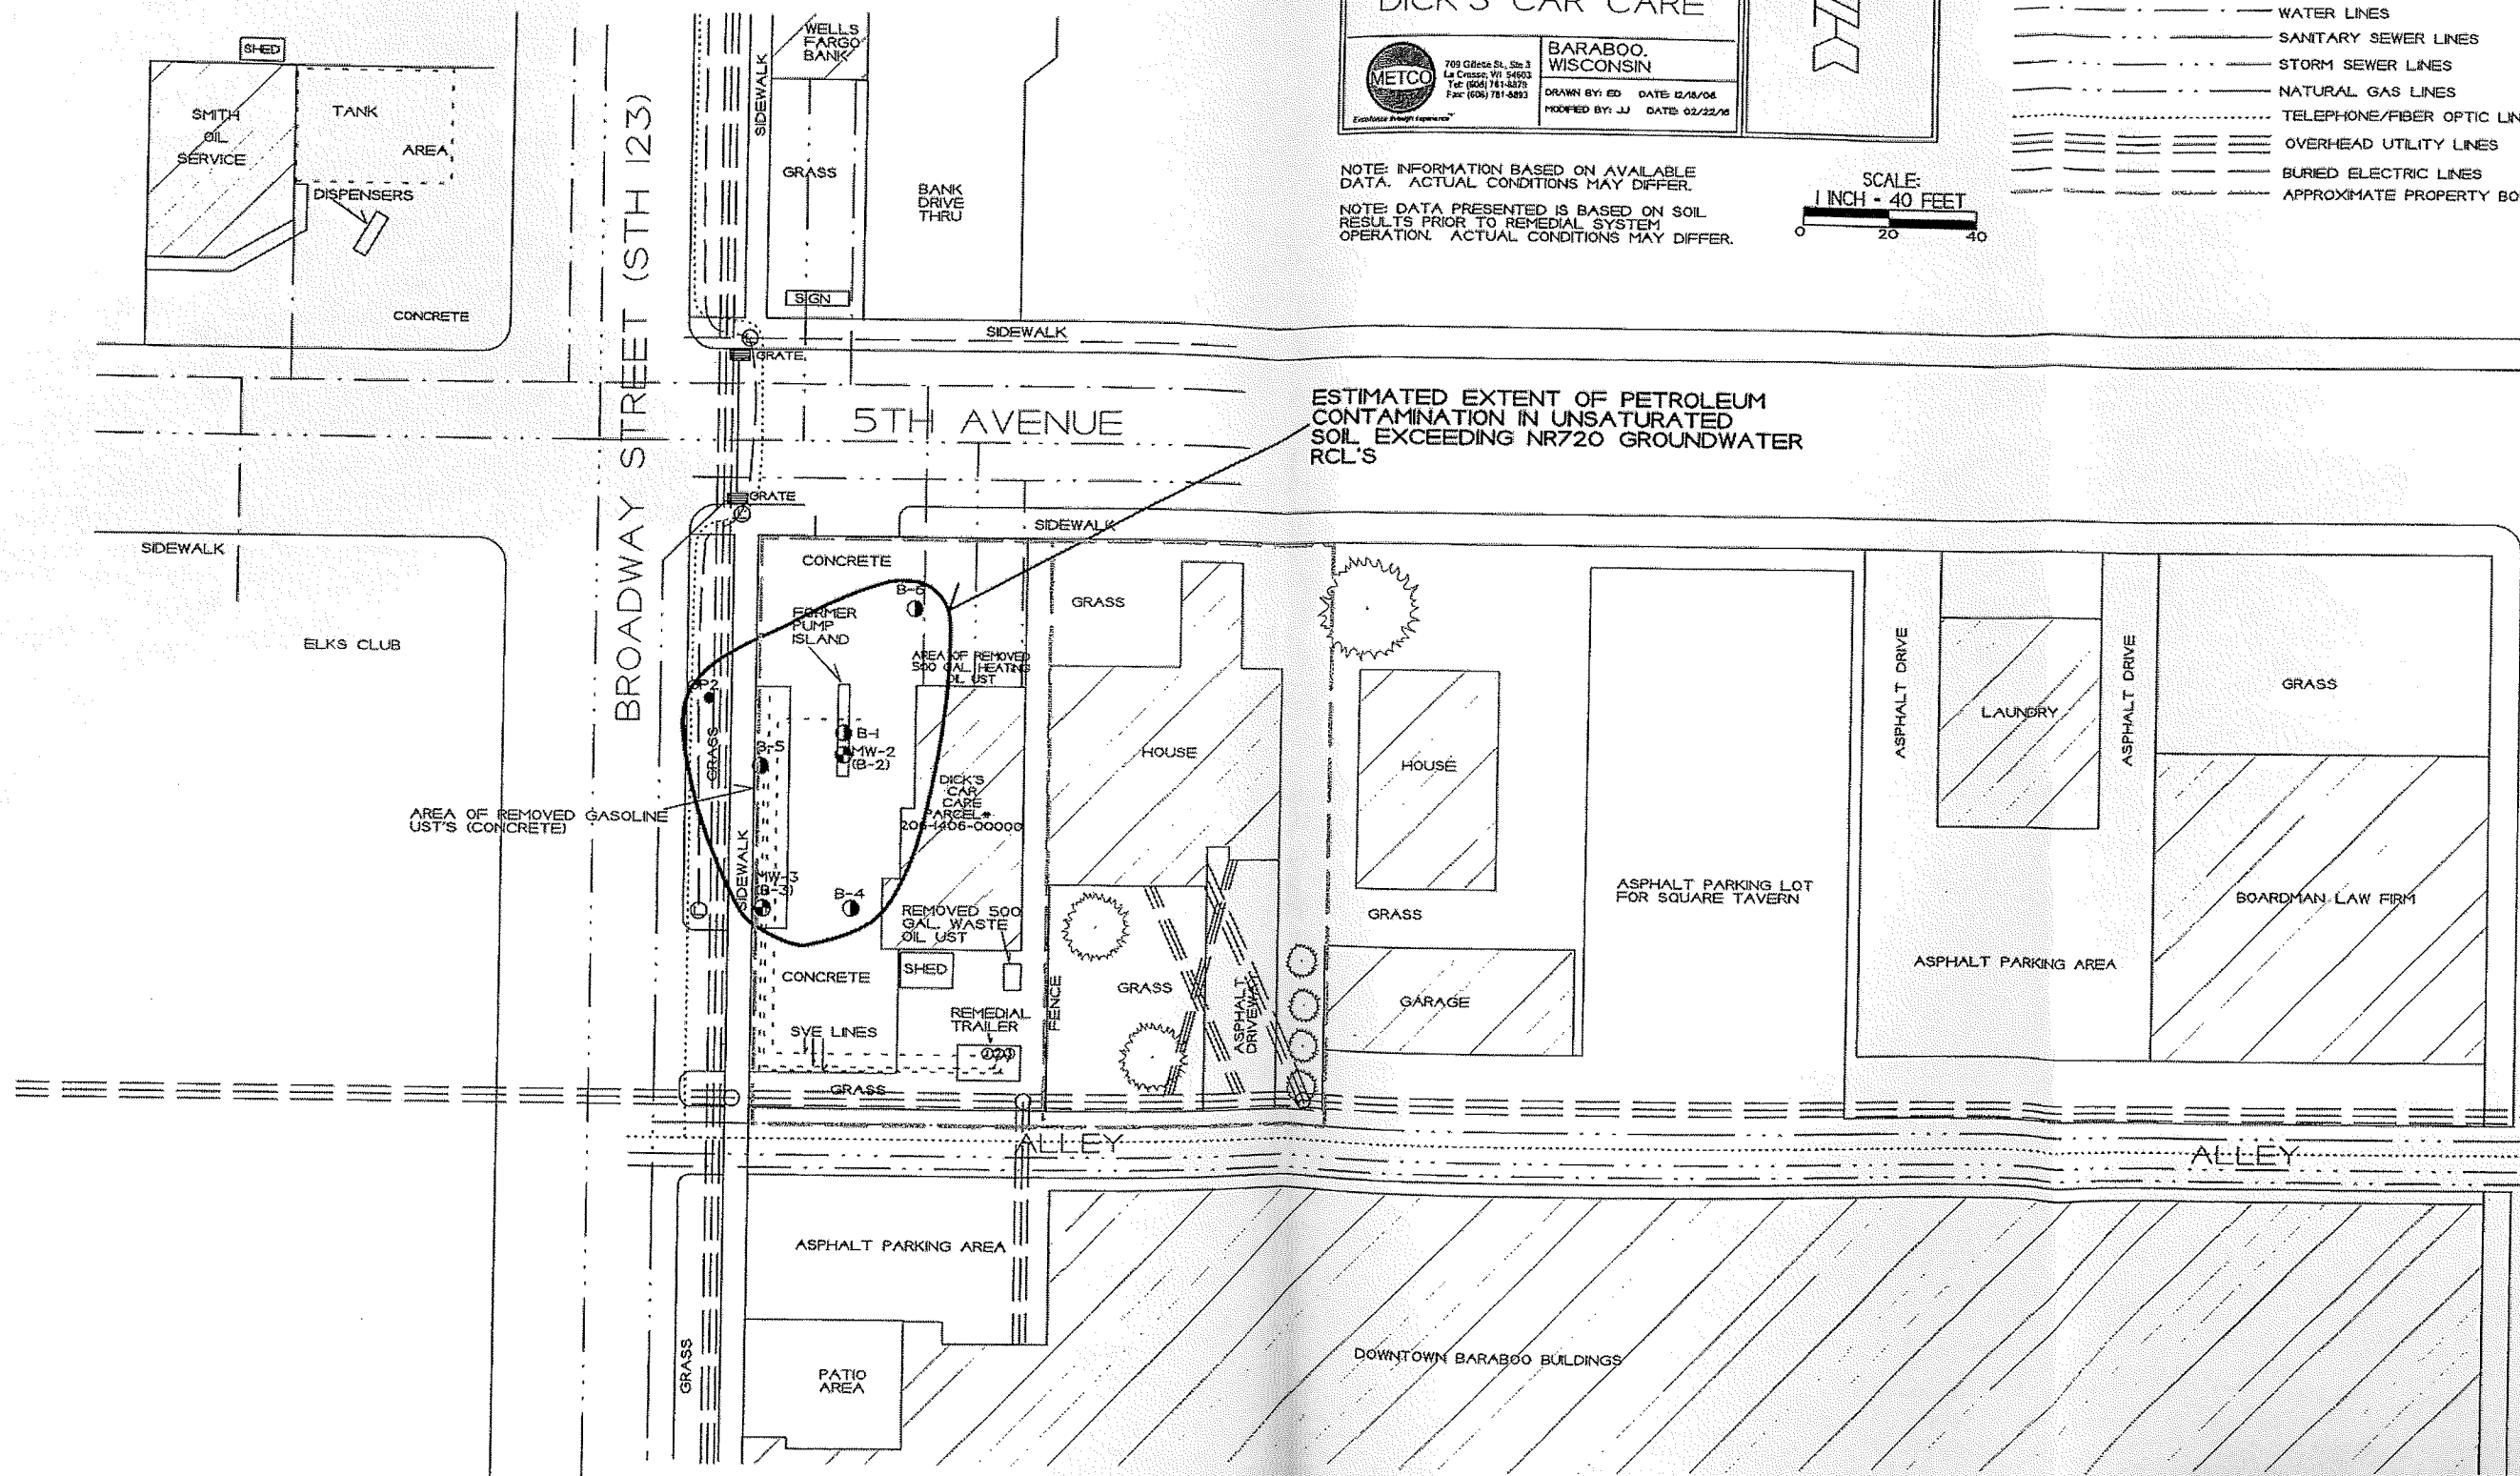
B.2.b. RESIDUAL SOIL CONTAMINATION

NOTE: INFORMATION BASED ON AVAILABLE DATA. ACTUAL CONDITIONS MAY DIFFER.  
NOTE: DATA PRESENTED IS BASED ON SOIL RESULTS PRIOR TO REMEDIAL SYSTEM OPERATION. ACTUAL CONDITIONS MAY DIFFER.

Soil contamination (petroleum-contaminated soil) remains beneath the areas of the former gasoline underground storage tanks (USTs) and pump island, and extending beneath the right-of-way along the east side of Broadway Street. The soil contamination occurs from a depth of 12 feet to 49 feet (37-feet-thick). Soil contamination occurs at B-1 and B-2/MW-2 (former pump island), and at GP-2 and B-5 (near the former USTs). In the right-of-way near the former UST locations, soil was contaminated at GP-2 at a depth of 12 feet. At depth and closer to the water table, contamination was detected at B-3 (44 feet below ground surface (bgs)), B-4 (36 feet bgs), and B-6 (44 feet bgs). The extent of soil contamination is indicated on the **attached map** (Residual Soil Contamination, Attachment B.2.b, February 22, 2016).

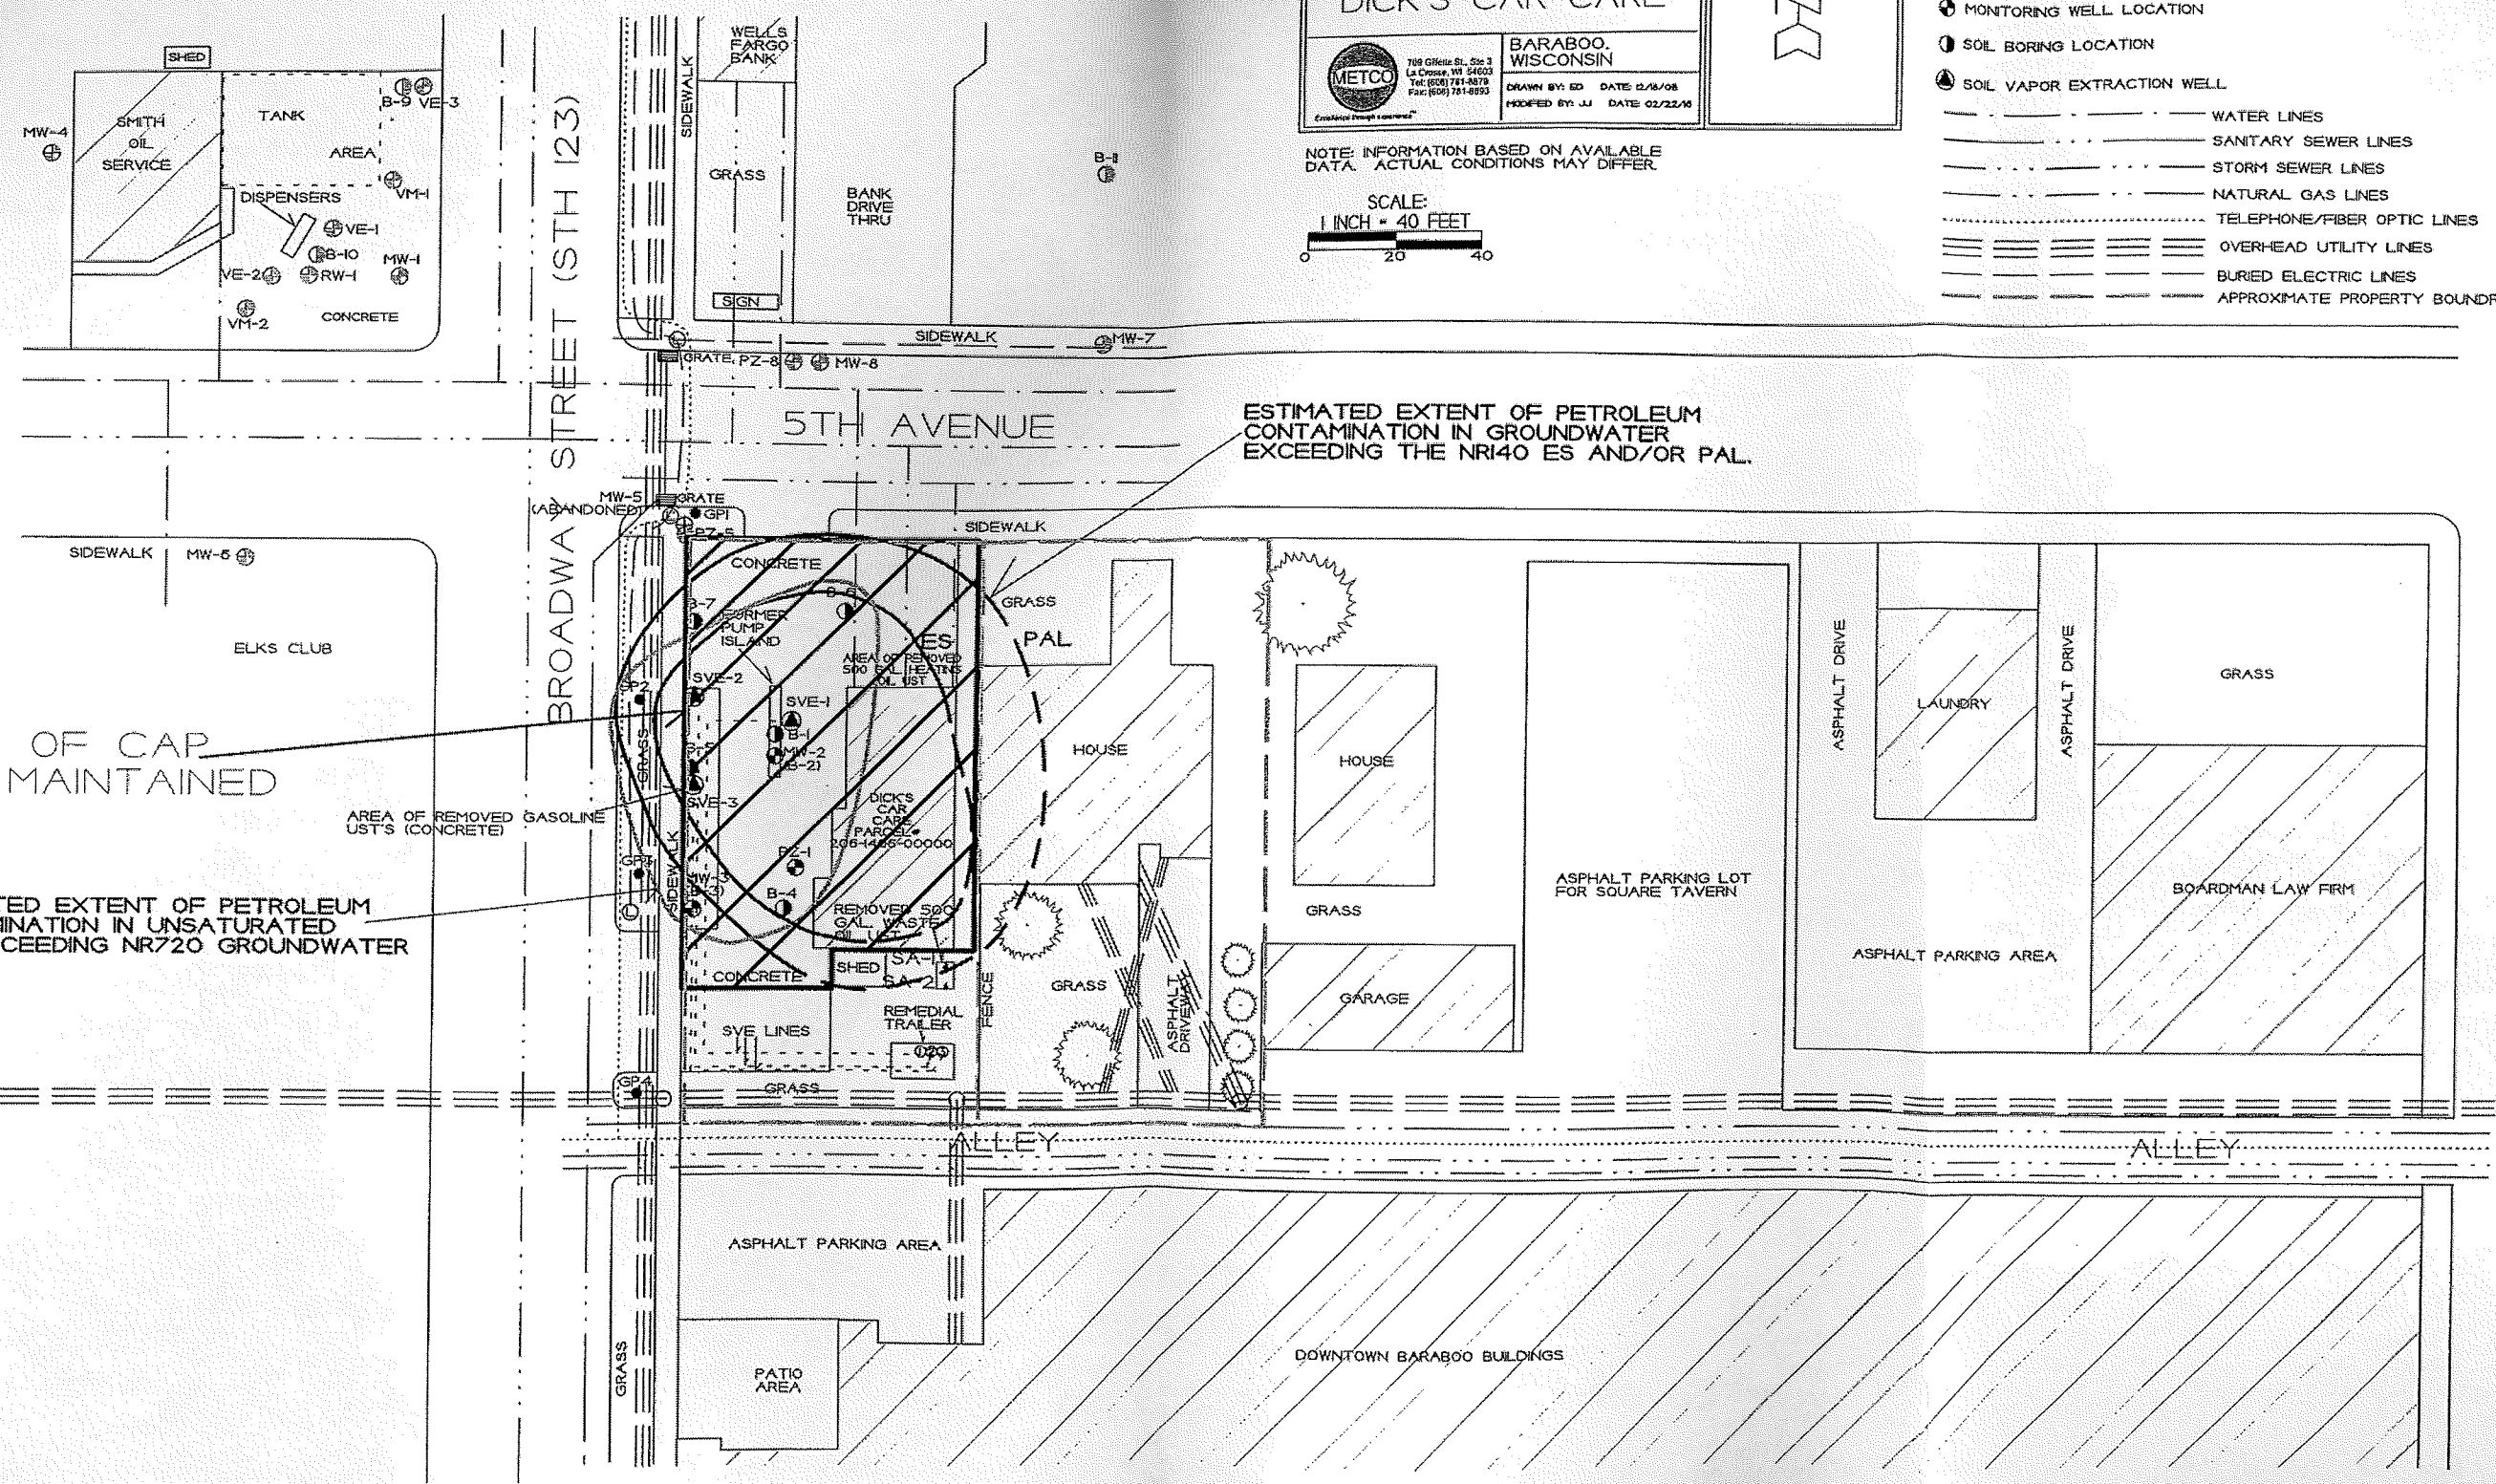
D.2. LOCATION MAP  
DICK'S CAR CARE

ESTIMATED EXTENT OF PETROLEUM CONTAMINATION IN GROUNDWATER EXCEEDING THE NR140 ES AND/OR PAL.

AREA OF CAP TO BE MAINTAINED

ESTIMATED EXTENT OF PETROLEUM CONTAMINATION IN UNSATURATED SOIL EXCEEDING NR720 GROUNDWATER RCL'S

AREA OF REMOVED GASOLINE UST'S (CONCRETE)

Soil contaminated by petroleum is located at a depth of 12-49 feet below ground surface. Groundwater contaminated by petroleum is located at a depth of 46-50 feet below ground surface. The extent of the soil and groundwater contamination is shown on Attachment D.2.

The cover consists of 4-6 inches of concrete and an existing building foundation (concrete slab on-grade, 4-6 inches thick). The Cap area is shown on Attachment D.2.

The concrete and building cover overlying the contaminated soil and as depicted in Attachment D.2 will be inspected once a year, normally in the spring after all snow and ice is gone, for deterioration, cracks and other potential problems that can cause exposure to underlying soils or additional infiltration through concrete. The inspections will be performed by the property owner or their designated representative. The inspections will be performed to evaluate damage due to settling, exposure to the weather, wear from traffic, increasing age and other factors. Any area where soils have become or are likely to become exposed and where infiltration from the surface will not be effectively minimized will be documented.

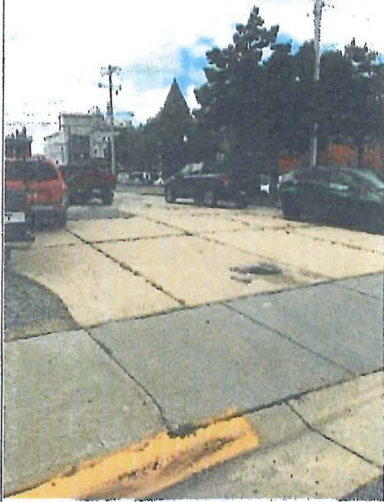
Title: Looking southwest at the area of concrete cap.

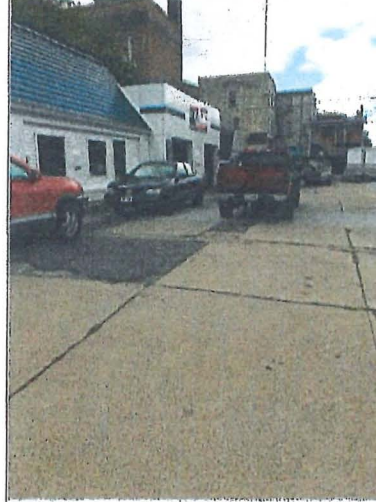
Title: Looking south at the area of concrete cap.

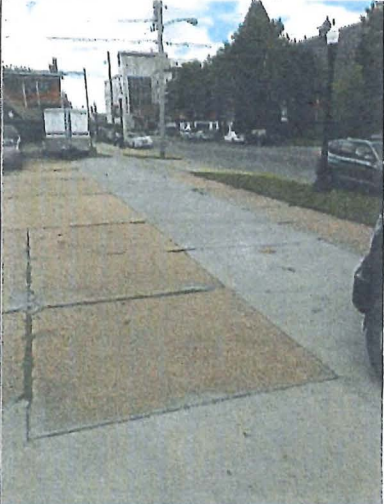
Title: Looking southeast at the area of concrete cap.

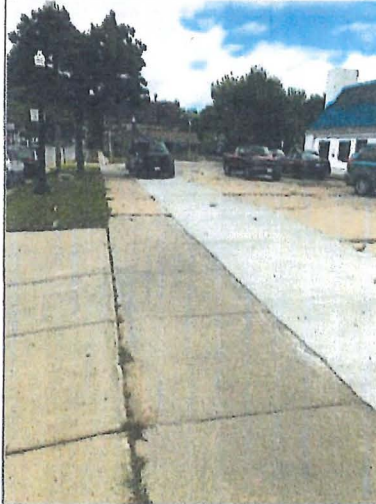
Title: Looking northeast at the area of concrete cap.
