REVISED REMEDIAL ACTION OPTIONS AND DESIGN REPORT

**FORMER PETER'S DRY CLEANERS
5094 WEST COLLEGE AVENUE
GREENDALE, WISCONSIN 53129
WDNR BRRTS# 02-30-552186**

April 27, 2022

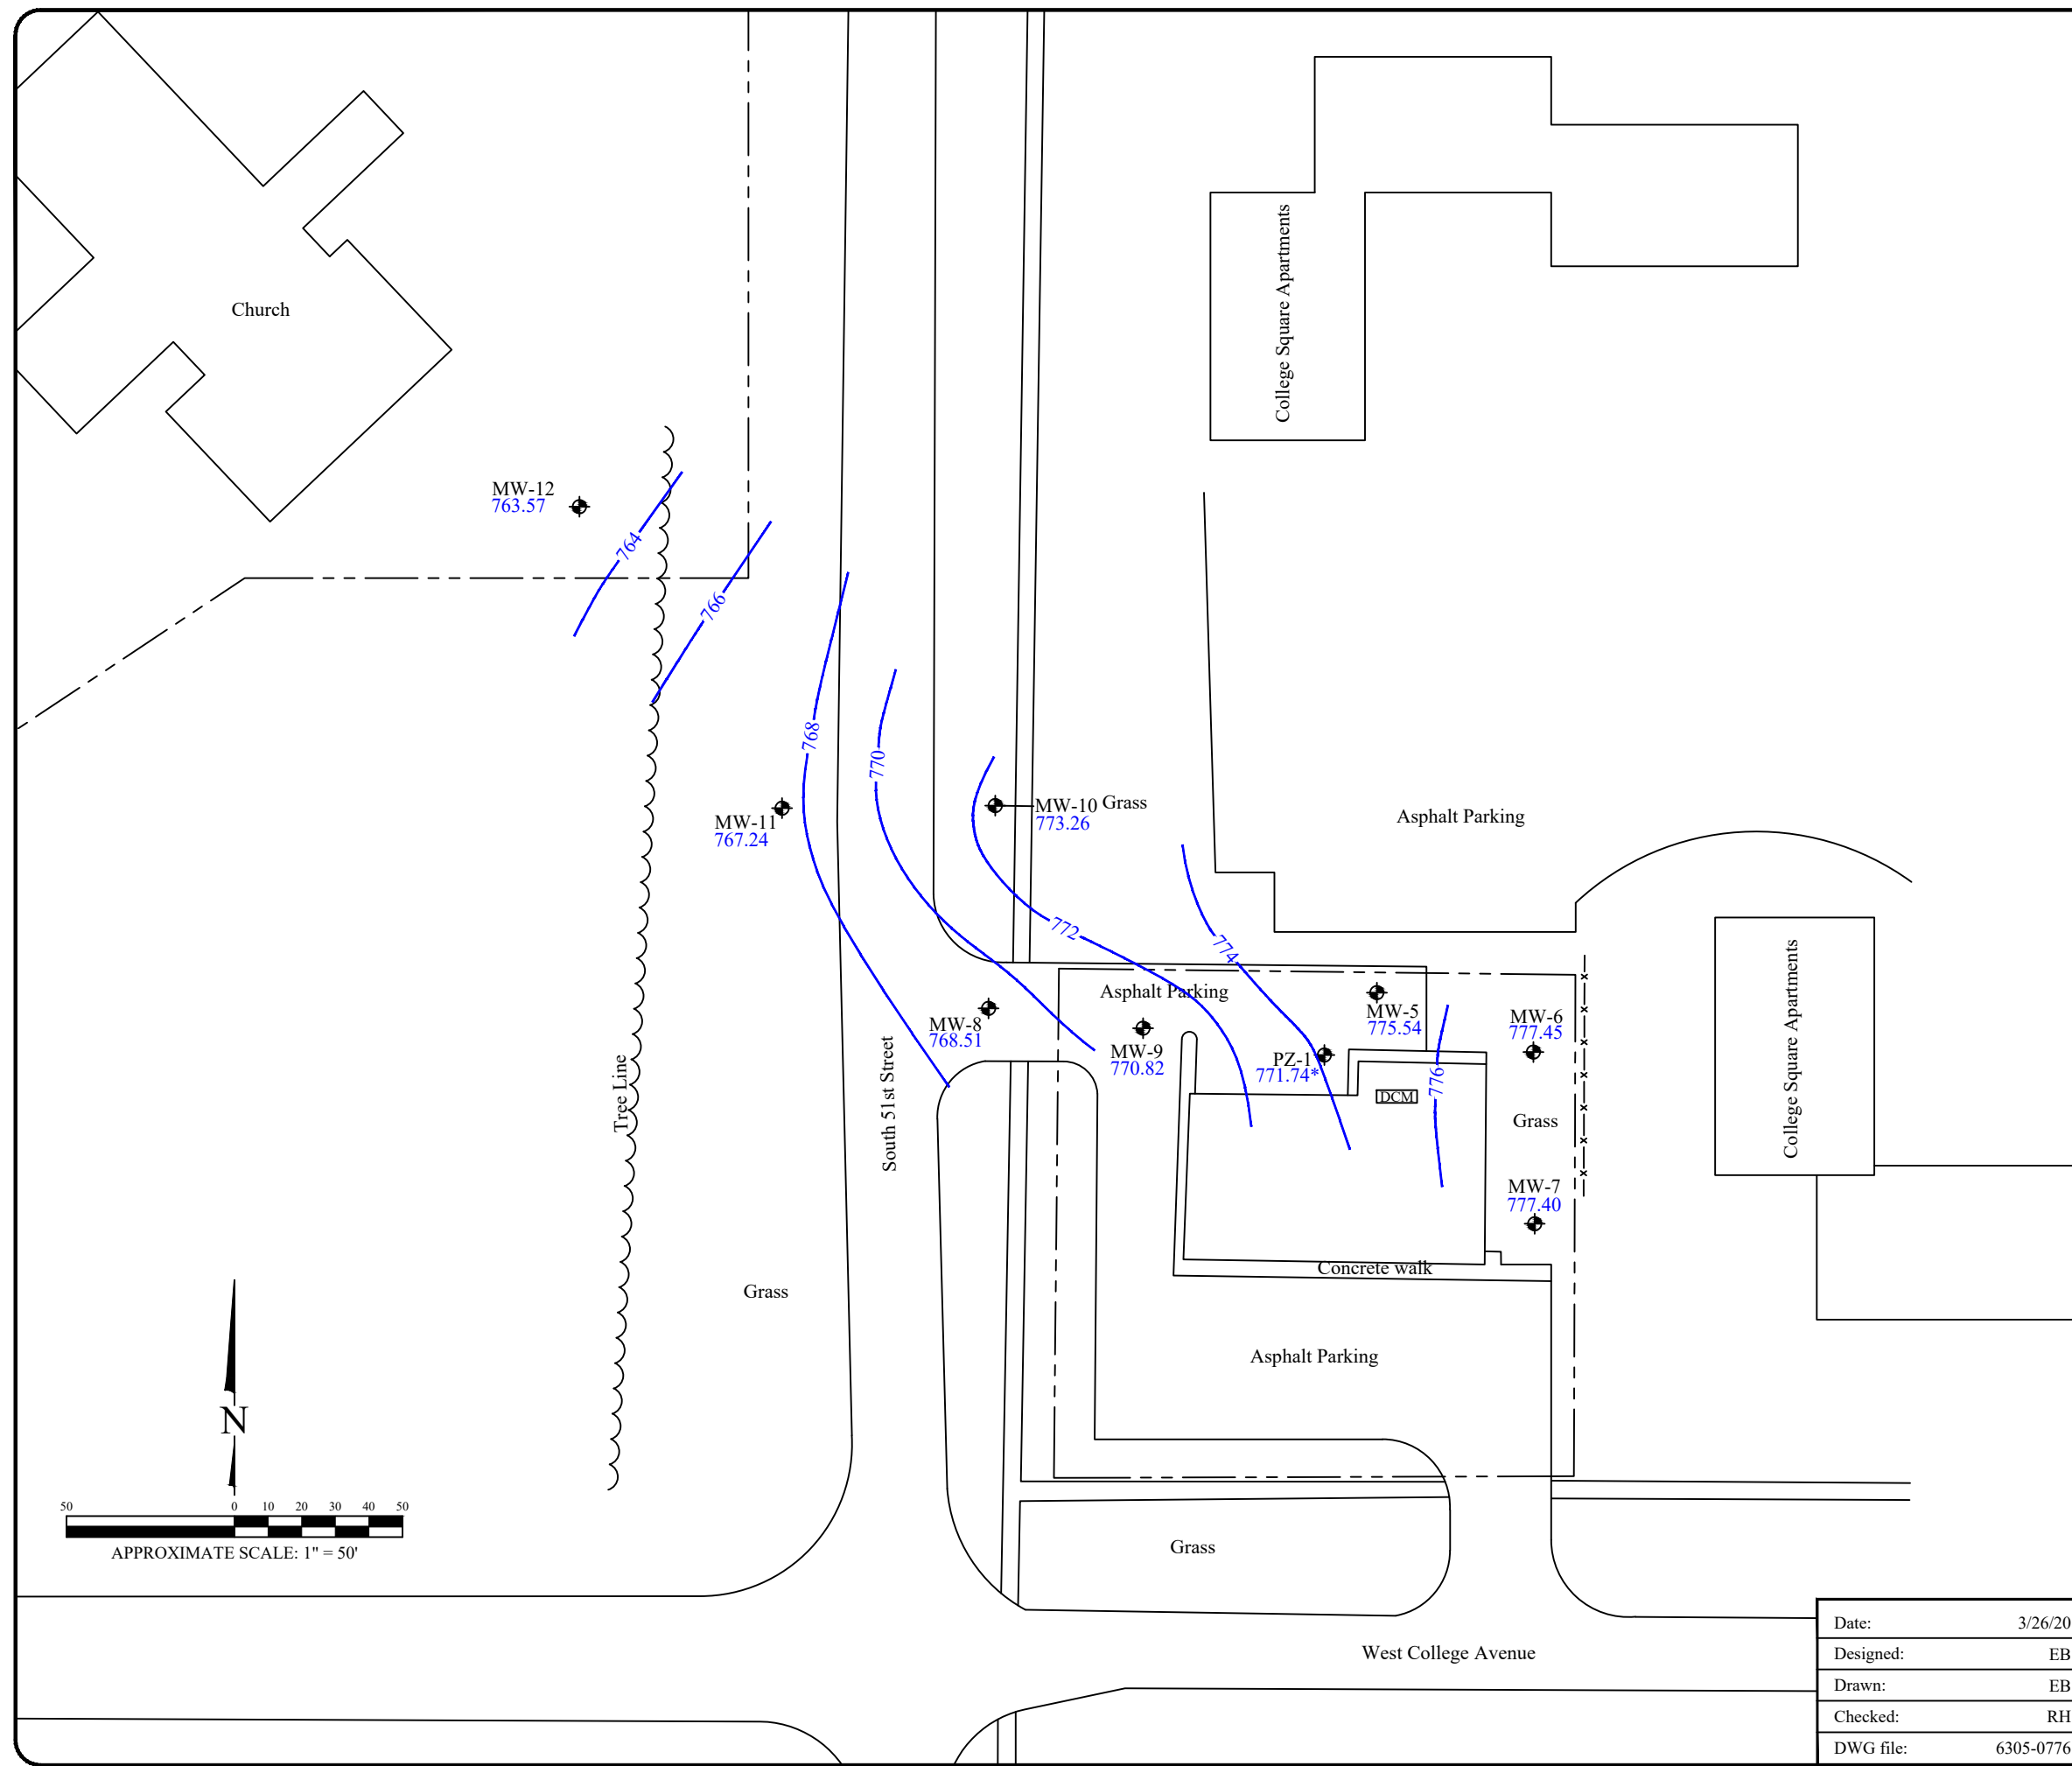
POTENTIOMETRIC SURFACE MAP
 JANUARY 2, 2020
 Former Peters Dry Cleaners
 5094 West College Avenue
 Greendale, WI

Groundwater elevation (feet above mean sea level)

Lake Michigan is the source of drinking water and groundwater is not used as a drinking water source. Groundwater is encountered at depths ranging from approximately 2.12 to 12.9 ft bgs at the Site. The hydraulic gradient measured indicates the direction of shallow groundwater flow is toward the west and north. The local topography controls groundwater flow on-Site to some extent, with the areas immediately surrounding the site representing a topographic high and the creek to the north representing the low. The most recent groundwater elevation data are shown in **Table 1** and **Figure 3** shows the most recent groundwater potentiometric surface map.

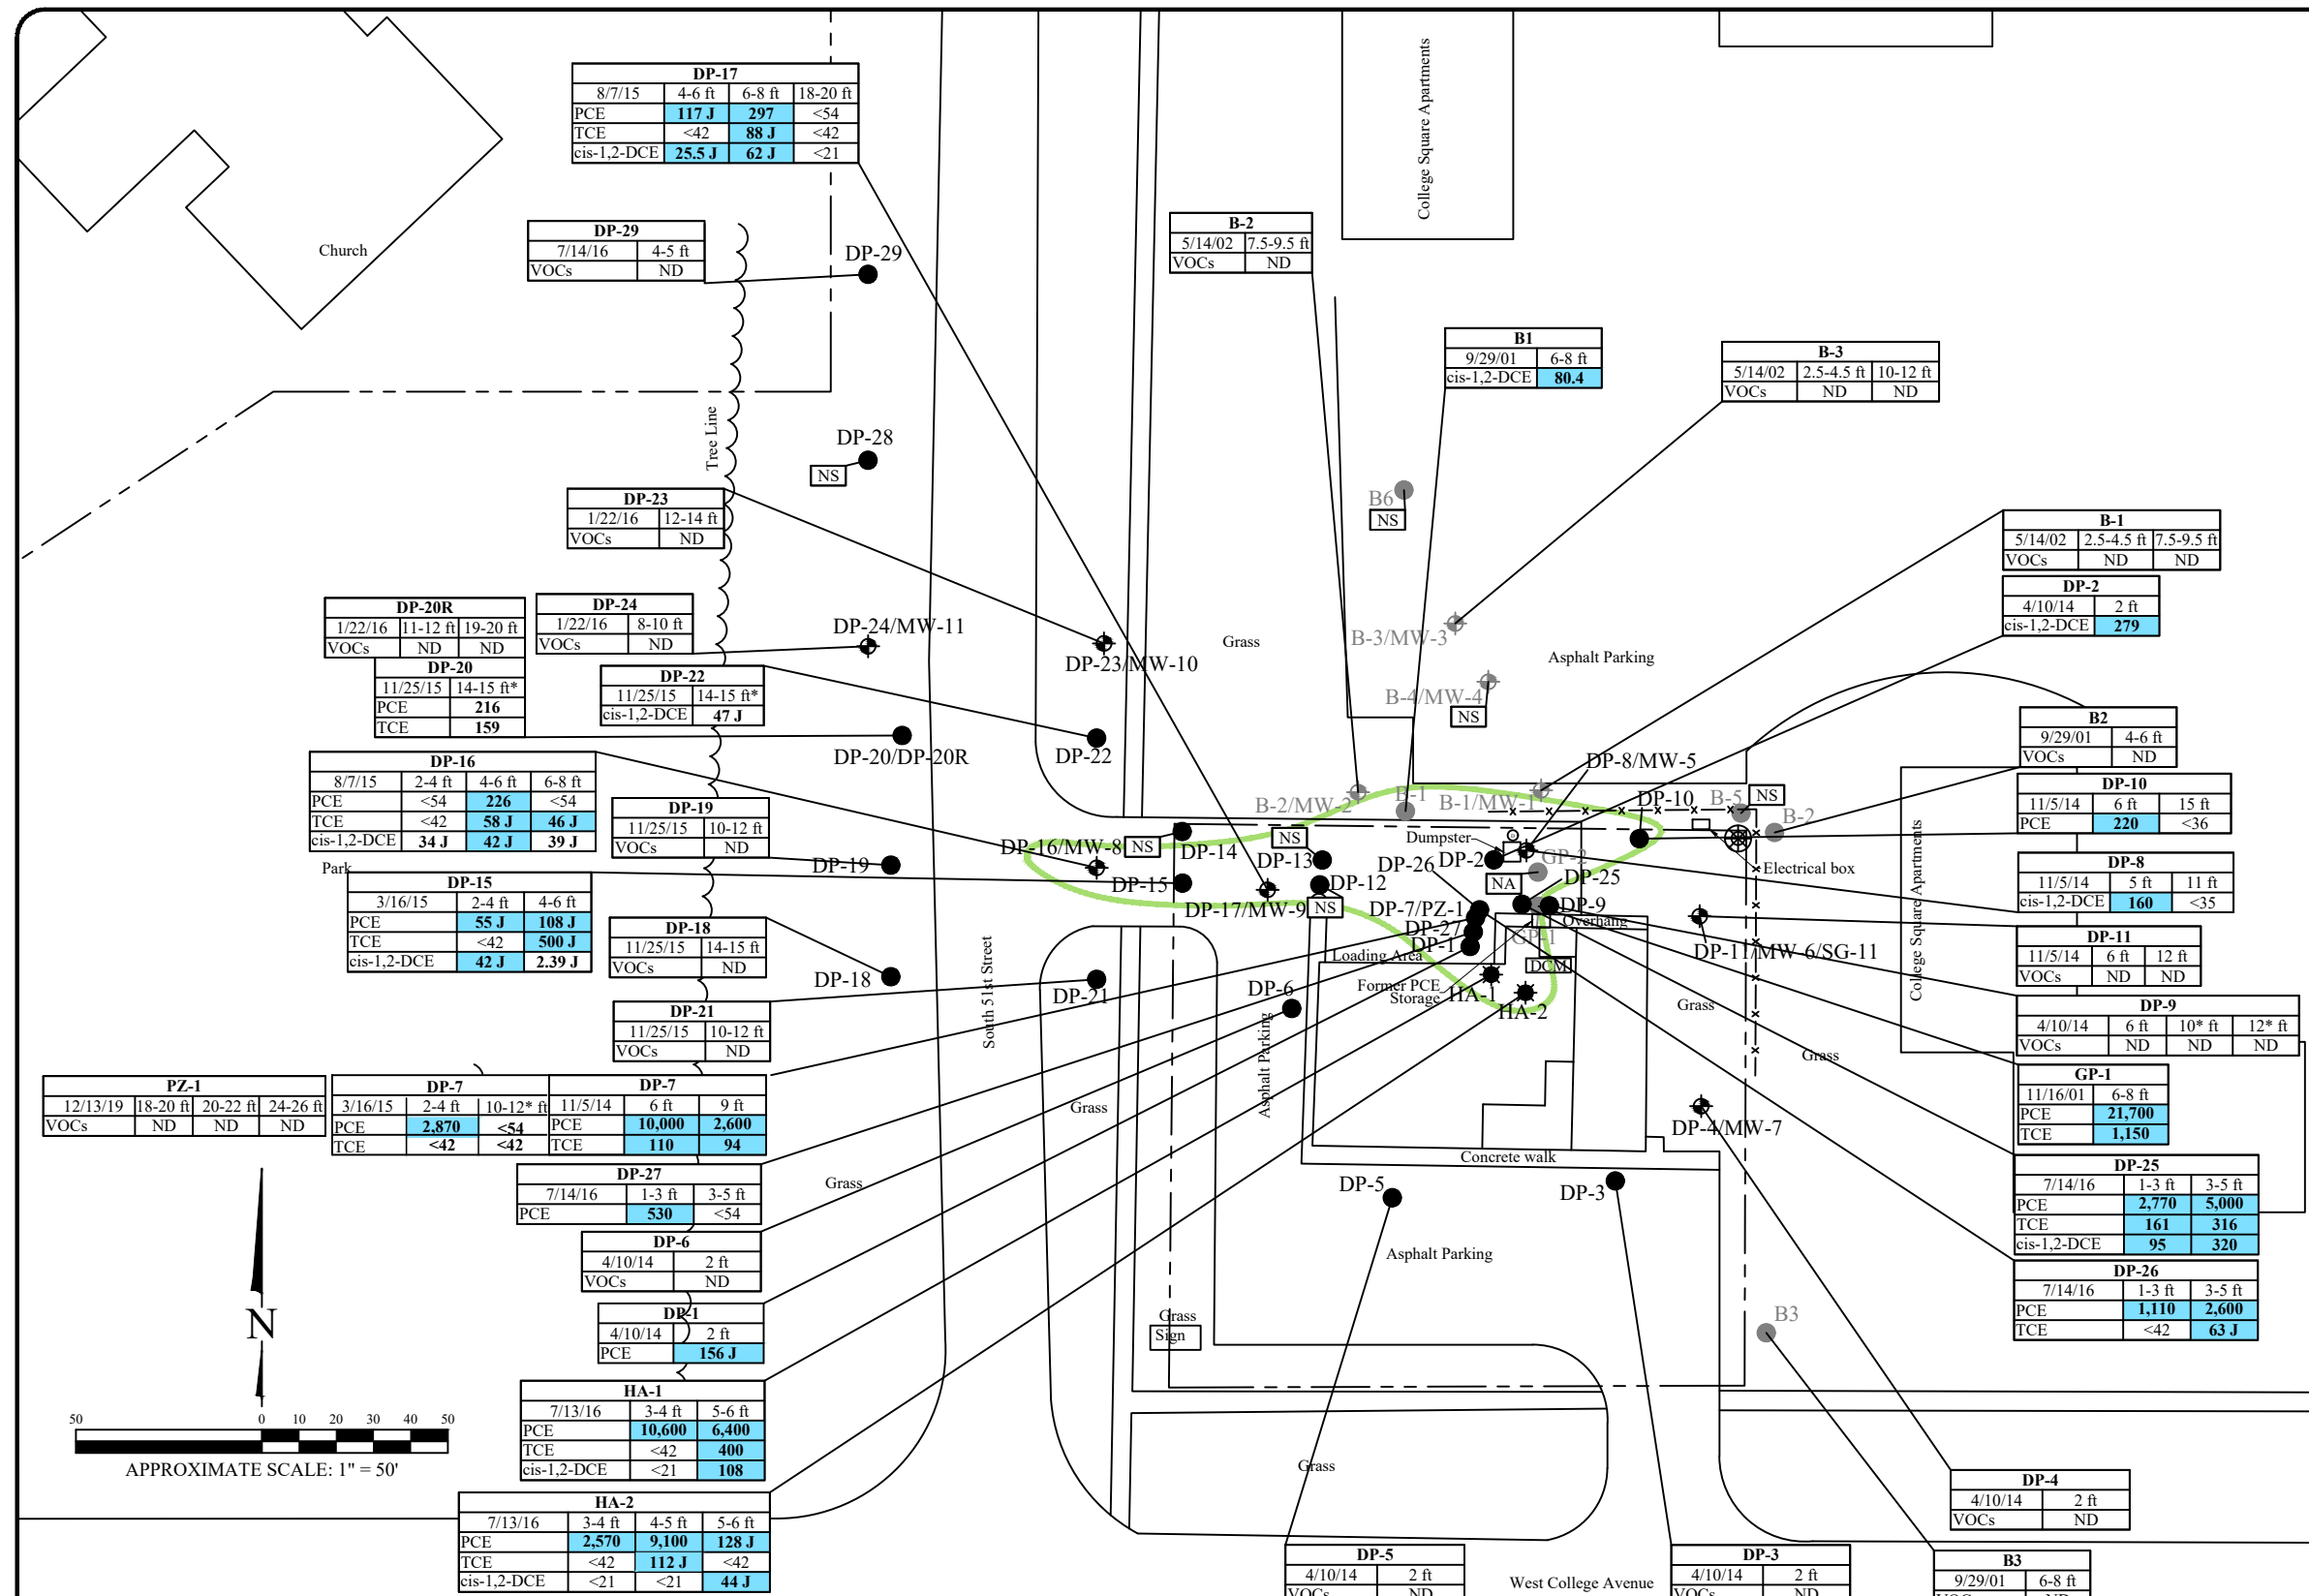
EXTENT OF SOIL IMPACTS

- Notes:
- Bolded and blue shaded values exceed the Soil to Groundwater Residual Contaminant Level (RCL)
 - Bolded values are above detection limits
 - J = Analyte concentration less than laboratory detection limits
 - Samples analyzed using EPA SW-846 Method 8260
 - All results reported in units of micrograms per kilogram (µg/kg)
 - PCE = Tetrachloroethene
 - TCE = Trichloroethene
 - cis-1,2-DCE = cis-1,2-Dichloroethene
 - trans-1,2-DCE = trans-1,2-Dichloroethene
 - ND = Not detected
 - NS = Not sampled
 - * = Saturated soil sample
 - VOCs = Volatile Organic Compounds
 - Non-target compound detected in DP-10 but not shown
- Extent of impacts above Soil to Groundwater Residual Contaminant Level

The Infiltration Cap will be the site building. The building footprint is depicted on **Figure 4** relative to the extent of soil contamination. The infiltration cap will be limited to the building because the primary source area is below the building at several orders of magnitude above the soil to groundwater RCL. With all the borings done behind the building, our investigation did not identify a source area. The contaminants do not represent a direct contact threat. We think the low-level contaminant concentrations are primarily due to a water line that ruptured during the initial investigation almost 20 years ago. The dry cleaning operations ceased at this Site nearly 35 years ago, and no significant migration has occurred. Because the groundwater plume mirrors the utilities, the water line breach dispersed the contaminants within the utility backfill. Because there is no source area and the building functions as a cap over the actual source, we do not expect these residual impacts to migrate further in the fine-grained silts and clays. The last consideration is that requiring the installation of a form cap places an additional financial burden on the property owner. A maintenance plan will be provided with the closure documentation to ensure the least amount of potential changes in the plan moving forward.

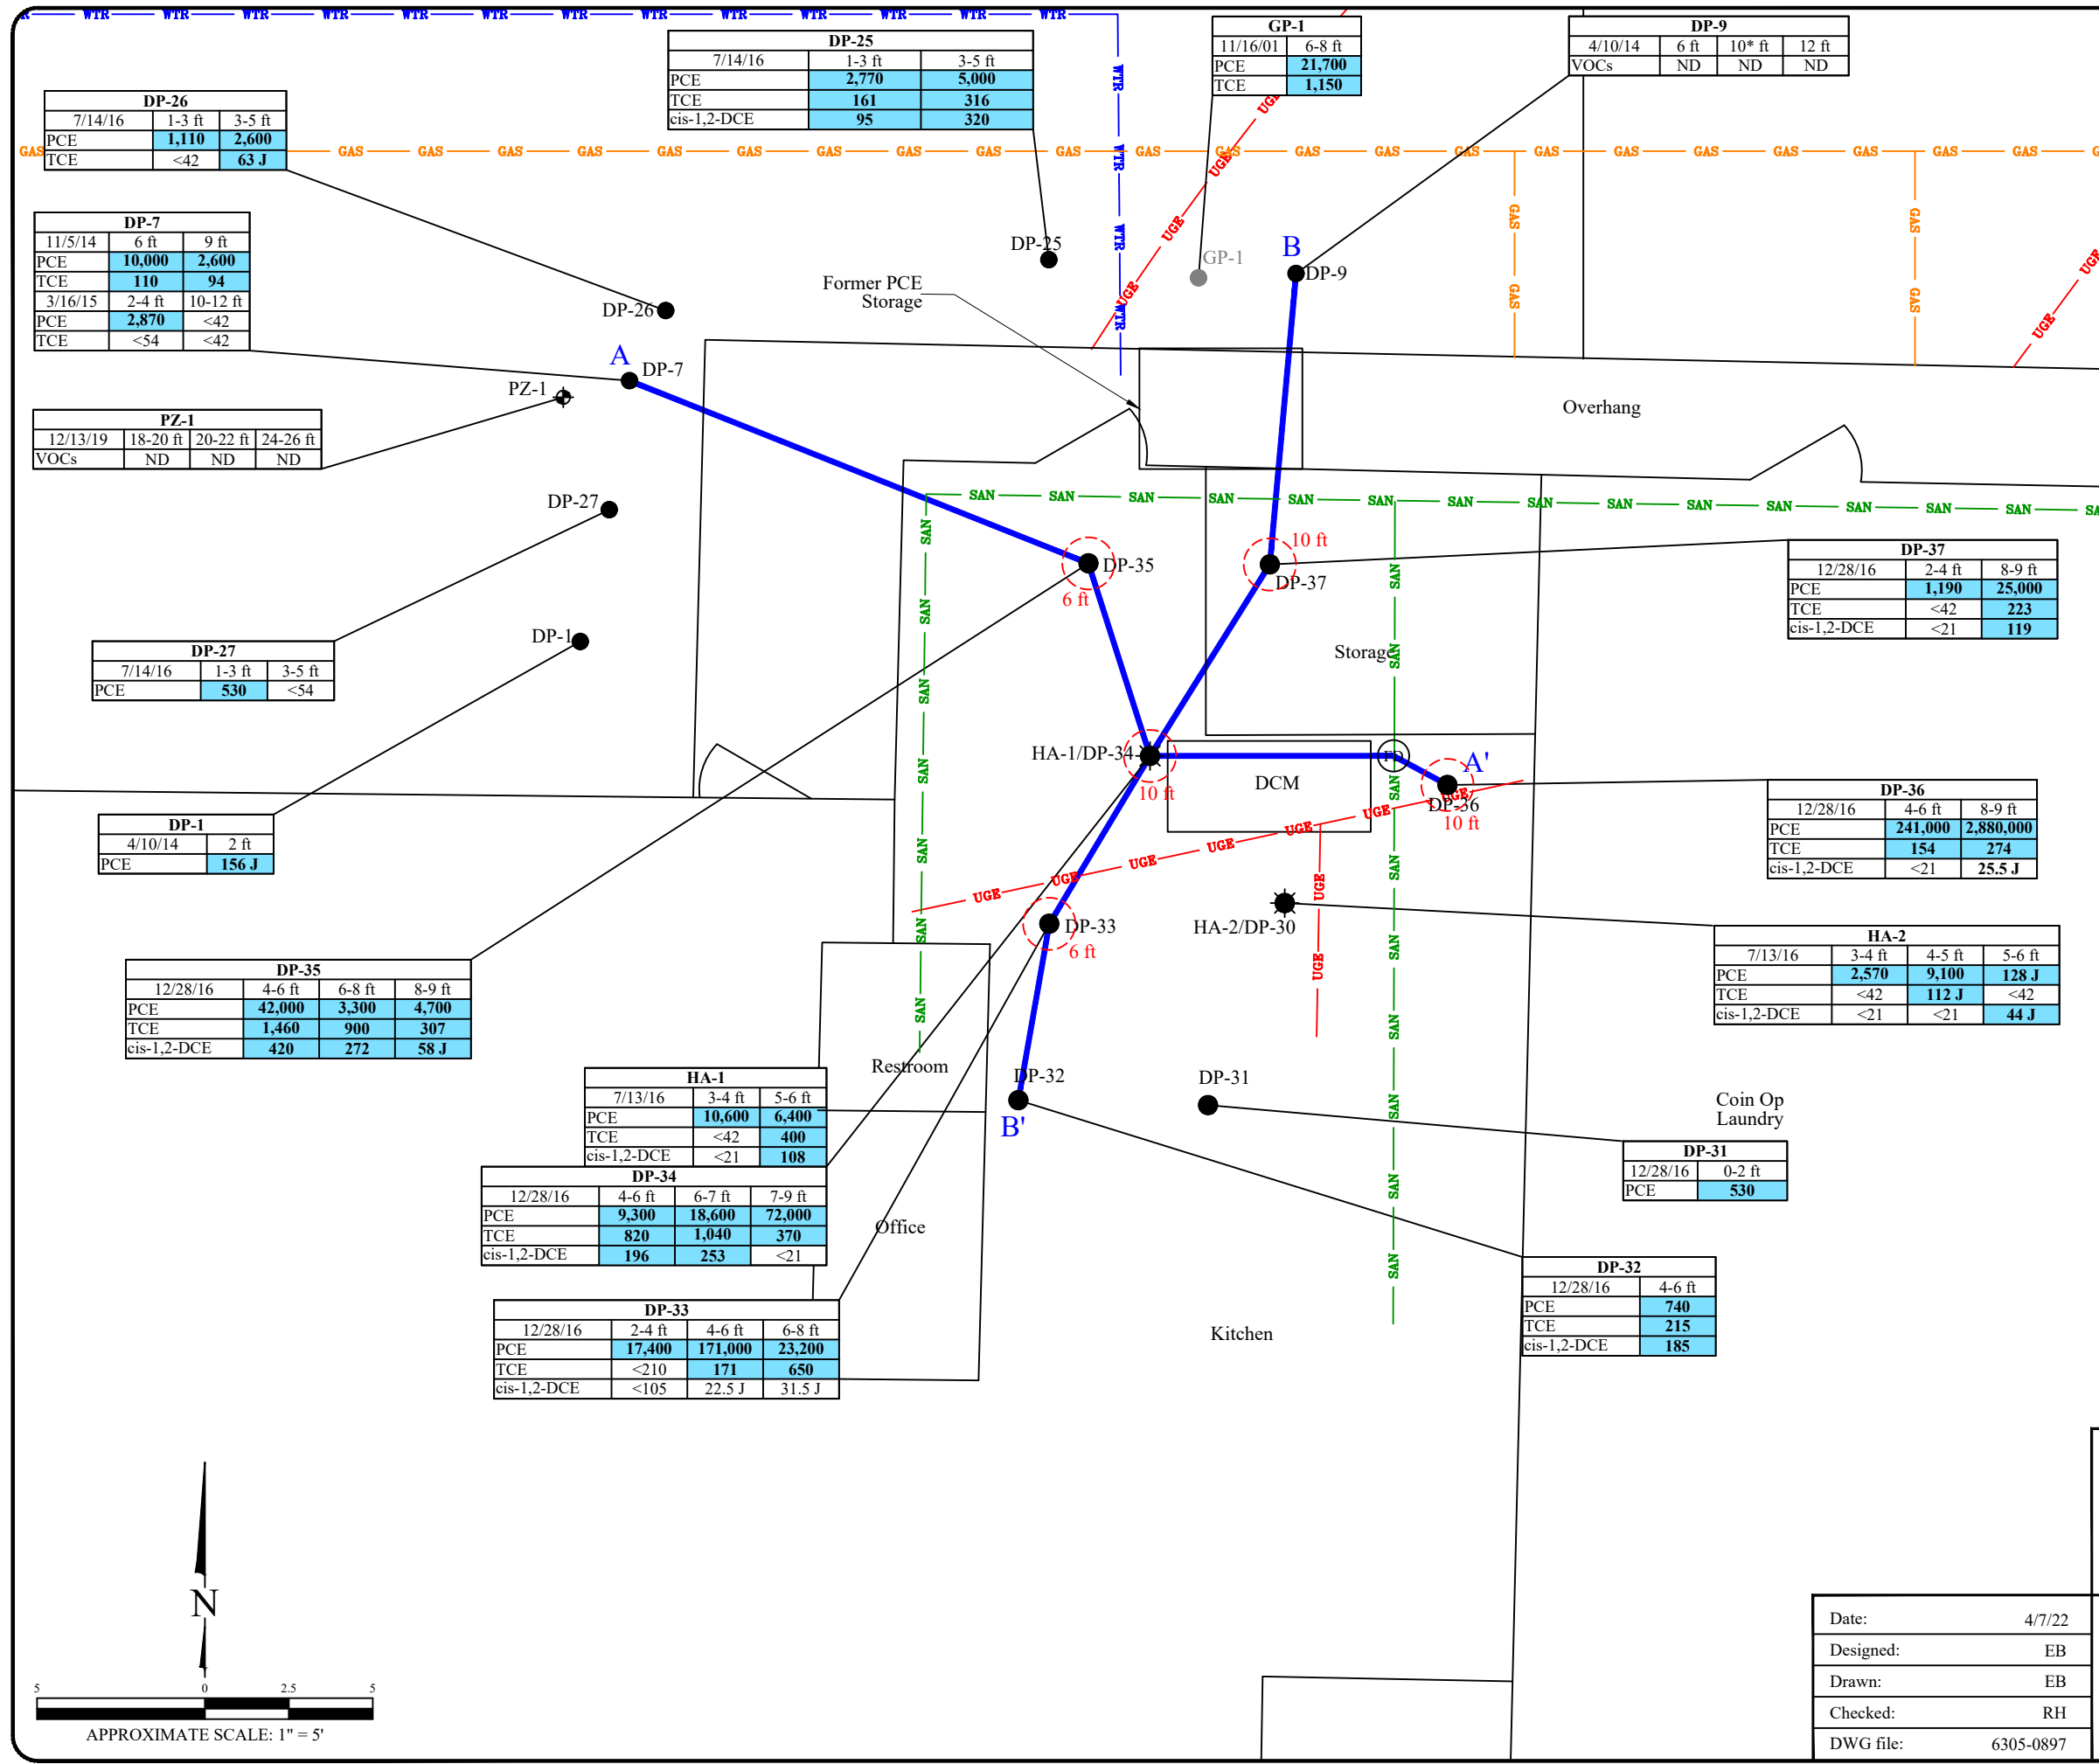
REMEDIAL CROSS SECTION TRANSECT MAP
A-A' AND B-B'
Former Peters Dry Cleaners
5094 West College Avenue
Greendale, WI

10 ft Remediation Auger with amendment Depth in Feet

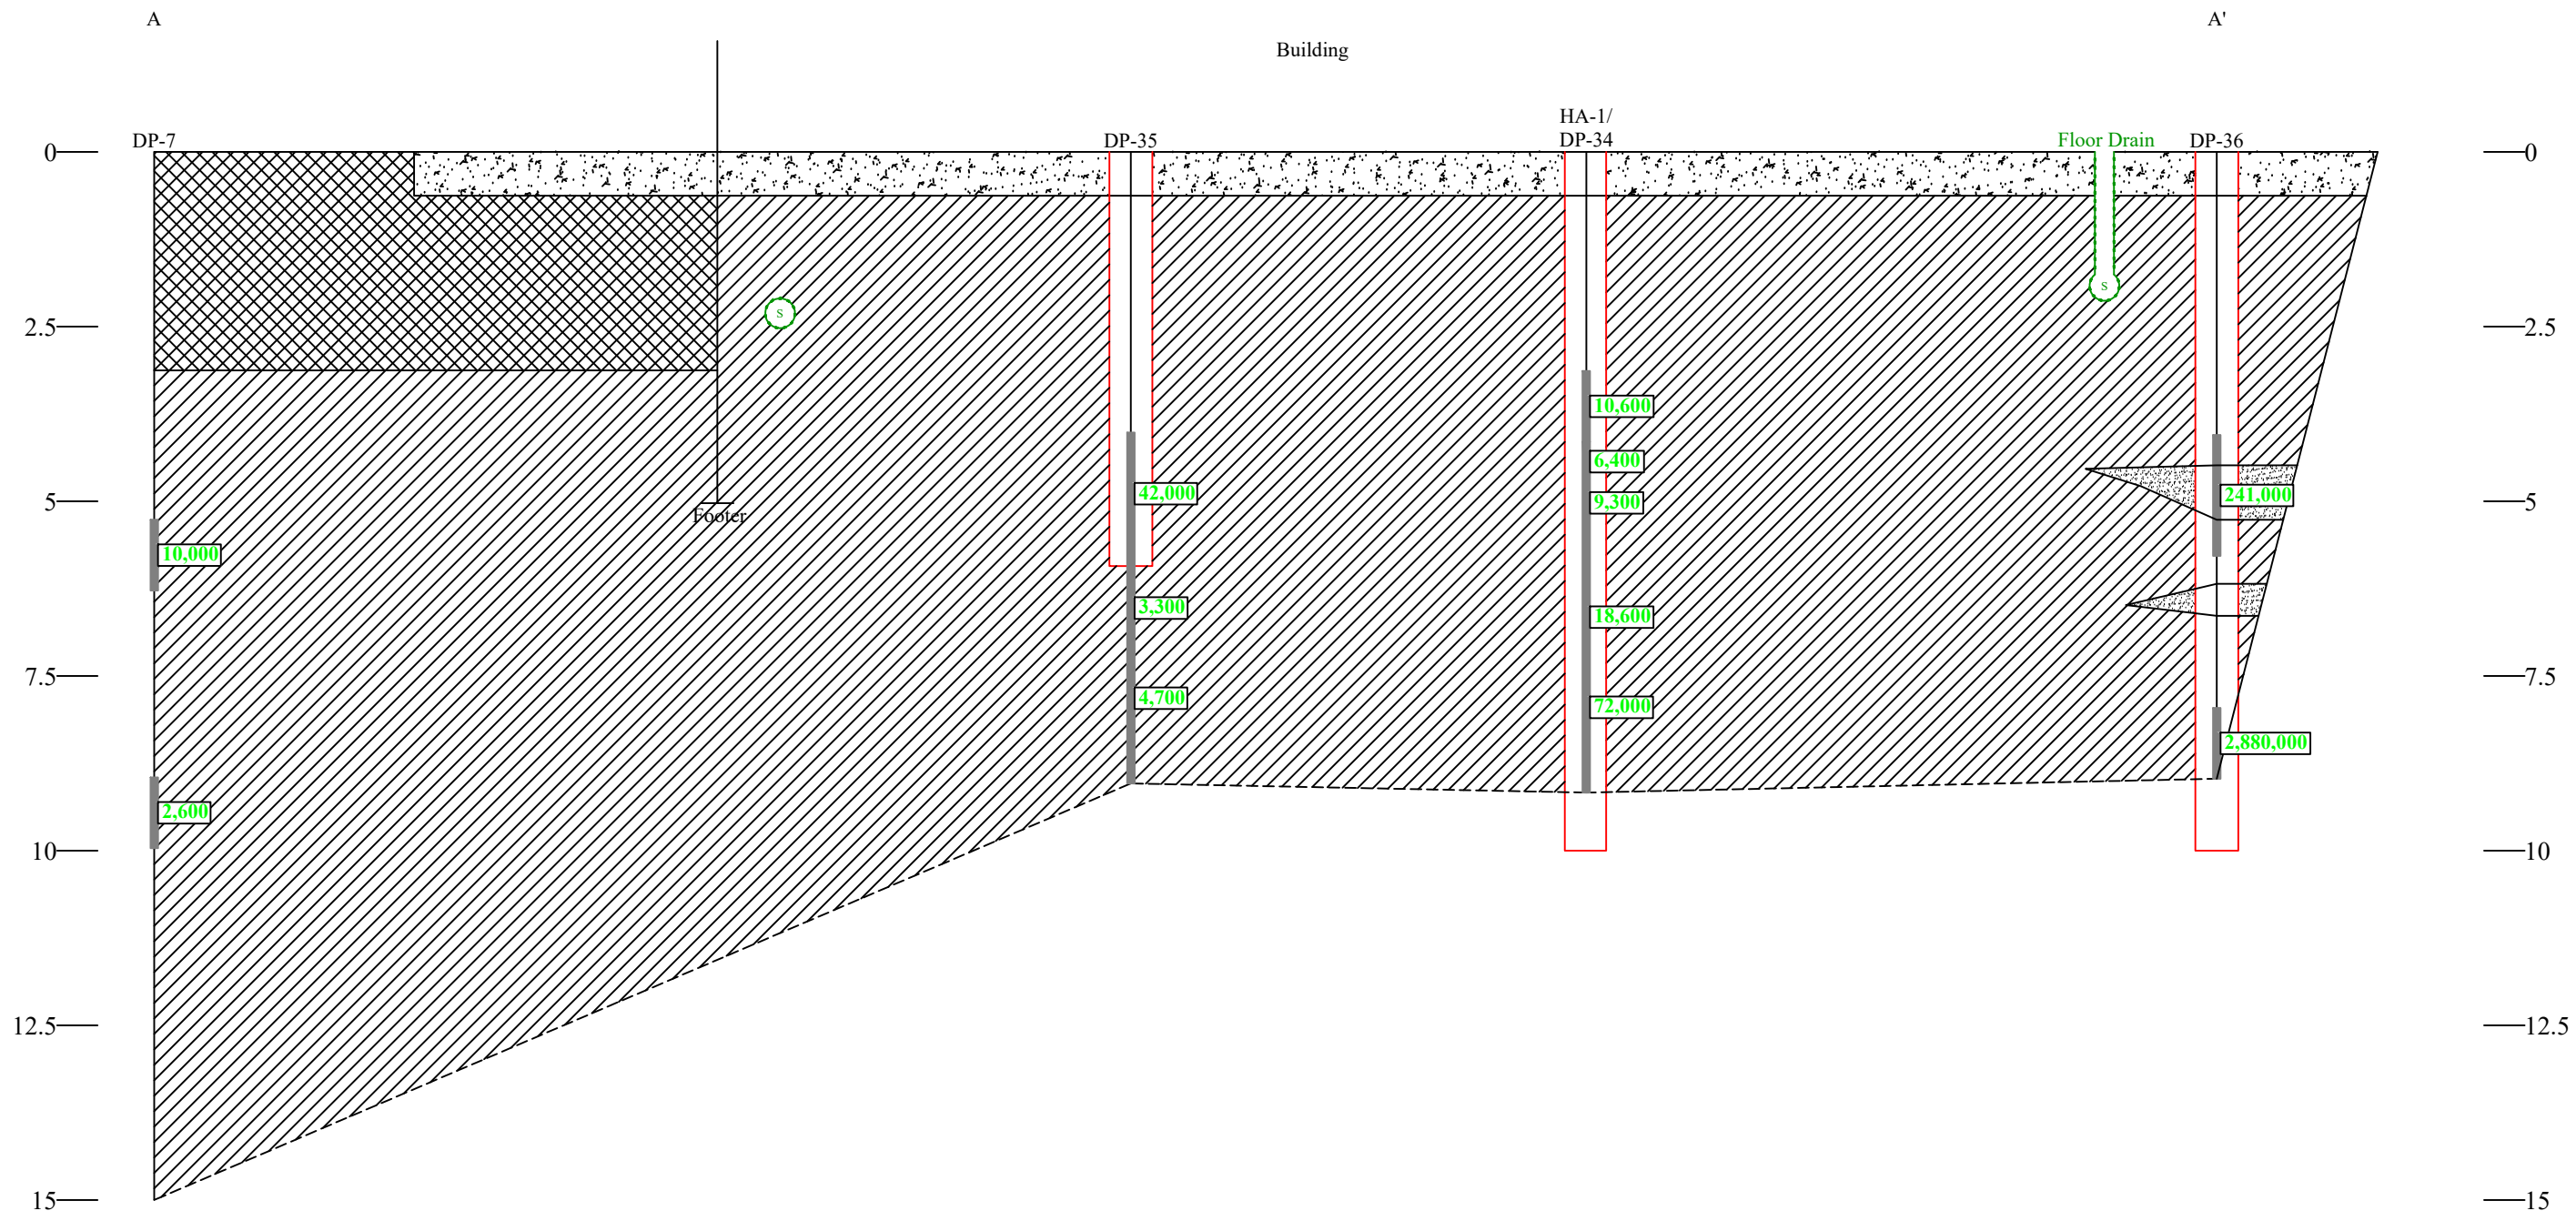
REMEDIAL CROSS SECTION A-A' Former Peters Dry Cleaners 5094 West College Avenue Greendale, WI	
Date: 4/7/22 Designed: EB Drawn: EB Checked: RH DWG file: 6305-0897	 825 North Capitol Avenue • Indianapolis, IN 46204 EnviroForensics.com
Figure	8
Project	6305

Concrete		Soil sample depth interval
	Fill		PCE concentration in soil sample (mg/kg)
	Sand		Remediation location with 7 inch hand auger
	Silty Clay		Dashed boundaries are inferred
	Sandy Clay		Sewer location

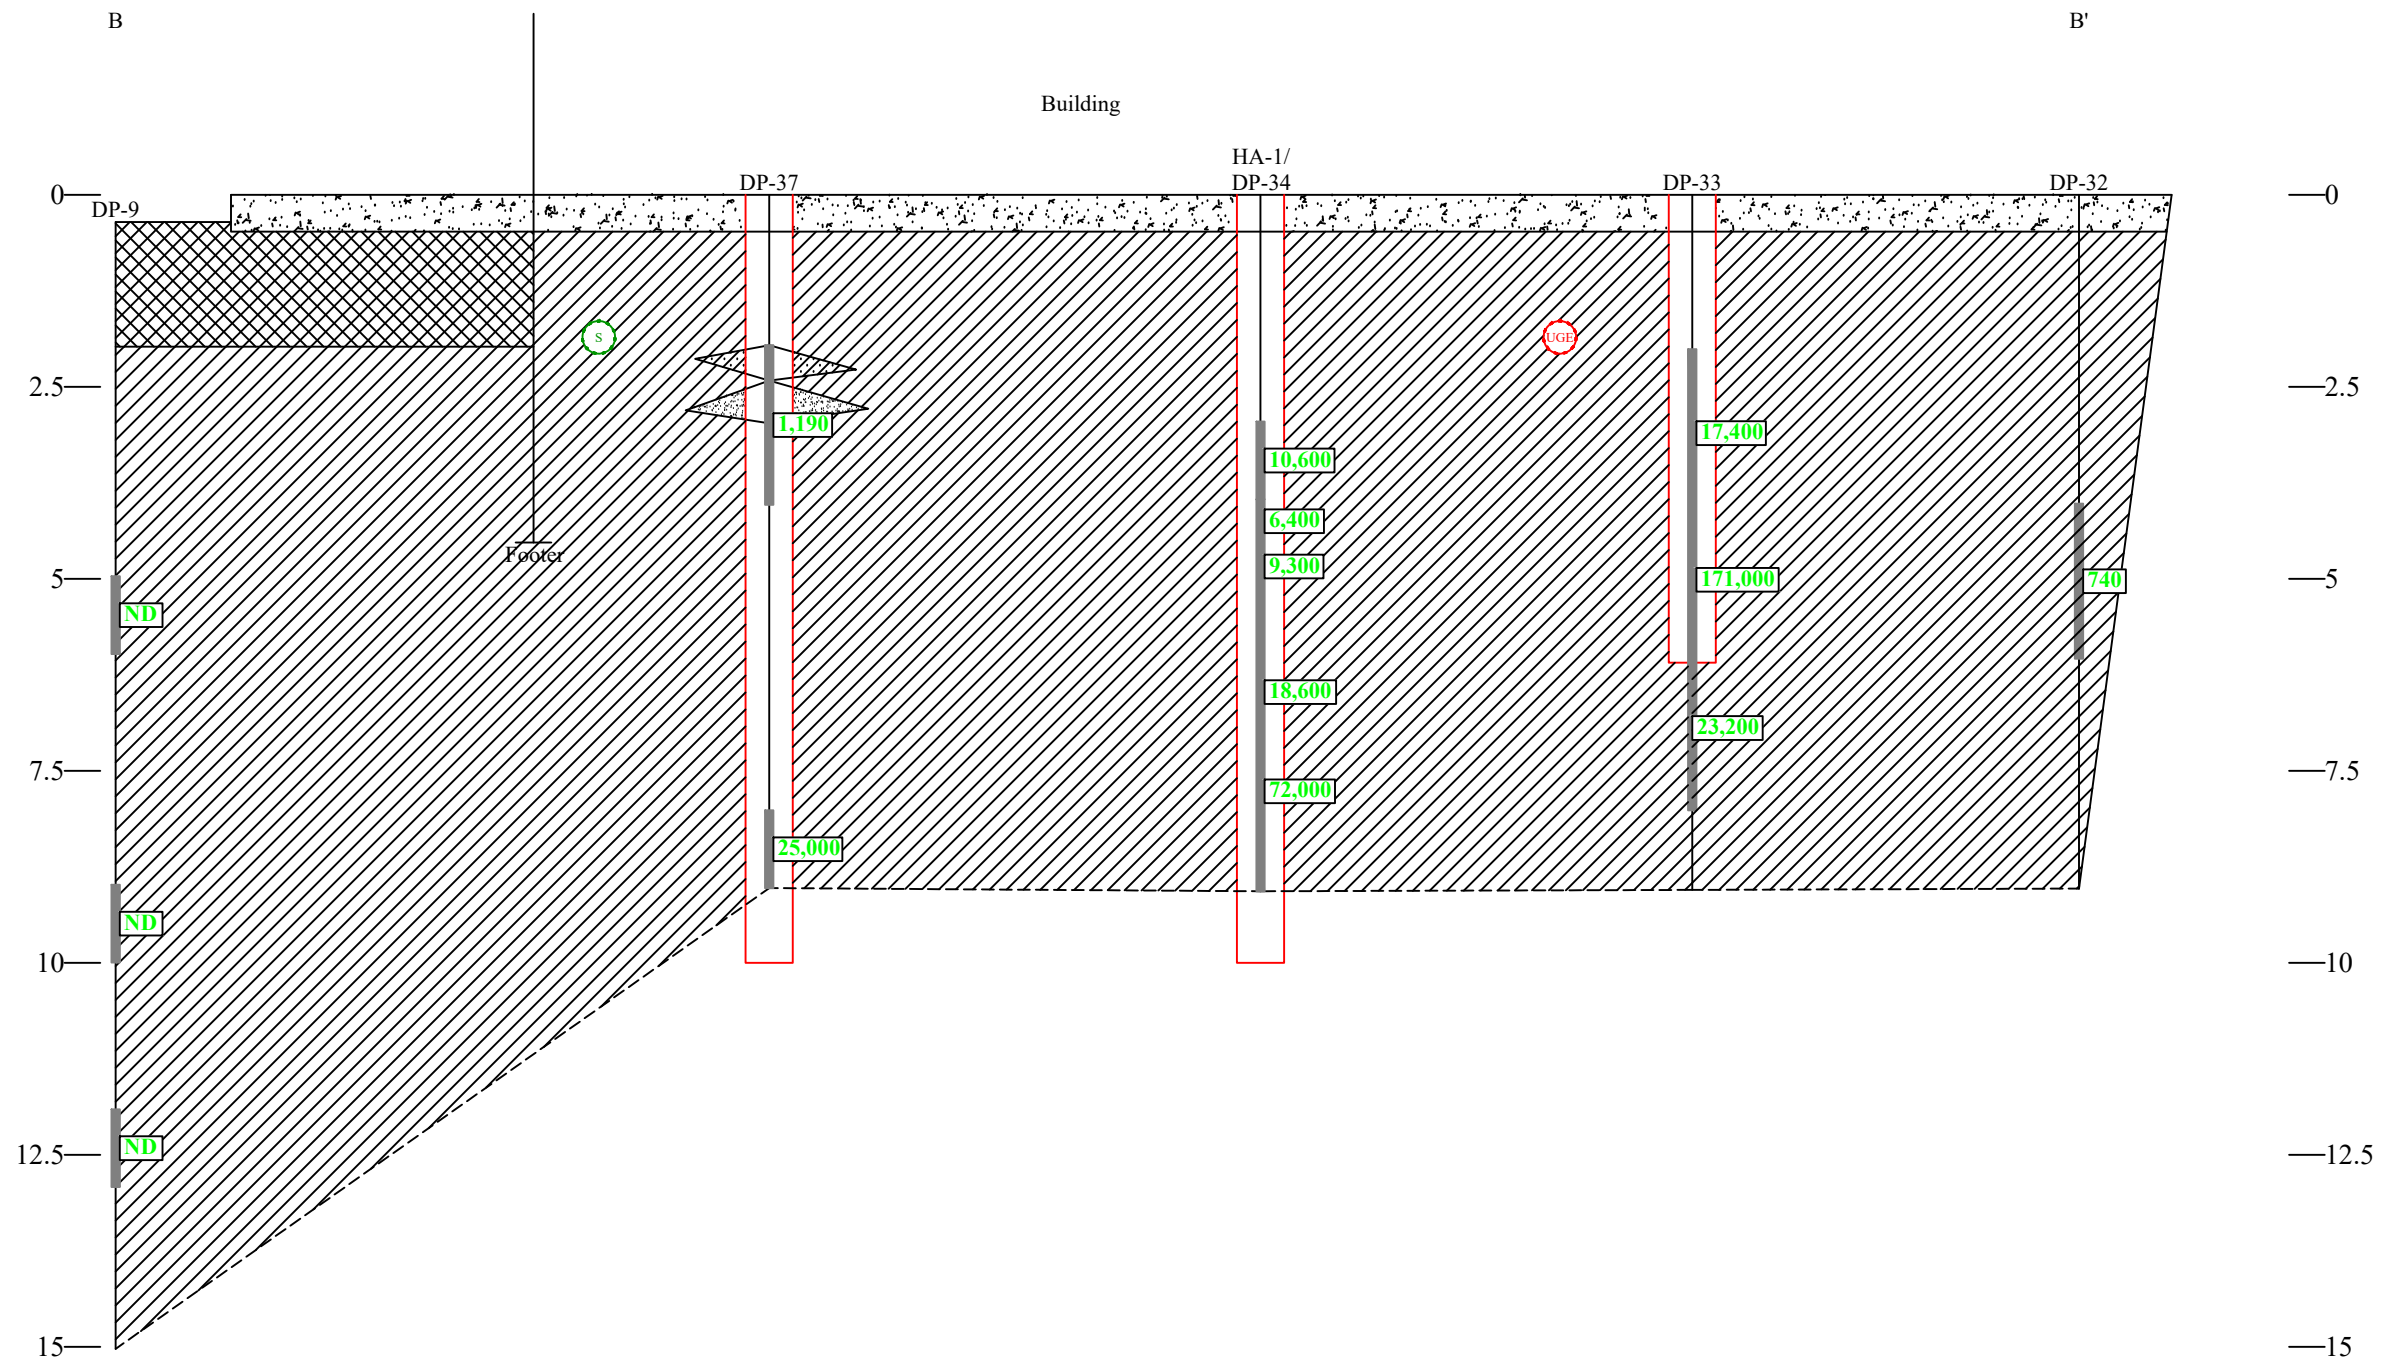
REMEDIAL CROSS SECTION
B-B'
Former Peters Dry Cleaners
5094 West College Avenue
Greendale, WI

Concrete		Soil sample depth interval
	Fill		PCE concentration in soil sample (mg/kg)
	Sand		Remediation location with 7 inch hand auger
	Silty Clay		Dashed boundaries are inferred
	Sandy Clay		Sewer location
			Underground electrical location
