**Subject:** RE: Request for services for system alarm at Wisconsin Chrome, BRRTS #02-45-000225 **Attachments:** Looking towards floor sump.022619.pdf; control panel.022619.pdf; looking to the

Subject: Request for services for system alarm at Wisconsin Chrome, BRRTS #02-45-000225

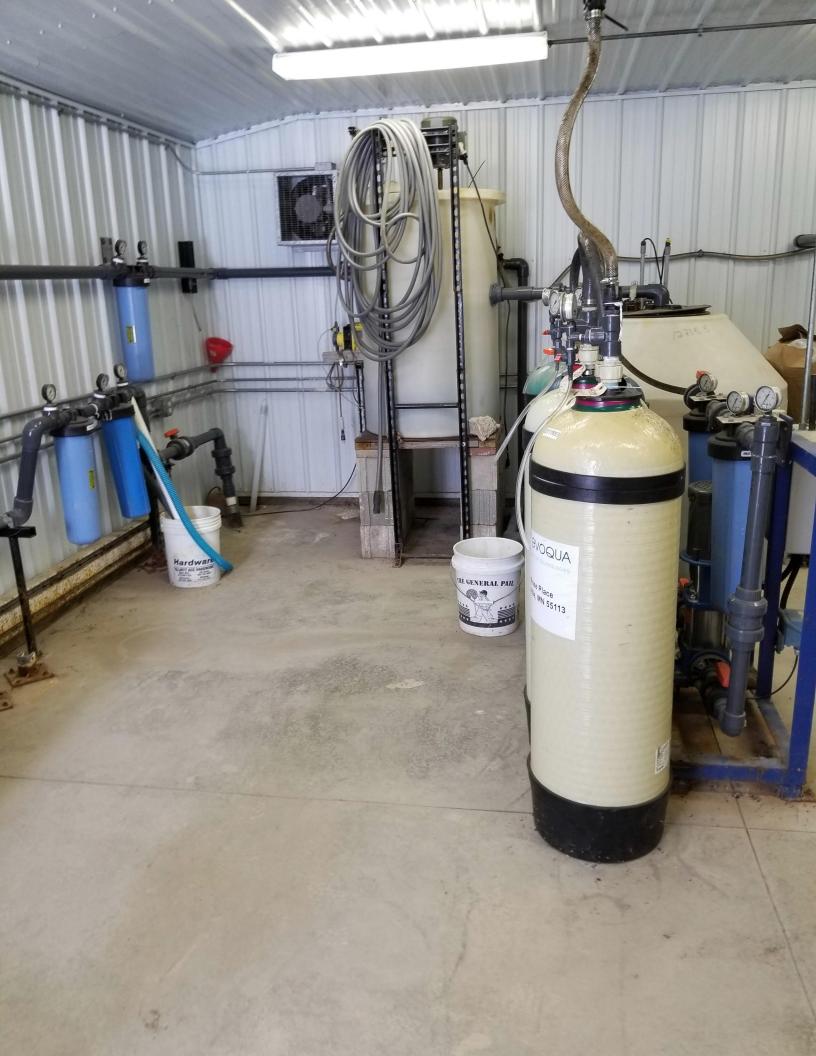
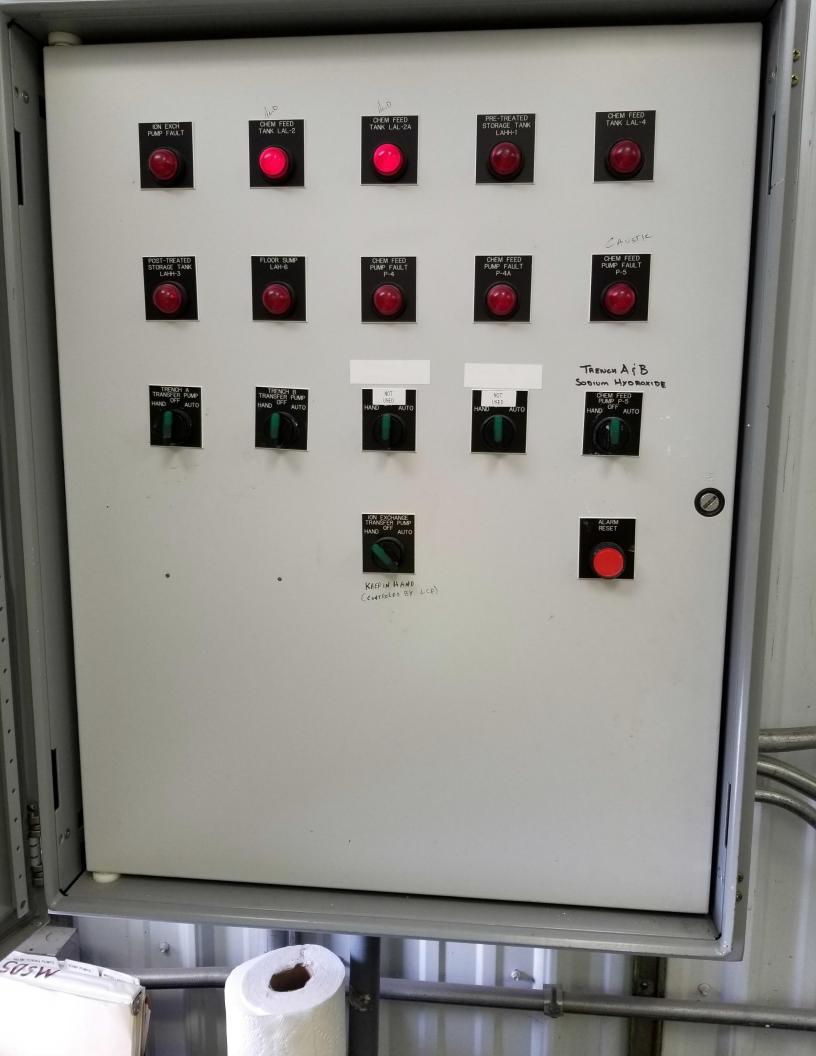
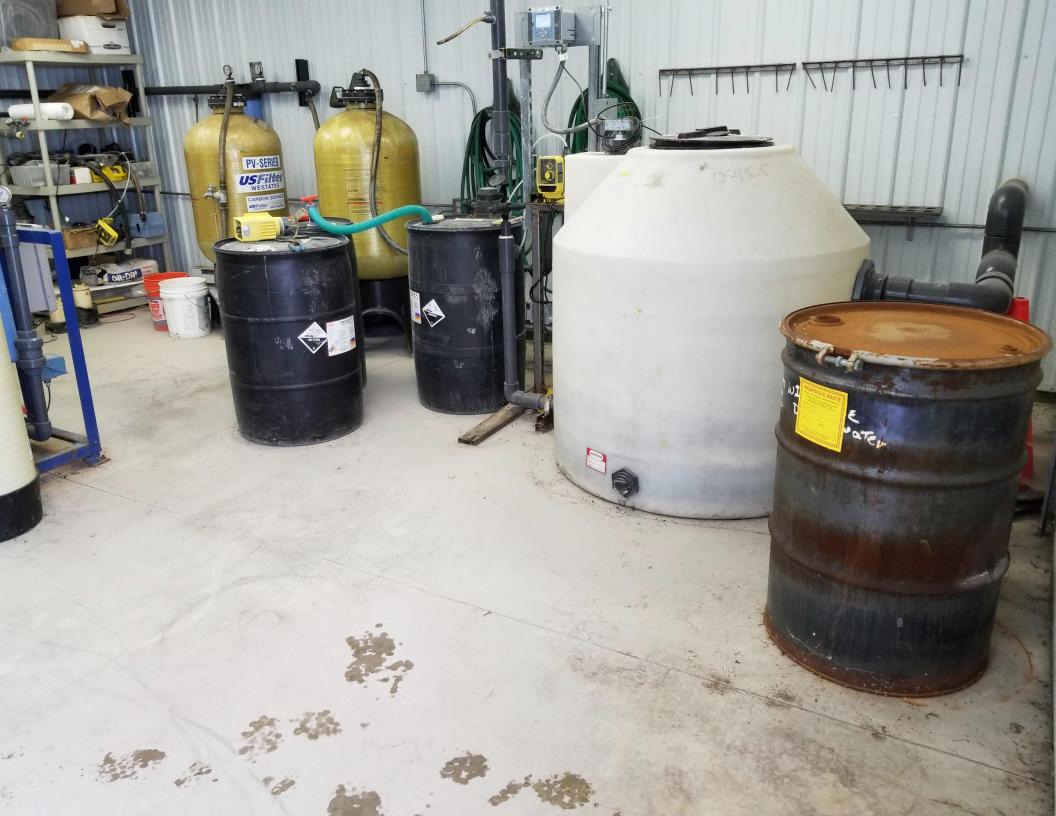
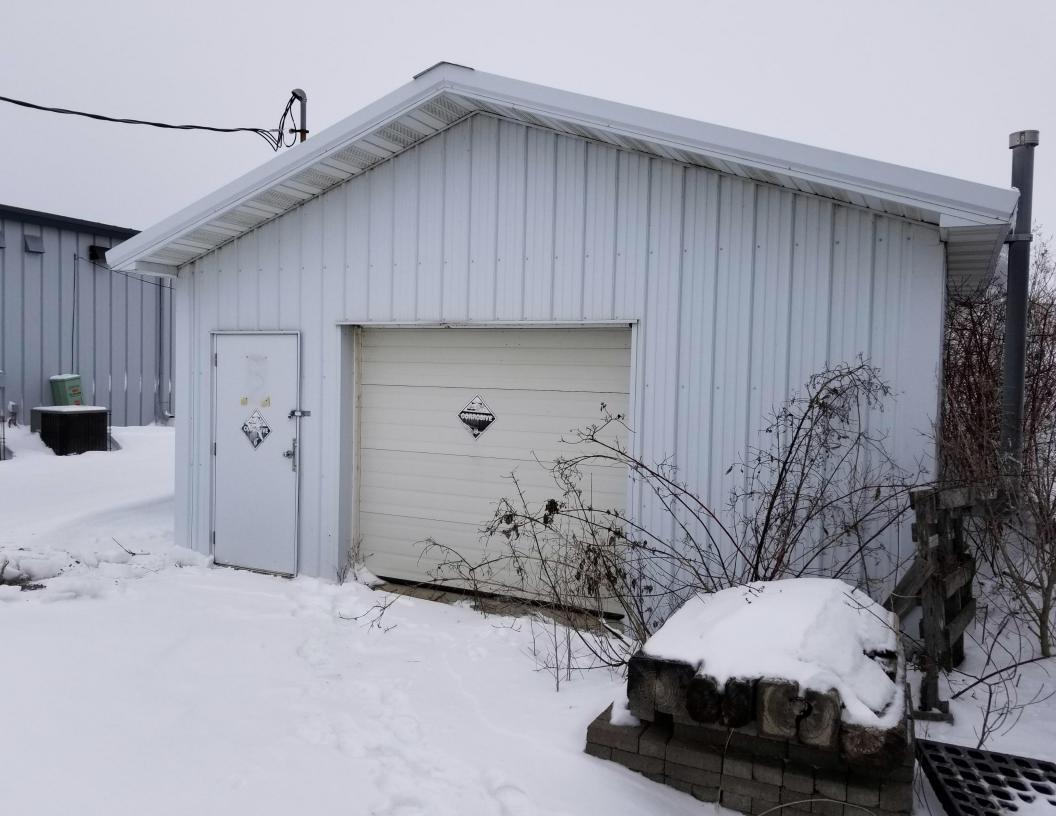
According to the autodialer, alarm #6 was the alert condition. However, upon arrival at the site no alarm conditions were evident on the control panel. Documentation available onsite indicated that alarm condition #6 was related to the floor sump. I inspected the floor sump and float switch. The floor sump was less than half full of water and the float switch was above that level. There was no evidence of a problem with the switch and no evidence of flooding inside the building at any time since my last visit to the site in March 2018. As such, I can only speculate as to what may have caused the alarm. If it continues it may be necessary to investigate the relay switch(es) and autodialer wiring and connections. I did raise the floor sump float switch about 2 inches.

Overall the building was in good shape and as I had left it in March 2018. The heat and electricity were still on and the control panel operable. One can still drive around the back side of Midwest carriers to access the building. I have attached pdf's of several photos that document current conditions. If and when the system is restarted, both of the pH meters should be replaced and the Sump A pump and transfer pump should be inspected and replaced if necessary prior to startup.
