Subslab Vapor Sampling Workplan

July 2009

*Prepared For
Tecumseh Products Company
Grafton, Wisconsin*

RMT, Inc. | Tecumseh Products Company
Final

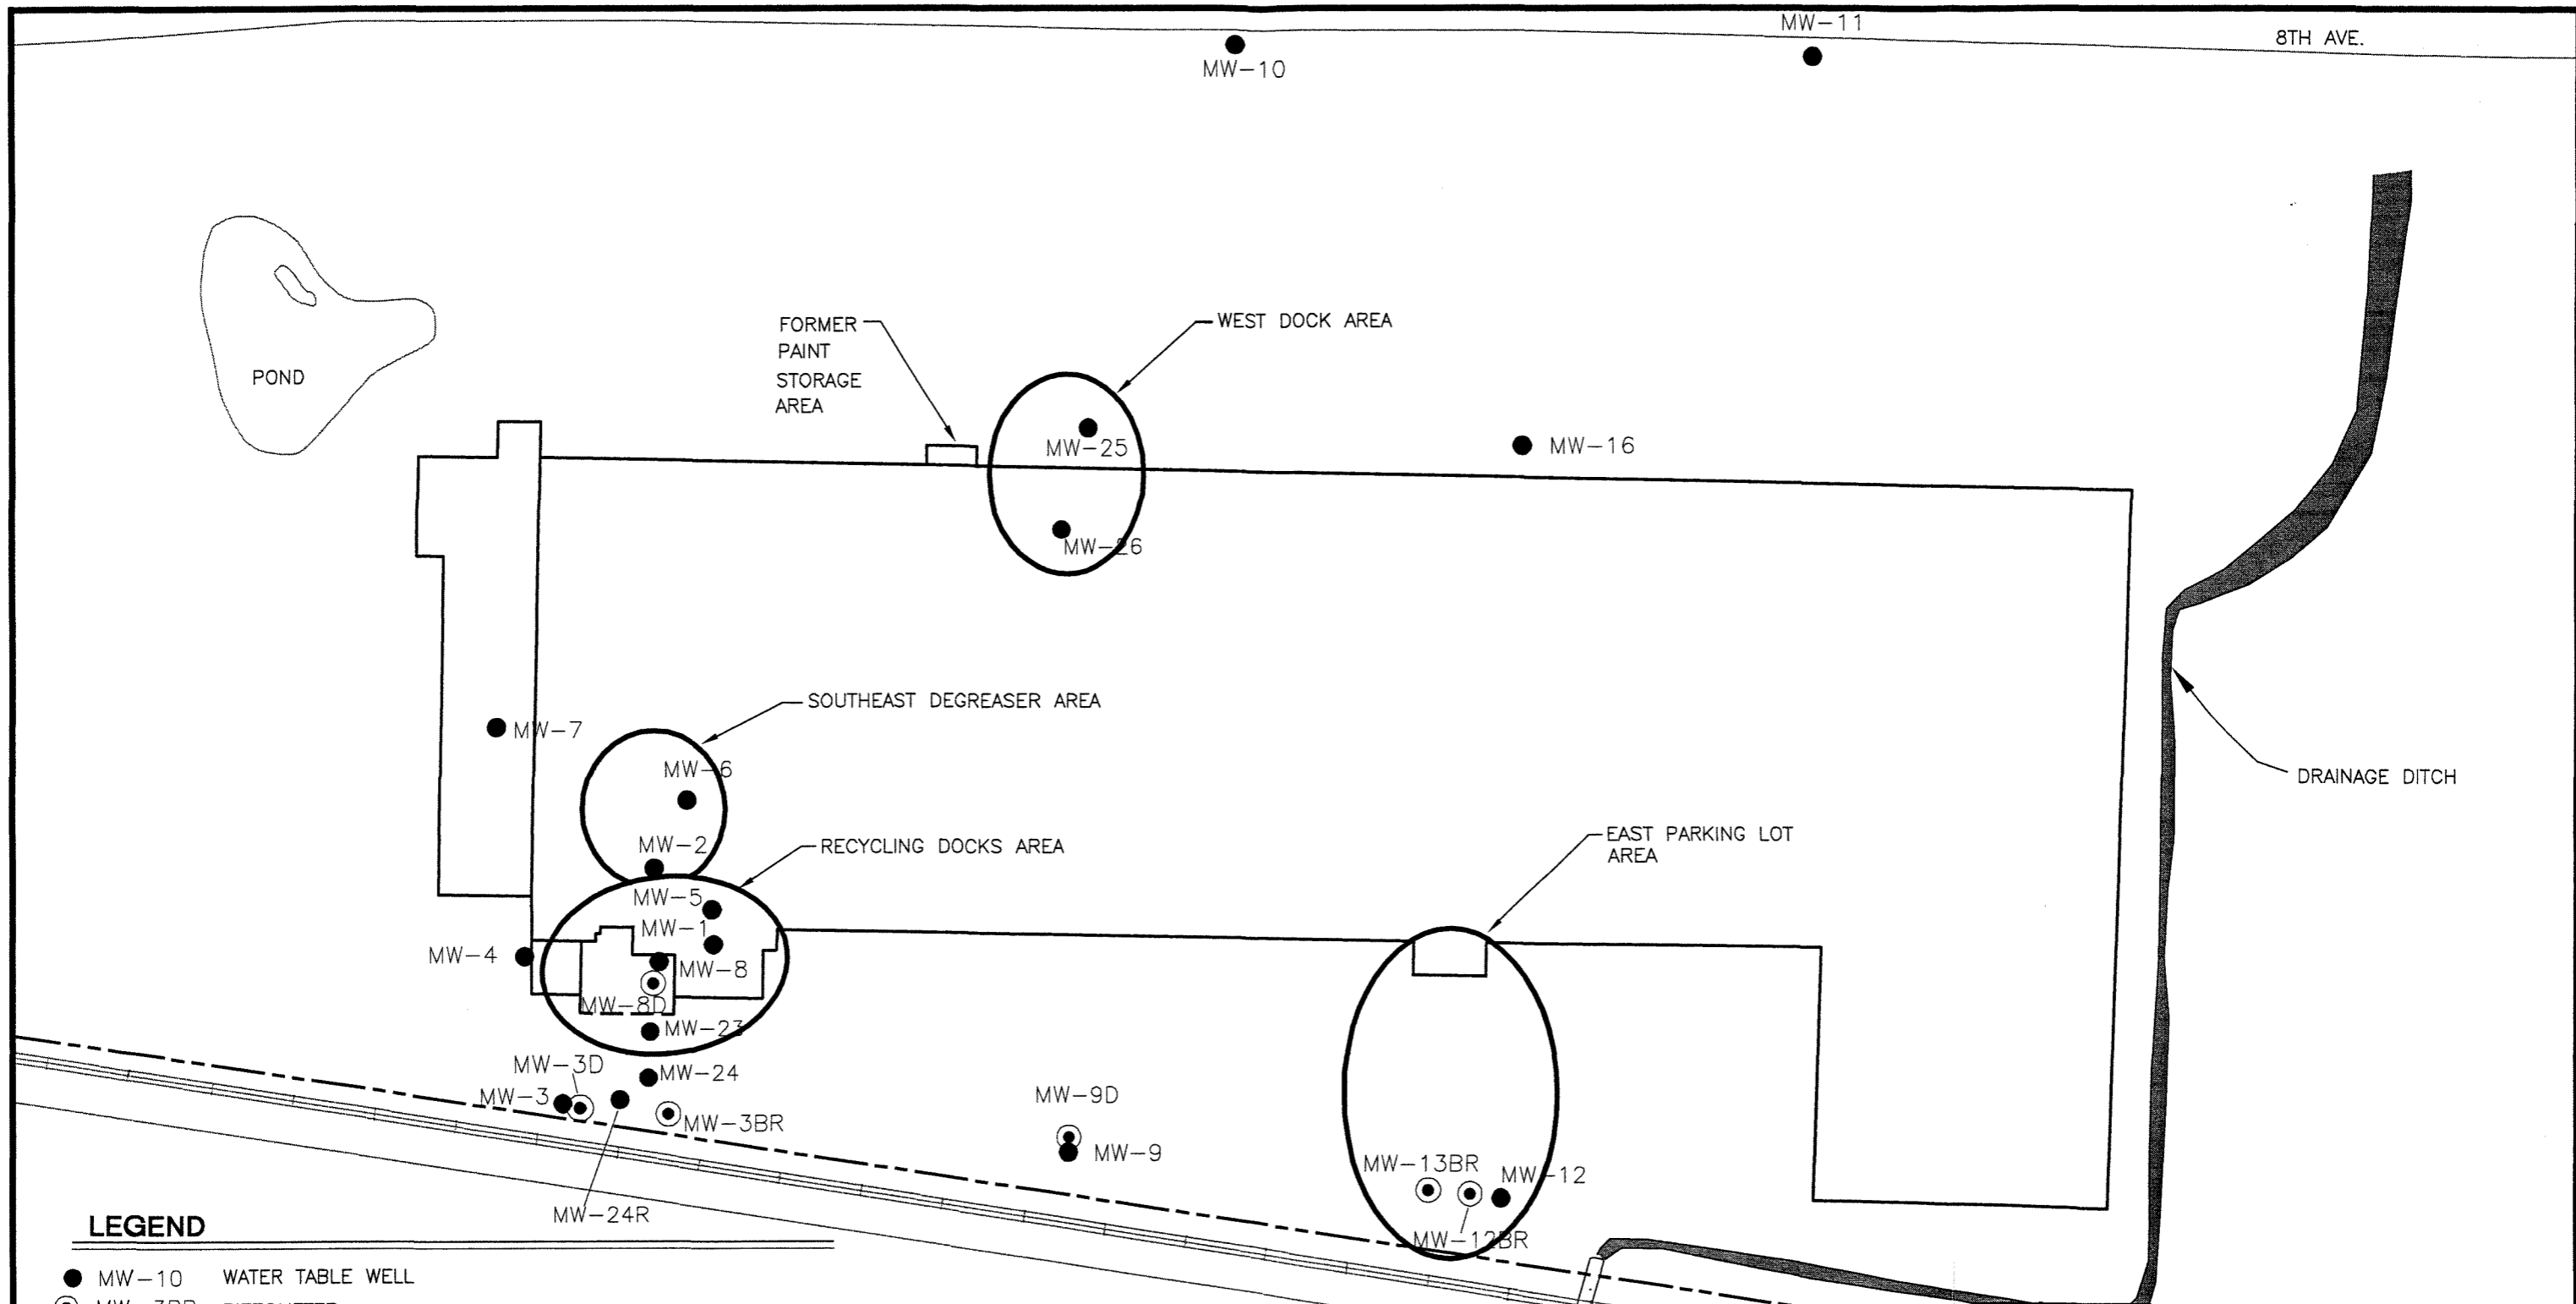
PROJECT:		
TECUMSEH PRODUCTS COMPANY GRAFTON, WISCONSIN		
SHEET TITLE:		
FORMER SOURCE AREAS		
DRAWN BY: FIEBRANT	SCALE: 1"=100'	PROJ. NO. 07397.10
CHECKED BY:		FILE NO. 73971004.DWG
APPROVED BY:	DATE PRINTED:	FIGURE 3
DATE: JULY 2009

As discussed in the introduction, extensive work has been done to characterize and remediate the soil and groundwater impacts at the site. The on-site investigations identified three main source areas for trichloroethene (TCE) and/or trichloroethane (TCA): the West Dock Area, the Recycling Dock/Southeast Degreaser Area, and the TCA Filling/East Parking Lot Area (Figure 3). Details on the site investigation and subsequent remediation activities for these areas can be found in the relevant documents submitted to the WDNR for each activity (KEY, 2000; KEY, 2002; RMT, 1997; RMT, 1999a; RMT, 1999b; RMT, 2002; RMT, 2003; RMT, 2004a; RMT, 2004b; RMT, 2005; and RMT, 2006). These activities are also summarized in one comprehensive document titled "Source Area Remediation Completion Report" (RMT 2007b). The following discussion highlights the portions of these activities that are critical to understanding the basis for the layout of the proposed vapor intrusion assessment.

The West Dock Source Area, which is primarily outside the facility (Figure 3), contained TCE and polycyclic aromatic hydrocarbon (PAH)/petroleum-related compounds in the soil. In 2002, limited soil excavation was completed to remove the PAH/petroleum-impacted soil, and infiltration trenches were constructed adjacent to the facility above the TCE source. The trenches were used to introduce a lactate solution to the subsurface to facilitate removal of the TCE from the soil and to enhance the naturally occurring biodegradation of TCE in the groundwater. The remedial objectives for the lactate infiltration were met; however, groundwater impacts remain, and a groundwater plume containing TCE and its breakdown products extends downgradient (east) from the West Dock Area under the building. The current extent of the plume based on recent VOC data collected from the site is shown on Figure 4. The plume under the building will be targeted as part of the proposed vapor intrusion assessment at the site.

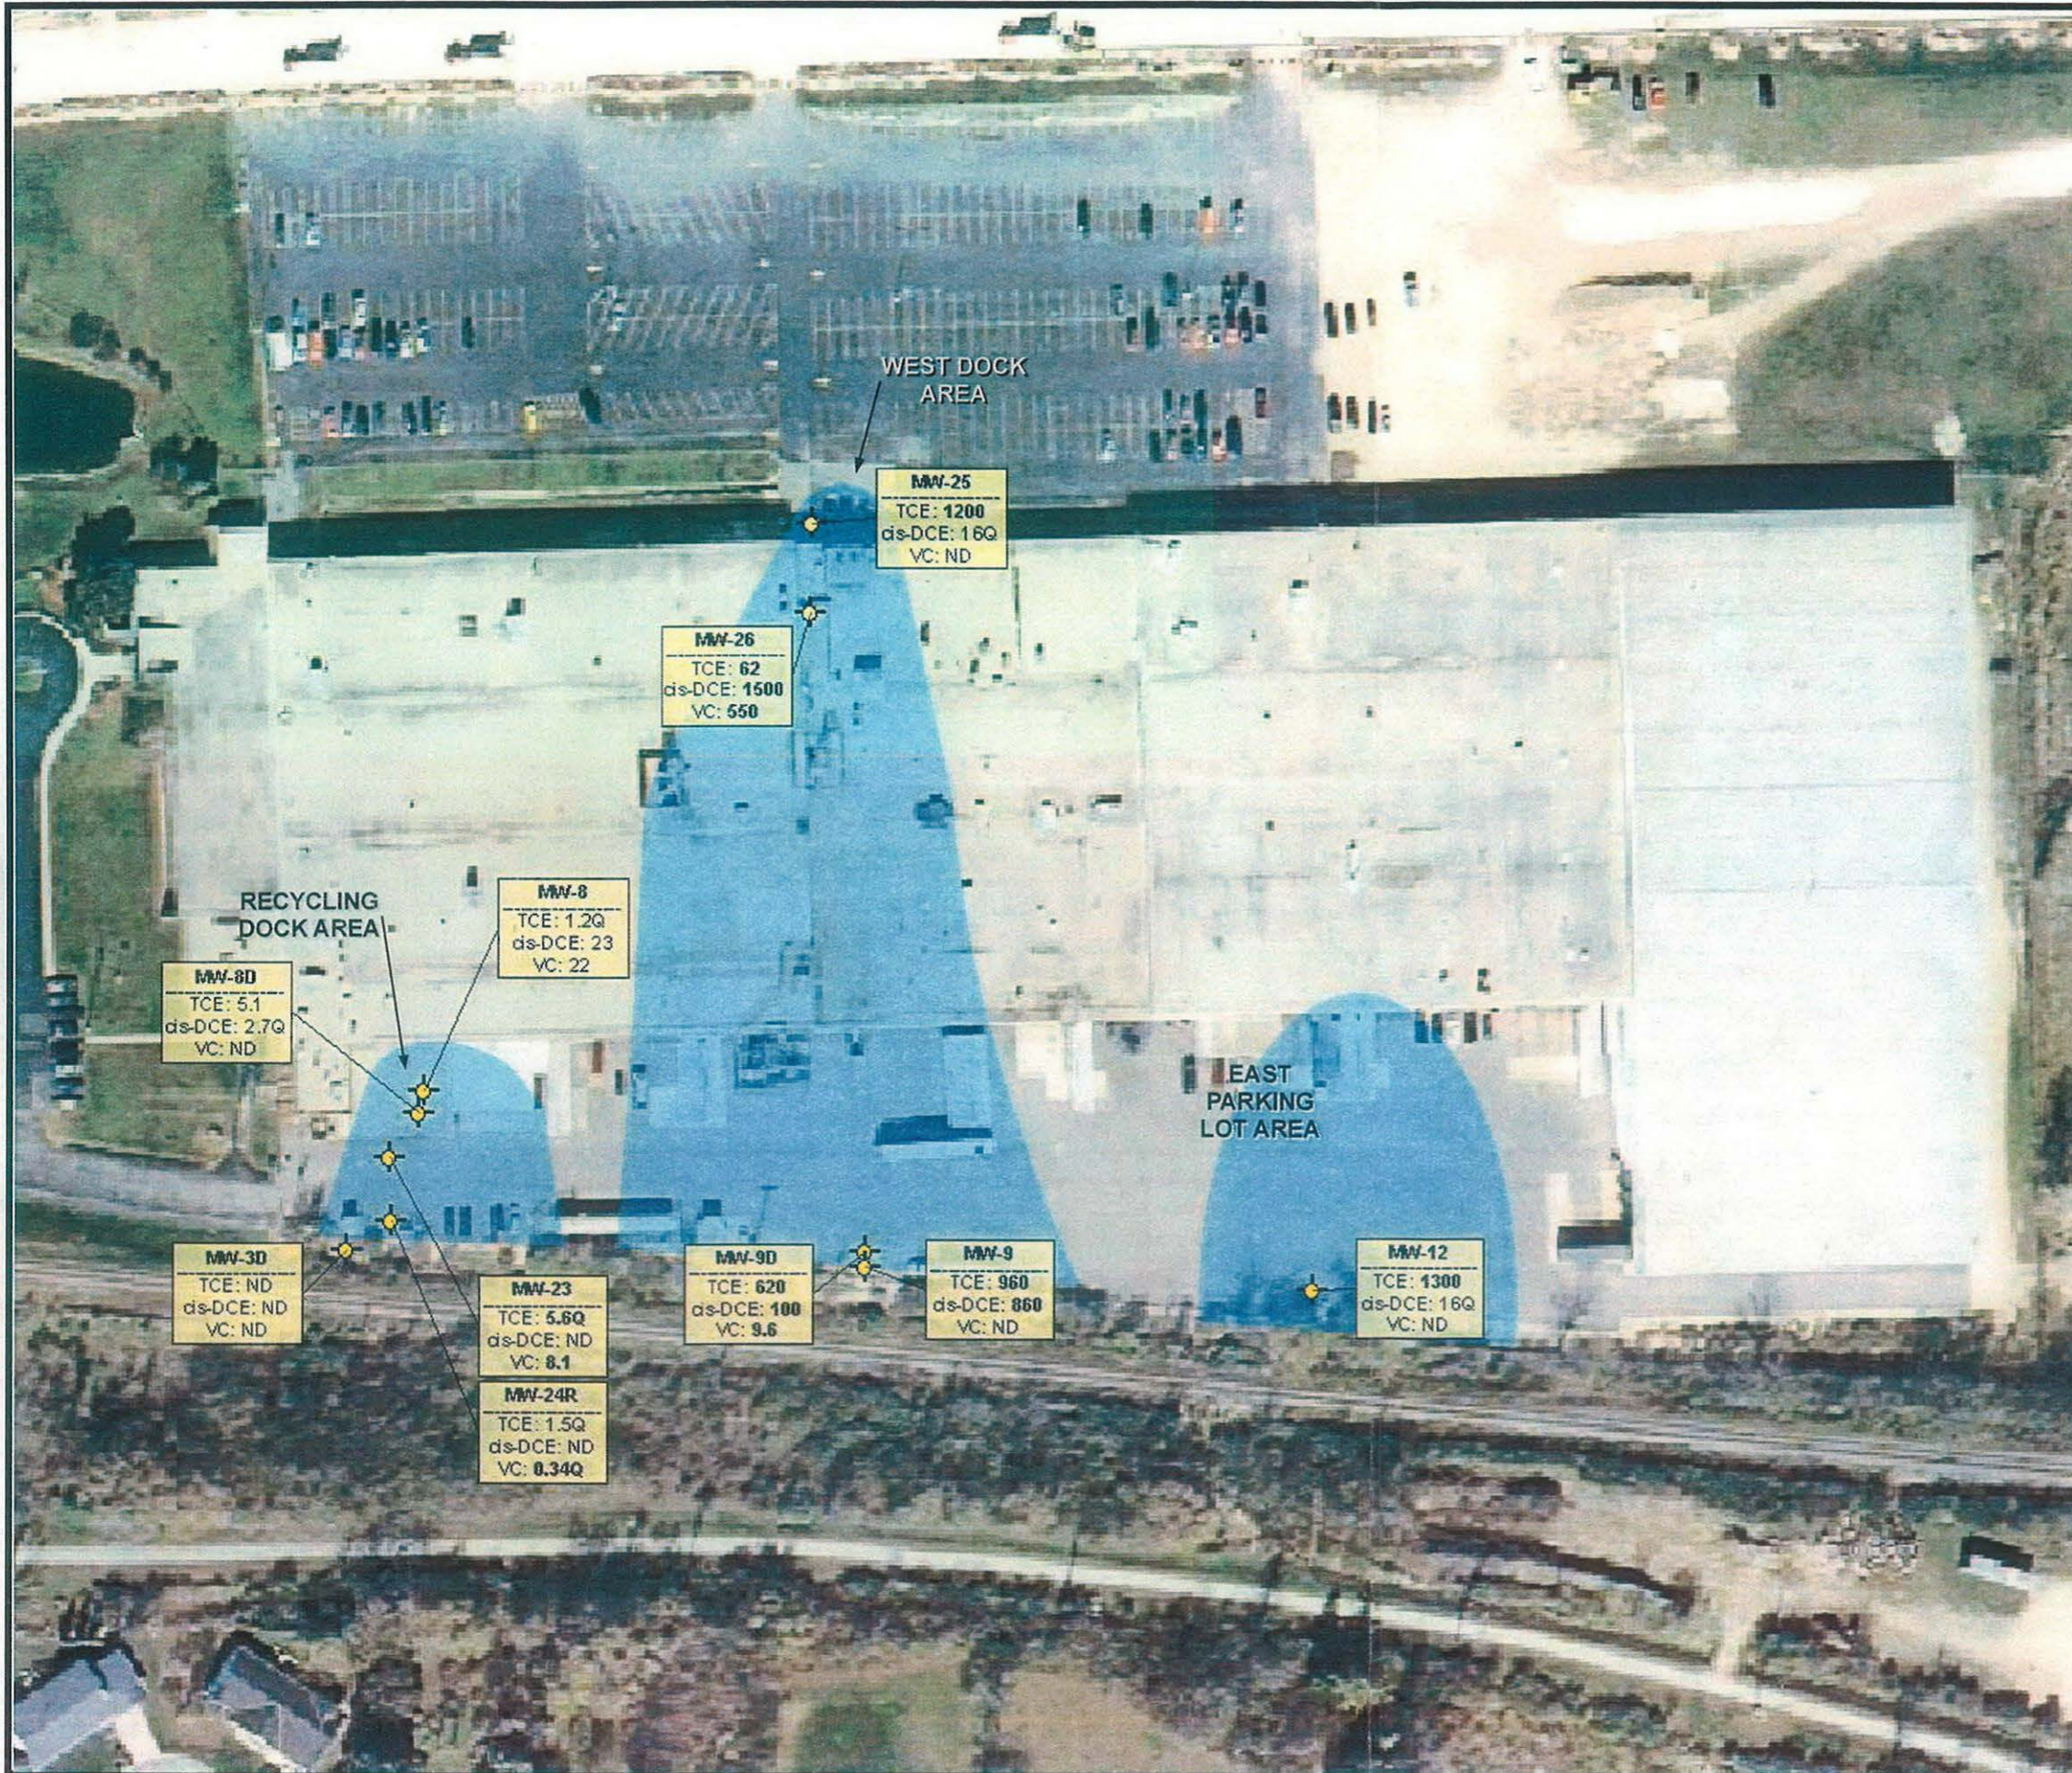
PROJECT: TECUMSEH PRODUCTS COMPANY GRAFTON, WI			
SHEET TITLE: APPROXIMATE EXTENT OF SHALLOW TCE IMPACTS TO ON-SITE GROUNDWATER			
DRAWN BY: PAPEZ J	SCALE: AS NOTED	PROJ. NO. 00-007397.02	
CHECKED BY: SAK		FILE NO. 30843017.mxd	
APPROVED BY: JMR	DATE PRINTED: 7/20/2009	FIGURE 4	
DATE: JULY 2009

- WELL LOCATION WITH MAY 2007 SAMPLE RESULTS (ug/L)
- APPROXIMATE EXTENT OF SHALLOW TCE IMPACT

BOLD VALUES INDICATE AN NR140 ES EXCEEDENCE.

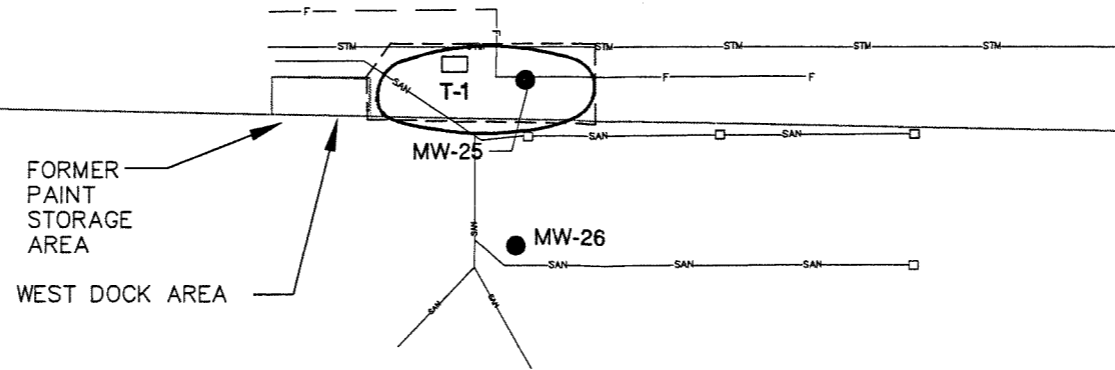
PROJECT: TECUMSEH PRODUCTS COMPANY GRAFTON, WISCONSIN		
SHEET TITLE: FORMER UST LOCATIONS		
DRAWN BY: FIEBRANT	SCALE: 1"=60'	PROJ. NO. 07397.10
CHECKED BY:	DATE PRINTED:	FILE NO. 73971005.DWG
APPROVED BY:	FIGURE 5	
DATE: JULY 2009

Eight underground storage tanks (USTs) were removed from the site between 1988 and 1992. The approximate locations of the historical tanks are shown on Figure 5. Seven of the tanks were located generally within the Recycling Dock/Southeast Degreaser Area, and one tank was located in the West Dock Area. The USTs primarily contained petroleum compounds. RMT, on behalf of Tecumseh, requested closure for these tanks in 2007 (RMT, 2007a), and provided additional information for the closure to the WDNR in December 2008 (RMT, 2008). The WDNR granted closure for the USTs on May 28, 2009.

UST SUMMARY TABLE			
UST #	SIZE (GAL)	CONTENTS	REMOVAL DATE
T-1	2,000	UNLEADED GASOLINE	10-19-1989
T-2	350	KEROSENE	06-15-1992
T-3	350	STODDARD SOLVENT	06-15-1992
T-4	11,000	MOTOR OIL	06-15-1992
T-5	500	LEADED GASOLINE	10-18-1989
T-6	1,000	UNLEADED GASOLINE	10-18-1989
T-7	300	UNLEADED GASOLINE (NOTE 4)	12-06-1988
T-8	300	UNKNOWN (NOTE 4)	12-06-1988

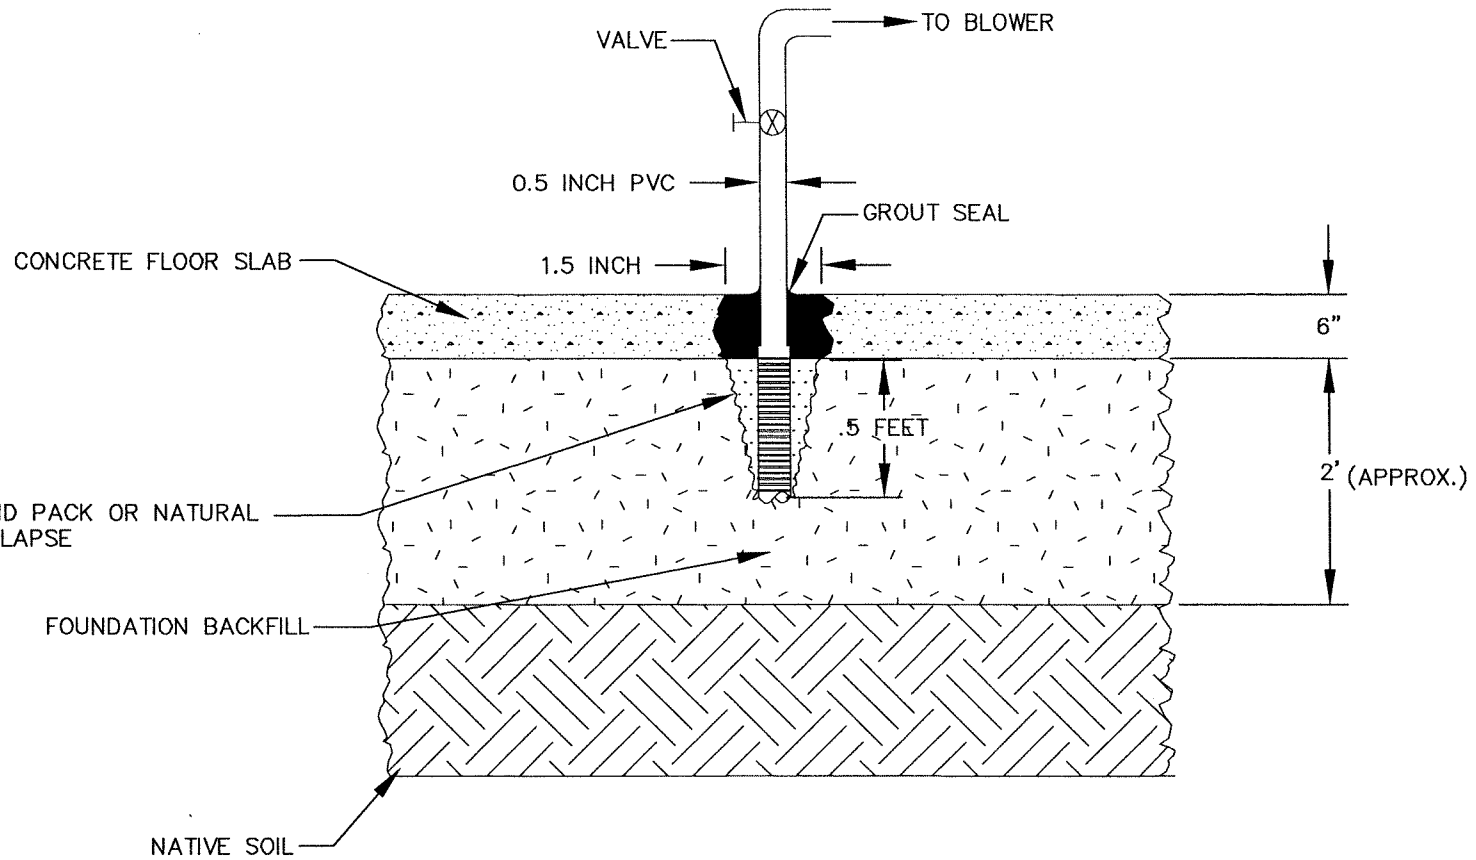
FIGURE 7

A conceptual drawing of a proposed sampling point is included on Figure 7. Each sampling point will be constructed using a Geoprobe®, or similar equipment. A 1.5- to 3-inch-diameter hole will be drilled through the concrete slab, and the hole will extend approximately 0.5 foot below the slab into the granular fill. A 0.5-inch-diameter PVC pipe with a slotted screen will be set in the fill, and a 0.5-inch-diameter PVC riser pipe will extend above grade to be connected to a blower. Sand will be placed around the well screen to fill the hole to the bottom of the slab, and concrete grout will be used to provide a firm seal between the slab and the pipe. The concrete grout will be allowed to set and dry prior to pulling a vacuum from each point. Each riser pipe will be capped when not being used for sampling, to eliminate the potential to draw indoor air into samples being collected at adjacent sampling points.

The sampling approach will be to collect an integrated sample of the subslab air from the void space in the 10- to 20-foot radius around each discrete sampling point. This integrated approach allows us to characterize the subslab air over a broad area (300-1,200 sf), rather than relying on the soil vapor conditions at a discrete point to represent a larger area. This integrated approach minimizes the potential for false-positives or negatives in the sampling, i.e., where the conditions at a discrete sampling point are not representative of the broader subslab conditions.
