UNDERGROUND STORAGE TANK (UST) SITE CLOSURE ASSESSMENT

Of A Former 500 Gallon Fuel Oil (UST)

Located At KNOLLS SERVICE STATION PROPERTY

13825 State Highway ' 32' Mountain, Wisconsin

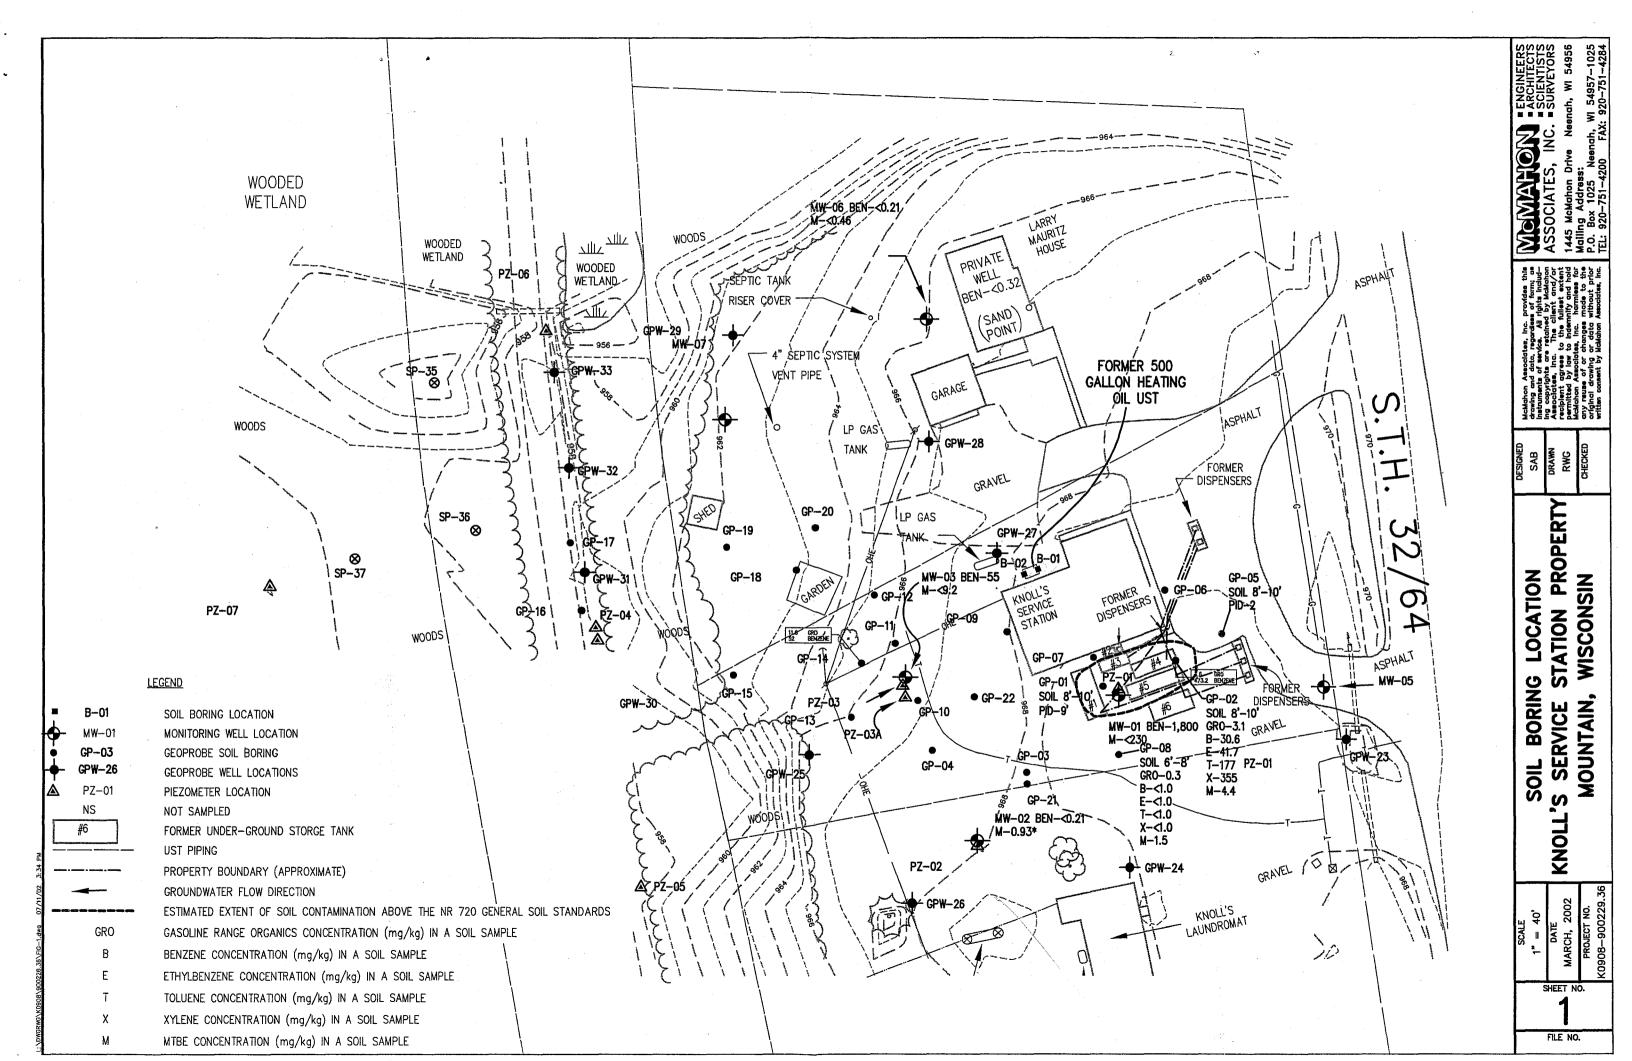
Figure #1 - Soil Sampling Locations

Soil samples were collected from beneath the bottom of the former UST. The top of the UST was located 16 inches below grade. Therefore, since the UST was 4 feet in diameter, the bottom of the UST was formerly 5 feet 4 inches below grade. Two soil borings (B-01 and B-02) were completed in the areas that were formerly the ends of the UST. The borings were completed with a 2-inch diameter hand auger. The locations of the soil borings and former UST area are shown on Figure #1. The location of the former UST area was staked by LaVern Knoll.
