**January 17, 2022**

RE: Off-Site Liability Exemption and Liability Clarification Application  
Heimes Garage - Former  
3418 – 66<sup>th</sup> Street  
Kenosha, WI  
BRRTS#: 03-30-409382  
FID#: 230058620

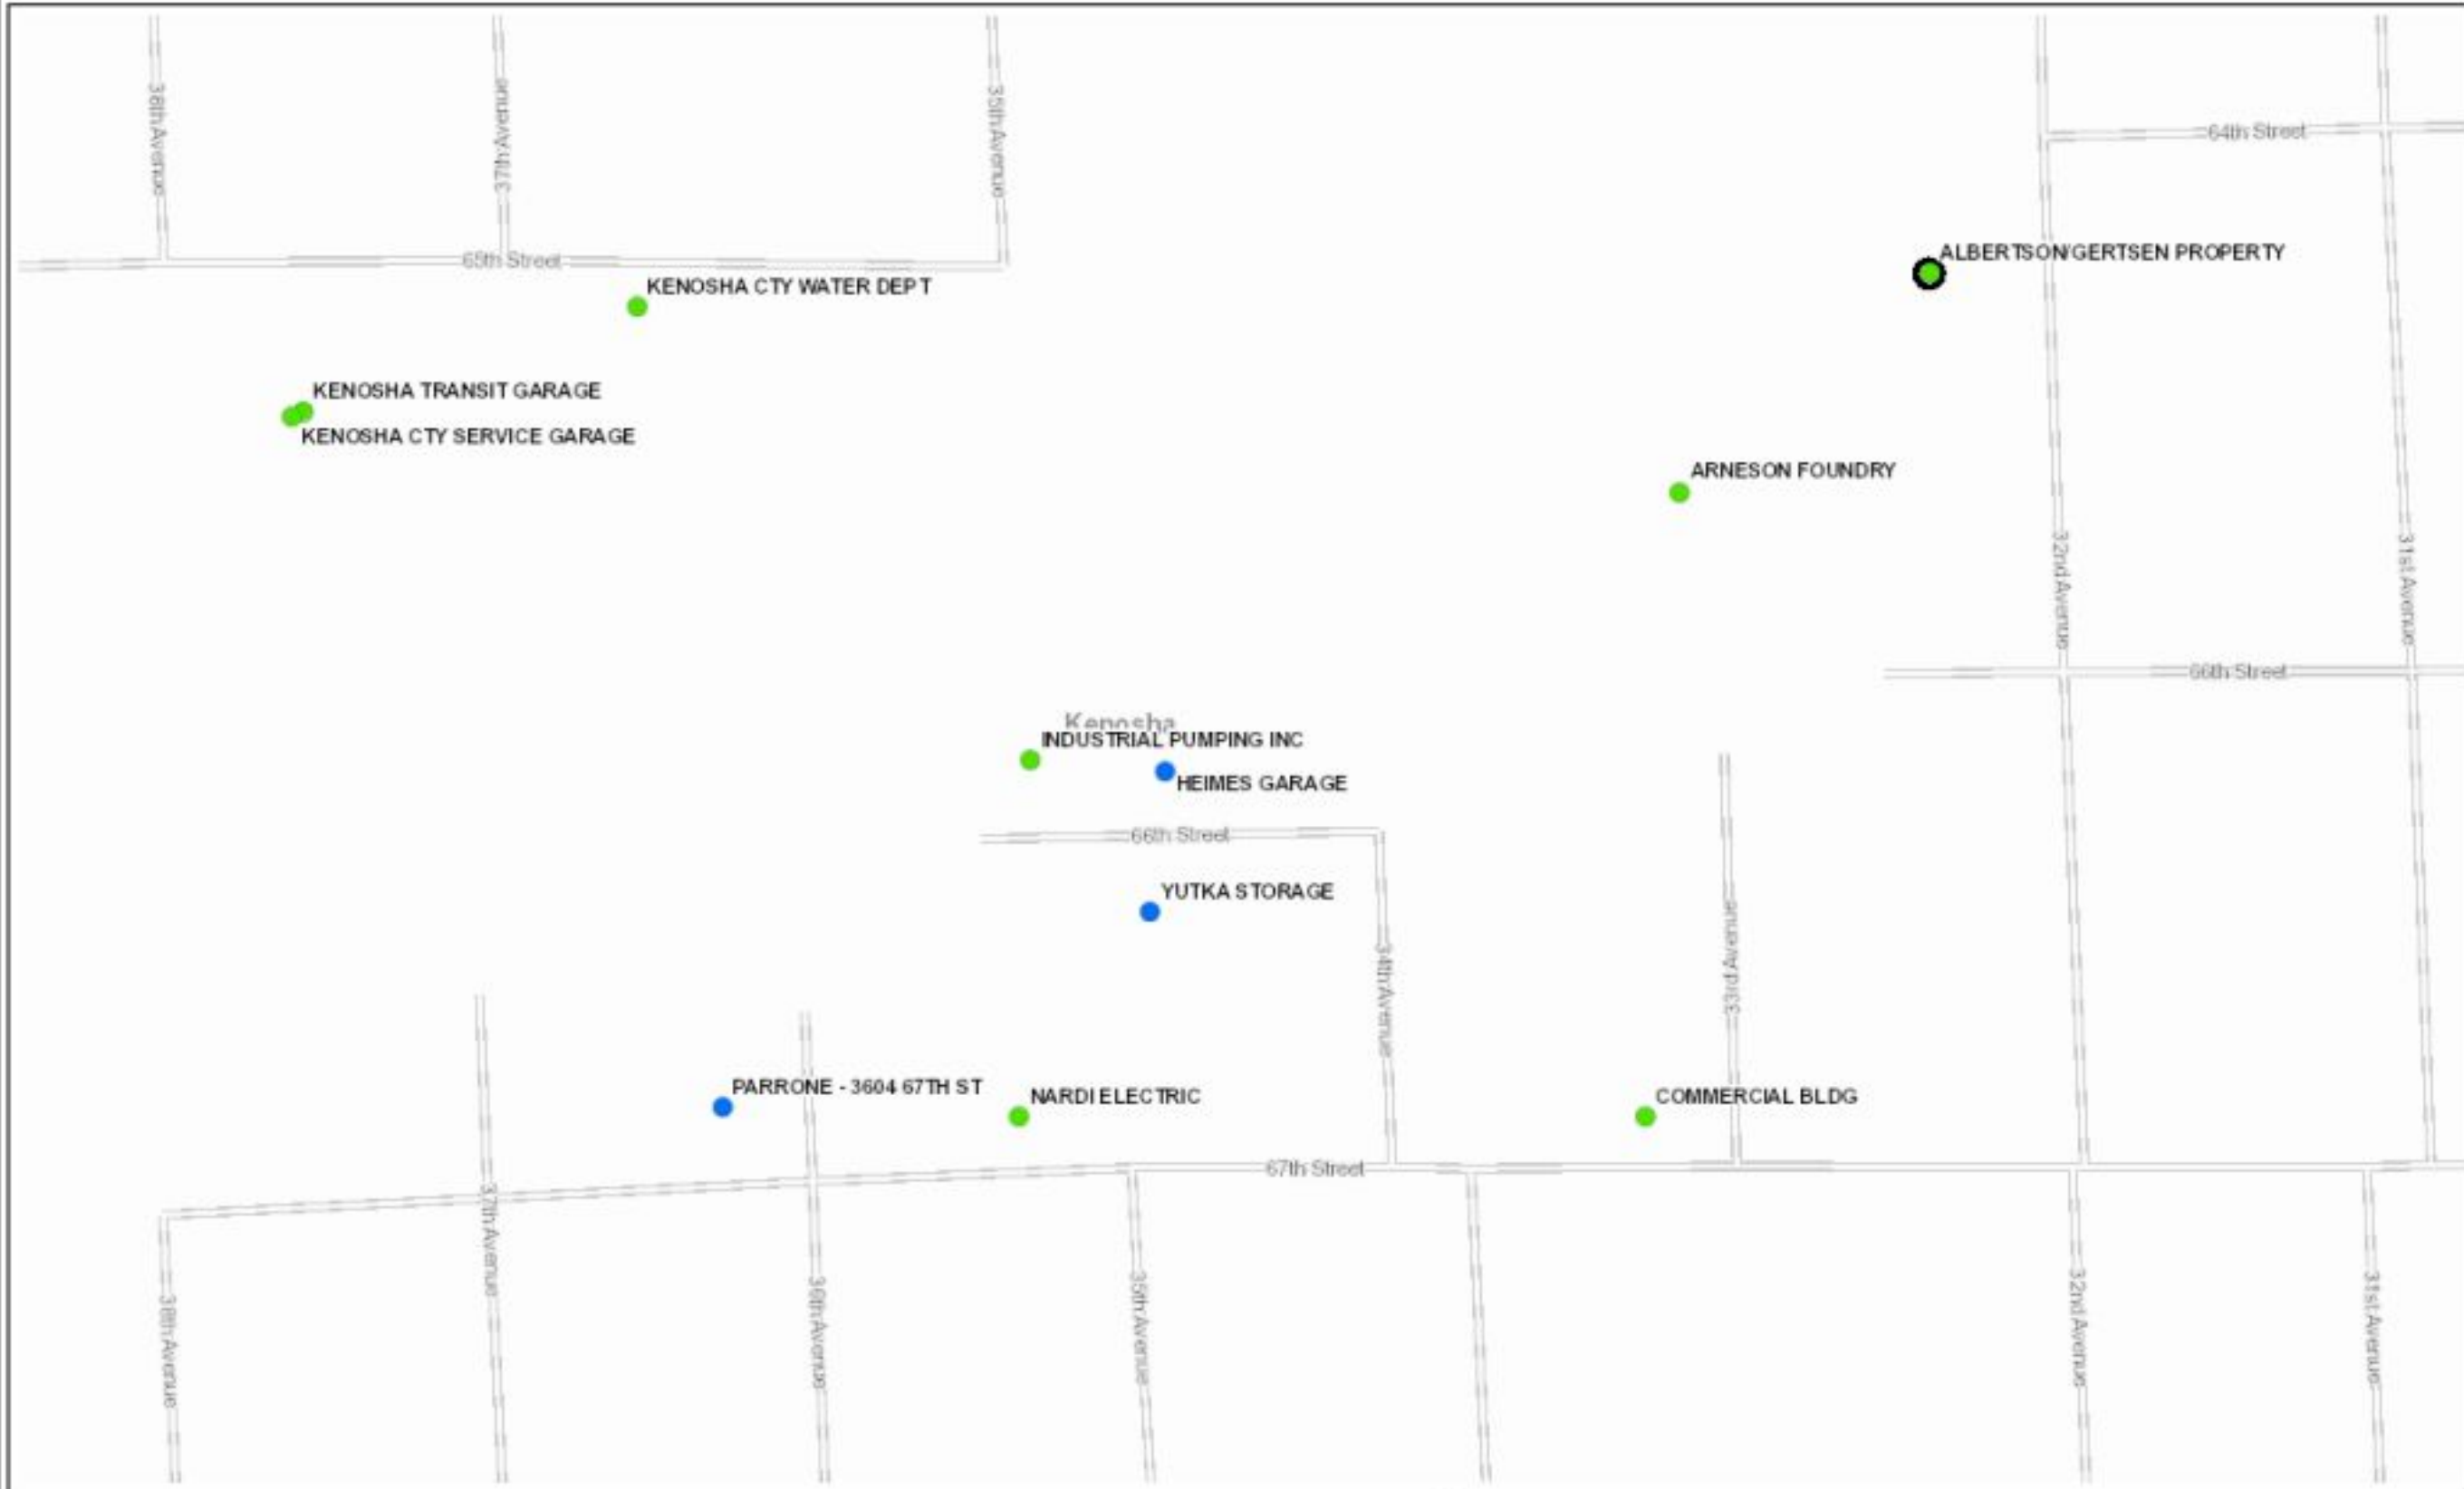
### **WDNR RR SITES MAP**

Former Heimes Garage SIWP  
3218 – 66<sup>th</sup> Street  
Kenosha, WI

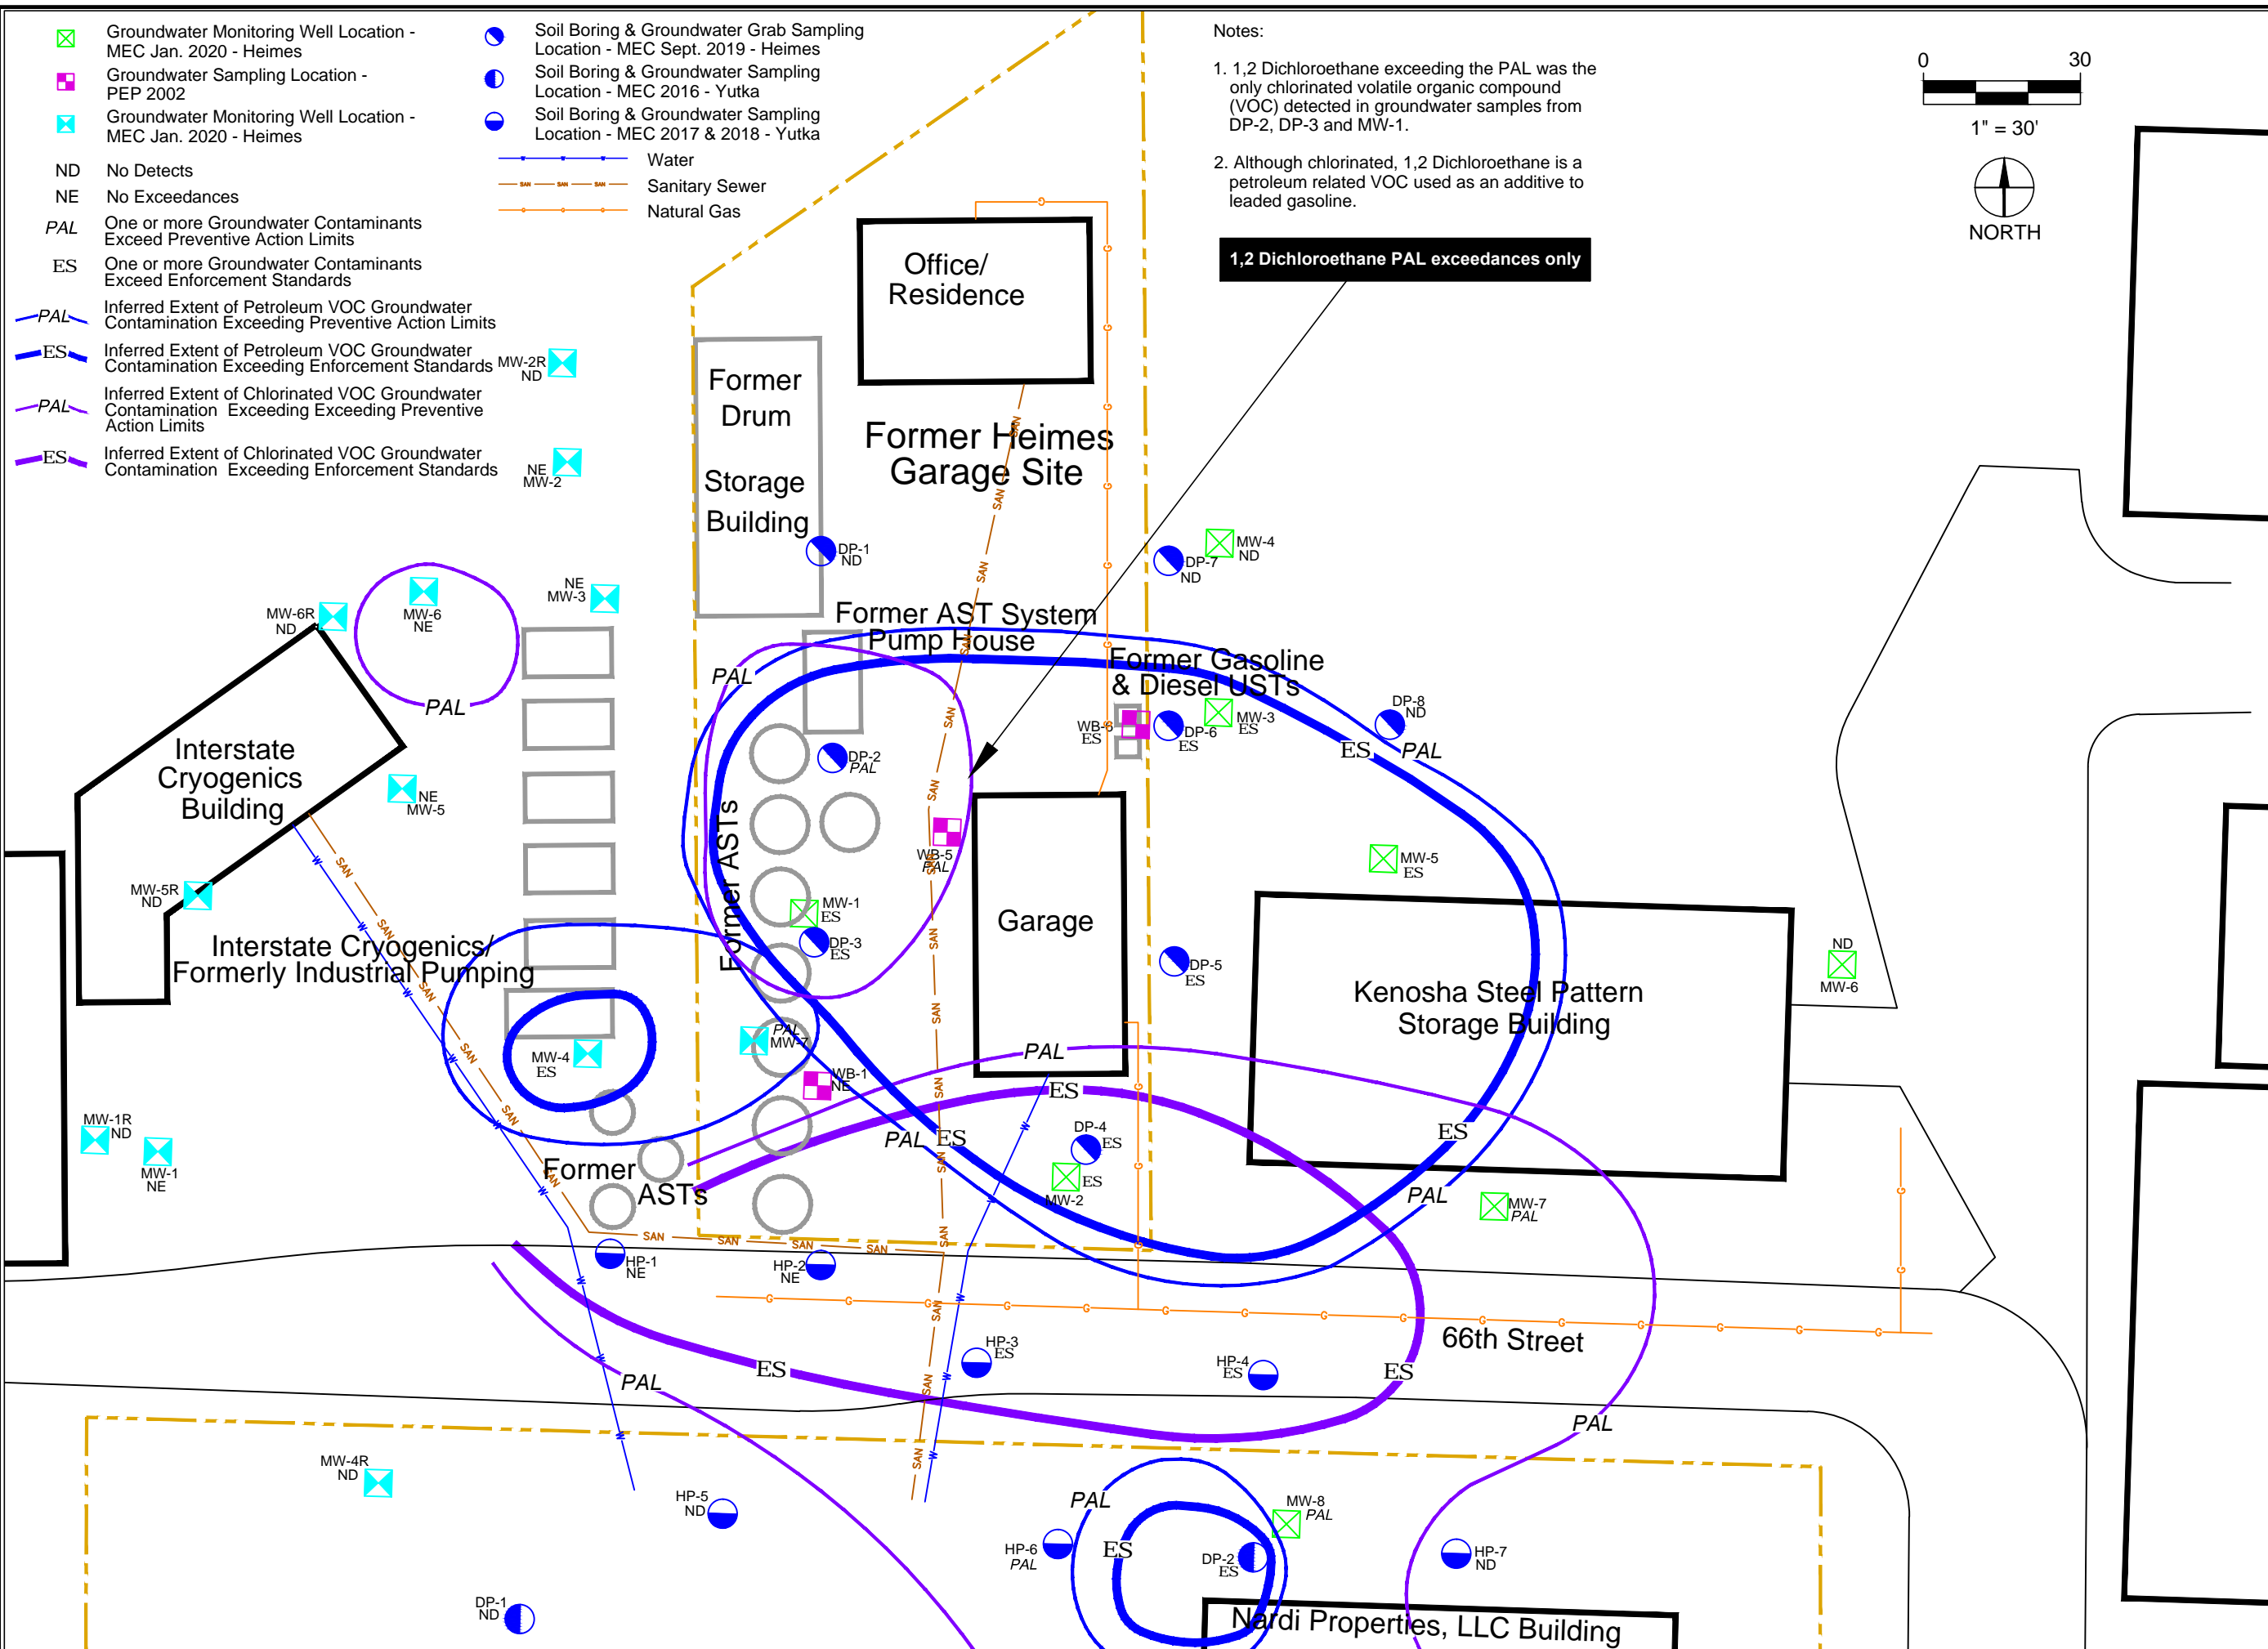
Approved By: <b>S. CRANLEY</b>	Figure <b>B.3.b.1</b>
Date Approved: 1/13/2022	
Date Drawn: 1/13/2022	
Drawn by: <b>R. SCHWARTZ</b>

# FIGURE B.3.b.1 GROUNDWATER CONTAMINATION HEIMES GARAGE 66TH STREET KENOSHA, WI

Maps including the Heimes site and the IP and Yutka Storage sites have been developed, depicting all the groundwater sampling locations from 1992 to 2020 and the related site contaminant conditions. These maps are provided on Figure B.1.b.2, B.3.b.1, B.3.b.2 and B.3.b.3 in Appendix B. The PEP and IP groundwater sampling results on the Heimes site are provided on Tables 5 and 8, respectively in Appendix C. The Yutka groundwater sampling results adjacent to the Heimes site are provided on Table 11 in Appendix C.

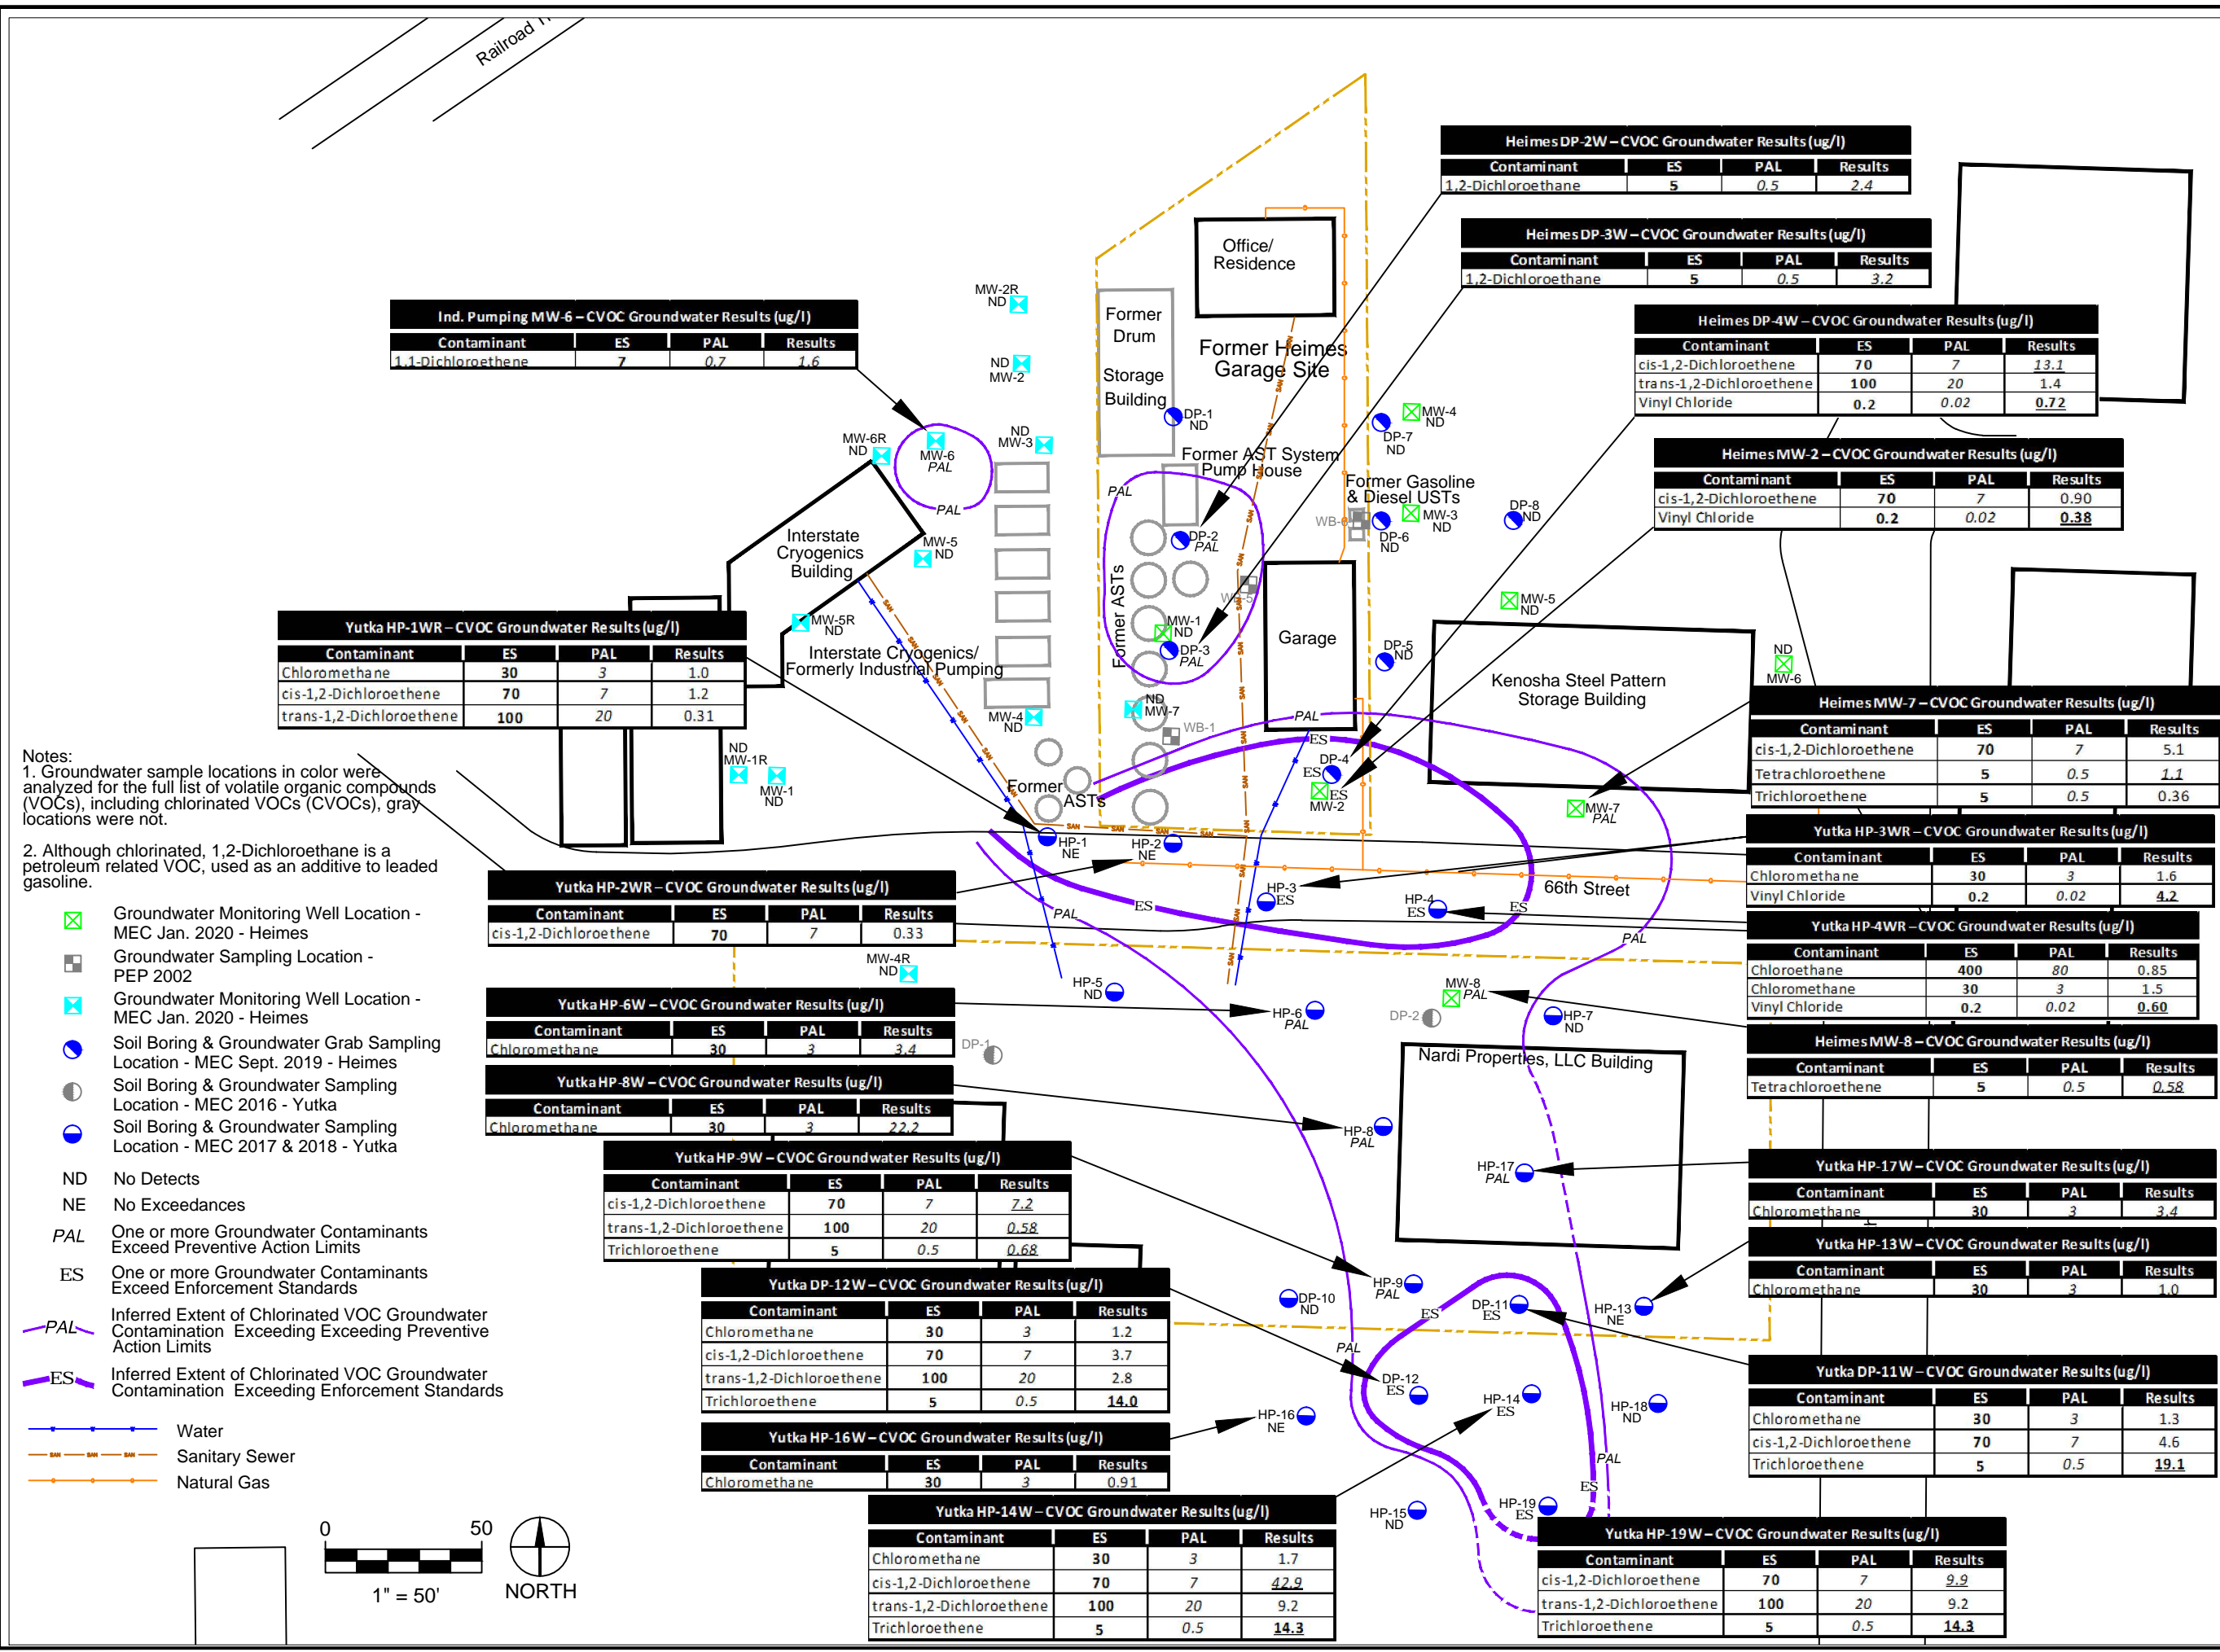
**FIGURE B.3.b.3  
GROUNDWATER CVO  
CONTAMINATION MAP  
HEIMES GARAGE  
66TH STREET  
KENOSHA, WI**

**Notes:**  
 1. Groundwater sample locations in color were analyzed for the full list of volatile organic compounds (VOCs), including chlorinated VOCs (CVOs), gray locations were not.  
 2. Although chlorinated, 1,2-Dichloroethane is a petroleum related VOC, used as an additive to leaded gasoline.

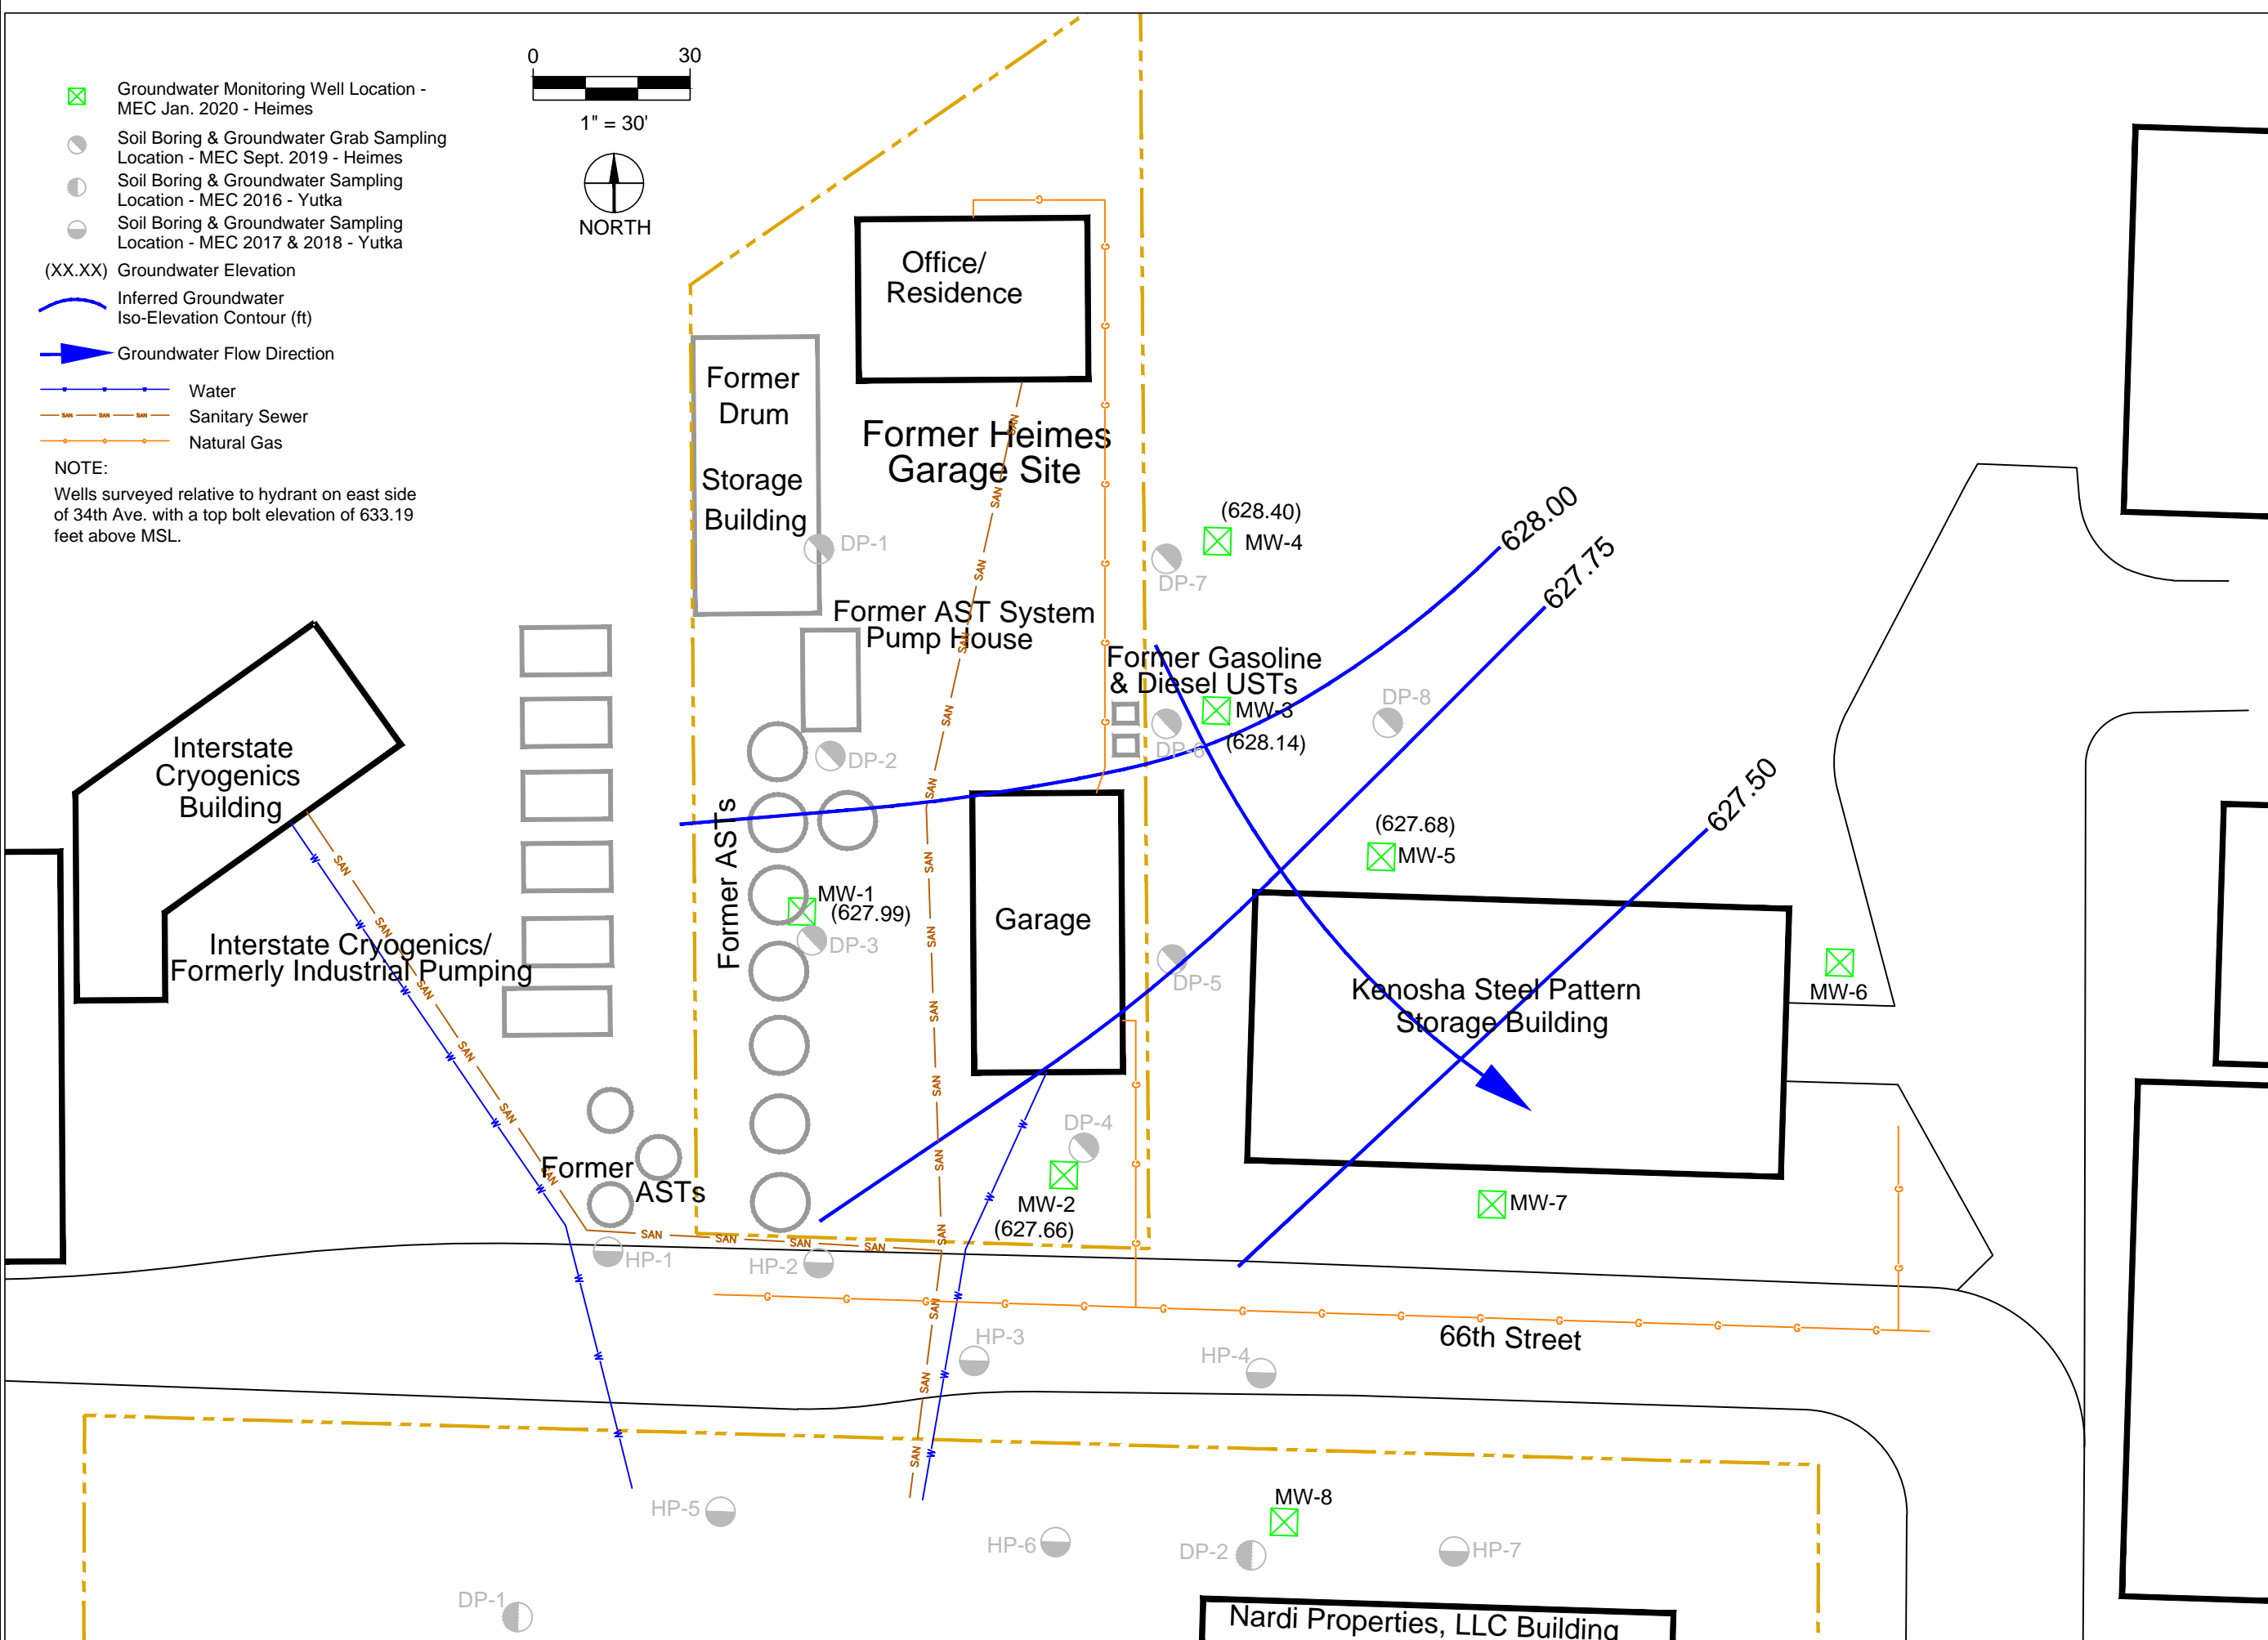
**FIGURE B.3.c.1**  
**GROUNDWATER FLOW**  
**1/29/20**  
**HEIMES GARAGE**  
66TH STREET  
KENOSHA, WI

Groundwater elevation data from the Heimes site investigation indicates that groundwater flow is to the south and southeast as illustrated on Figures B.3.c.1, B.3.c.2 and B.3.c.3 in Appendix B. Groundwater flow as established by the IP site investigation was consistently to the southeast over the period from 1992 to 1994. The southeasterly groundwater flow in the area is further corroborated by data from the Perrone site (BRRTS#: 03-30-553041) at 3604 67<sup>th</sup> Street, approximately 700 feet southwest of Heimes. See Figure B.1.c in Appendix B. Groundwater flow maps for the IP and Perrone sites are provided in Appendix D. The southward deviation in groundwater flow observed by the Heimes data, may be attributable the unusually wet conditions and related high groundwater elevations in 2020 as compared to historical data. Groundwater monitoring wells have yet to be installed as part of the Yutka site investigation. Consequently, groundwater elevation and flow data are not currently available for the Yutka site.

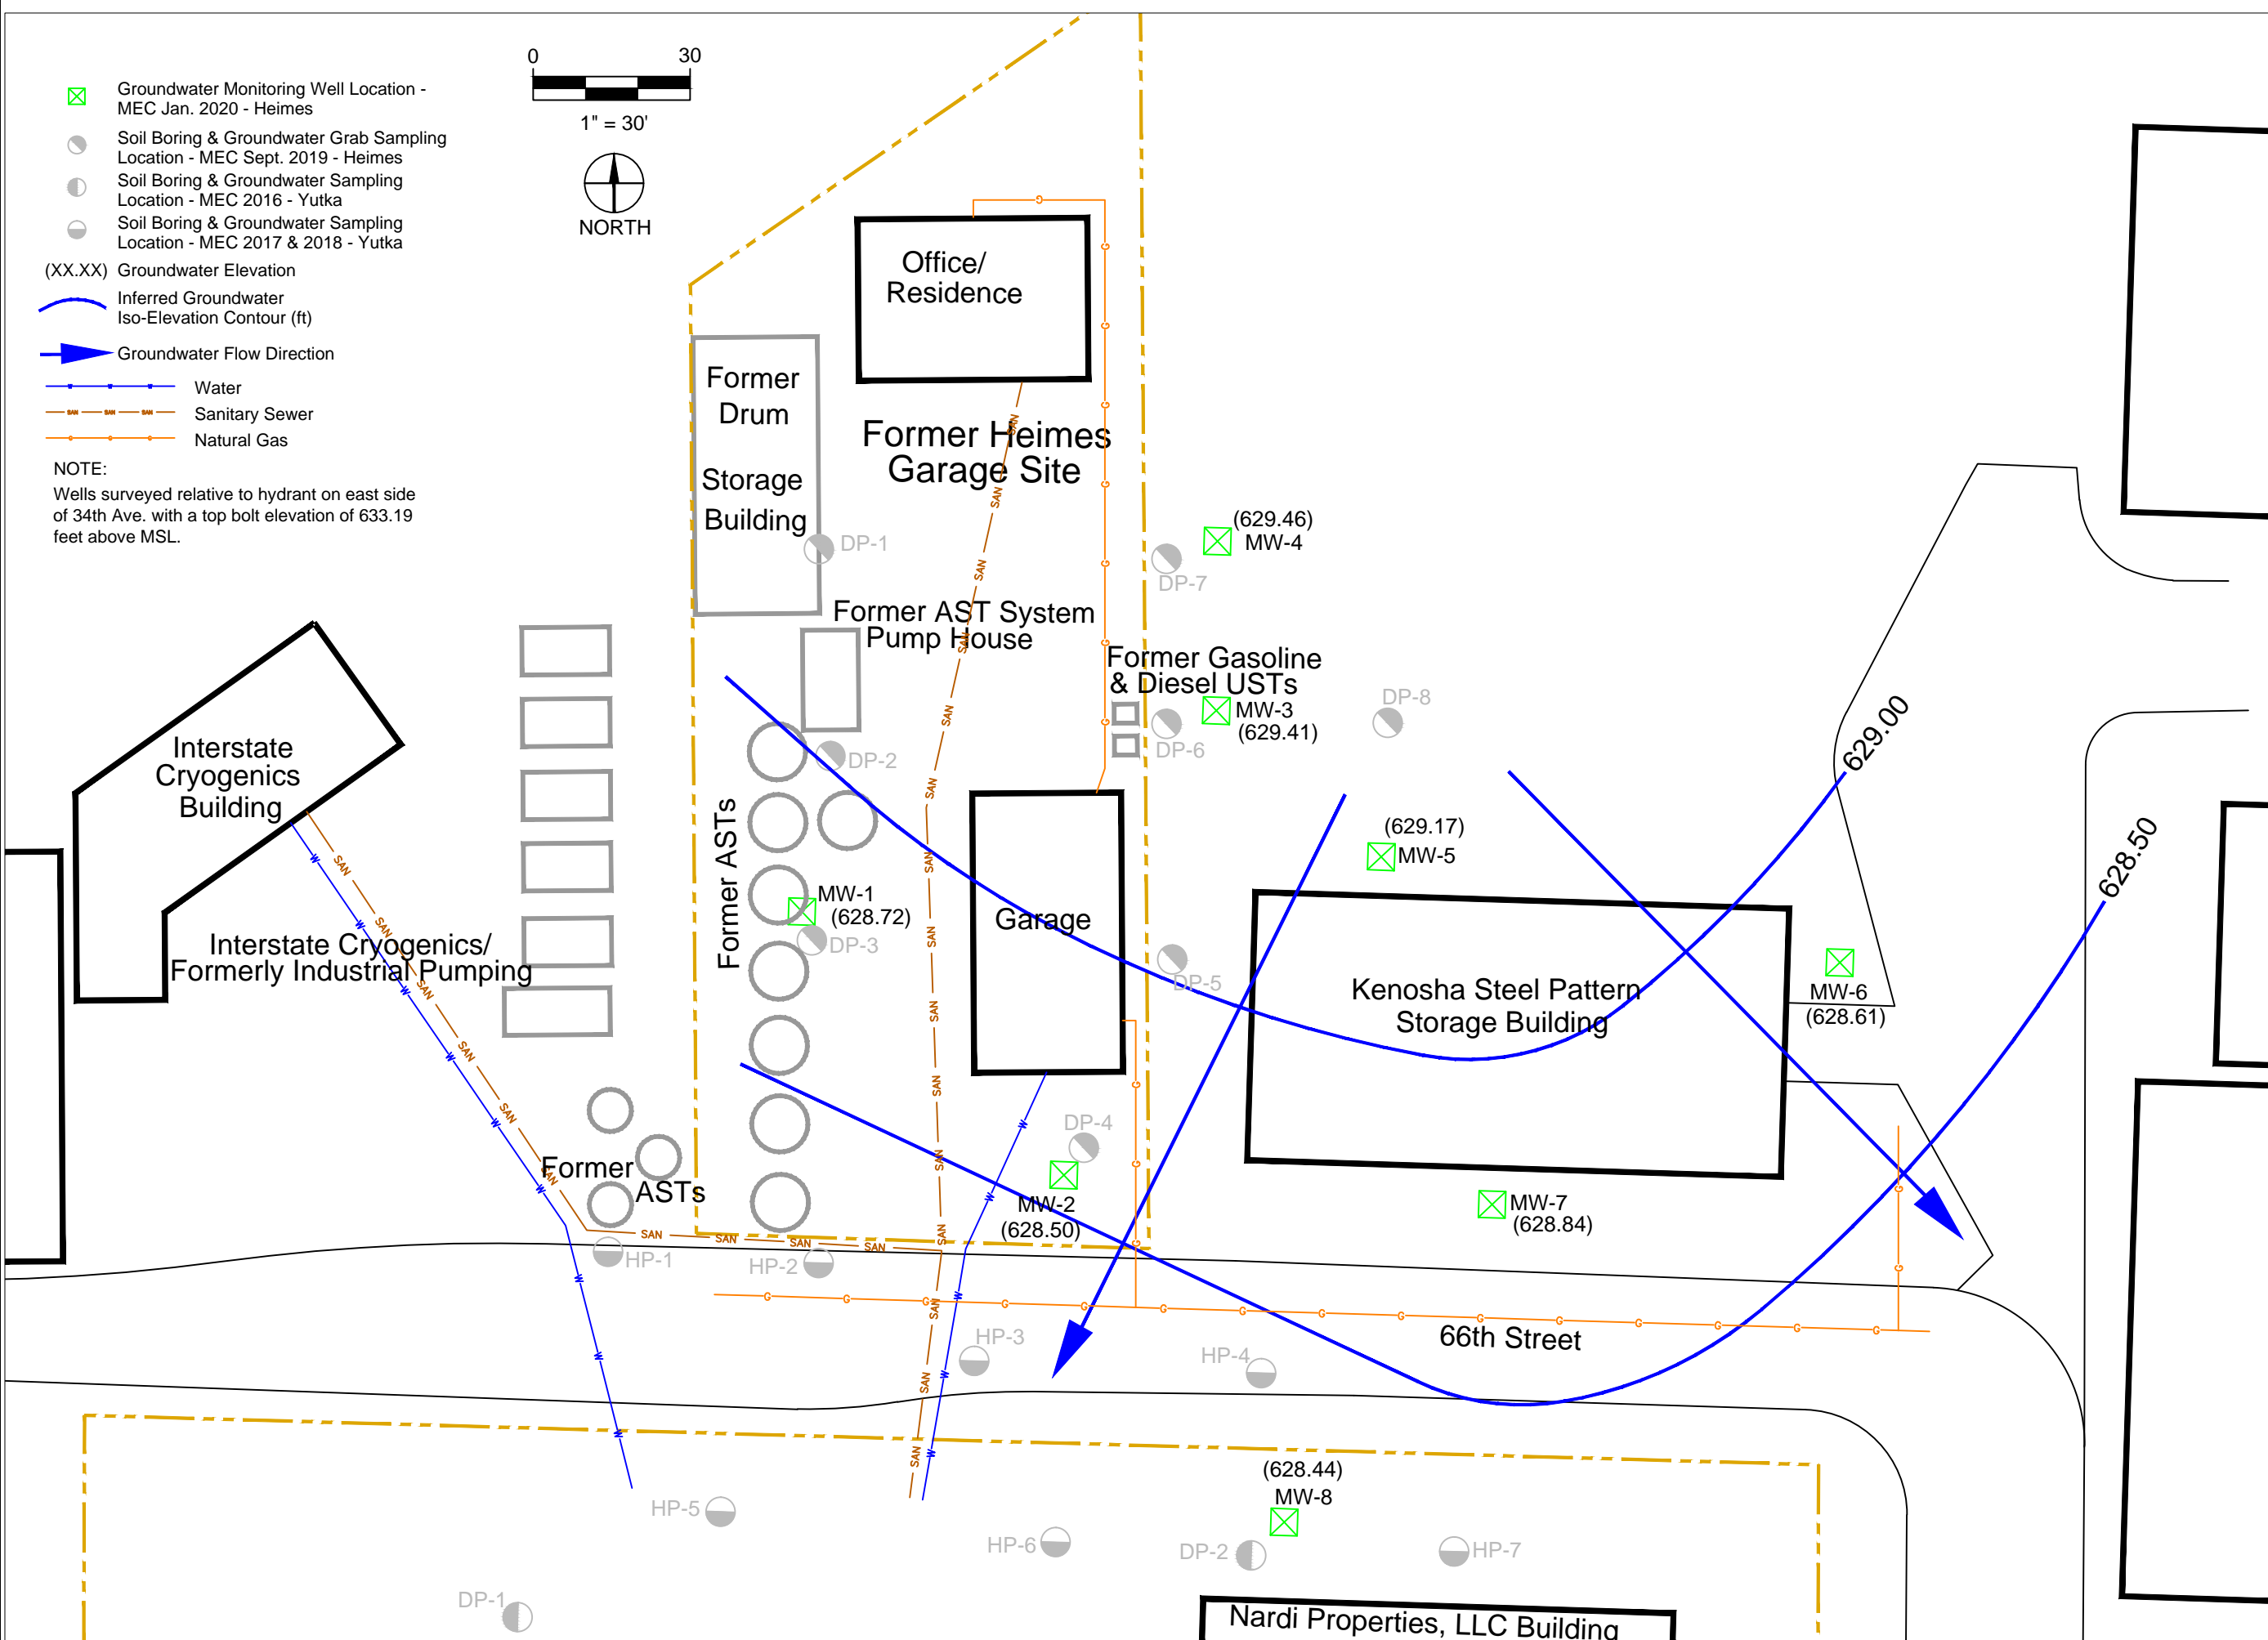
**FIGURE B.3.c.2**  
**GROUNDWATER FLOW**  
**2/17/20**  
**HEIMES GARAGE**  
66TH STREET  
KENOSHA, WI

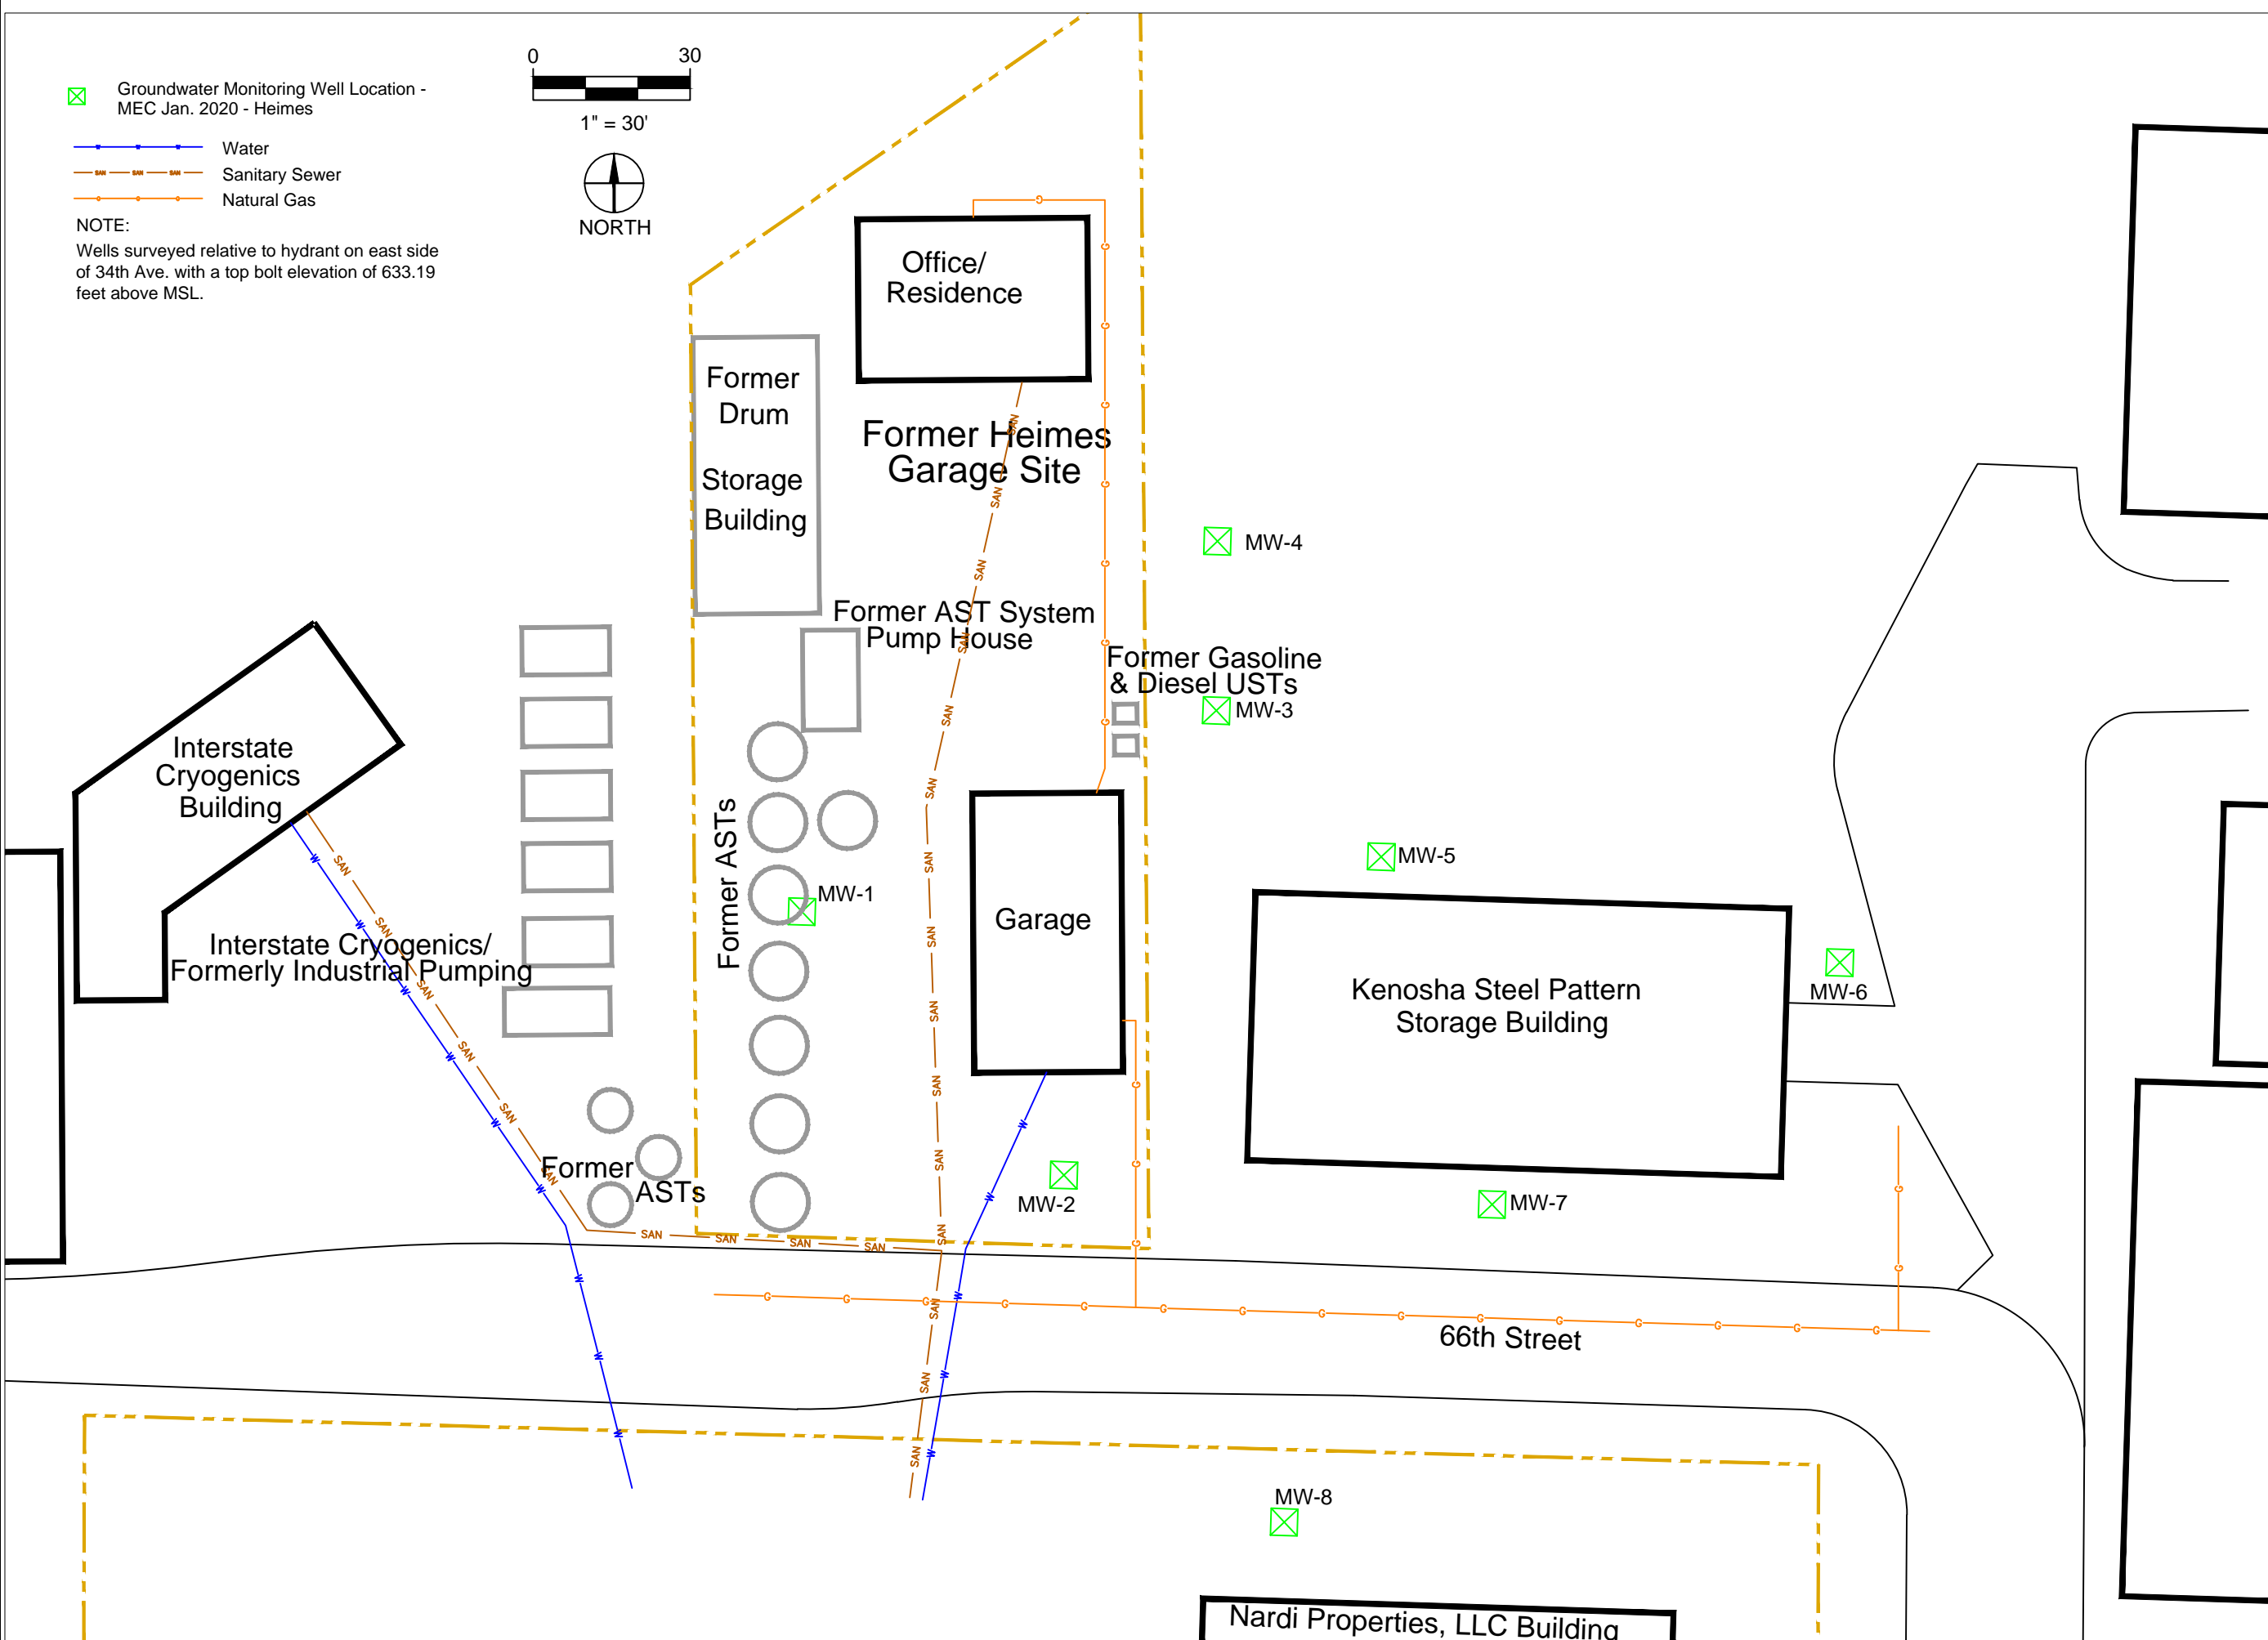
Approved By: <b>S. CRANLEY</b>	Figure
Date Approved: 1/13/2022	<b>B.3.d</b>
Date Drawn: 1/13/2022	
Drawn by: <b>R. SCHWARTZ</b>

**FIGURE B.3.d**  
**MONITORING**  
**WELLS**  
**HEIMES GARAGE**  
66TH STREET  
KENOSHA, WI
