**January 17, 2022**

RE: Off-Site Liability Exemption and Liability Clarification Application  
Heimes Garage - Former  
3418 – 66<sup>th</sup> Street  
Kenosha, WI  
BRRTS#: 03-30-409382  
FID#: 230058620

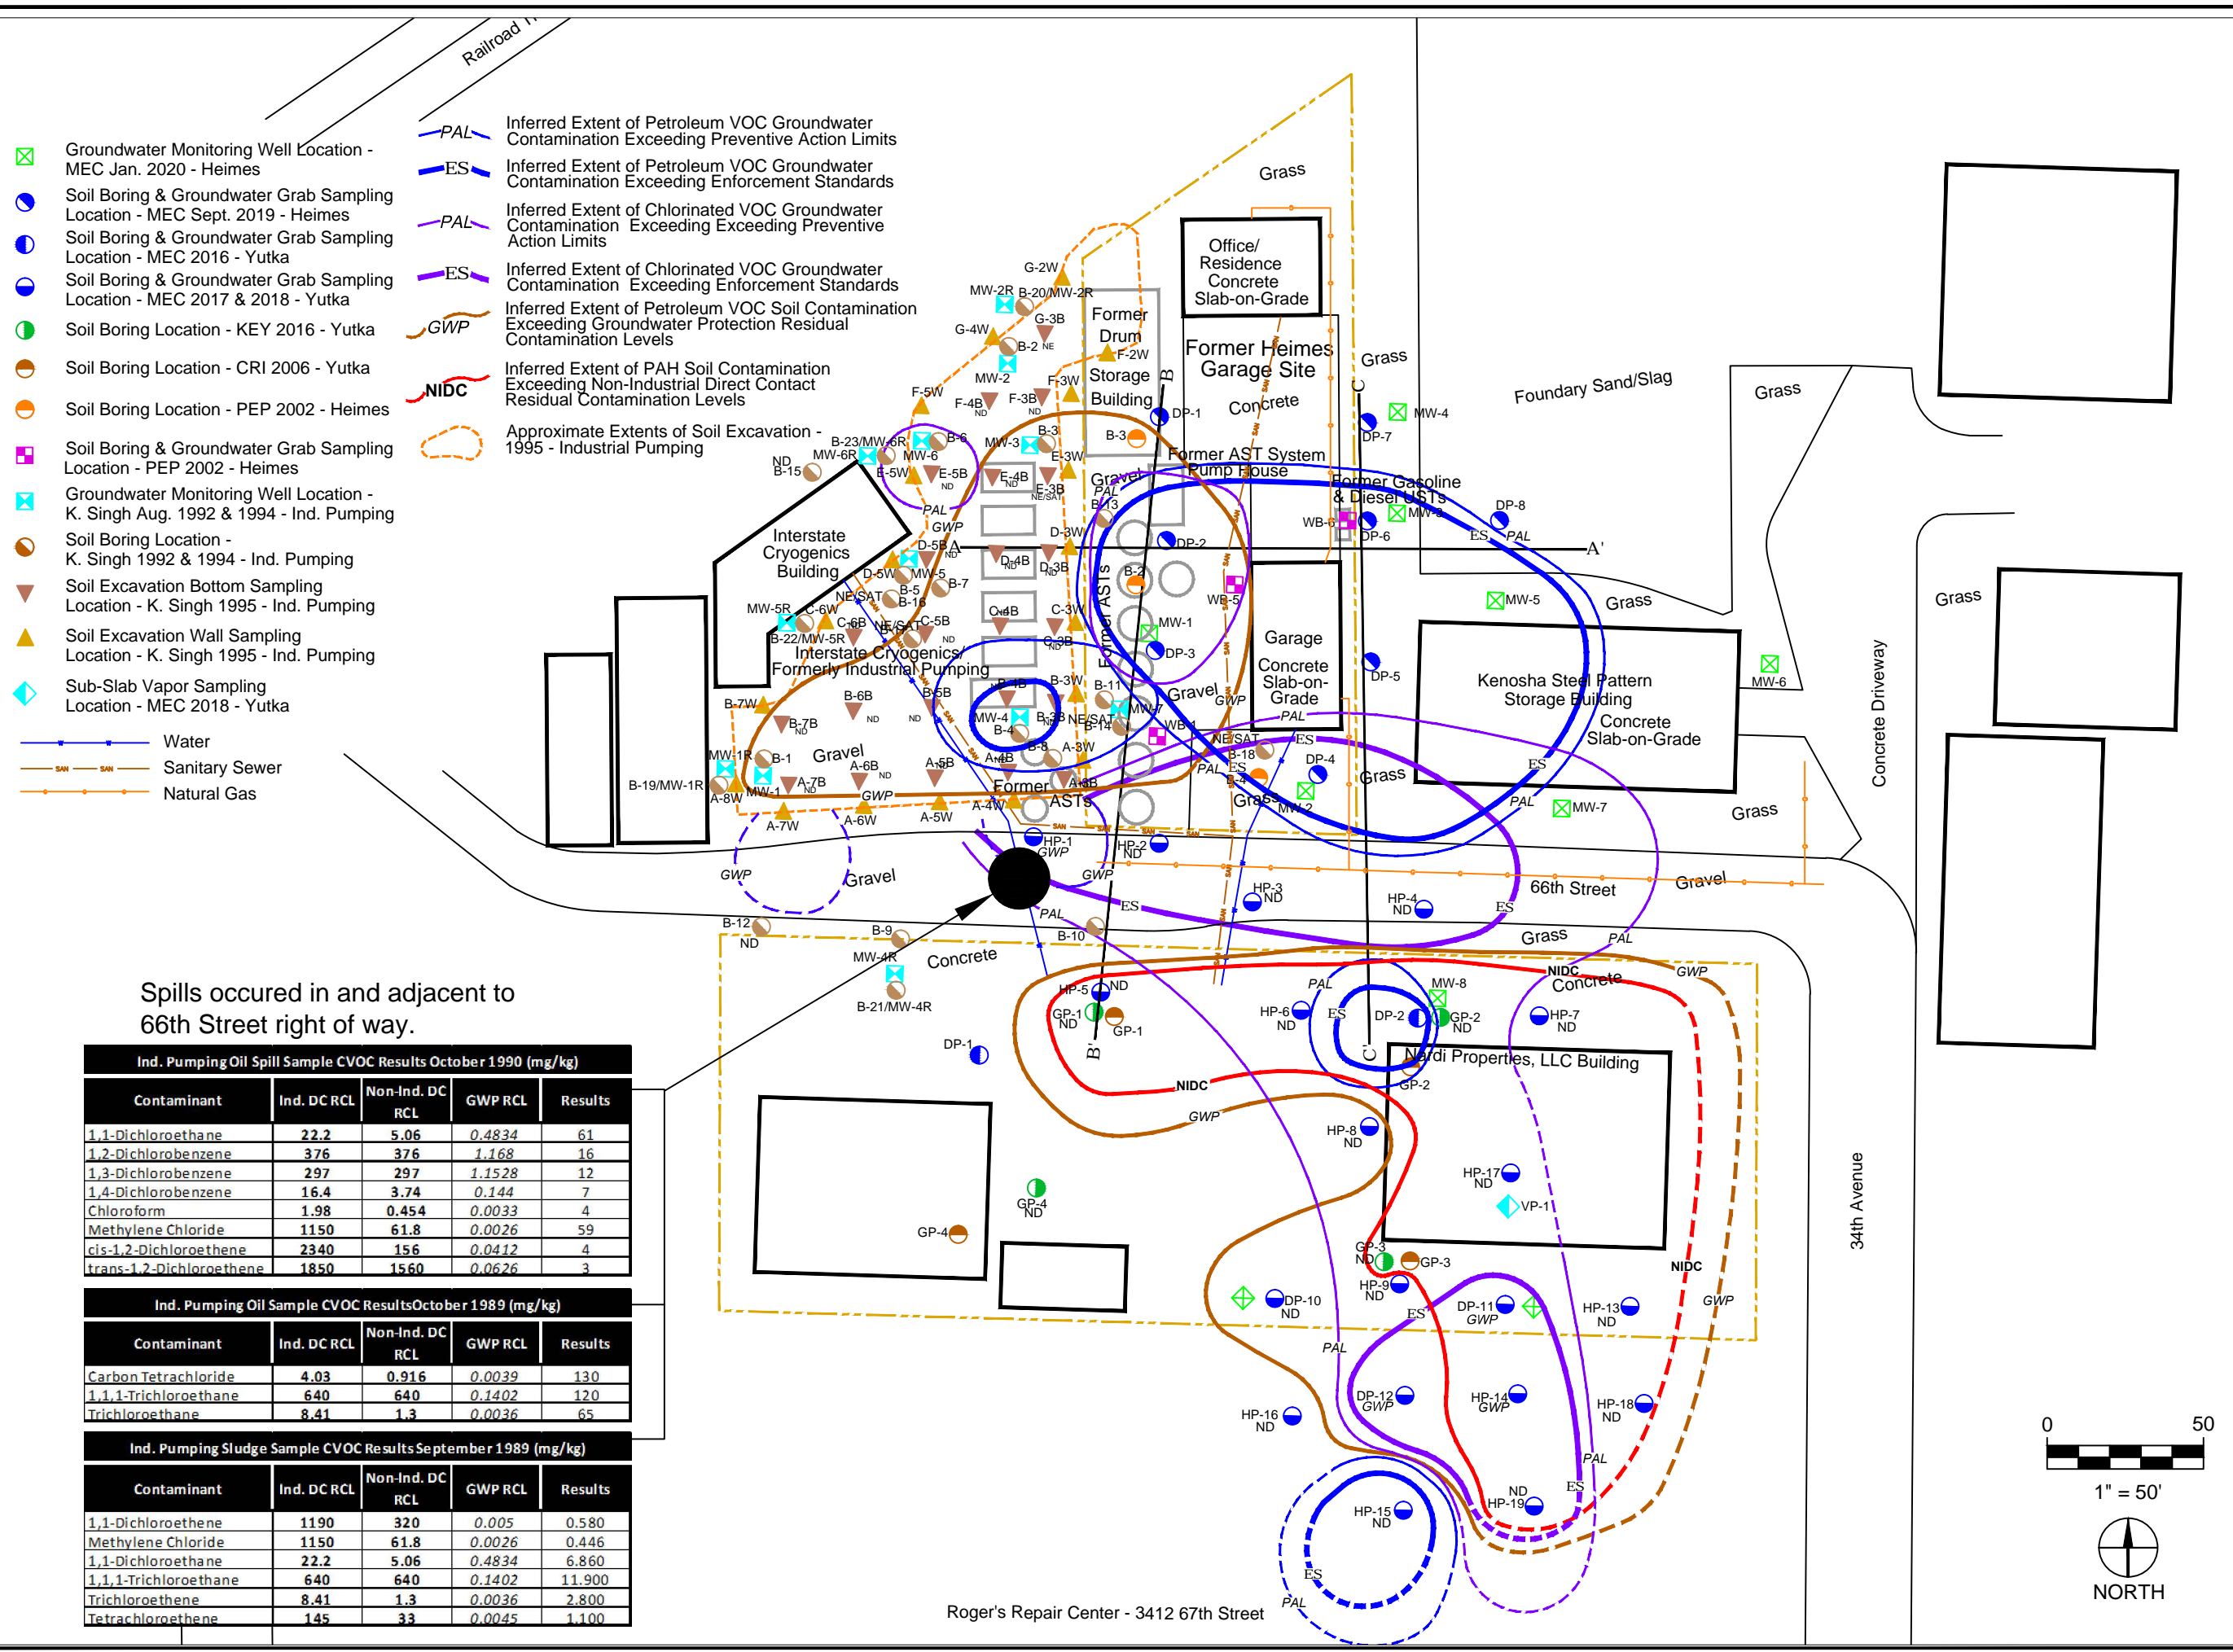
**FIGURE B.4.c**  
**OIL SPILL**  
**CVOC MAP**  
**HEIMES GARAGE**  
66TH STREET  
KENOSHA, WI

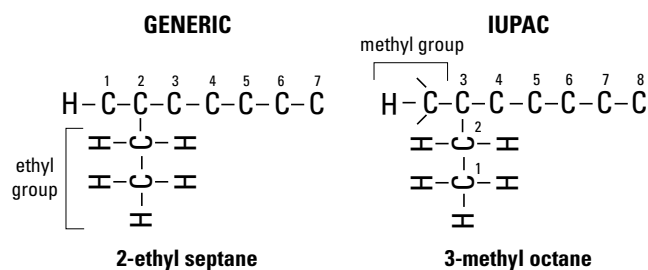
**Figure 1.** Generic and International Union of Pure and Applied Chemistry (IUPAC) naming conventions for the same aliphatic compound.

The simplest IUPAC rules for naming organic chemicals are those for the alkane compounds. First, the compound is named for the longest carbon-carbon (C-C) chain in the compound. If the compound contains a halogen or a branching alkyl group, then each carbon in the compound is numbered starting at the end that is closest to the halogen or alkyl group. The longest carbon chain may include the original branching alkyl group and result in a branching alkyl group with a different carbon position and name. After identifying the longest C-C chain in the compound, the numerical position of the alkyl group or halogen, if any, on a particular carbon is determined. The alkyl group is named based on the number of carbon atoms it contains corresponding to a name in the alkane series (table 3). To illustrate the IUPAC naming process, consider the following example: before the IUPAC rules, a seven-carbon alkane (septane) with an ethyl functional group (table 3) on the second carbon would be named 2-ethyl septane (fig. 1). Under IUPAC rules, however, the longest carbon chain in this example begins at the first carbon in the ethyl group. This new carbon chain contains eight carbon atoms rather than the original seven and is now called octane. Moreover, the octane compound now has a methyl group branching from its third carbon. Therefore, the new IUPAC name is 3-methyl octane (fig. 1).

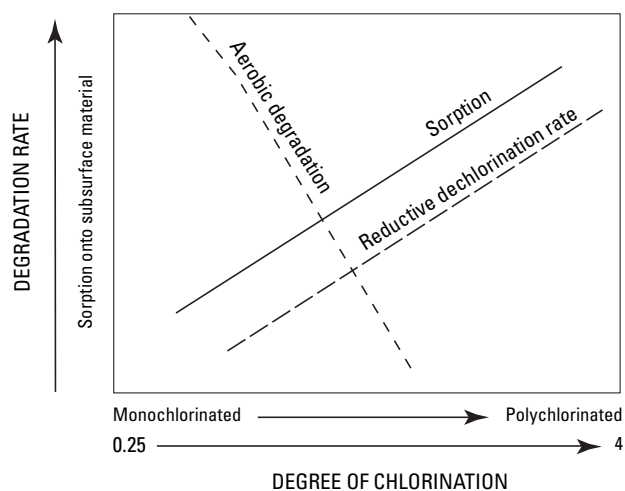
**Figure 2.** Relation between degree of chlorination and anaerobic reductive-dechlorination, aerobic degradation and sorption onto subsurface material (modified from Norris and others, 1993, p. 10–19). Degree of chlorination is number of chloride atoms divided by number of carbon atoms.

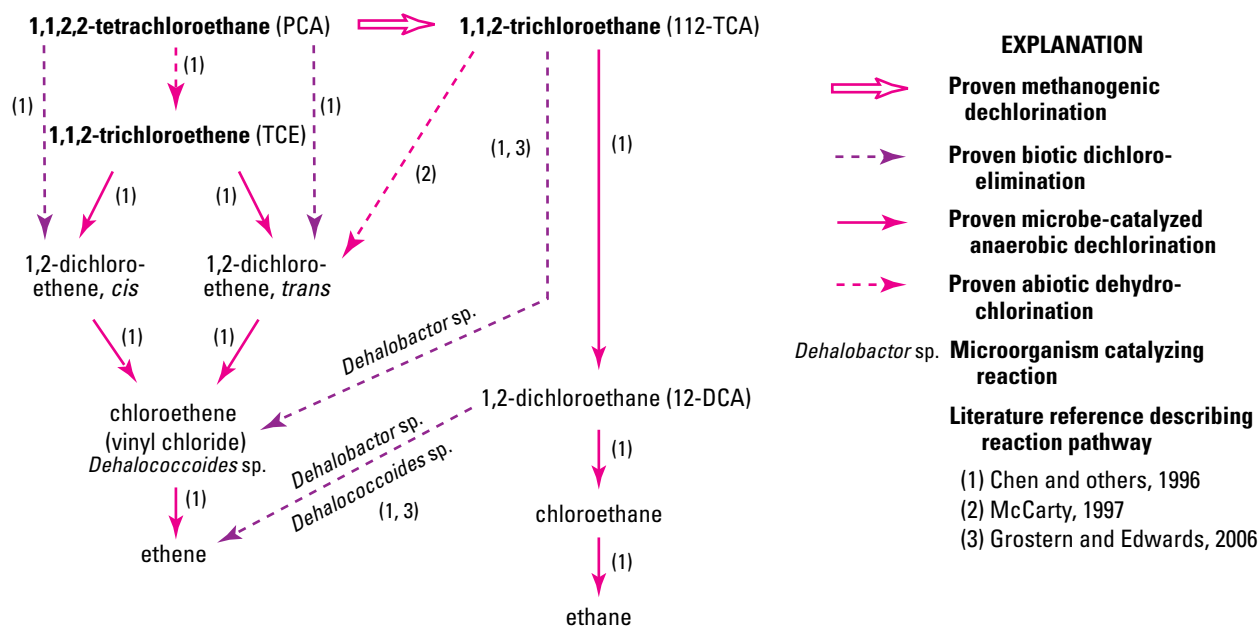
**Figure 3.** Laboratory-derived pathway for the abiotic degradation, anaerobic, and methanogenic biodegradation of 1,1,2,2-tetrachloroethane; 1,1,2-trichloroethene; and 1,1,2-trichloroethane (modified from Chen and others, 1996).

Chen and others (1996) show that PCA can be abiotically transformed to TCE under methanogenic conditions (fig. 3). In addition, the abiotic degradation of 111-TCA has been well studied in the scientific literature (fig. 4; Jeffers and others, 1989; McCarty and Reinhard, 1993; Chen and others, 1996; McCarty, 1997). McCarty and Reinhard (1993) indicate that the transformation of 111-TCA by hydrolysis is about four times faster than by dehydrochlorination. During abiotic degradation, about 80 percent of 111-TCA is transformed to acetic acid by hydrolysis (McCarty, 1997), and the remaining 20 percent is transformed to 11-DCE by dehydrochlorination (table 7; Vogel and McCarty, 1987b; McCarty, 1997). The presence of 11-DCE in contaminated ground water is probably the result of the dehydrochlorination of 111-TCA (McCarty, 1997).

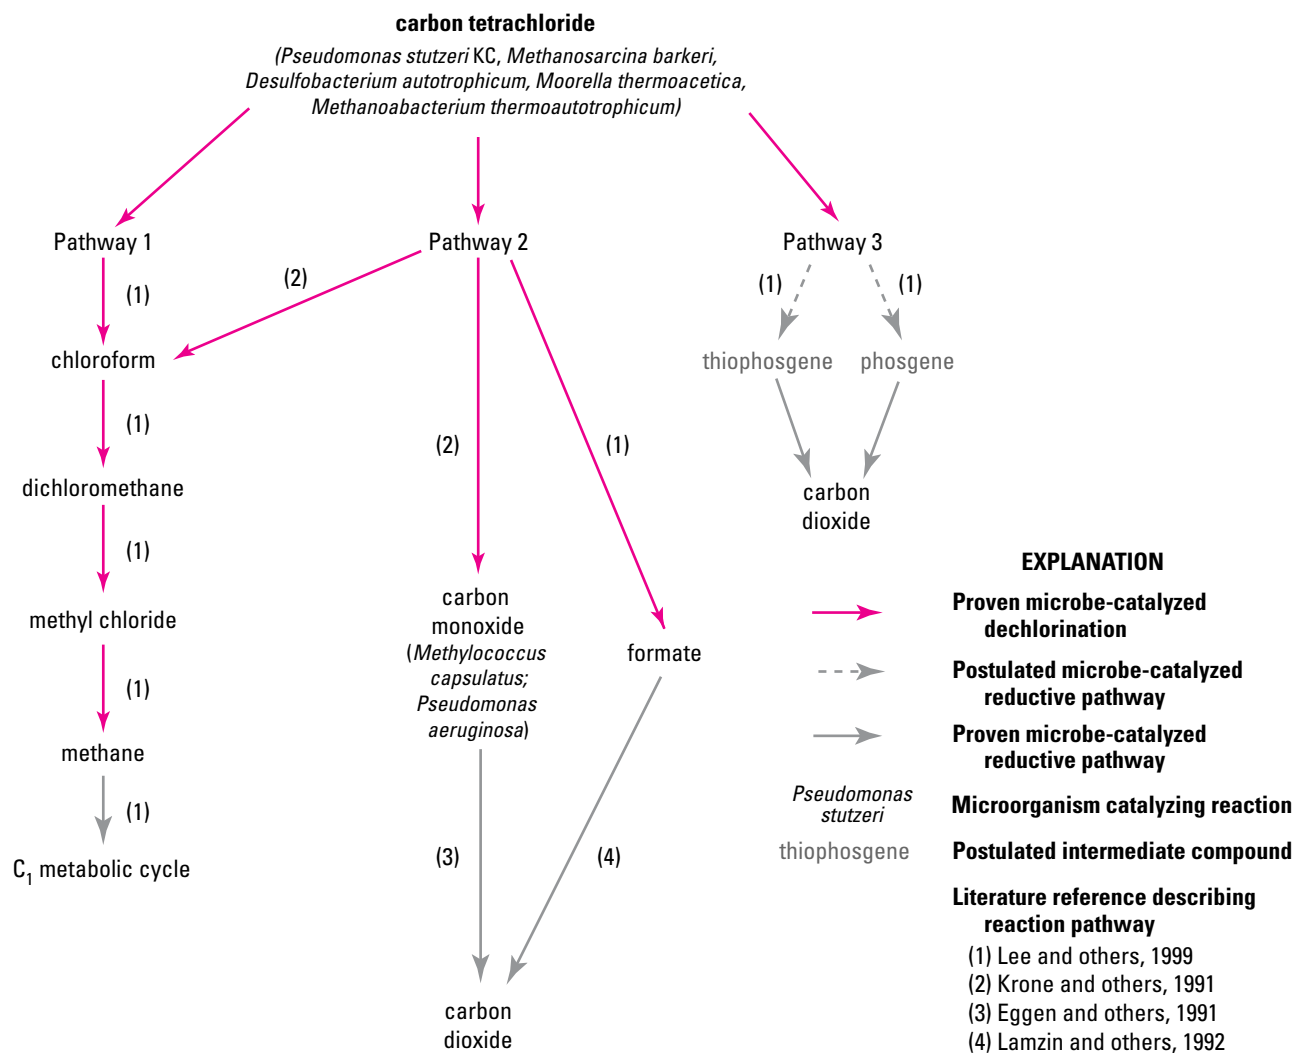
**Figure 6.** Laboratory-derived pathways for the anaerobic biodegradation of tetrachloromethane (carbon tetrachloride; modified from Ma and others, 2005; Sands and others, 2005).

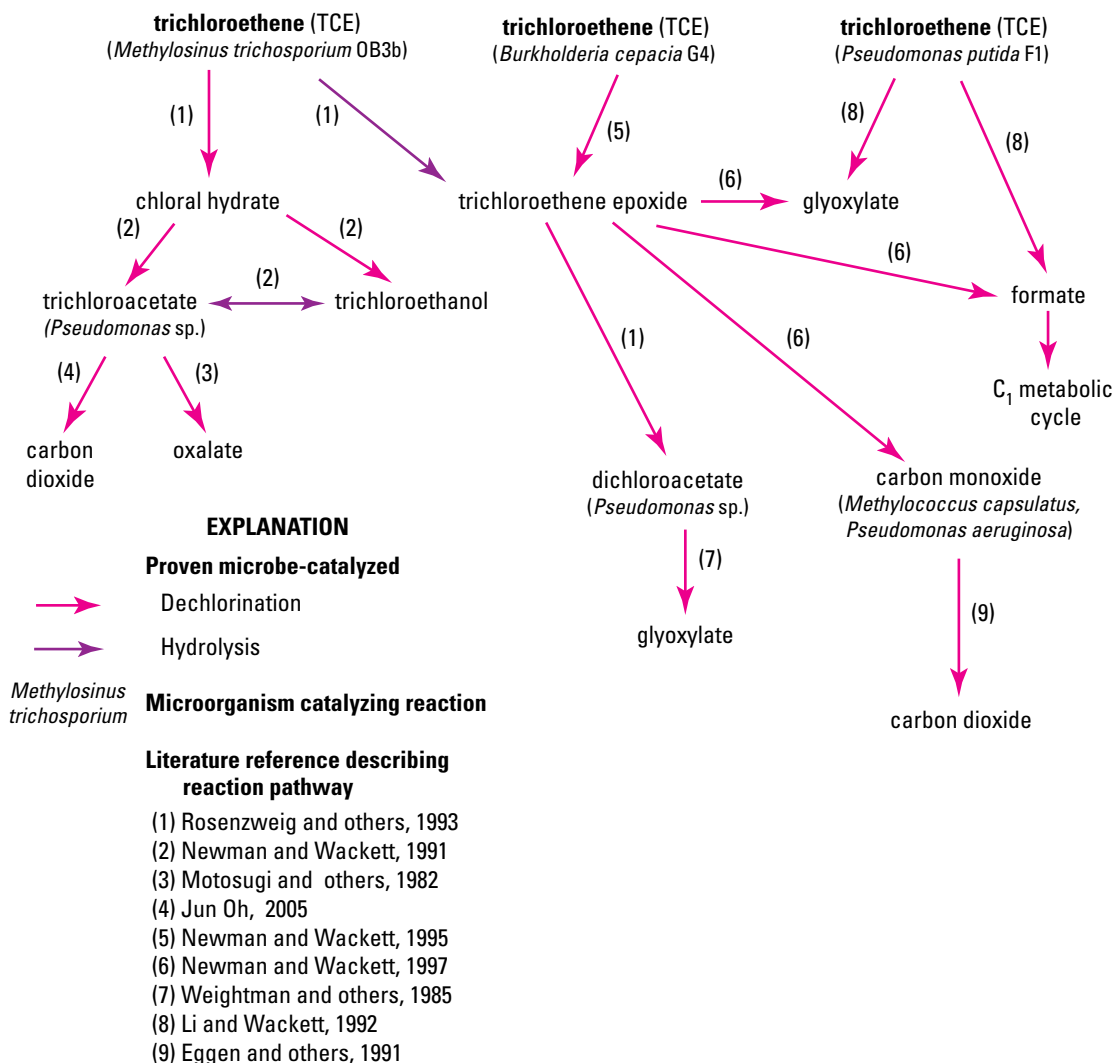
**Figure 7.** Laboratory-derived pathways for the aerobic biodegradation of trichloroethene (modified from Whittaker and others, 2005).

Although PCE is not known to degrade through co-metabolism under aerobic conditions, co-metabolism is known to degrade TCE, the dichloroethenes, and VC. The rate of co-metabolism increases as the degree of chlorination decreases on the ethene molecule (Vogel, 1994). During aerobic co-metabolism, the chlorinated alkene is indirectly dechlorinated by oxygenase enzymes produced when microorganisms use other compounds, such as BTEX compounds, as a carbon source (Wiedemeier and others, 1998). The co-metabolic degradation of TCE, however, tends to be limited to low concentrations of TCE because high concentrations in the milligram per liter range are toxic to microbes catalyzing this reaction (Wiedemeier and others, 1998). In field studies by Hopkins and McCarty (1995), VC is shown to degrade by co-metabolism under aerobic conditions when phenol and toluene were used as a carbon source.

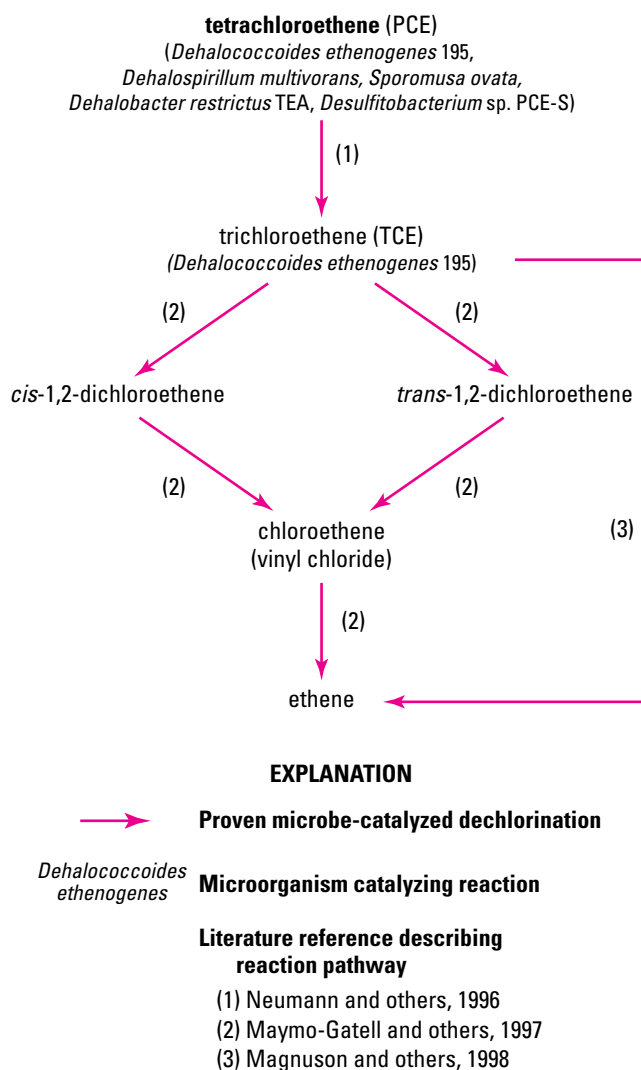
**Figure 8.** Laboratory-derived pathway for the anaerobic biodegradation of tetrachloroethene (modified from Ellis and Anderson, 2005).

The highly chlorinated alkenes are commonly used as electron acceptors during anaerobic biodegradation and are reduced in the process (Vogel and others, 1987). The primary anaerobic process driving degradation of CVOCs, except VC, is reductive dechlorination (figs. 3 and 8; Bouwer and others, 1981; Bouwer, 1994). Tetrachloroethene and TCE are the most susceptible to reductive dechlorination because they are the most oxidized of the chlorinated ethenes; however, the more reduced (least oxidized) degradation by-products such as the dichloroethenes and vinyl chloride are less prone to reductive dechlorination. The main by-product of anaerobic biodegradation of the polychlorinated ethenes is VC (fig. 8), which is more toxic than any of the parent compounds (Agency for Toxic Substances and Disease Registry, 2004). The rate of reductive dechlorination tends to decrease as the reductive dechlorination of daughter products proceeds (Vogel and McCarty, 1985; Bouwer, 1994). Murray and Richardson (1993) suggest that the inverse relation between the degree of chlorination and the rate of reductive dechlorination may explain the accumulation of 1,2-DCE and VC in anoxic ground water contaminated with PCE and TCE. In addition, the anaerobic reduction of VC to ethene is slow and inefficient under weak reducing conditions, which favors the persistence of VC in anoxic ground water (Freedman and Gossett, 1989).

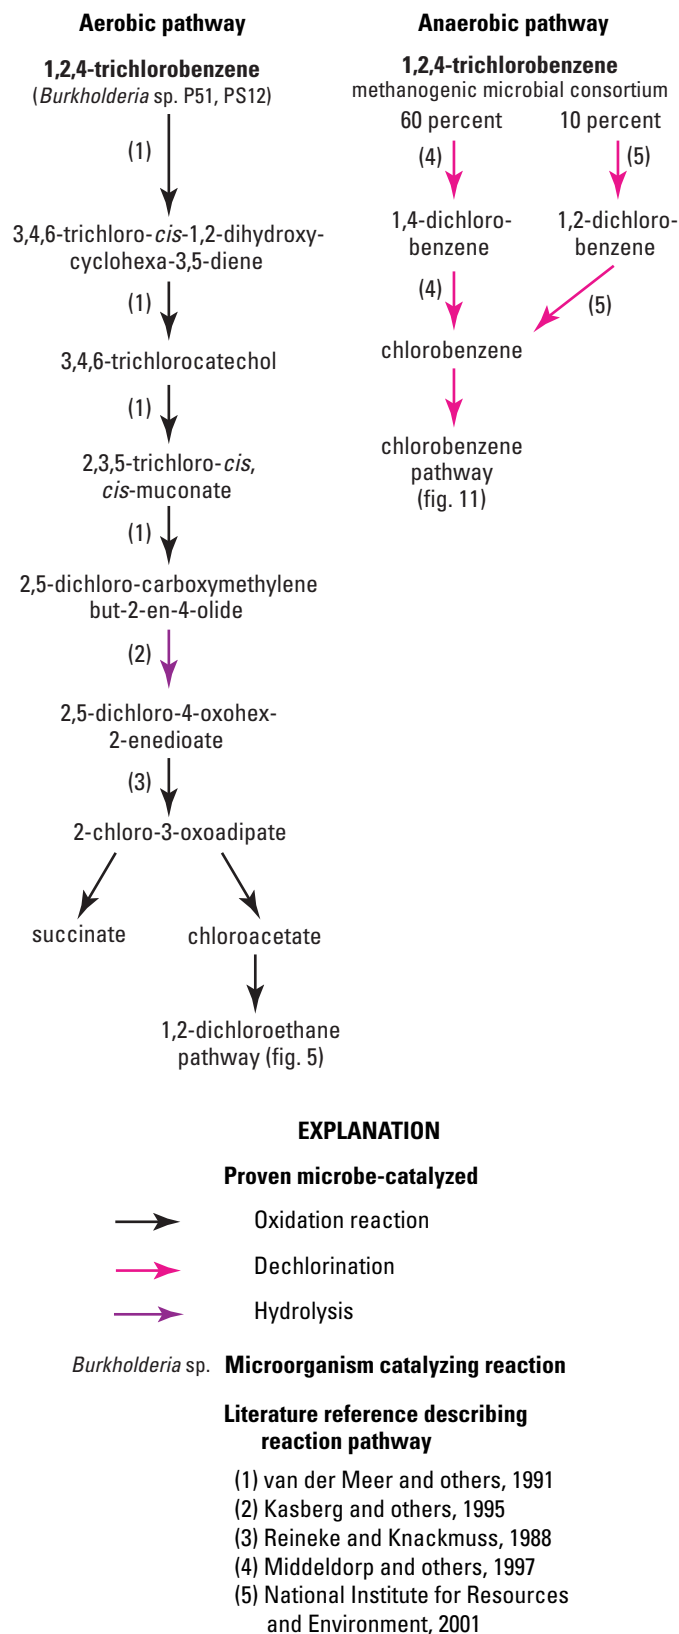
**Figure 9.** Laboratory-derived pathways for the aerobic and anaerobic biodegradation of 1,2,4-trichlorobenzene (modified from Yao, 2006).

Although Wiedemeir and others (1998) indicate that few studies existed that described the anaerobic degradation of the chlorobenzene compounds, a study by Ramanand and others (1993) did suggest that 124-TCB could be biodegraded to chlorobenzene with 14-DCB as an intermediate compound under anaerobic conditions. Moreover, Middeldorp and others (1997) show that 124-TCB was reductively dechlorinated to 14-DCB, then to chlorobenzene in a methanogenic laboratory microcosm in which chlorobenzene-contaminated sediment was enriched with lactate, glucose, and ethanol. These compounds served as carbon sources. Furthermore, the microbial consortia facilitating the dechlorination of 124-TCB also was able to degrade isomers of tetrachlorobenzene to other isomers of TCB and 12-DCB. More recent studies show that a strain of the bacterium, *Dehalococcoides*, can reductively dechlorinate 124-TCB under anaerobic conditions (Holscher and others, 2003; Griebler and others, 2004a). In addition, Adrian and others (1998) suggest that fermentation is the primary degradation process for the chlorobenzenes under anaerobic conditions. This study also showed that the co-metabolism of 124-TCB was inhibited by the presence of sulfate, sulfite, and molybdate.

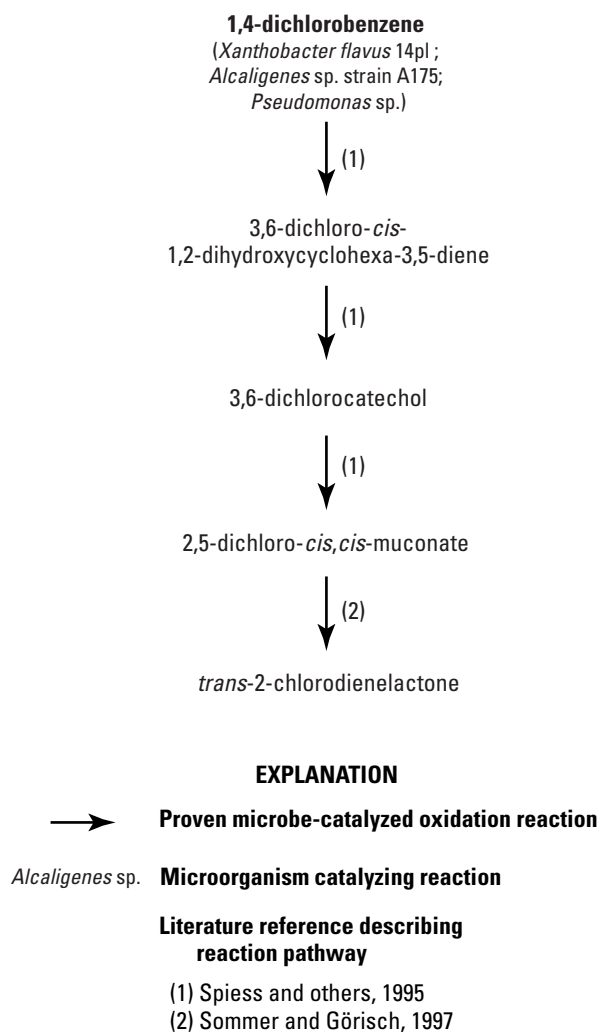
**Figure 10.** Laboratory-derived pathway for the aerobic biodegradation of 1,4-dichlorobenzene (modified from Liu, 2006).

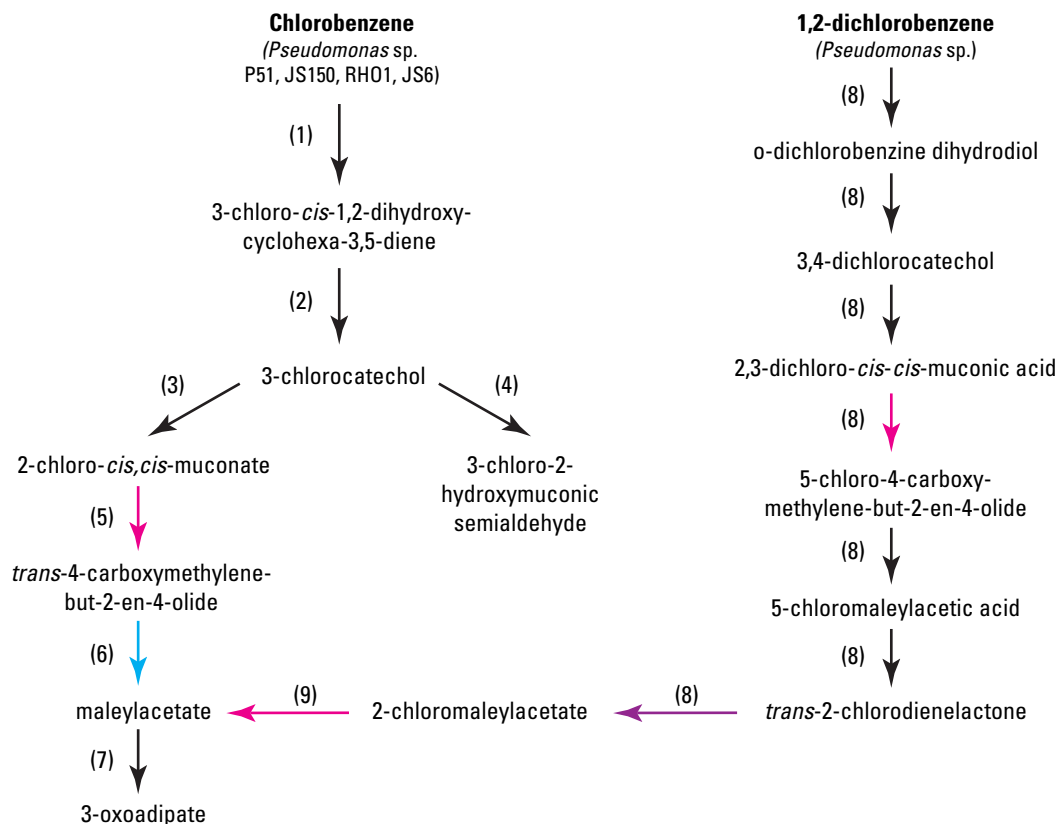
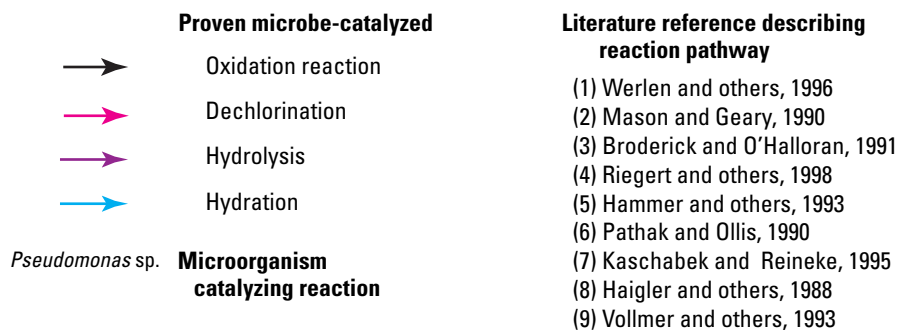
**Figure 11.** Laboratory-derived pathway for the aerobic biodegradation of chlorobenzene and 1,2-dichlorobenzene (modified from McLeish, 2005).

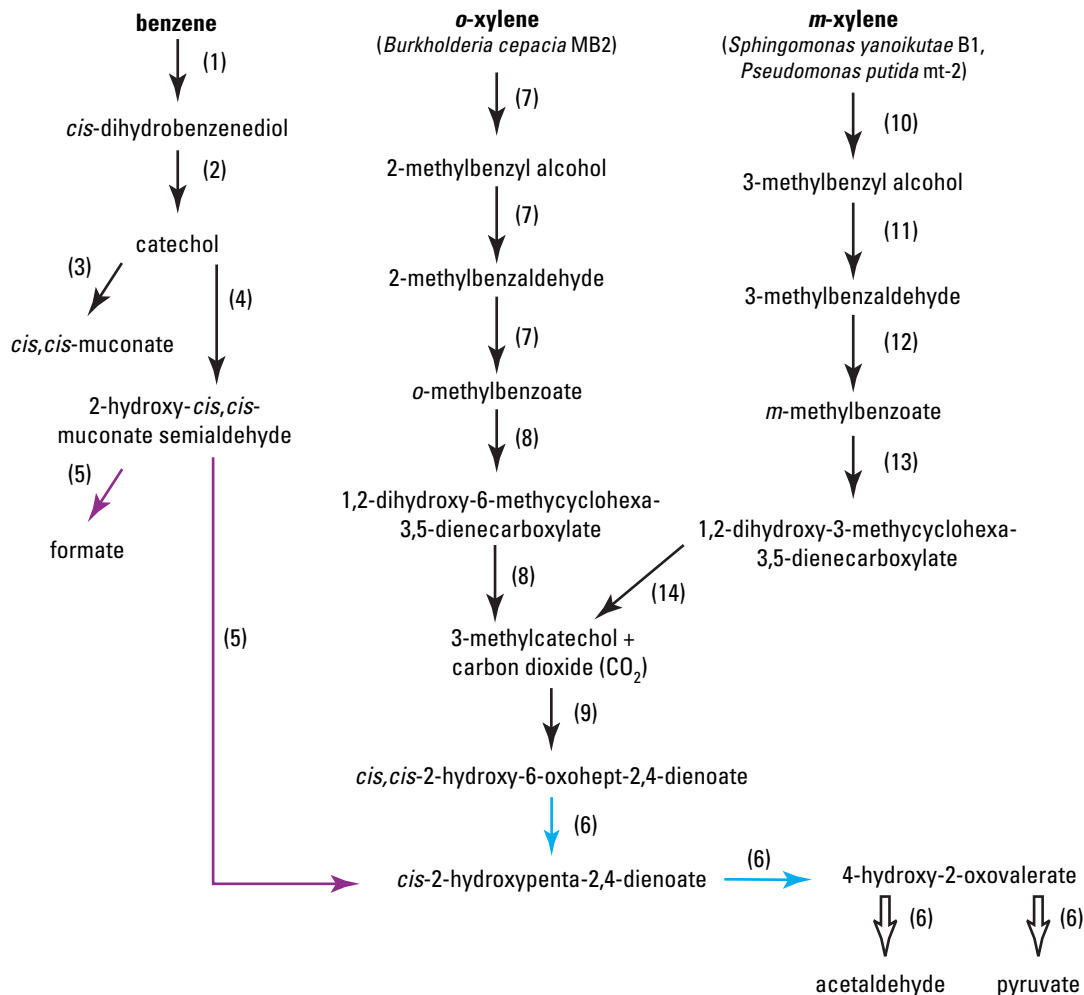
**Figure 12.** Laboratory-derived pathways for the aerobic biodegradation of benzene, *o*-, and *m*-xylene (modified from Hyatt and Jun Oh, 2005; Jun Oh, 2005).

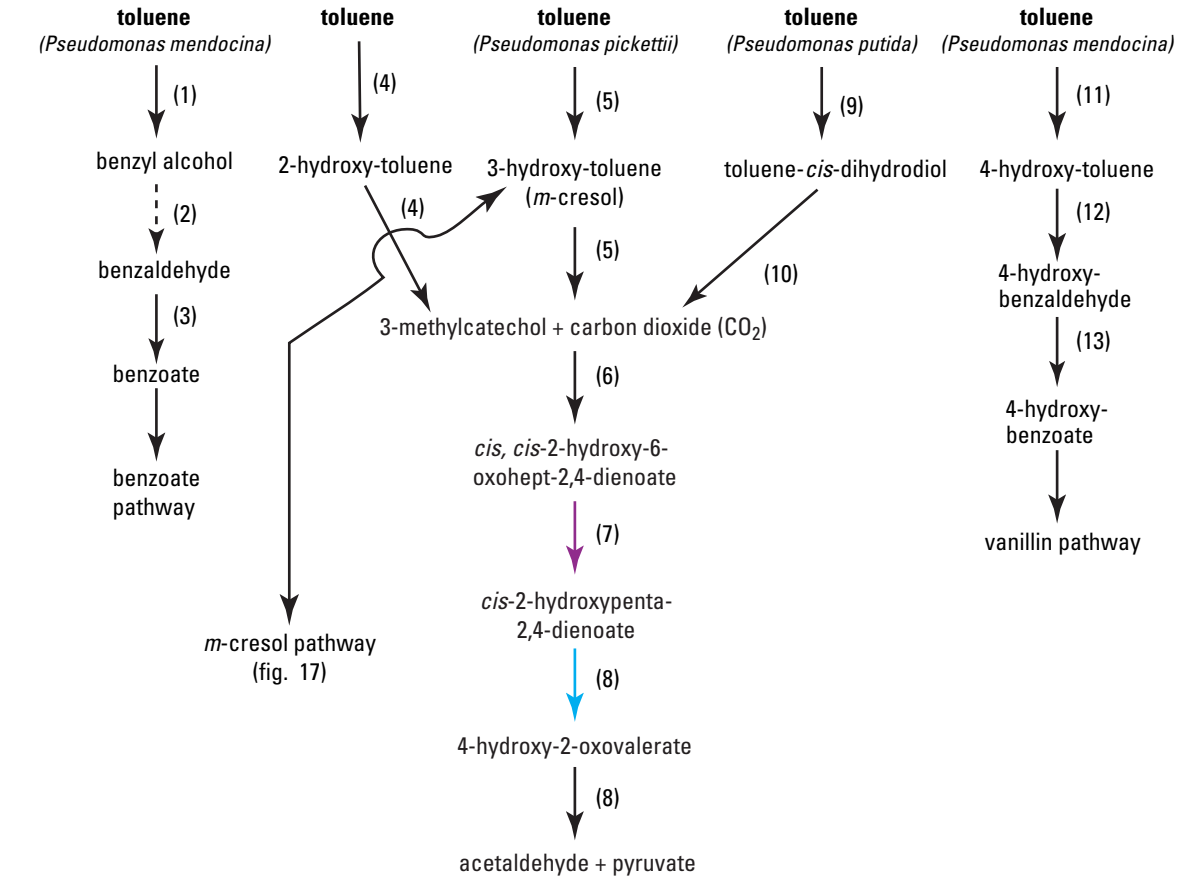
**Figure 13.** Laboratory-derived pathways for the aerobic biodegradation of toluene (modified from Wackett and Zeng, 2004).

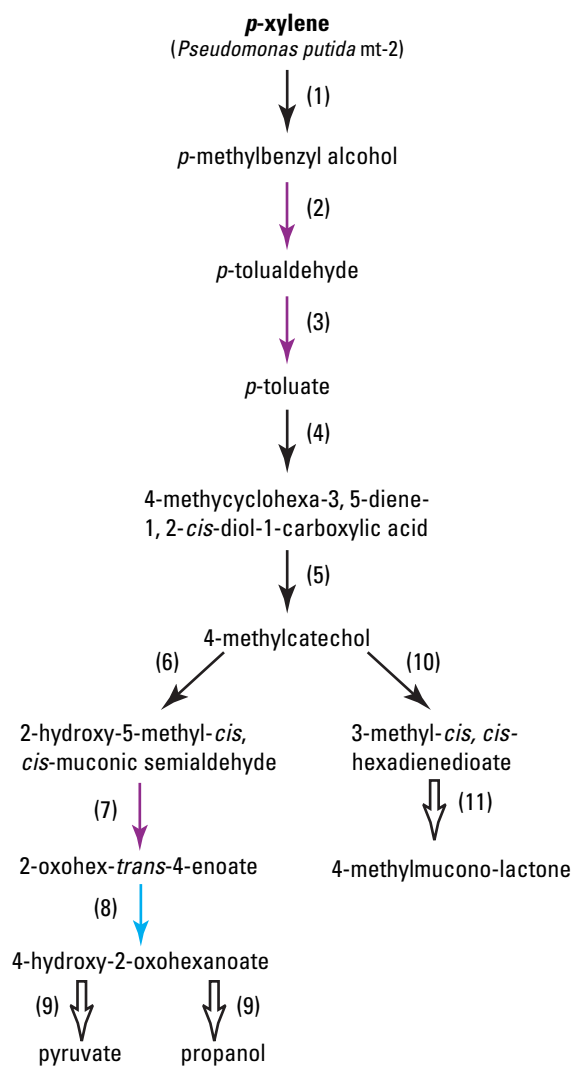
**Figure 14.** Laboratory-derived pathways for the aerobic biodegradation of *p*-xylene (modified from Mili and Stephens, 2006).

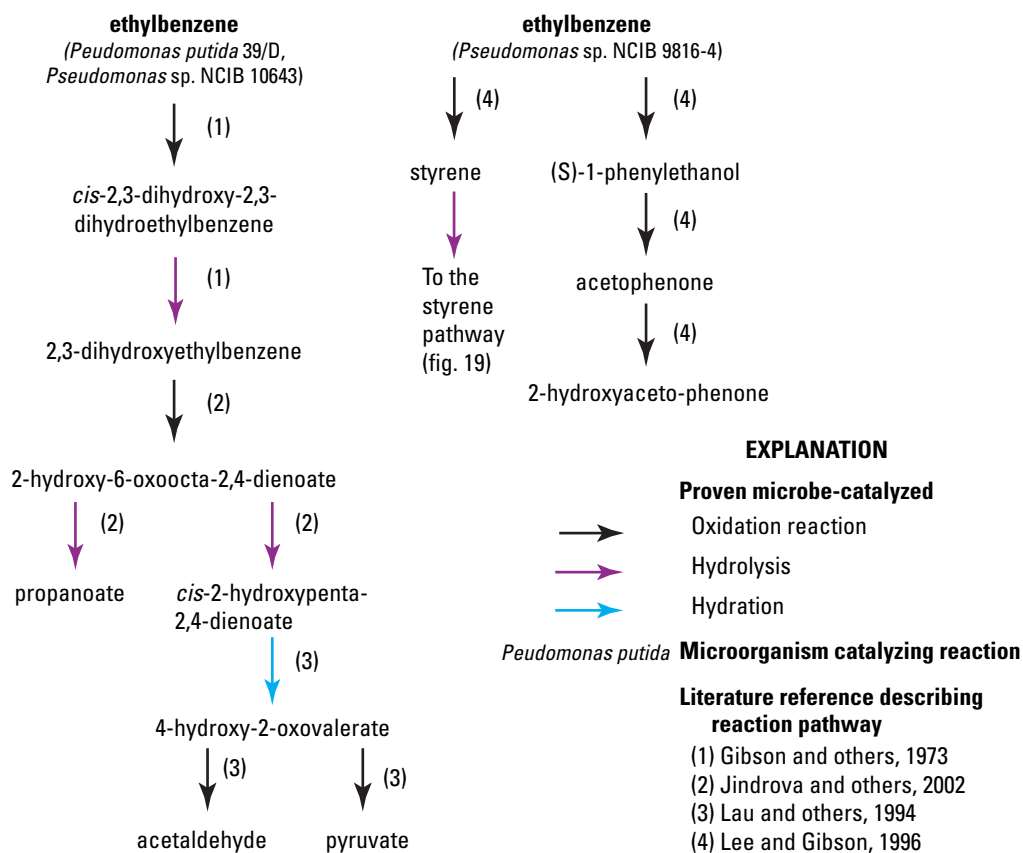
**Figure 15.** Laboratory-derived pathway for the aerobic biodegradation of ethylbenzene (modified from McLeish, 2005).

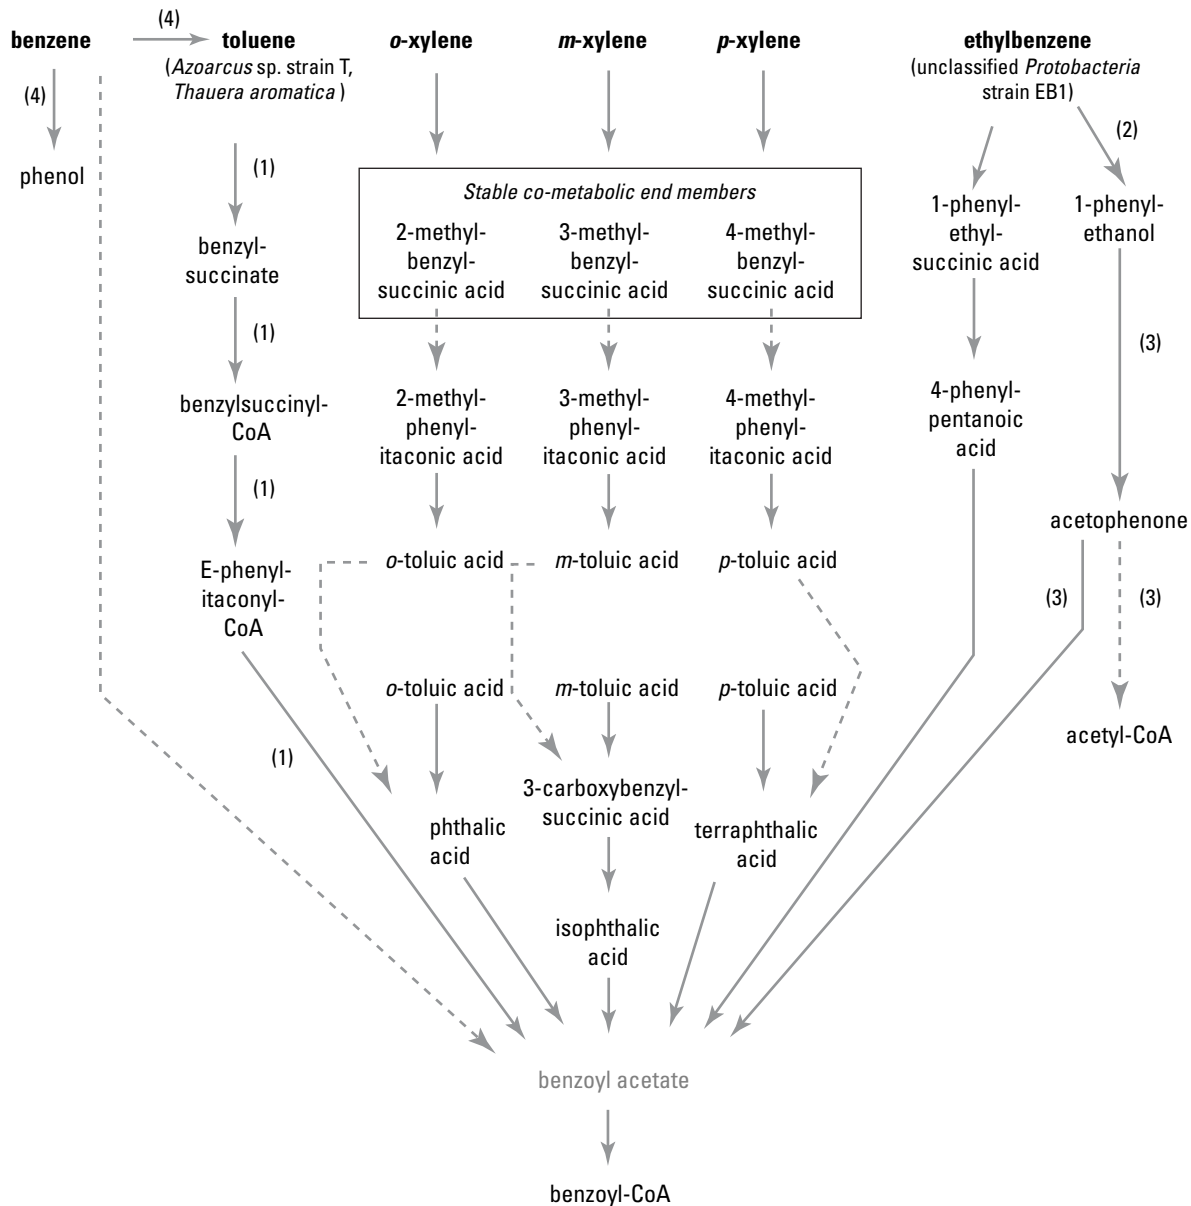
**Figure 16.** Field and laboratory-derived pathways for the anaerobic biodegradation of the BTEX compounds—benzene, toluene, ethylbenzene, and xylene (modified from Edwards and Grbić-Galić, 1994; and Griebler and others, 2004b).

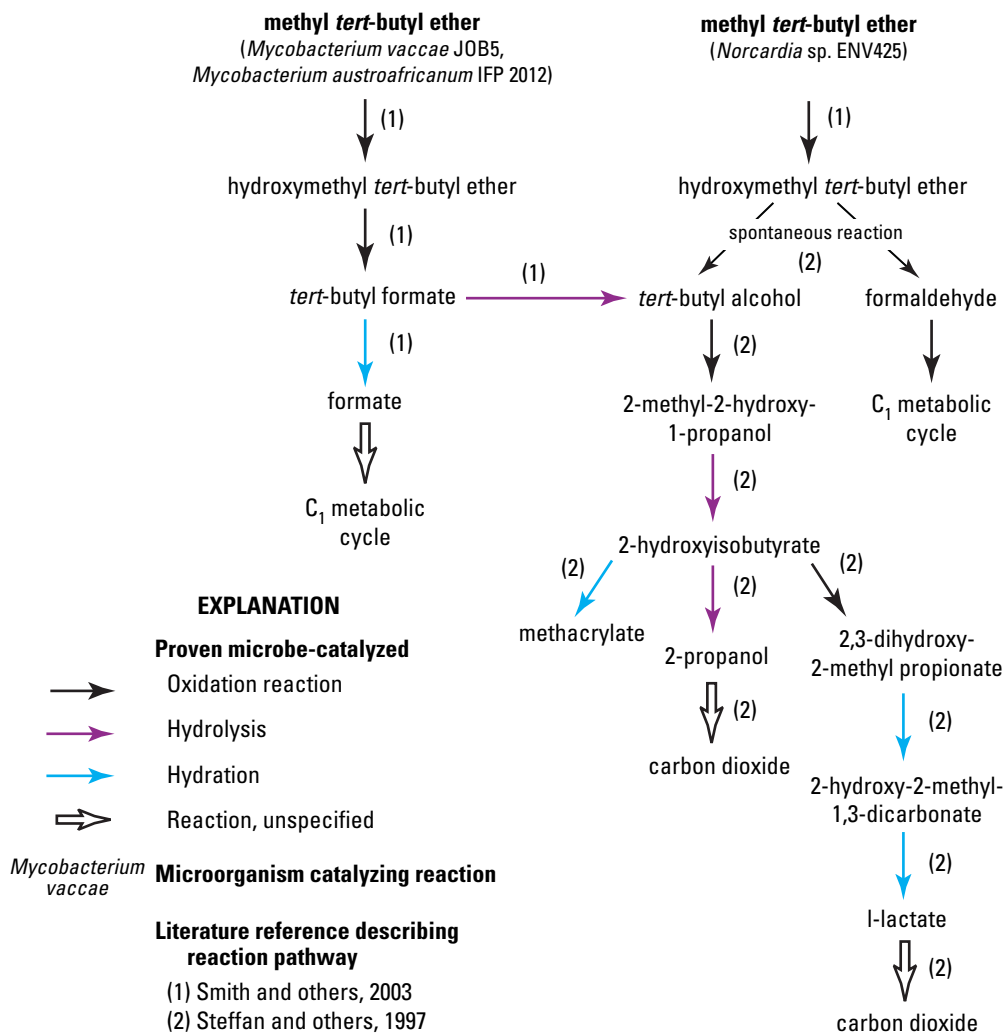
**Figure 17.** Laboratory-derived pathway for the aerobic biodegradation of methyl *tert*-butyl ether (modified from Pedersen and Essenberg, 2005).
