GIS REGISTRY

ACTIVITY NAME: COUNTRY FAIR SHOPPING CNTR & EXPRESS CLEANER

Subject: Case Closure With NR 140 Exemption
Former Express Cleaners, 5620 S. 108th Street, Hales Corners, Wisconsin
WDNR BRRTS # 02-41-420848

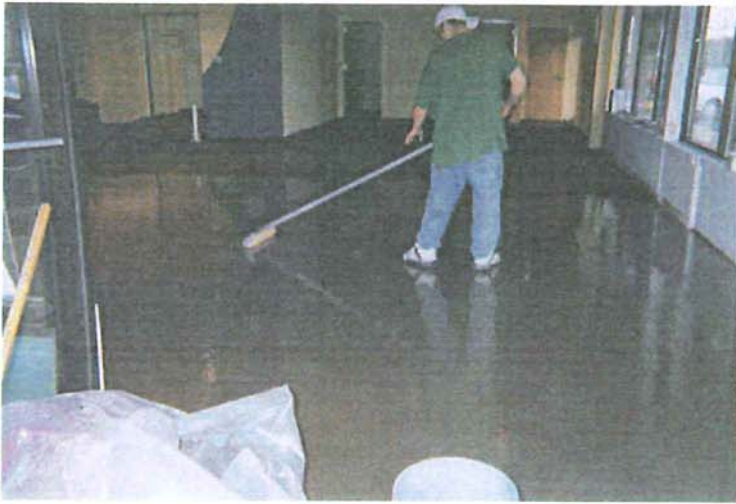
1. Applying ECO-POXI with 18" roller brush.

To respond to the potential vapor intrusion risk posed by the residual soil contamination, a sealant was placed over the floor of the former Express Cleaners space. Additionally, a piping system was installed beneath the floor in the source area to allow for passive re-direction of any PCE that volatilizes into vapor phase from the soil contamination. The continued maintenance and inspection of these features, institutionalized through a property deed restriction, is a condition of case closure. The sub-slab venting system is currently being enhanced by an electric fan. The Department approves and encourages the continued use of the fan. The existing building and surrounding pavement also serve as a barrier to rain infiltration, thus limiting the potential for migration of the PCE soil contamination into groundwater. These features should be maintained, as required through the deed restriction, as a condition of case closure. If the building is removed from the source area and adjacent tenant spaces in the future, further assessment and remedial actions may be required. This is also stated in the deed restriction. The Department has received the required documentation that a deed restriction meeting Department requirements has been recorded for this property.

In the event that the vapor barrier is repaired or replaced, a floor sealant equivalent to the previously installed vapor barrier (40 mils epoxy) must be applied over the repaired/replaced flooring and extended well beyond any disturbed area. Any of the flexible sealant that had been placed at the floor-wall joints and/or expansion joints must be replaced if disturbed. Additionally, a flexible sealant will be liberally applied at and immediately surrounding any anchor points or other areas where the epoxy floor sealant is breached (screw holes, nail holes, plumbing fixtures...). Any replacement barrier will be subject to identical maintenance and inspection guidelines unless indicated otherwise by the WDNR or its successor.

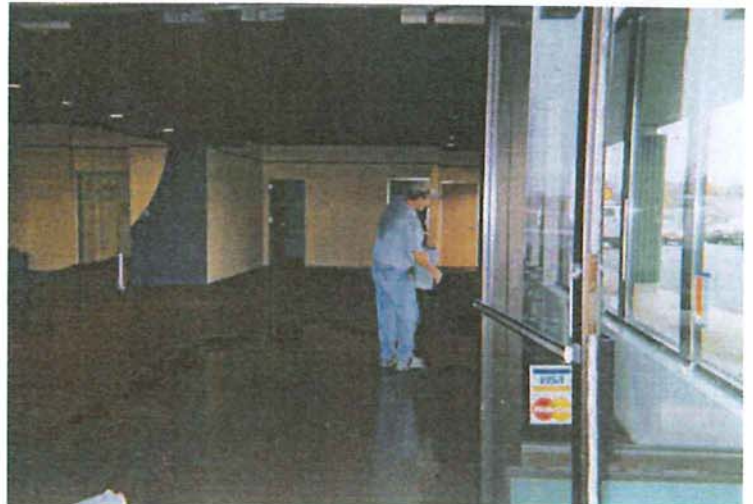
2. Applying silica sand to ECO-POXI floor.

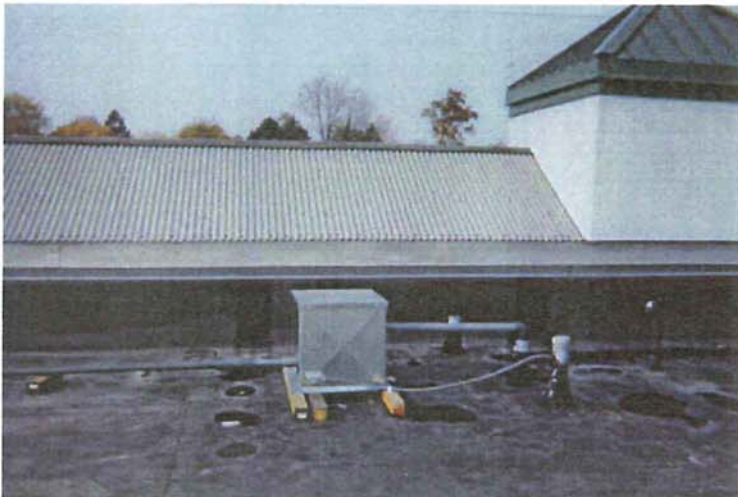
3. Vapor Mitigation System on the Roof.

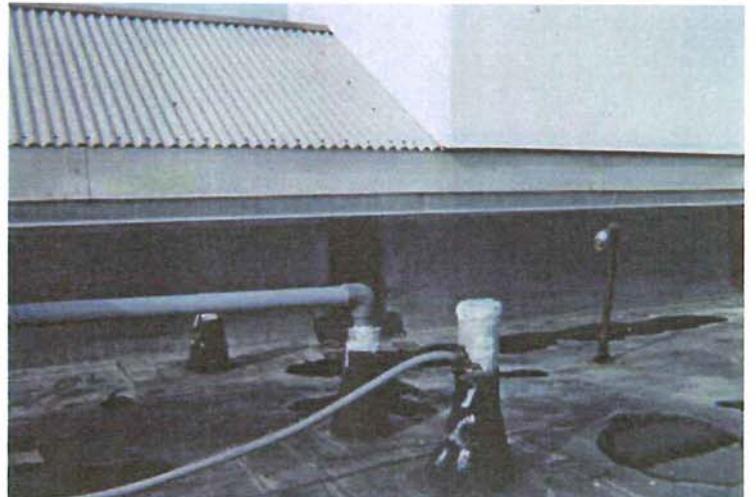
4. Plugged roof vents.

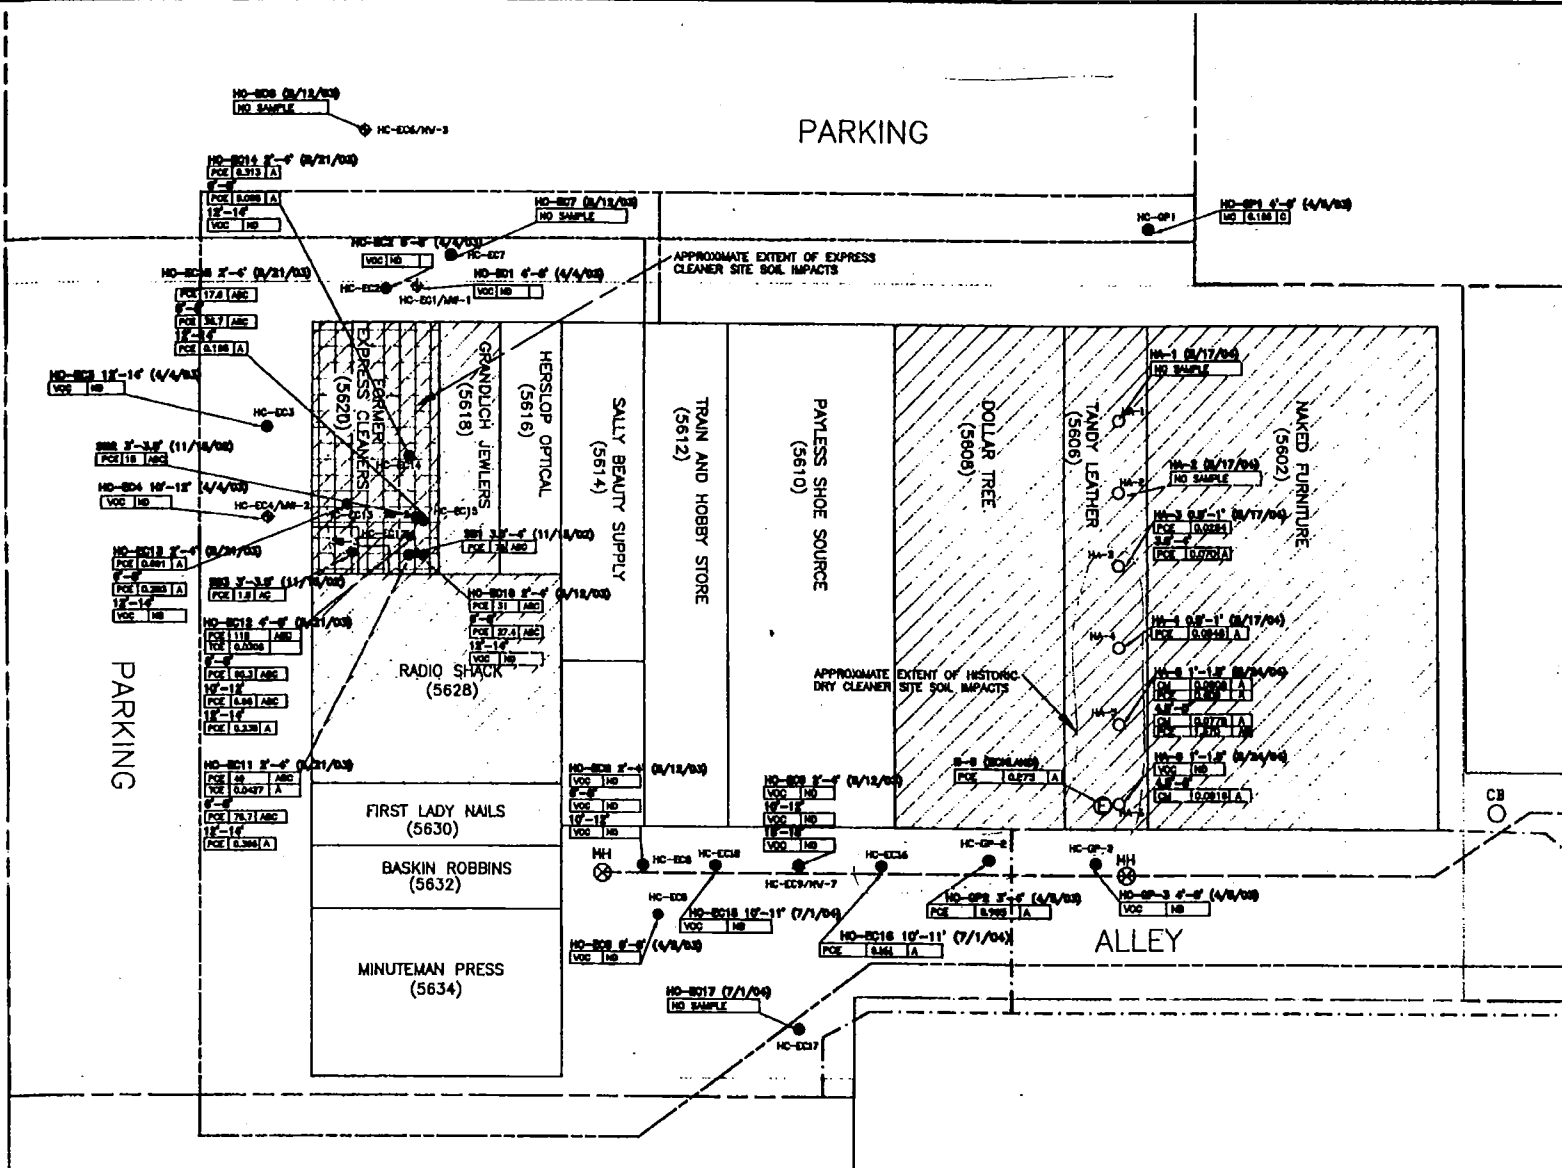
ATTACHMENT I
SUMMARY OF SOIL ANALYTICAL RESULTS (mg/kg)
 FORMER EXPRESS CLEANERS AND HISTORIC CLEANERS
 5280 AND 5806 S. 108TH STREET, HALES CORNERS, WI

Interior space limitations in the area of the adjacent tenant spaces, identified as Tenant Spaces 5618 S. 108th St., 5628 S. 108th St., 5608 S. 108th St., and 5602 S. 108th St. on ATTACHMENT 1, existing at the time of the investigation and remedial action, made complete investigation of the soil contamination on this property impracticable. If the building foundations adjacent to the former Express Cleaners are removed, the property

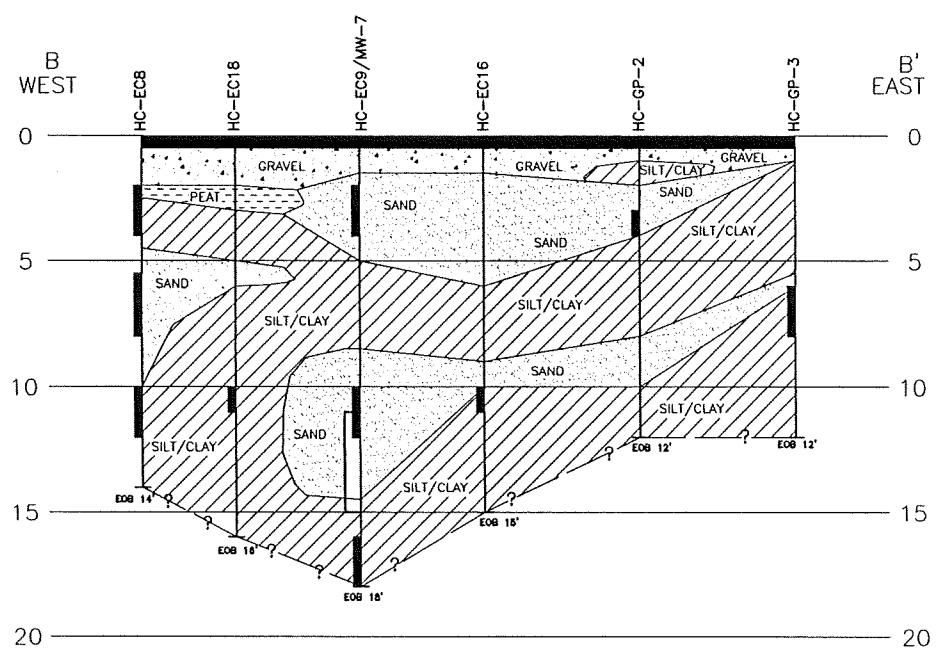
- NOTES:
1. SOIL BORINGS WERE COMPLETED BY MSC ON 4/5/03, 8/12/03, 7/1/04, 8/17/04, AND 8/24/03.
 2. EOB = END OF BORING
 3. ? - DENOTES UNKNOWN EXTENT OF STRATUM

FIGURE B8
 GEOLOGIC CROSS SECTIONS A-A' AND B-B'
 HISTORIC DRY CLEANERS
 5606 S. 108TH STREET, HALES CORNERS, WI

Figure #: 3 **Title: Geologic Cross Section**

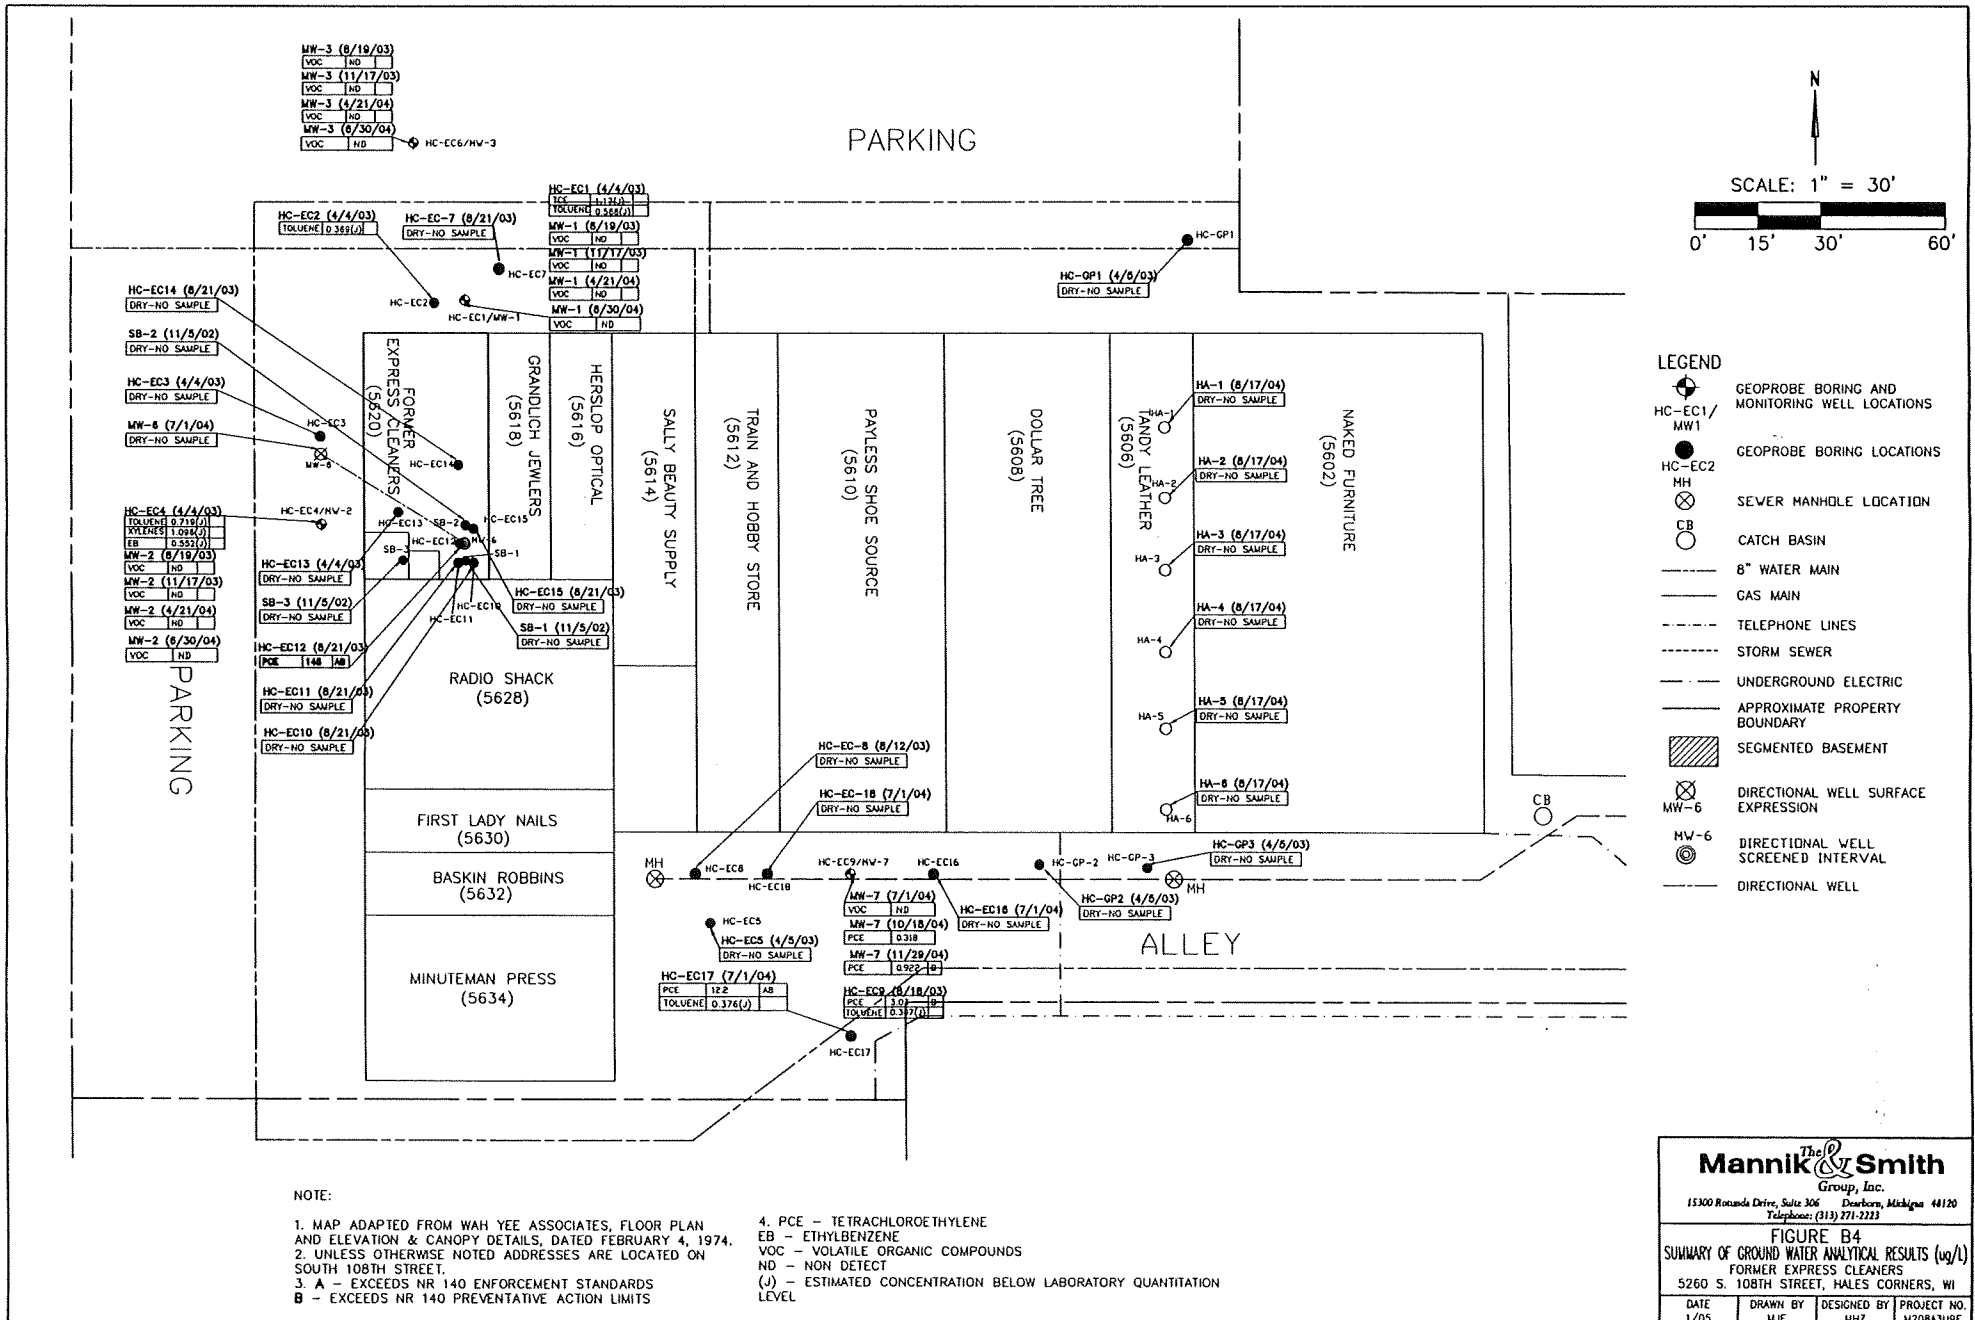
FIGURE B4
SUMMARY OF GROUND WATER ANALYTICAL RESULTS (ug/L)
FORMER EXPRESS CLEANERS
5260 S. 108TH STREET, HALES CORNERS, WI

Figure #: B4 **Title: Summary of Ground Water Analytical Results**
