SUBJECT: Vapor Investigation Review
Master Drycleaning, Inc., 6326 West Bluemound Road, Wauwatosa, WI
BRRTS # 02-41-545142; FID # 241398630

TCE in the Air

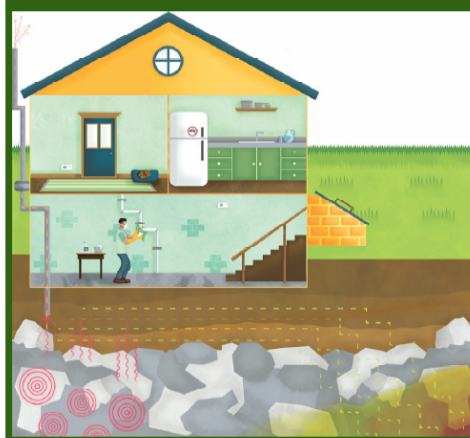
A "sub-slab mitigation" system moves air from below to outside the house.
