**LIMITED SITE ASSESSMENT  
CLARE CENTRAL  
1003 AND 1033 WEST ATKINSON AVENUE  
MILWAUKEE, MILWAUKEE COUNTY, WISCONSIN**

**TERRACON PROJECT NO. 38067034  
AUGUST 16, 2006**

**LIMITED SITE ASSESSMENT**

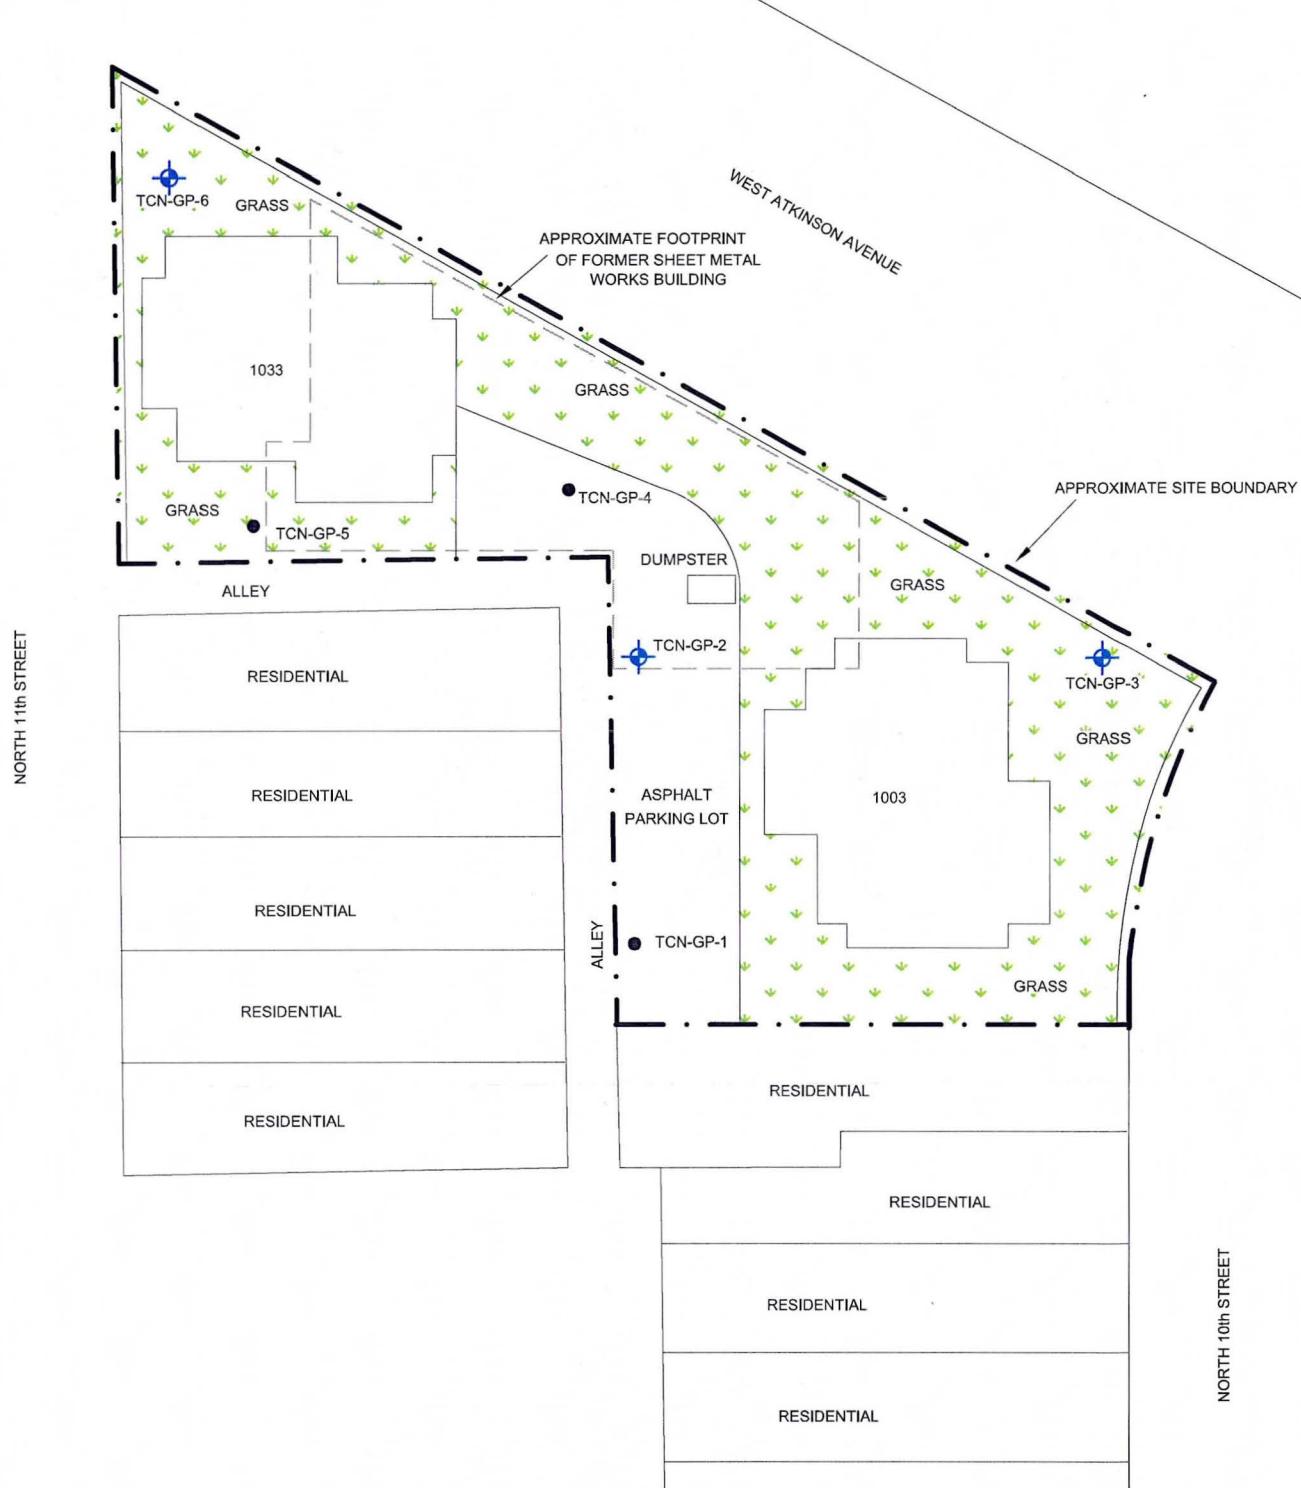
Project Mngr:	MAK	Project No.	38067034
Designed By:	AJP	Scale:	1" = 50'
Checked By:	BAL	Date:	8/2/06
Approved By:	BRS	Drawn By:	AJP (38)
File Name:	38067034sm.dwg	Layout1	Figure No. 2

- SOIL & GROUNDWATER PROBE LOCATION
- SOIL PROBE LOCATION

#### SITE DIAGRAM TELOS PROPERTIES CLARE CENTRAL 1000 WEST ATKINSON AVENUE MILWAUKEE, WISCONSIN

Terracon mobilized to the subject site on July 20 and 21, 2006 to advance six soil borings (TCN-GP-1 through TCN-GP-6). Each push-probe boring was advanced to a depth of approximately 16 feet below ground surface (bgs) with the exception of boring TCN-GP-2, which was advanced to a depth of 19 feet bgs to facilitate collecting a groundwater sample. Each boring was advanced using a truck-mounted push-probe rig. Soil samples were collected continuously over the depth of each boring location using a 4-foot long, 2-inch diameter macro core barrel sampler. Each 4-foot length of sample was collected with a new disposable liner inserted within the sampler. Probing equipment was decontaminated between use at each probe location using a high pressure washer. The soil type and characteristics were logged and a discrete sample was collected at each approximate two foot interval. A Site Diagram depicting the location of the borings advanced at the site relative to site features is included as Figure 2 of Appendix A.
