March 3, 2021
File No. 25211374.50

Subject: Vapor Sample Results – 1738 Roth Street, Madison
Laundry Land Cleaners (former), Northgate Shopping Center
1131 N. Sherman Avenue, Madison, Wisconsin
WDNR BRRTS #02-13-552183

Figure 1
Sample Location

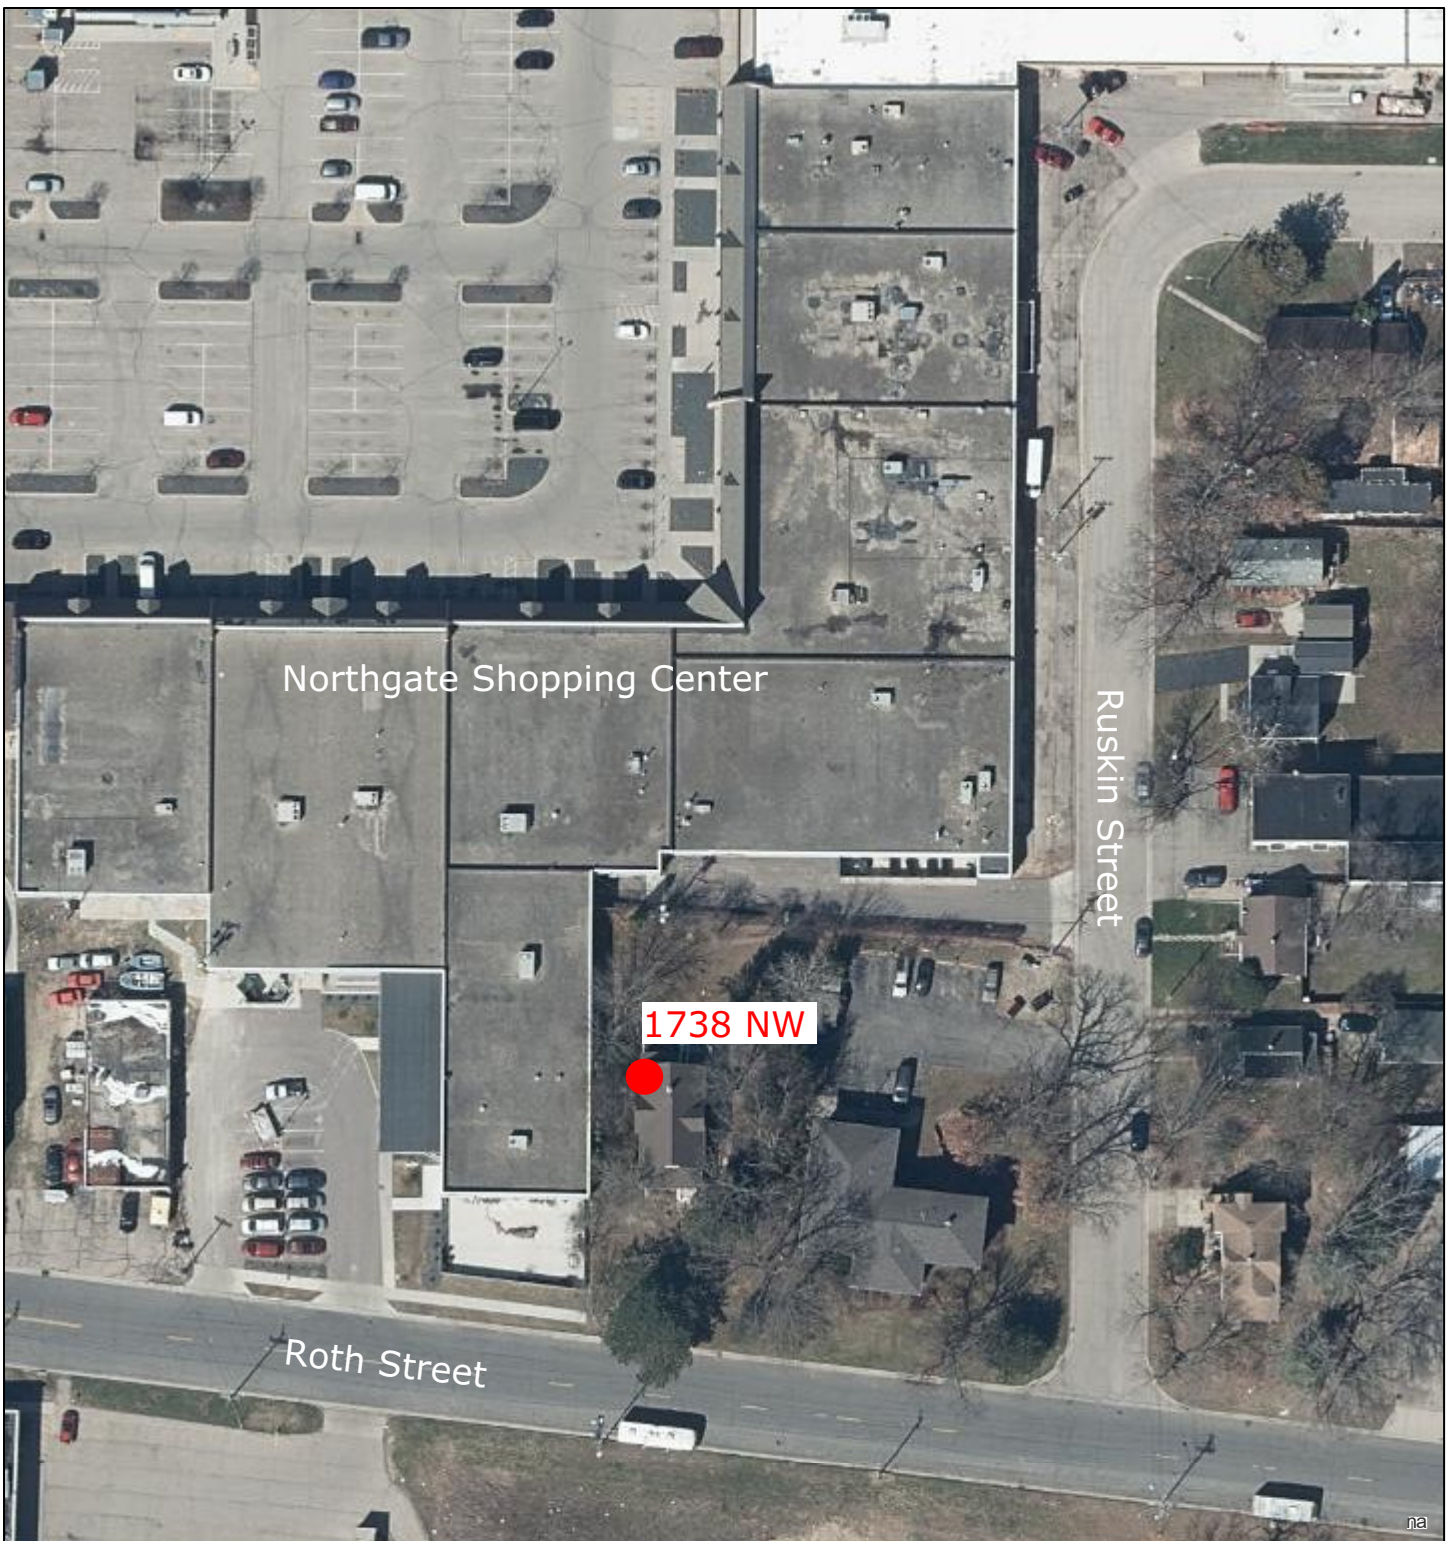
Figure 1 - Sample Location

On January 8, 2021, SCS installed and sampled a stainless steel Vapor Pin® (vapor pin). The vapor pin was installed through basement floor slab at the northwest corner of the building (**Figure 1**). The sample was collected consistent with WDNR RR-800 vapor sampling guidance and was submitted to Pace Analytical of Minneapolis, Minnesota, for analysis of tetrachloroethene (PCE), trichloroethene, cis-1,2-dichloroethene, trans-1,2-dichloroethene, and vinyl chloride via method TO-15. The laboratory report is provided in **Attachment A**.

● Sub-slab sample number and approximate sampling location at 1738 Roth Street.

PCE was the only constituent detected in the sample. The PCE concentration of 111 micrograms per cubic meter ($\mu\text{g}/\text{m}^3$) does not exceed the WDNR's residential sub-slab vapor risk screening level of $1,400 \mu\text{g}/\text{m}^3$.

Based on these findings there does not appear to be a vapor intrusion risk for the property at 1738 Roth Street. SCS proposes that no further vapor assessment be required for the property or the adjoining property to the east (1110 Ruskin Street).
