CORRESPONDENCE/MEMORANDUM

SUBJECT: Site Investigation Completeness Review –Additional SI Work Required

This property is a 3.9 acre lot zoned heavy industrial, located at 867 W. Valley Rd in the City of Menasha. At the time of this review the site has been cleared of buildings and foundations and is awaiting department review prior to redevelopment. Proposed redevelopment consists of the construction of self-storage units. The only identified contamination is a chlorinated solvent release that began investigation prior to the City taking acquisition and entering the VPLE program.

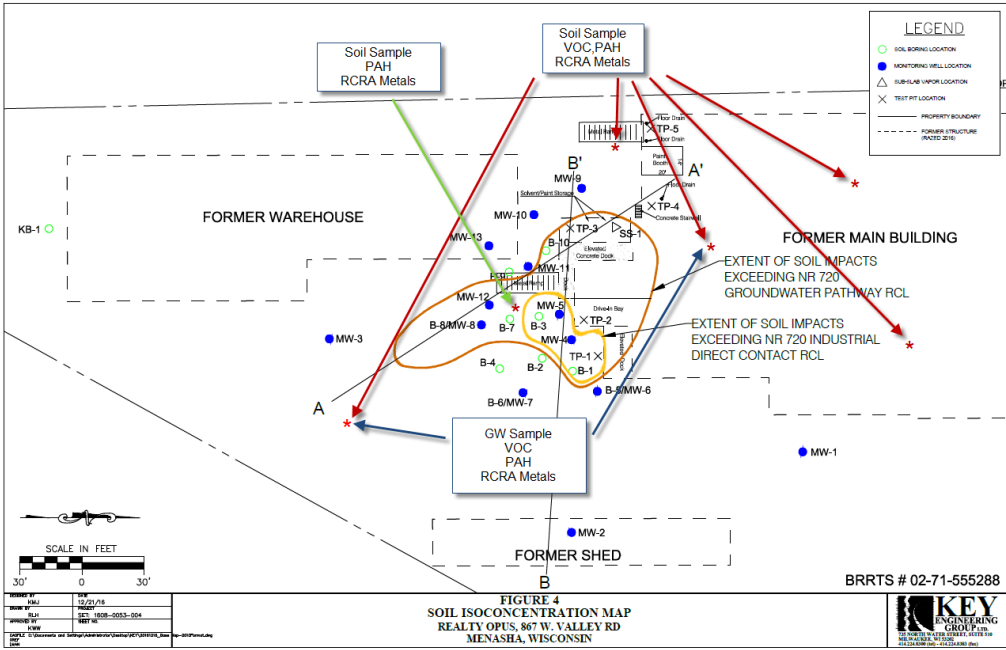
No confirmed source of soil contamination identified. Based on site history, chlorinated solvent and ethylbenzene observed is from historic site use, spills/dumping by the former loading dock. Four test pits were sampled post building demolition in potential source areas and to define extent of soil contamination. 2 soil borings were performed in other areas of the property after demo.

NI-DC – TCE @ B-1 and Ethylbenzene @ B-3 exceed NI-DC (ethylbenzene not observed over PAL in GW)

S-GW – Chlorinated solvent – B-1, B-3, B-7, B-8, MW-4, MW-12 and TP-1 (0.125mg/kg highest level PCE observed)

- Site Investigation should be tracked as “not approved”
- Request additional soil sampling for VOC, PAH, RCRA Metals in 5 locations identified on Figure 4 attached.

- Request additional soil sampling for PAH and RCRA Metals in 1 location identified on Figure 4.
- Collect groundwater samples for VOC, PAH and RCRA Metals in 2 of the soil sample locations as identified on Figure 4.

- Soil samples should be taken from 2-4 foot bgs interval. Deeper soil samples are not needed due to shallow water table.
- VI system is not warranted in the area of residual soil and groundwater contamination; however, a vapor barrier should be installed under any future building. This determination is solely for the proposed self-storage warehouse plan. If redevelopment proposal changes the VI pathway will need to be re-evaluated prior to development.
