**Re: Sample Results Notification - Groundwater:  
Suggar Property  
3301 – 60<sup>th</sup> St.  
Kenosha, WI 53144  
PECFA# 53144-4143-05  
BRRTS# 03-30-004964  
FID# 230156410**

FIGURE 4  
MONITORING  
WELL LOCATIONS

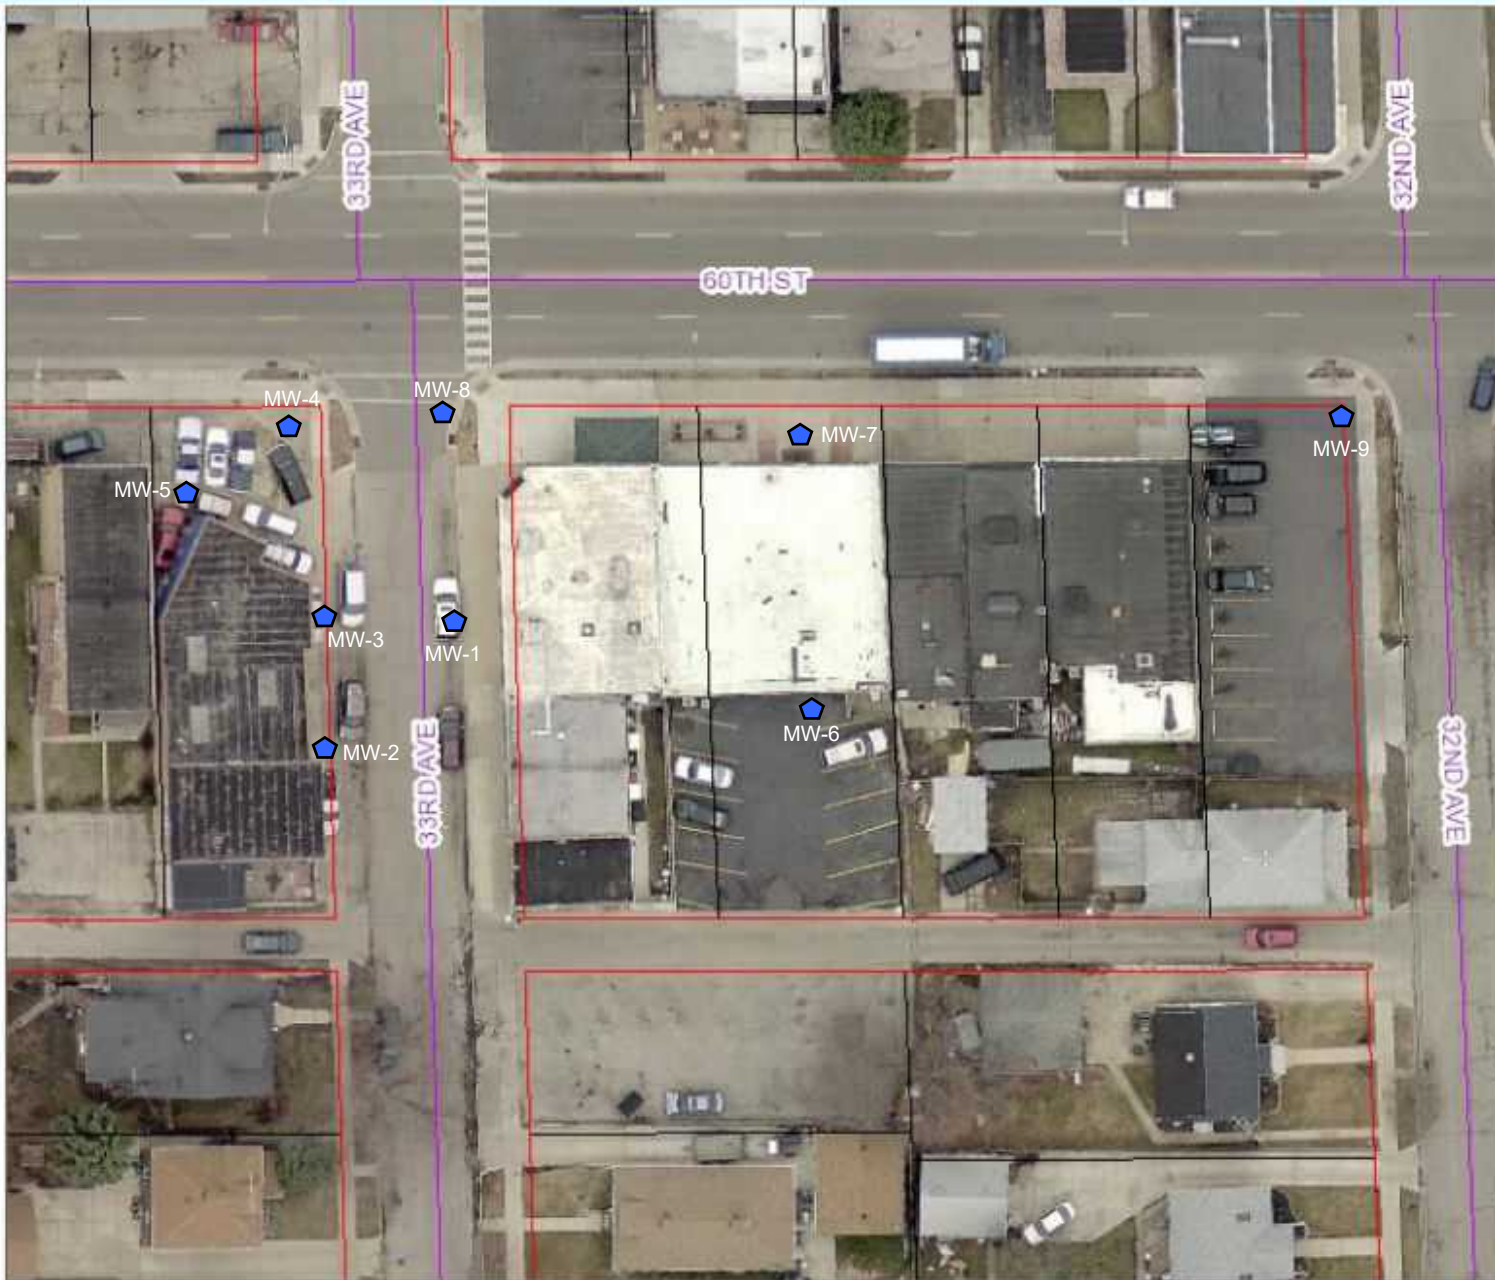
◆ = MONITORING WELL

The following Sample Results Notification is being provided as required by Wisconsin Administrative Code (WAC) Chapter NR 716.14(2). On January 22, 2020, a groundwater sample was collected from groundwater monitoring well for the Suggar Property site, MW-9 located on property owned by Westtown LLC at 3213 – 60<sup>th</sup> Street in Kenosha, WI. The sampling was conducted to further characterize the degree and extent of petroleum groundwater contamination exceeding applicable standards that is associated with leaking underground storage tanks at the site. The sampling location is depicted on the attached figure.
