Re: PFAs Additional Evaluation Work Plan BRRTS #: 02-41-576336 & 02-41-579429 FID #: 241828620 Sunrise Shopping Center 2410-2424 10<sup>th</sup> Avenue & 1009 Marquette Avenue

# ATTACHMENT 1 PFAS ADDITIONAL SAMPLING WORK PLAN

#### PFAS GROUNDWATER SAMPLING WORK PLAN

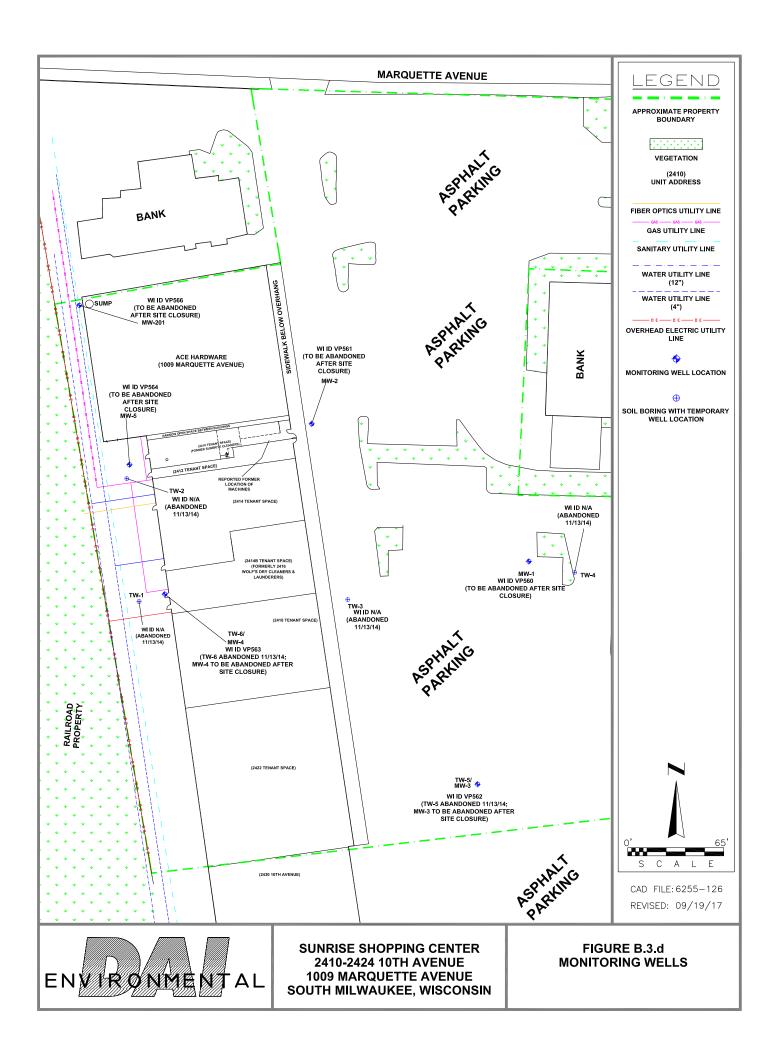
ATTACHMENT 2 FIGURE

Based upon the observation of various PFAS constituents in the groundwater sampling, including certain constituents at concentrations above the recommended (but not yet formally approved) Preventative Action Limits (PALs) and Enforcement Standards, WDNR has requested that all available monitoring wells on-site be sampled. Therefore, samples will be collected from six (6) existing monitoring wells: MW-1 to MW-5 and MW-201. This additional sampling will include the resampling of MW-3 and MW-5 for comparison to previous sampling results. No additional sampling for 1,4-Dioxane or n-Nonane are planned based upon the lack of any observed concentrations. Figure B.3.d in Attachment 2 shows the locations of the six (6) monitoring wells.
