Site Name: Bader Philanthropies Headquarters
 Address: 3300-3318 N. MLK Drive & 3317-3333 N. 4th Street
Milwaukee, WI 53212
 FID# 341285010 / 34128512C
 BRRTS # 02-41-578975 / 02-41-578976 / 02-41-578977

Subject: NR 718.12 Contaminated Soil Management Request

Bader Philanthropies Headquarters - 3300, 3306, 3314 and 3318 N. Martin Luther King Jr. Drive & 3317, 3323 and 3333 N. 4th Street, Milwaukee, WI 53212
BRRTS #02-41-578975 / FID #341285010: 3318 N. MLK Jr. Drive
BRRTS #02-41-578976 / FID #341285120: 3314 N. MLK Jr. Drive
BRRTS #02-41-578977 / FID #341285230: 3300 N. MLK Jr. Drive

Former Lakefield Sand and Gravel Property
7003 W. Good Hope Road, Milwaukee, WI 53223
BRRTS #02-41-548828 / FID #241377070

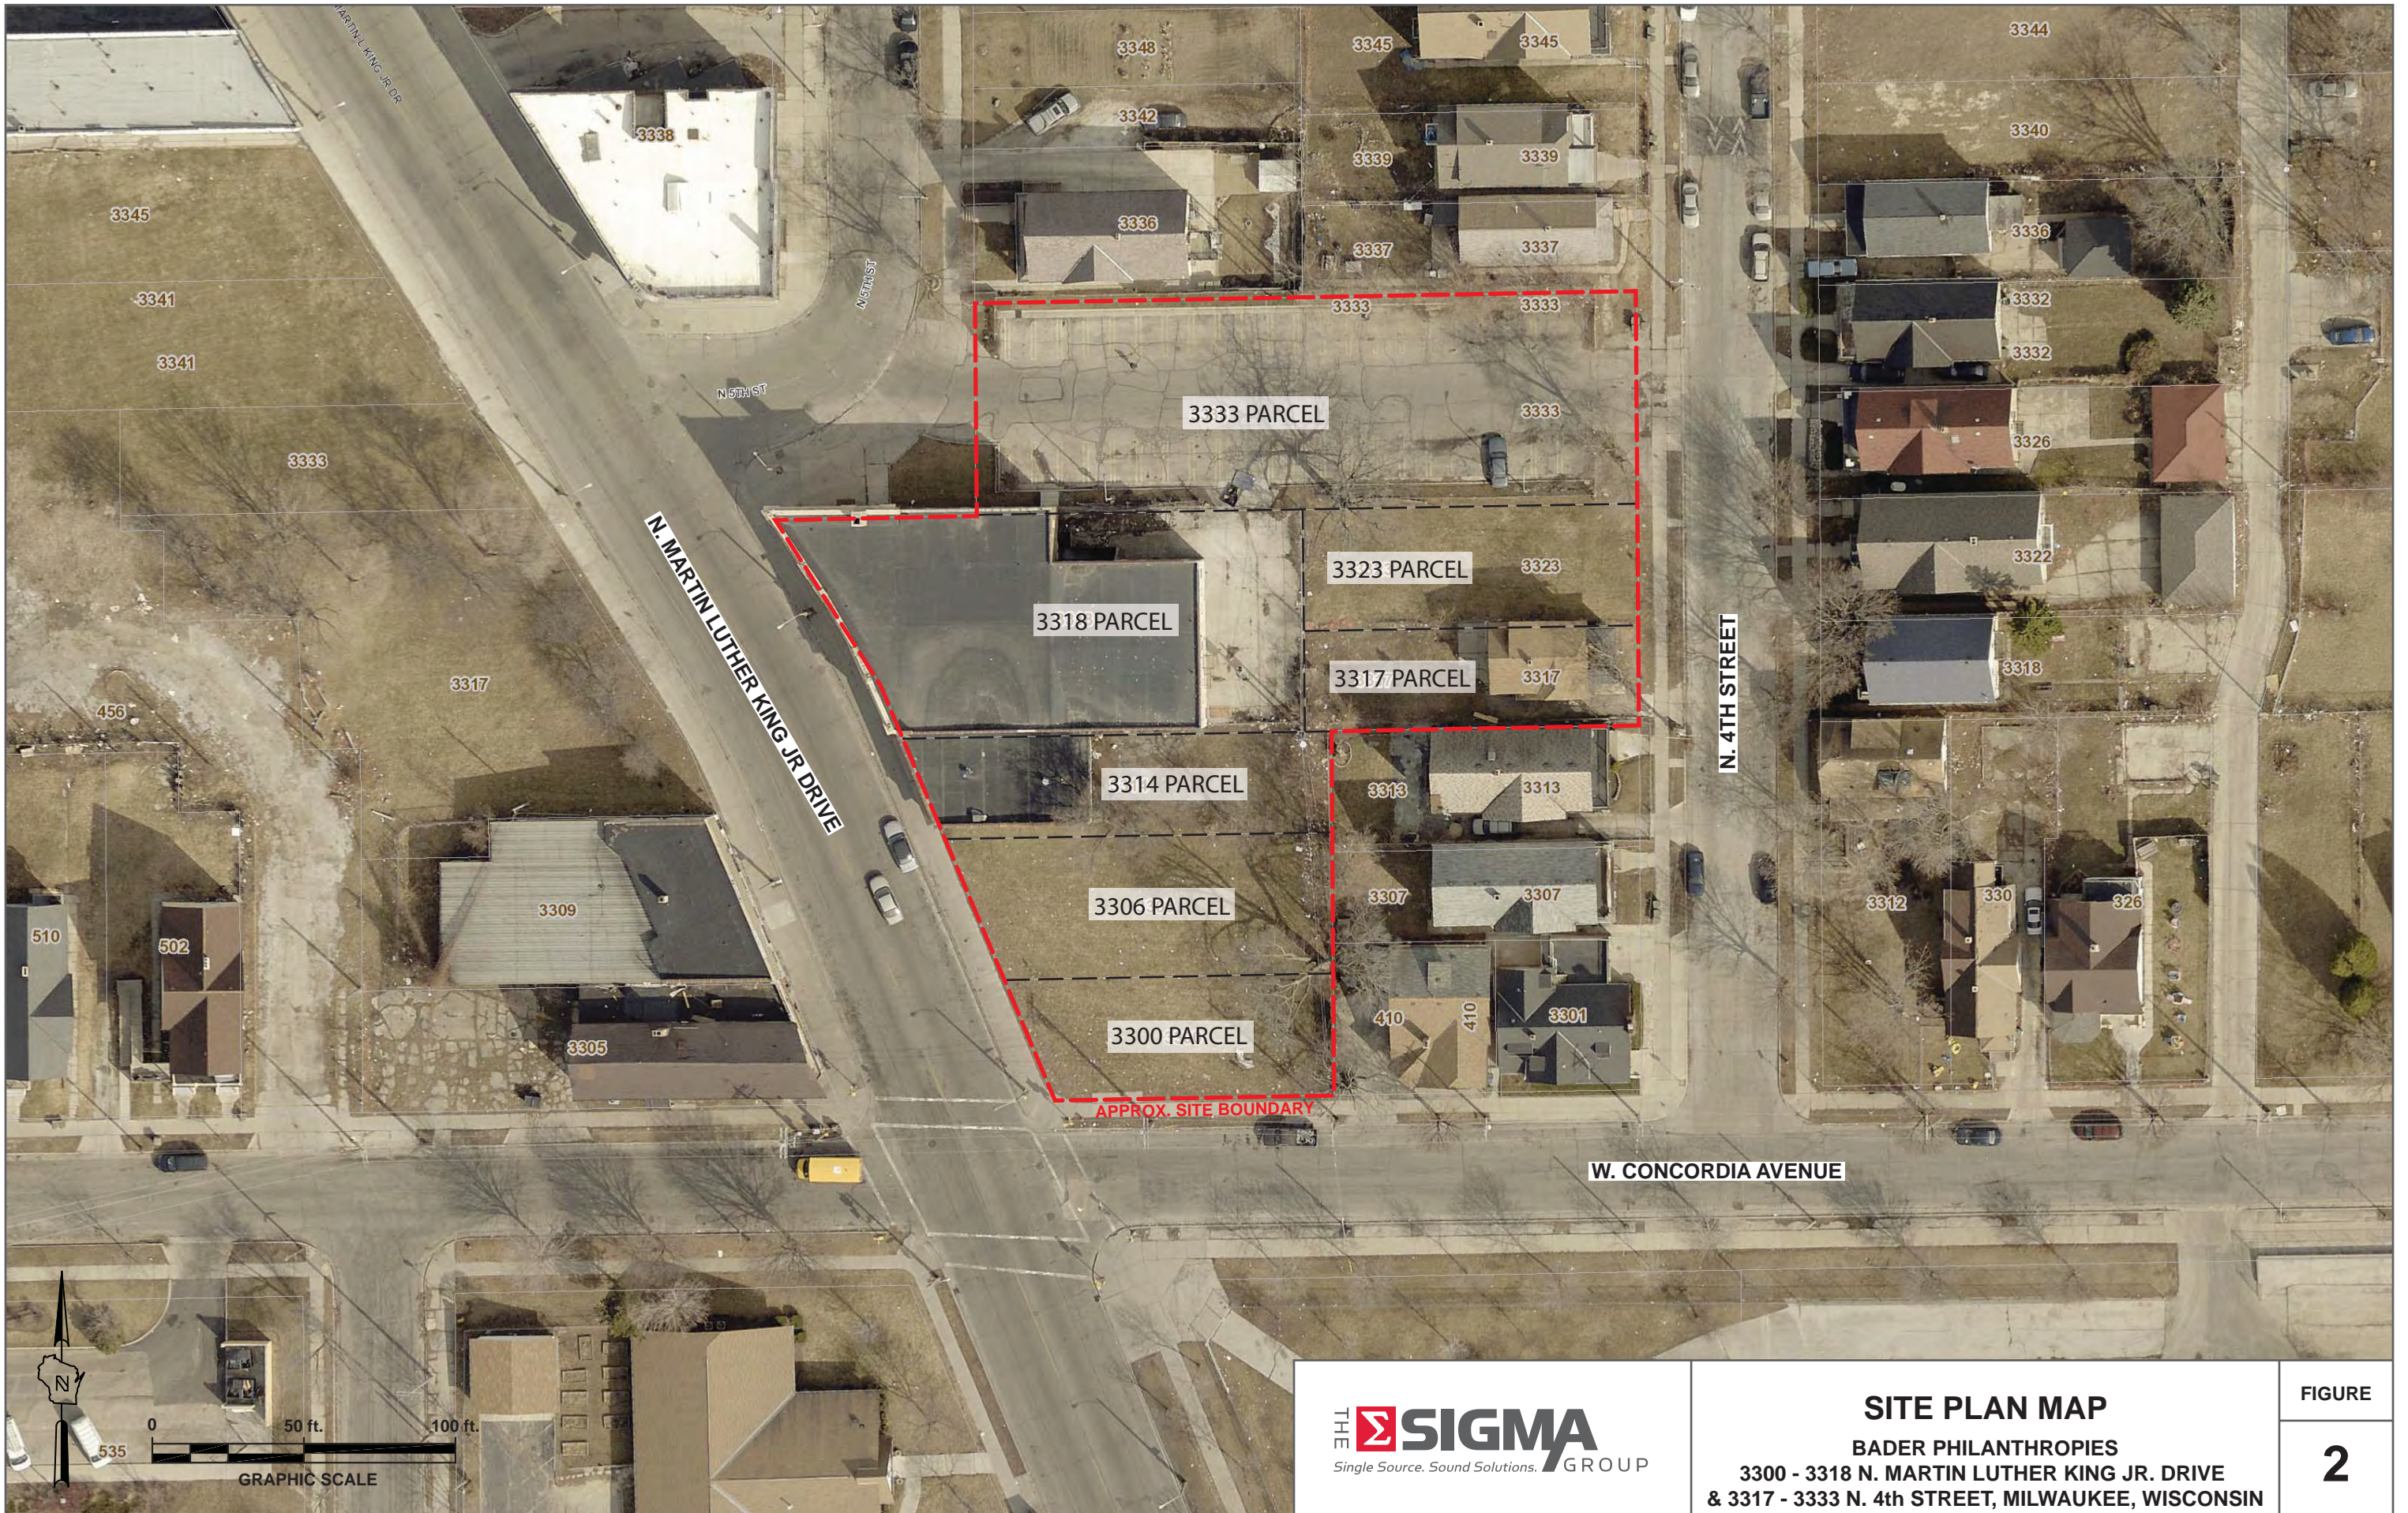
FIGURE
2

SITE PLAN MAP
BADER PHILANTHROPIES
3300 - 3318 N. MARTIN LUTHER KING JR. DRIVE
& 3317 - 3333 N. 4th STREET, MILWAUKEE, WISCONSIN

Background. A draft Phase I Environmental Site Assessment (ESA)² was completed in July 2016 for the Source Property. Historical uses of the Source Property included (refer to **Figure 2** for parcel address):
