From: Denice Nelson <denice.karen.nelson@jci.com>
Sent: Friday, May 3, 2024 4:00 PM
To: Sellwood, Alyssa A - DNR
Cc: May, Wesley; TerBeek, Emma
Subject: Re: Tyco GETS Material Management Plan - Request for Approval for Soil Reuse- WDNR BRRS Number 02-38-580694
Attachments: Figure 1.pdf; Attachment 1_Photolog.pdf

Figure 1
Materials Management Locations

ATTACHMENT 1 SOIL STOCKPILE PHOTOGRAPH LOG

Material Management Plan (MMP) Activities, GETS Optimization,
Marinette, Wisconsin

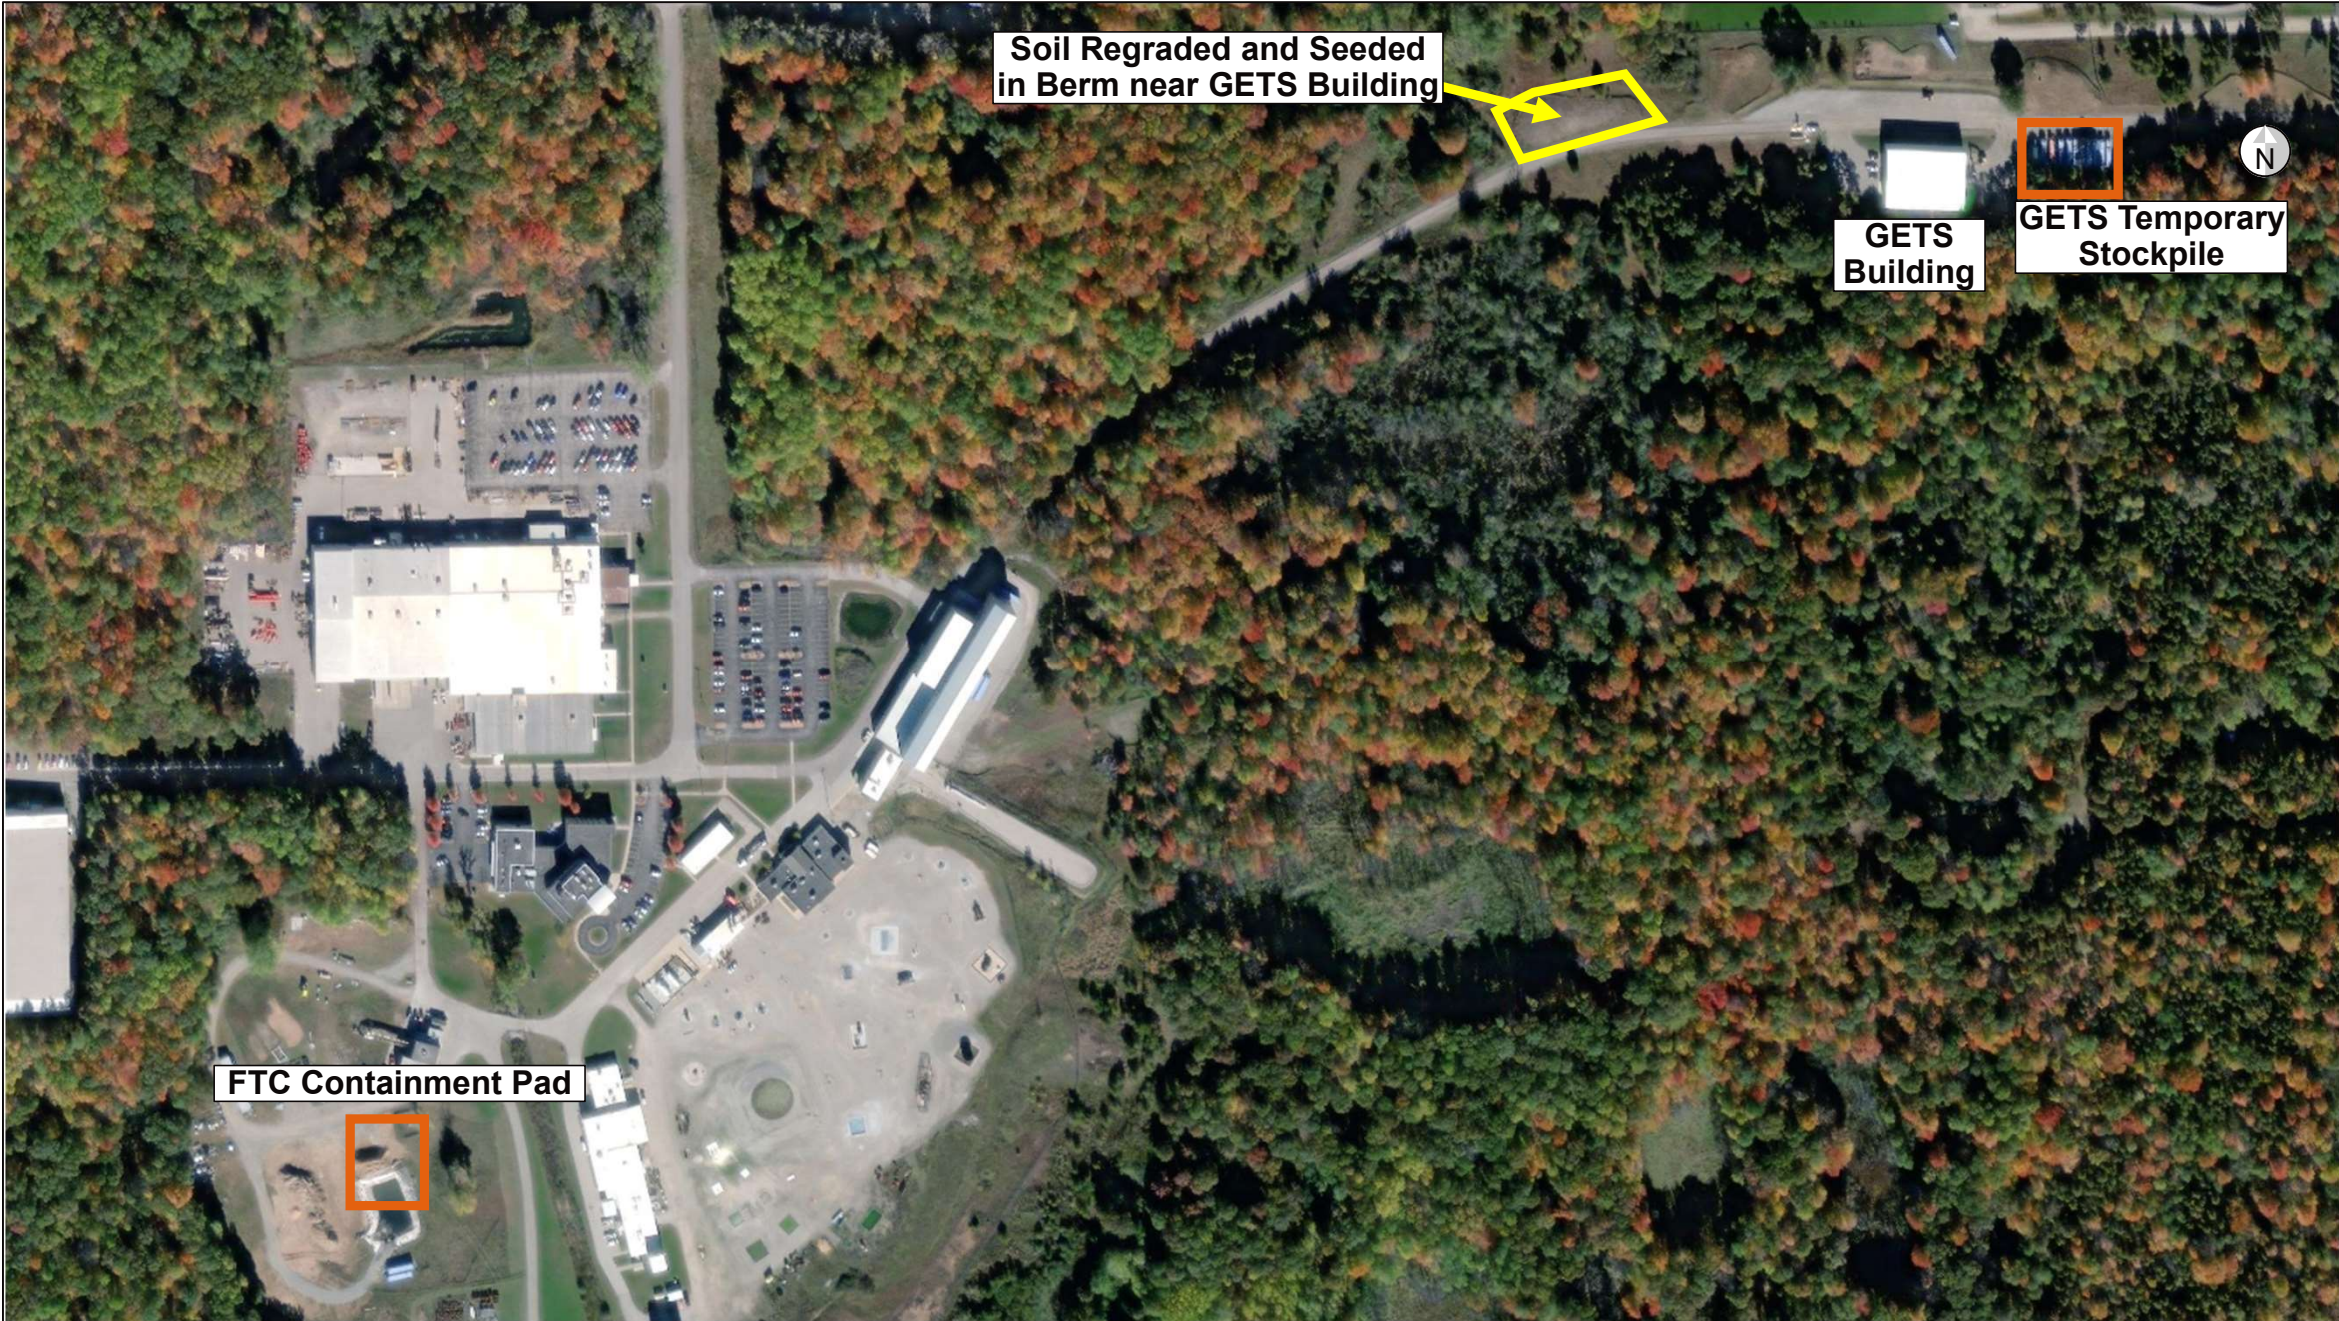
A photolog of the above activities as included as Attachment 1. The locations of the soil stockpiles are shown on Figure 1. Approximately 160 cubic yards were stockpiled between the two areas. The stockpiled soil at the FTC Containment Pad and the GETS Temporary Stockpile Area were removed on March 14 and 15, 2024, and placed northwest of the GETS building (Attachment 1). The area used for temporary stockpiling near the GETS Building was restored to previous conditions. Aerial site photos of the restored GETS Building area are also included in Attachment 1.

GETS Optimization, Marinette, Wisconsin

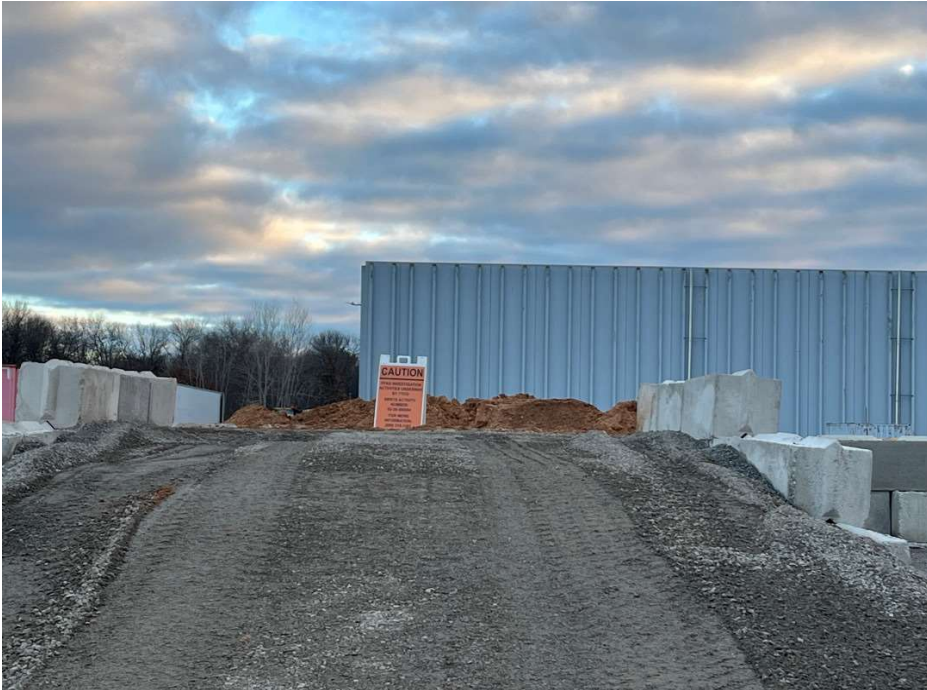
Photo: 1

Sign placed in front of GETS soil in the containment pad at the FTC. Soil is from directional drilling work and sampled today for analysis for clean fill. (GETSWC_1_02012024).

Containment pad at FTC

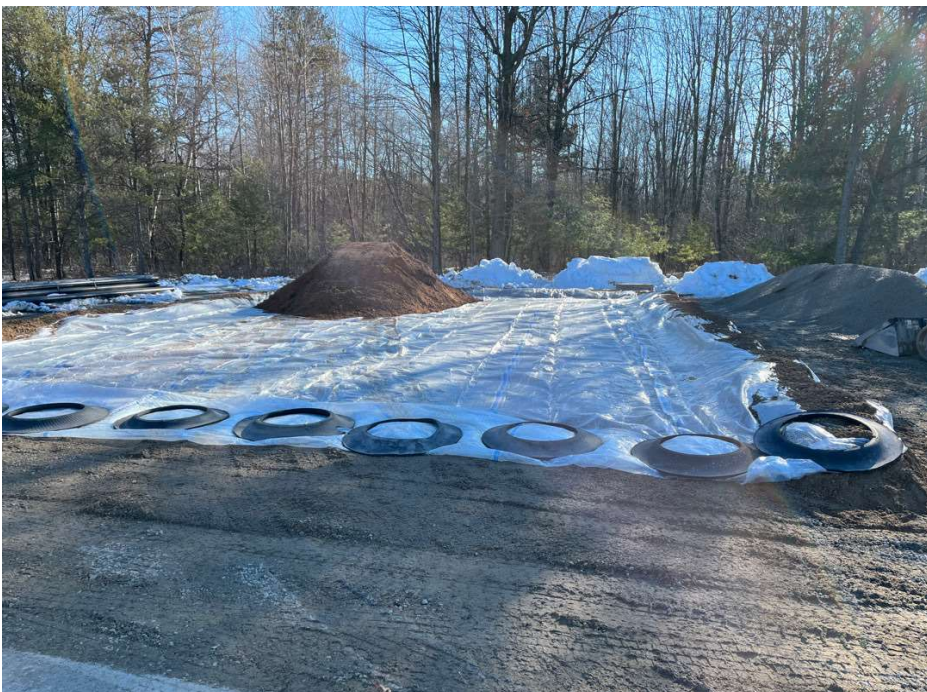
Photo: 2

Soil containment pad from soil removed from EX-1S excavated vault. Containment pad is 20 ft wide x 25 ft long.

East of GETS building

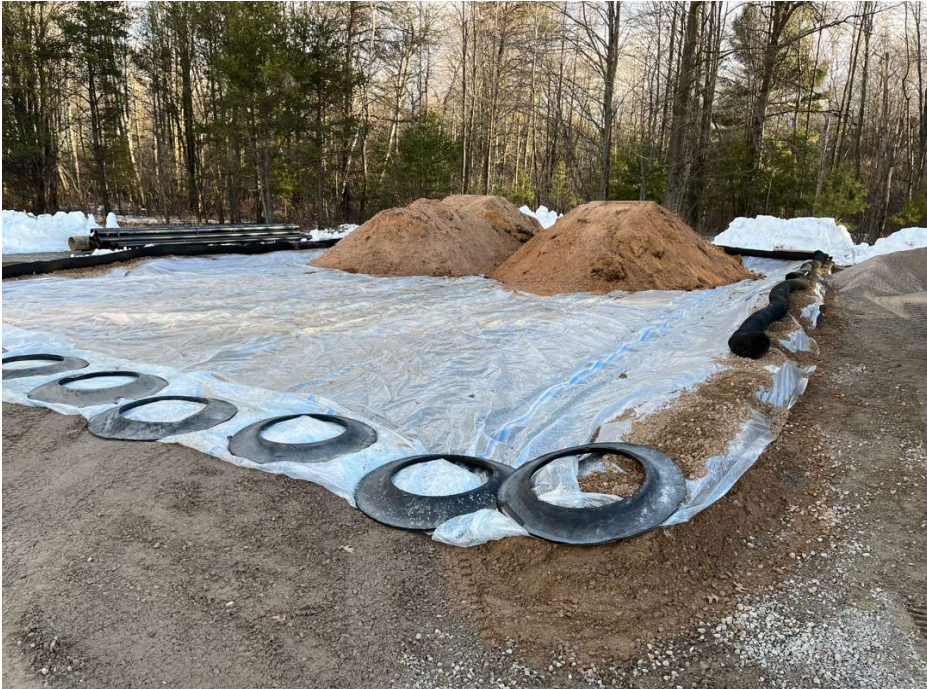
Photo: 3

GETS soil containment pad.
Soil from EX-1S and part of
North Receiving Pit.
Soil sampled for analysis today
(GETSWC_2_02012024).

GETS containment pad east of
building

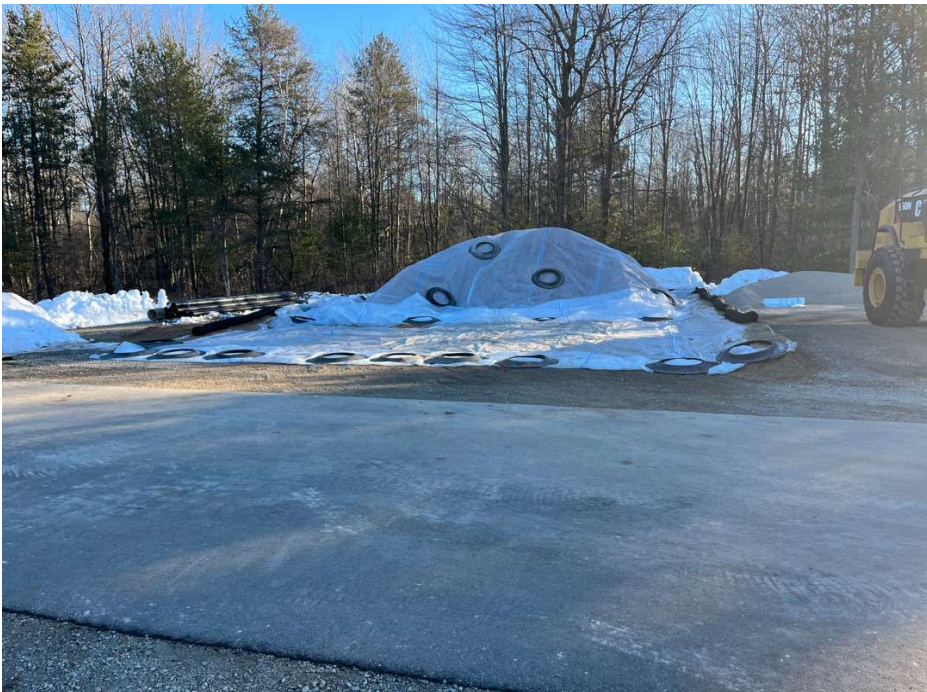
Photo: 4

Soil stockpile covered with tarp
while awaiting analysis of soil
samples.

GETS stockpile

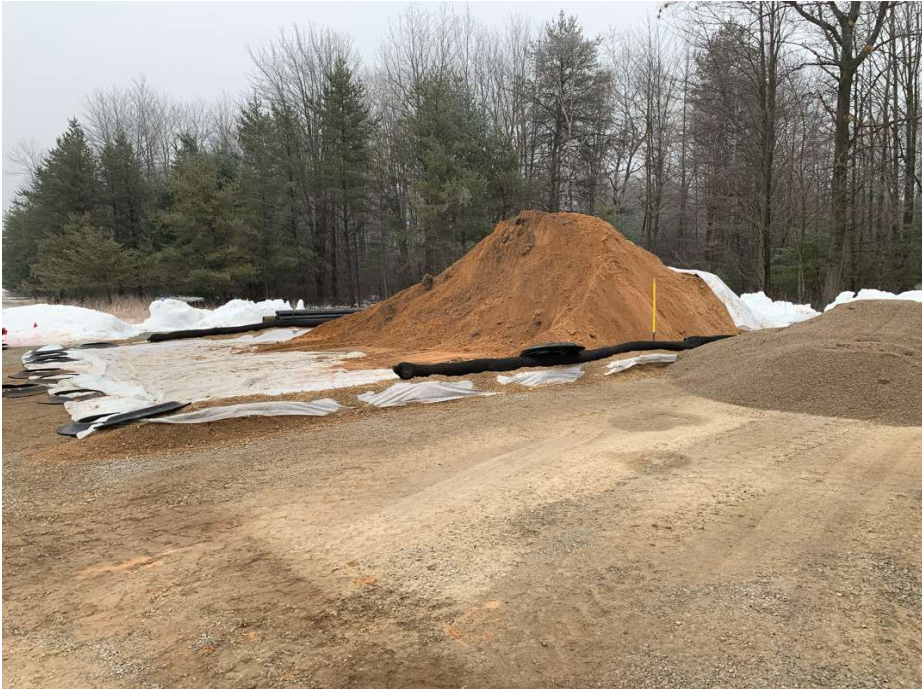
Photo: 5

Stockpile at the end of the day from EX-2S excavated vault and receiving pit.

Soil stockpile east of GETS building

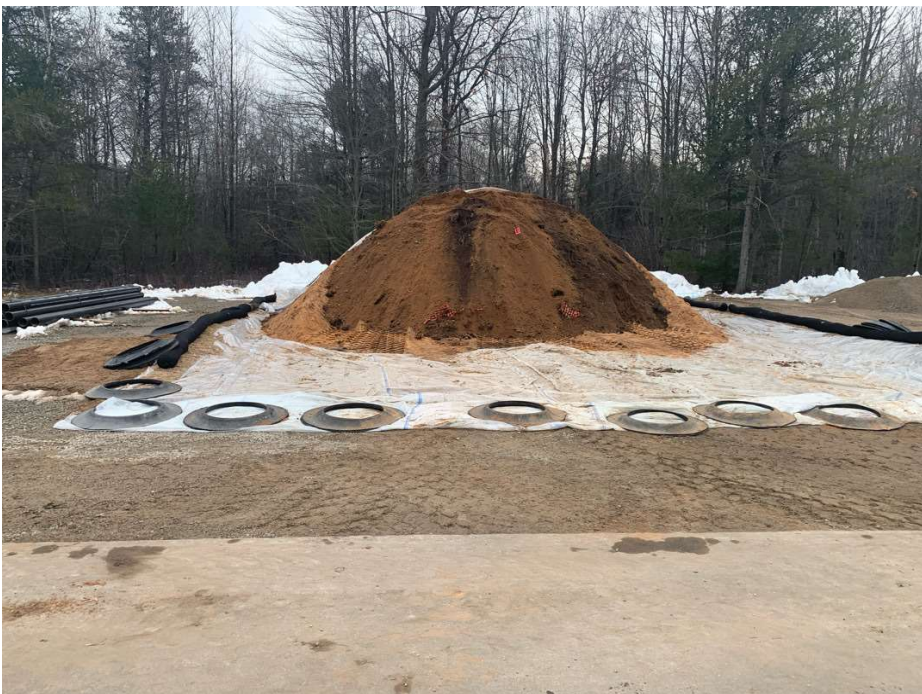
Photo: 6

Soil added to soil pile from trenching of conduit at both EX-1S and EX-2S. Final soil stockpile.

Soil stockpile east of GETS building

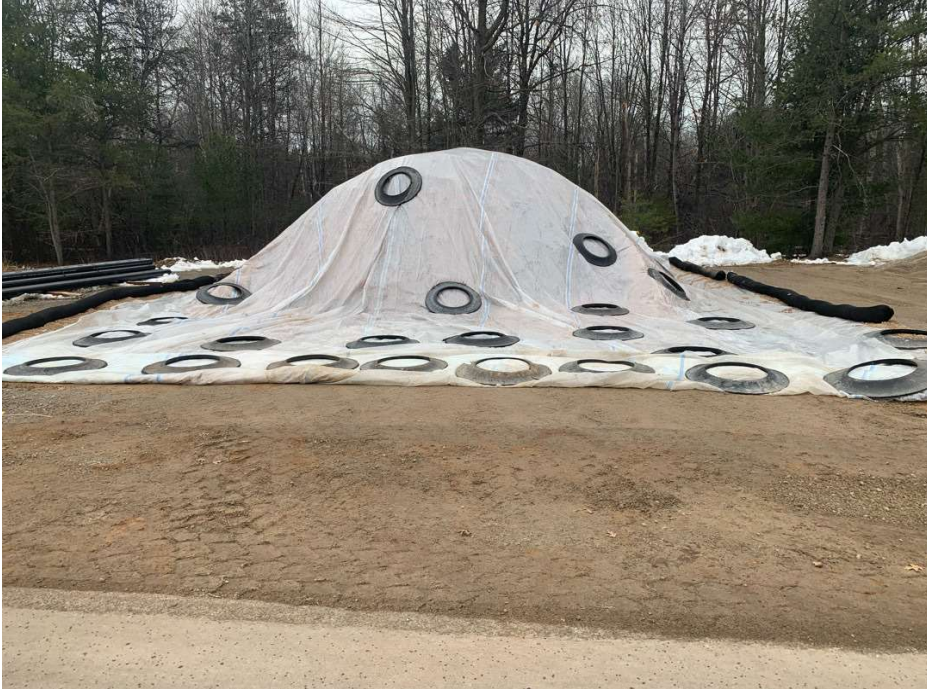
Photo: 7

Covered soil pile prior to demobilization; soil pending analysis.

Soil pile

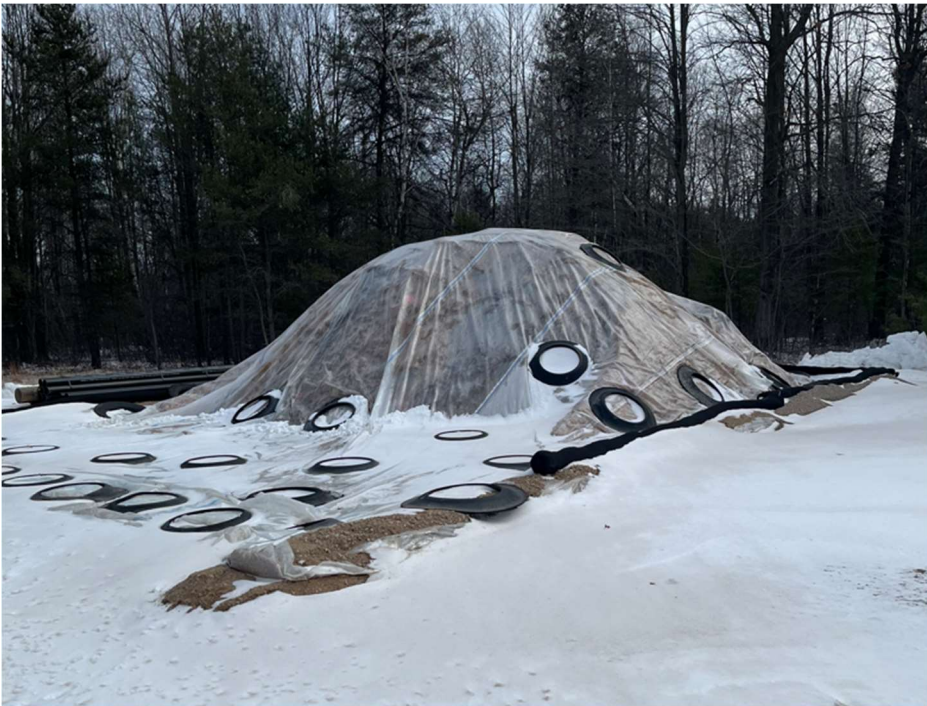
Photo: 8

Covered soil pile east of the GETS building awaiting regrading in the spring. Cover maintained throughout the winter.

Soil pile east of GETS building

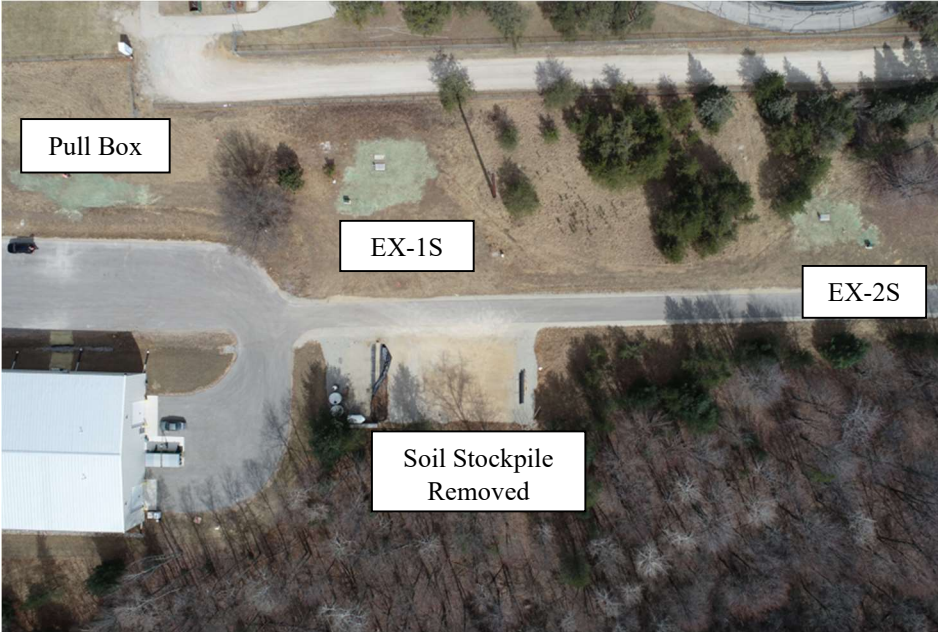
Photo: 9

Drone photo showing the soil stockpile has been removed, restored, and regraded at the site, north of the GETS building.

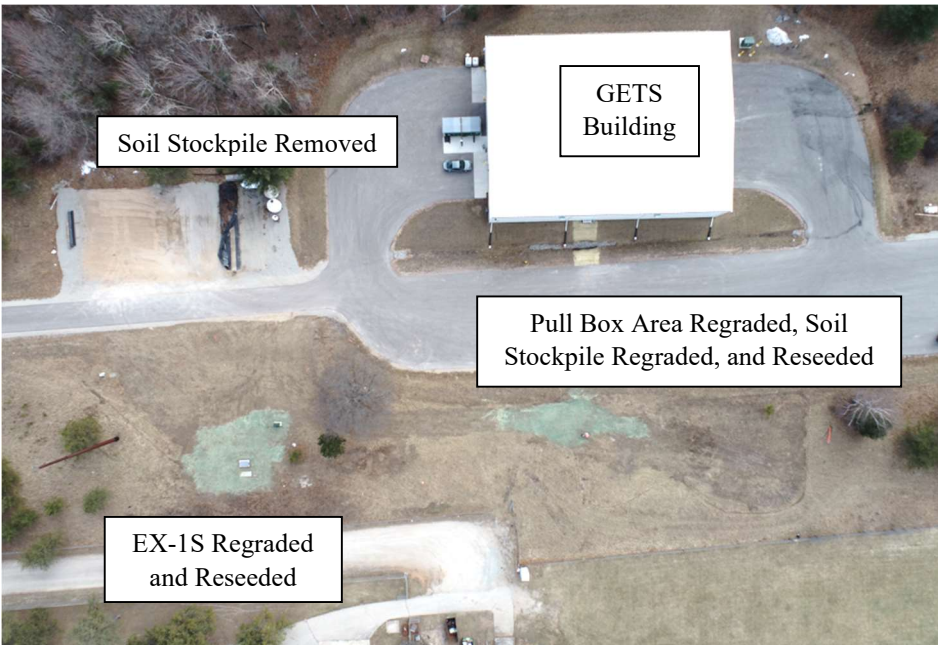
Photo: 10

Drone photo showing the soil stockpile has been removed, restored, and regraded at the site, north of the GETS building.
