# Memorandum

**Subject: Summary of Perimeter Air Monitoring Results: May 22, 2018 – Between 00:00 and 23:59**

HUSKY ENERGY – SUPERIOR REFINERY FIRE  
 SUPERIOR, WISCONSIN

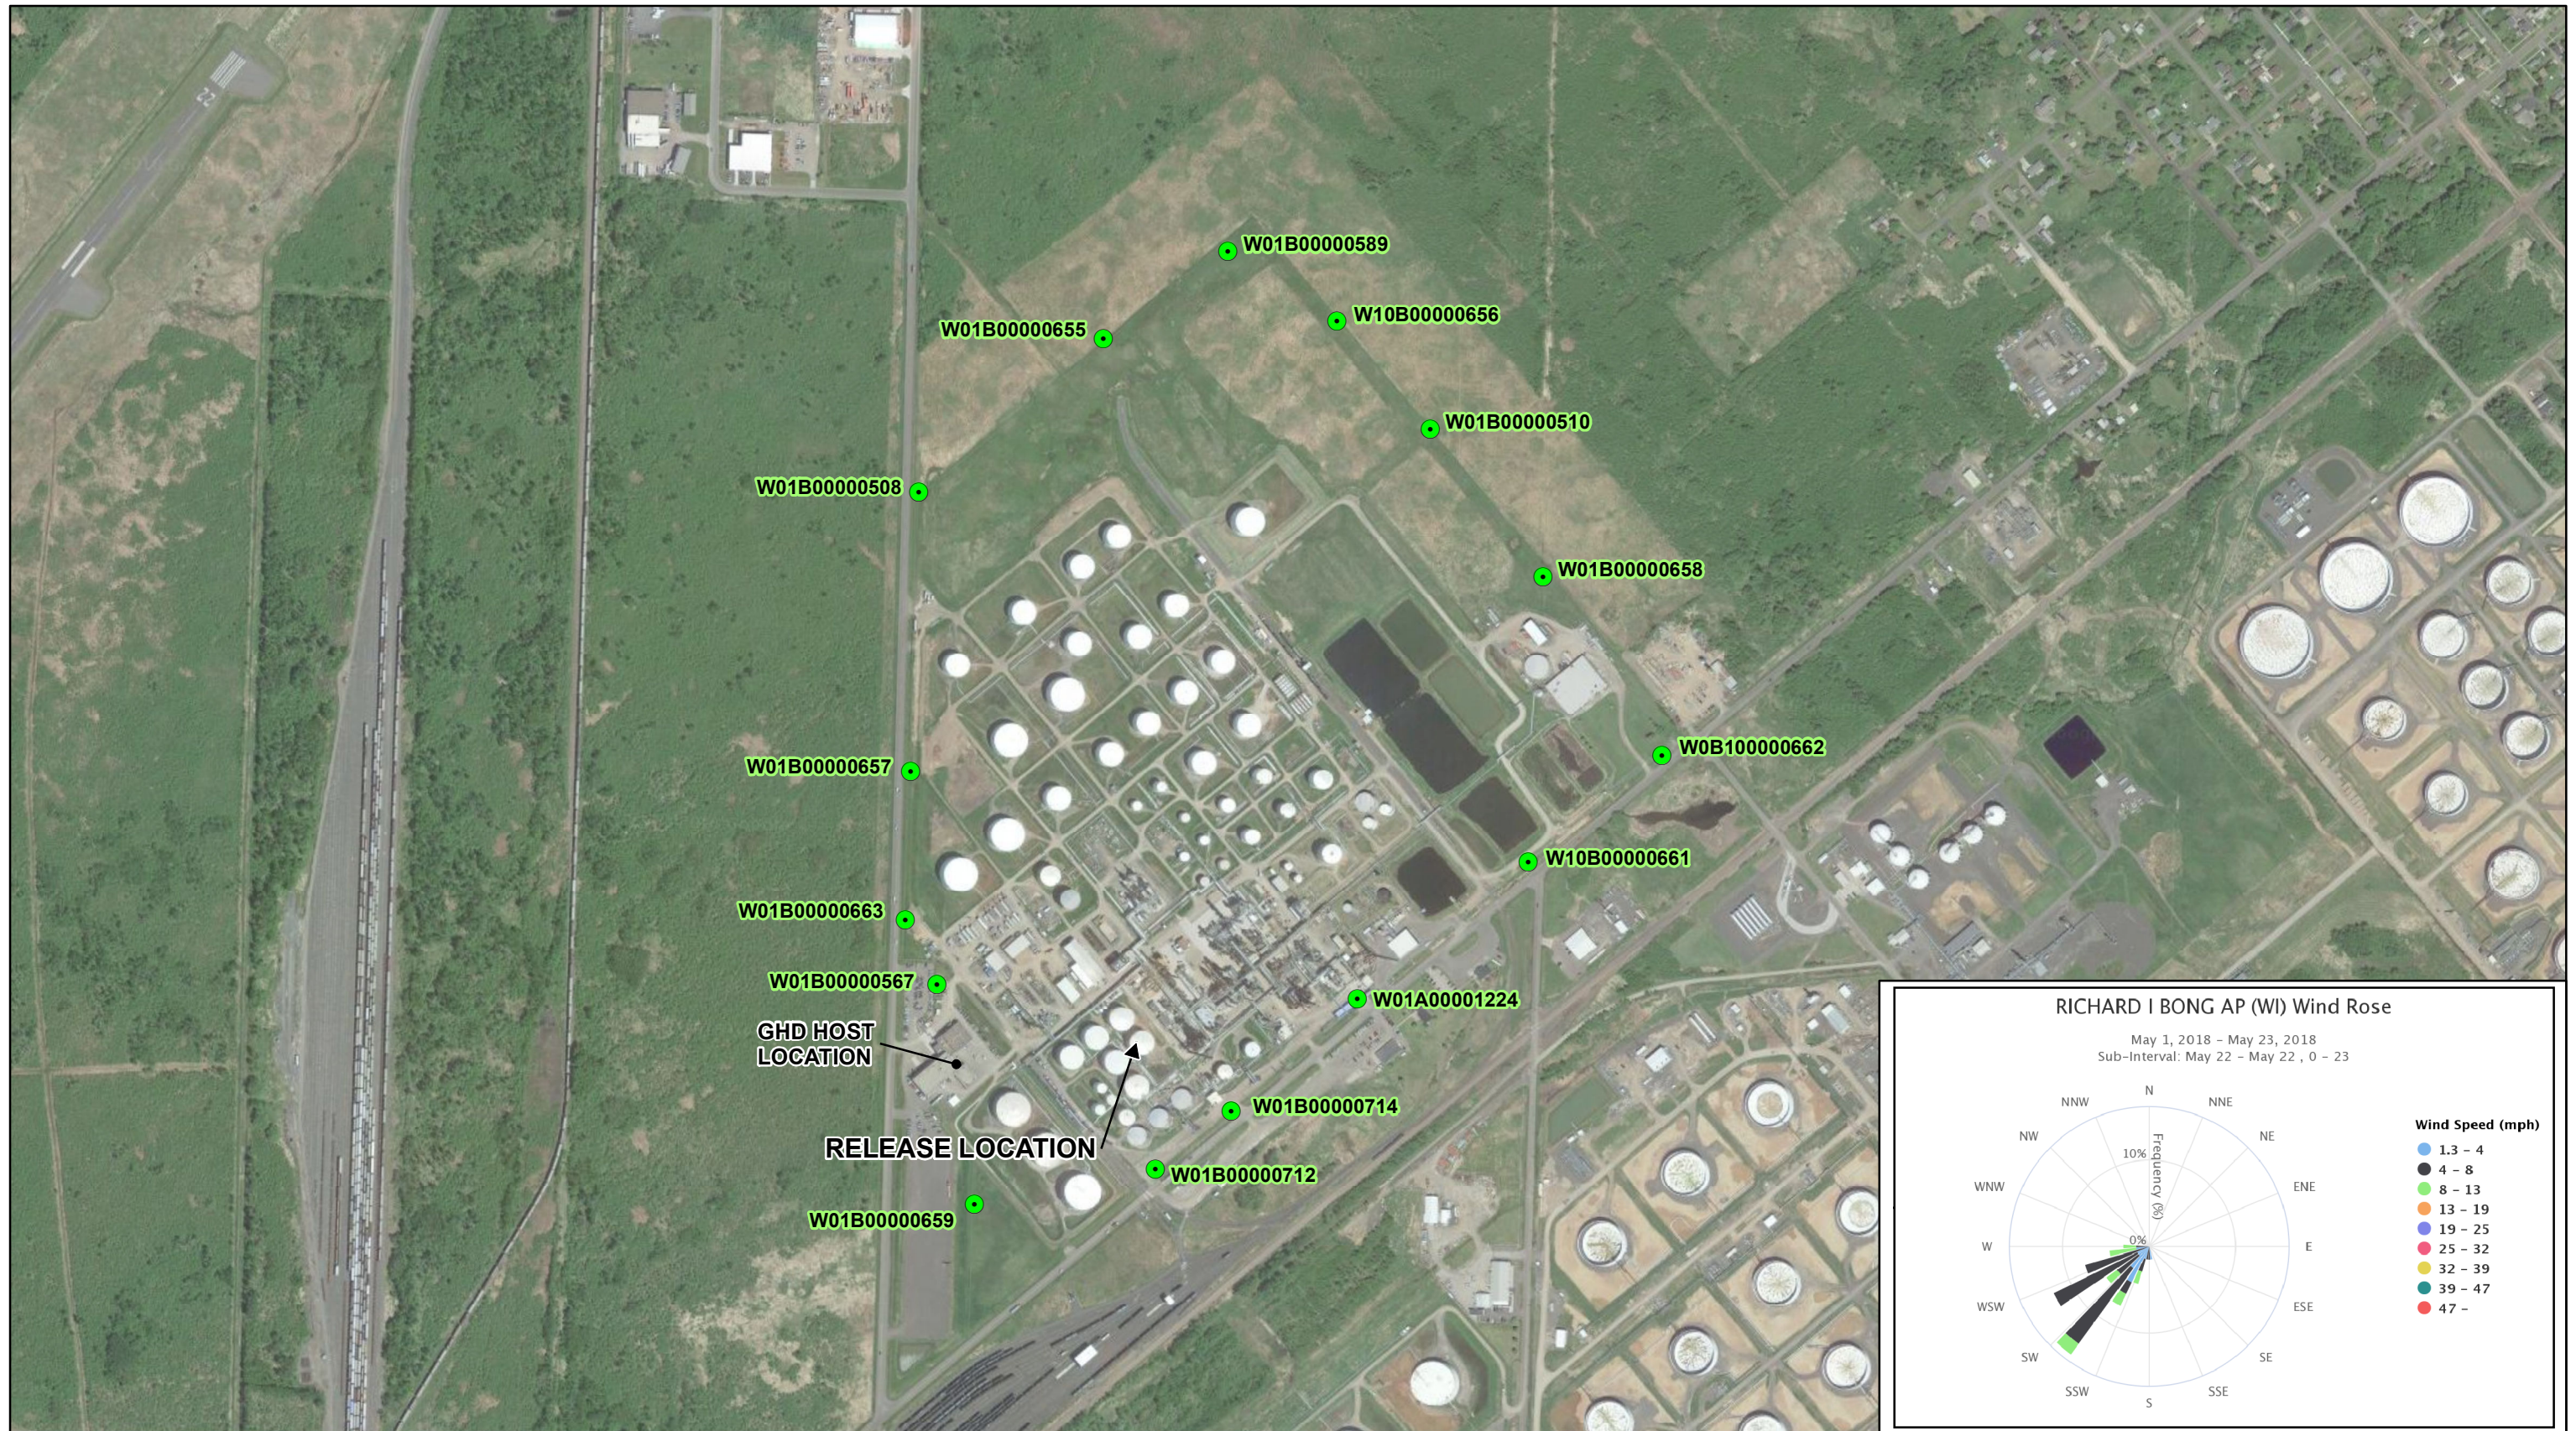
**FIGURE 1**

Perimeter monitoring locations and status with respect to community action levels over the period of May 22, 2018 between 00:00 and 23:59 are presented on Figure 1.

**SUMMARY OF PERIMETER ZONE AIR MONITORING RESULTS  
 MAY 22, 2018 - 00:00 TO 23:59**
