Memorandum

Subject: Summary of Perimeter Air Monitoring Results: June 2, 2018 – Between 00:00 and 23:59

HUSKY ENERGY – SUPERIOR REFINERY FIRE
 SUPERIOR, WISCONSIN

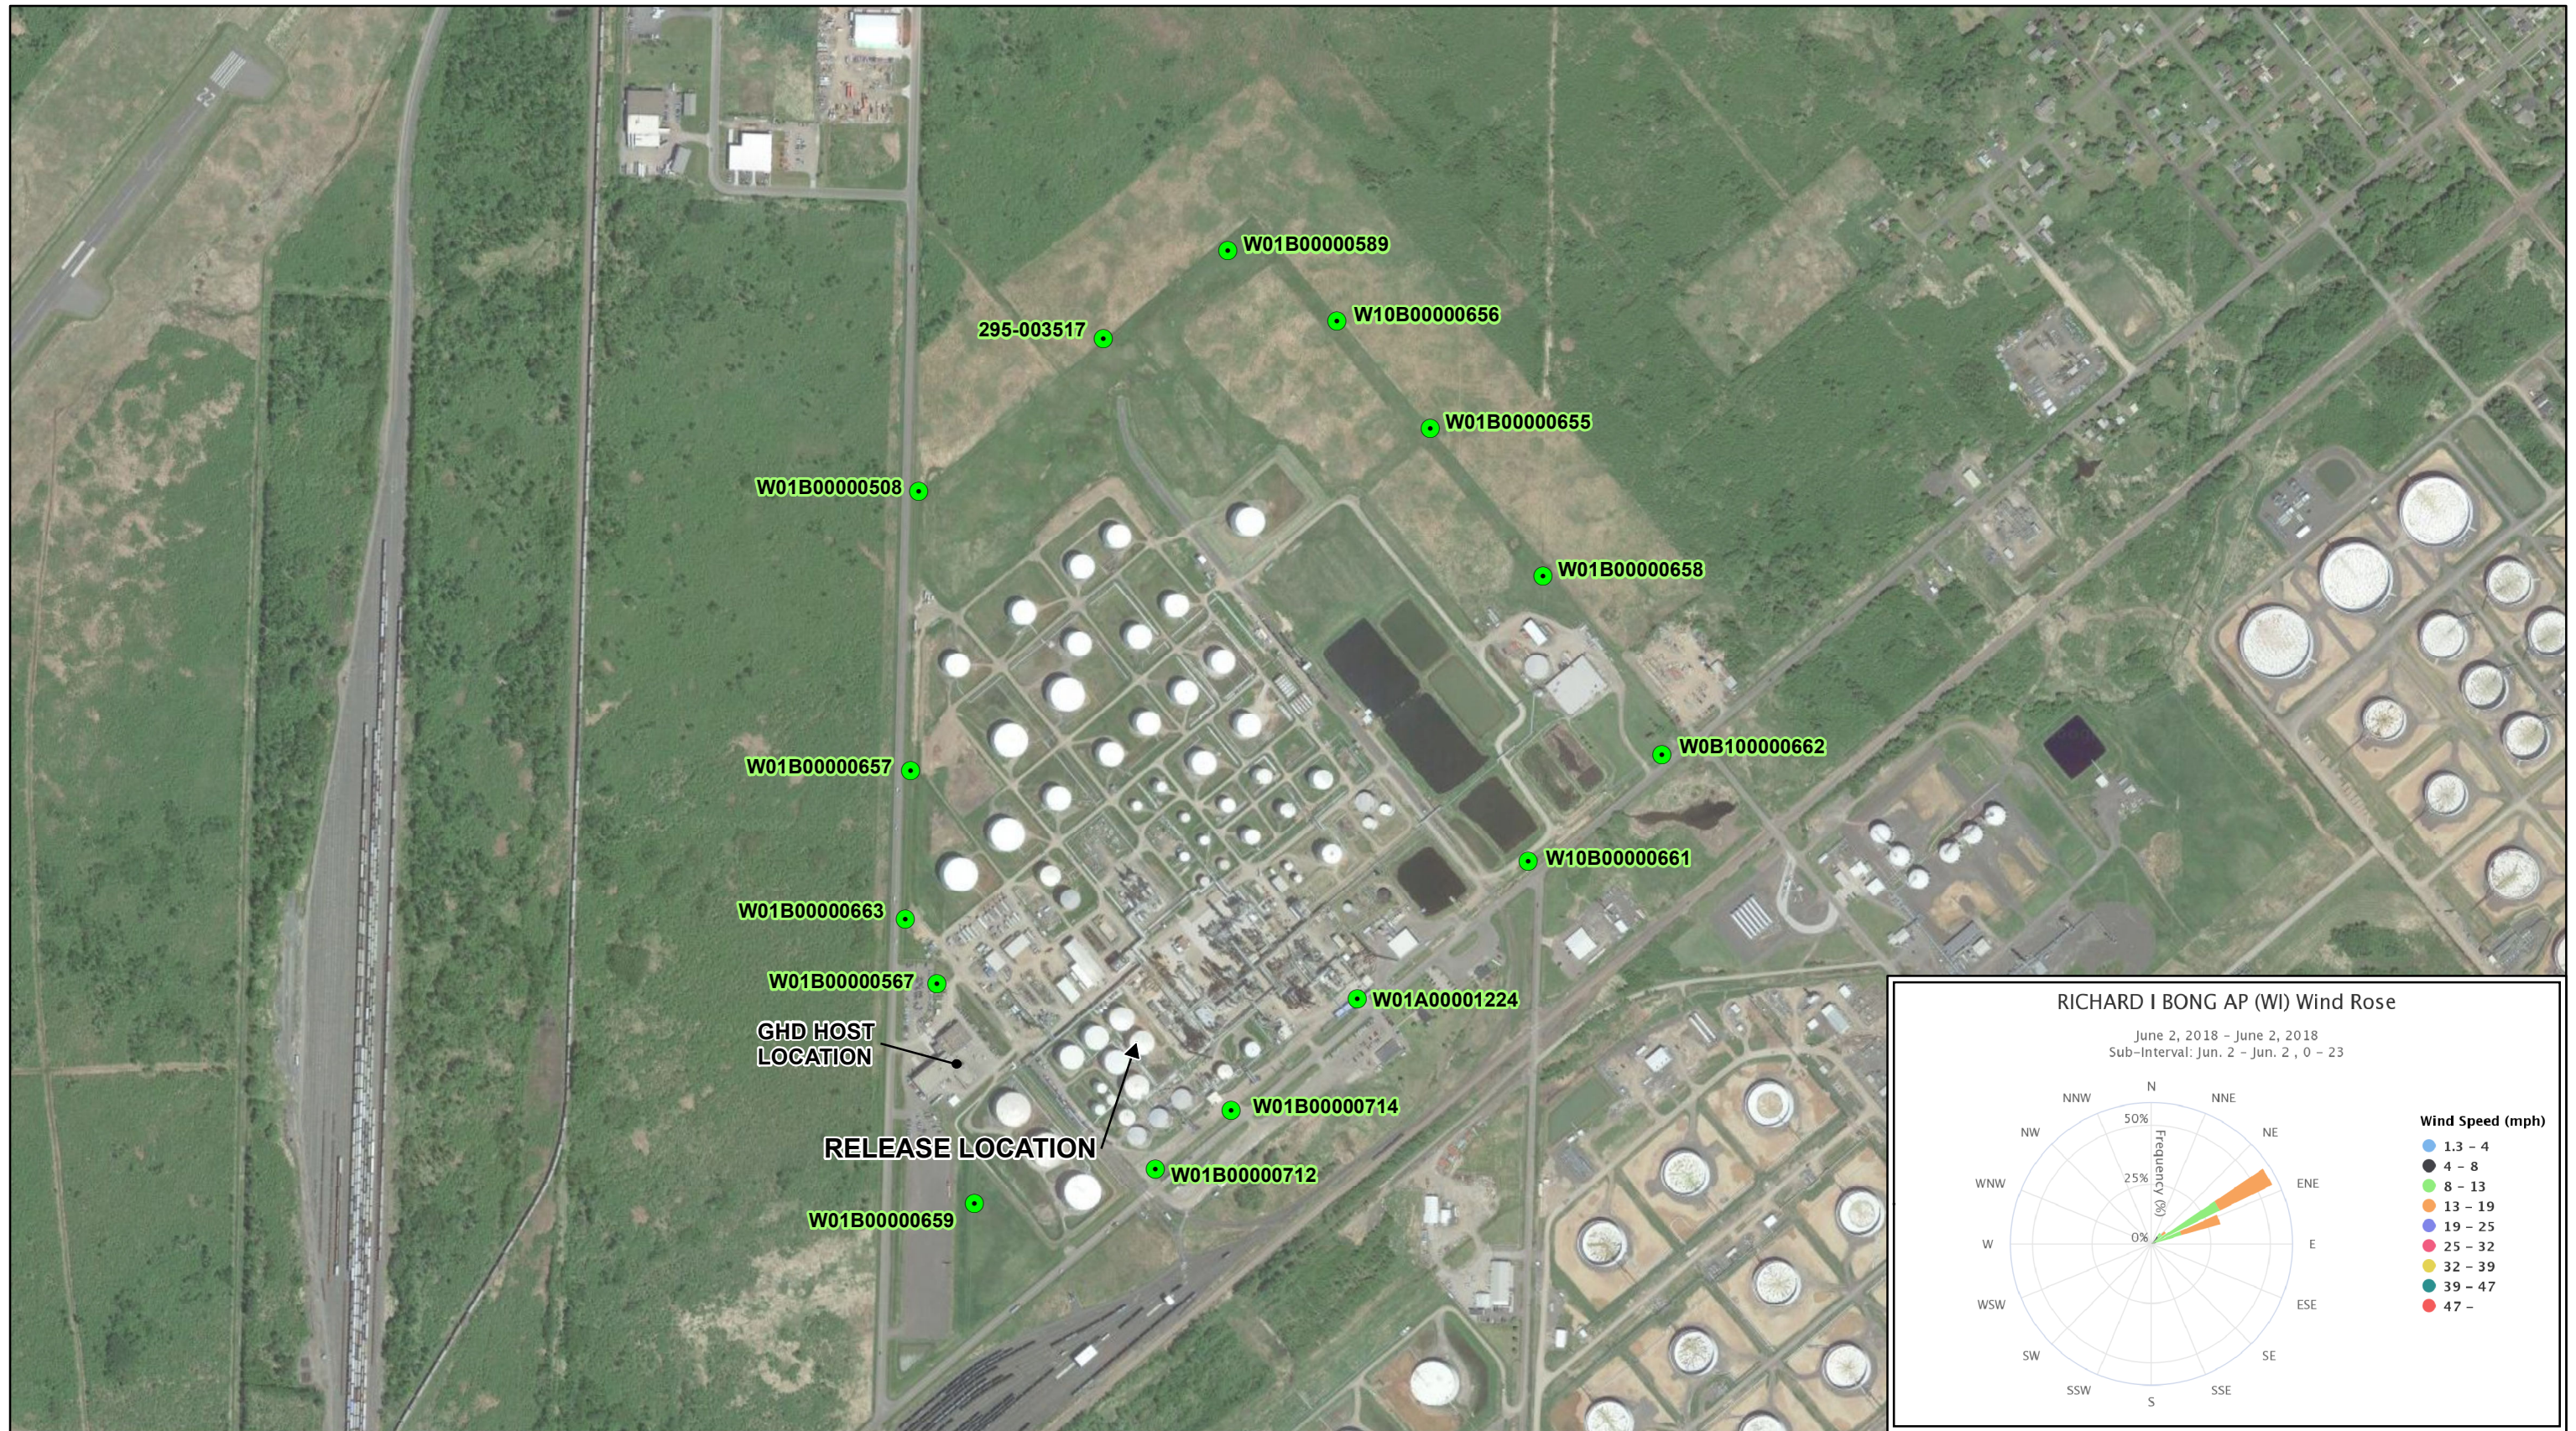
FIGURE 1

Perimeter monitoring locations and status with respect to community action levels over the period of June 2, 2018 between 00:00 and 23:59 are presented on Figure 1.

**SUMMARY OF PERIMETER ZONE AIR MONITORING RESULTS
 JUNE 2, 2018 - 00:00 TO 23:59**

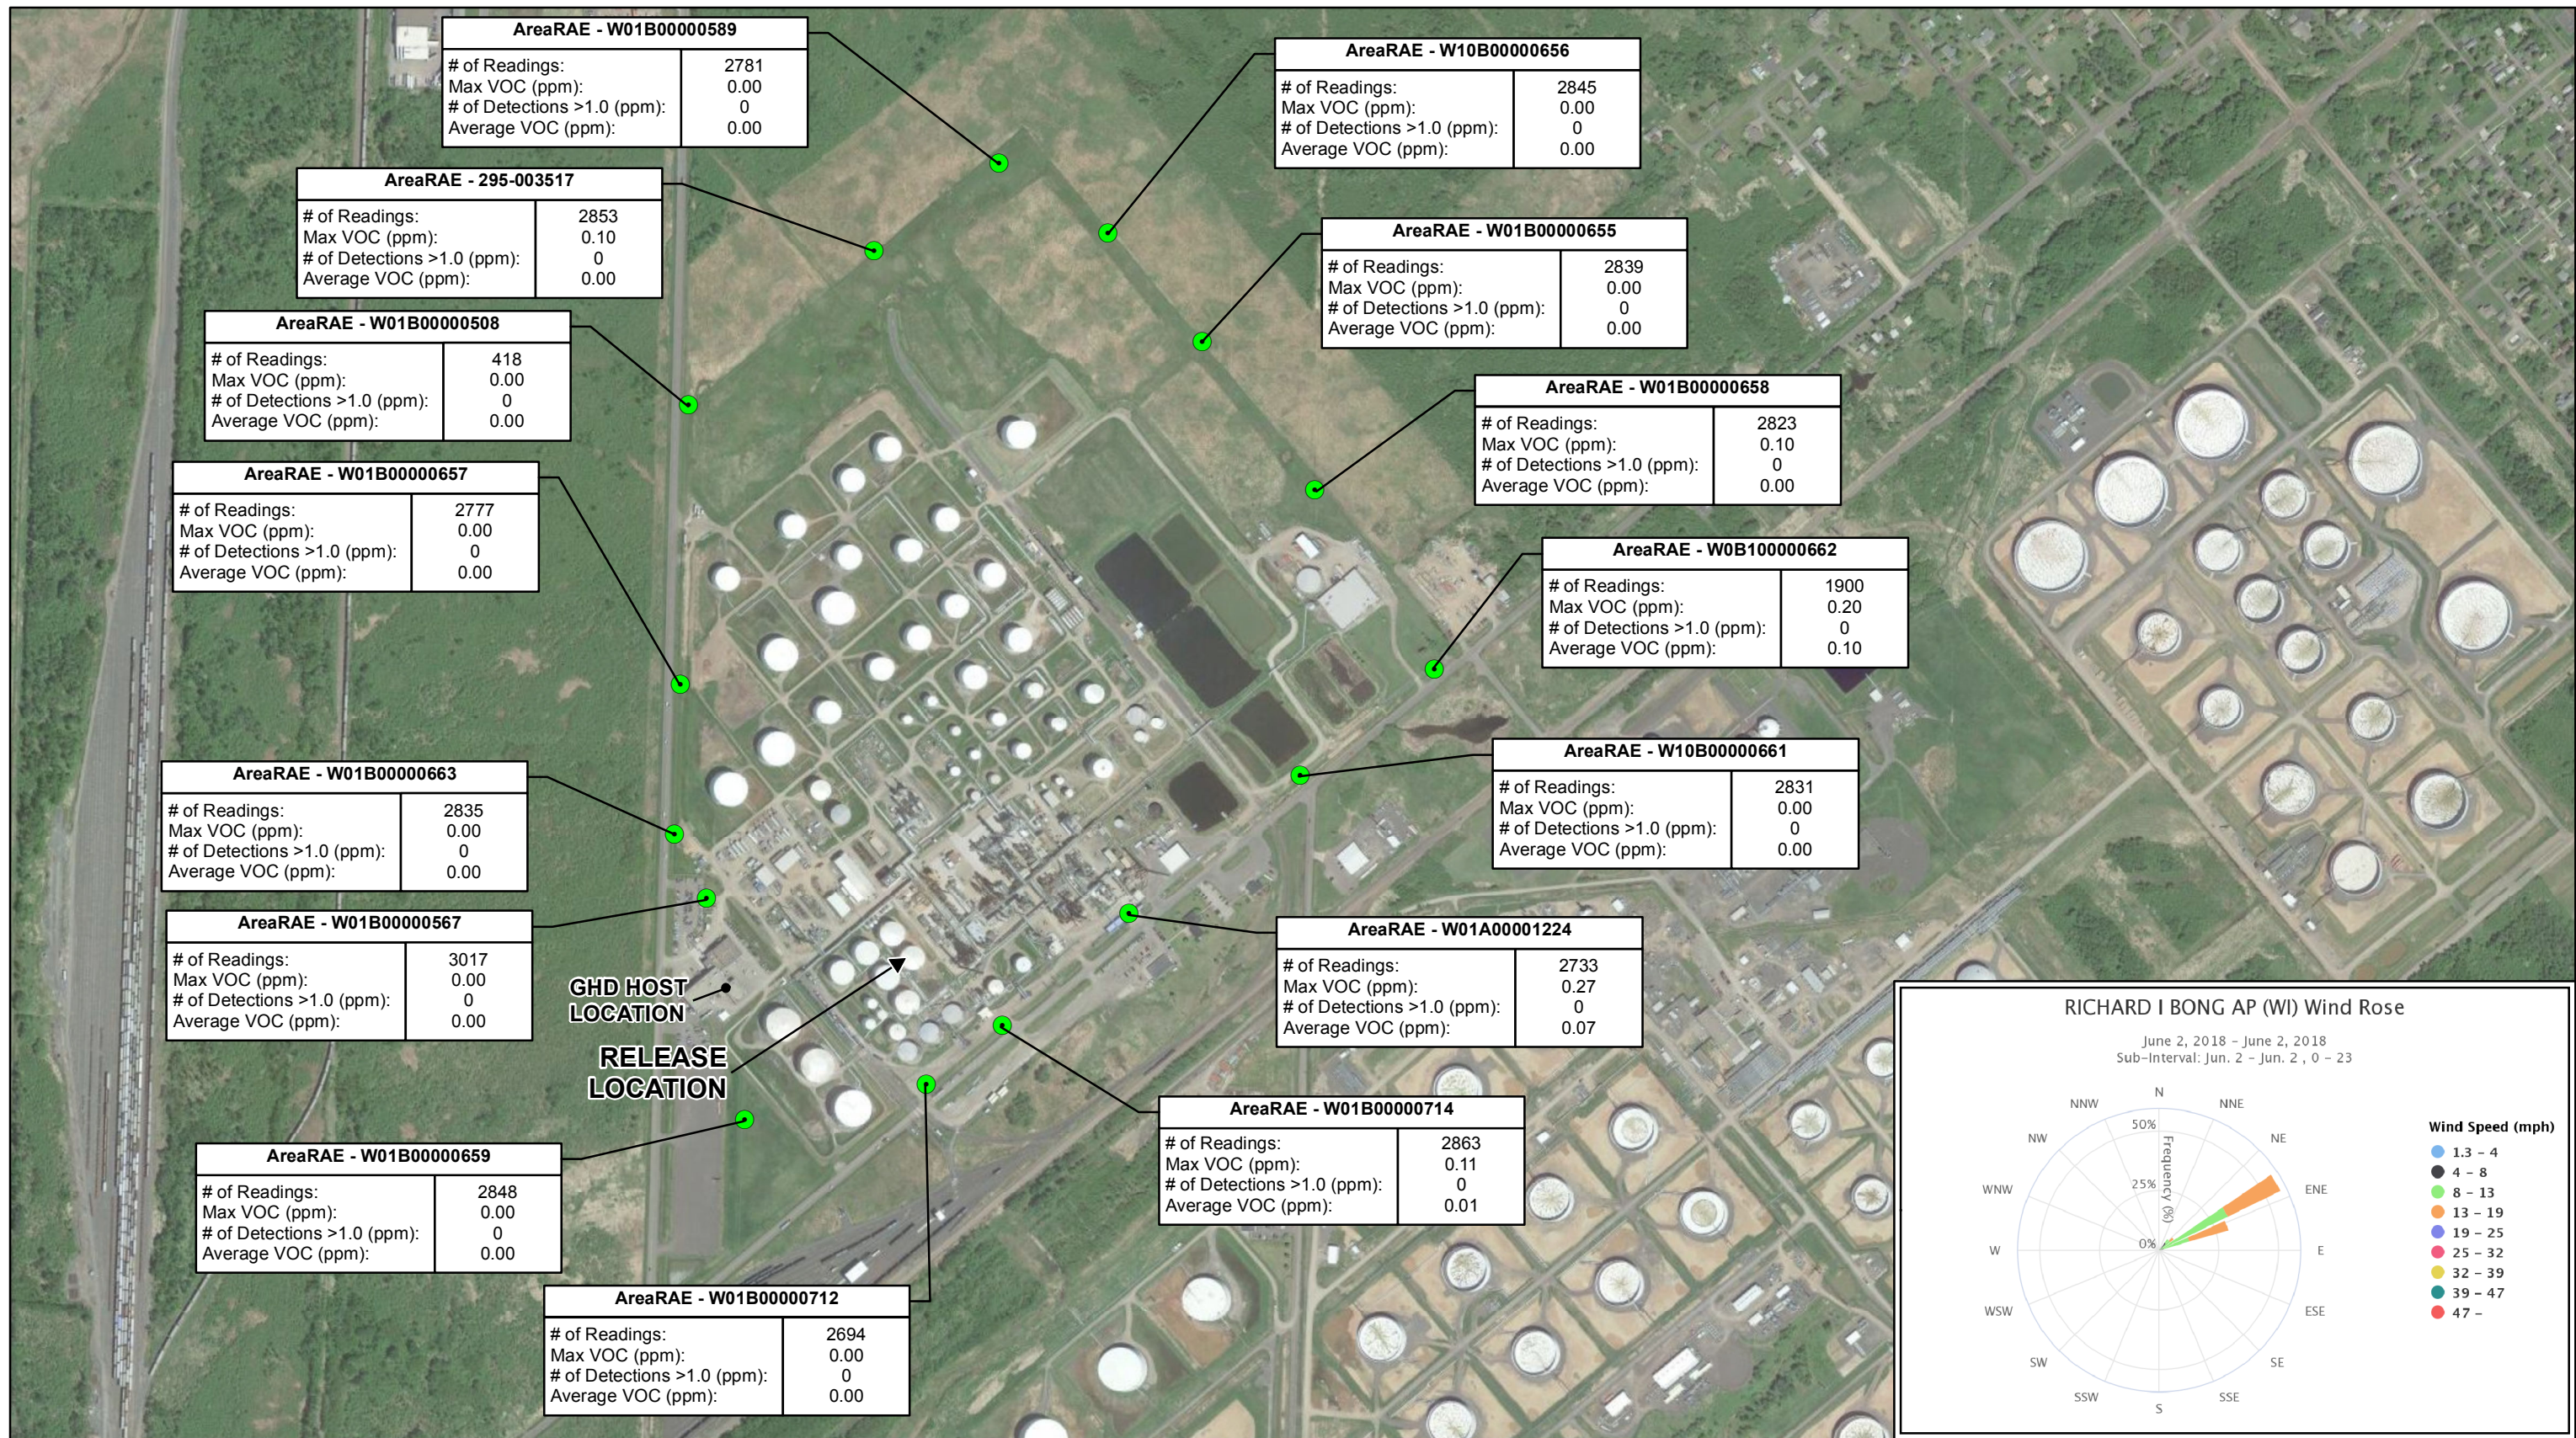
FIGURE 2

Perimeter air monitoring results for VOCs, H₂S, and SO₂ over this period are presented on Figures 2 through 4, respectively.

PERIMETER ZONE AIR MONITORING RESULTS - VOCS (PPM)
 JUNE 2, 2018 - 00:00 TO 23:59

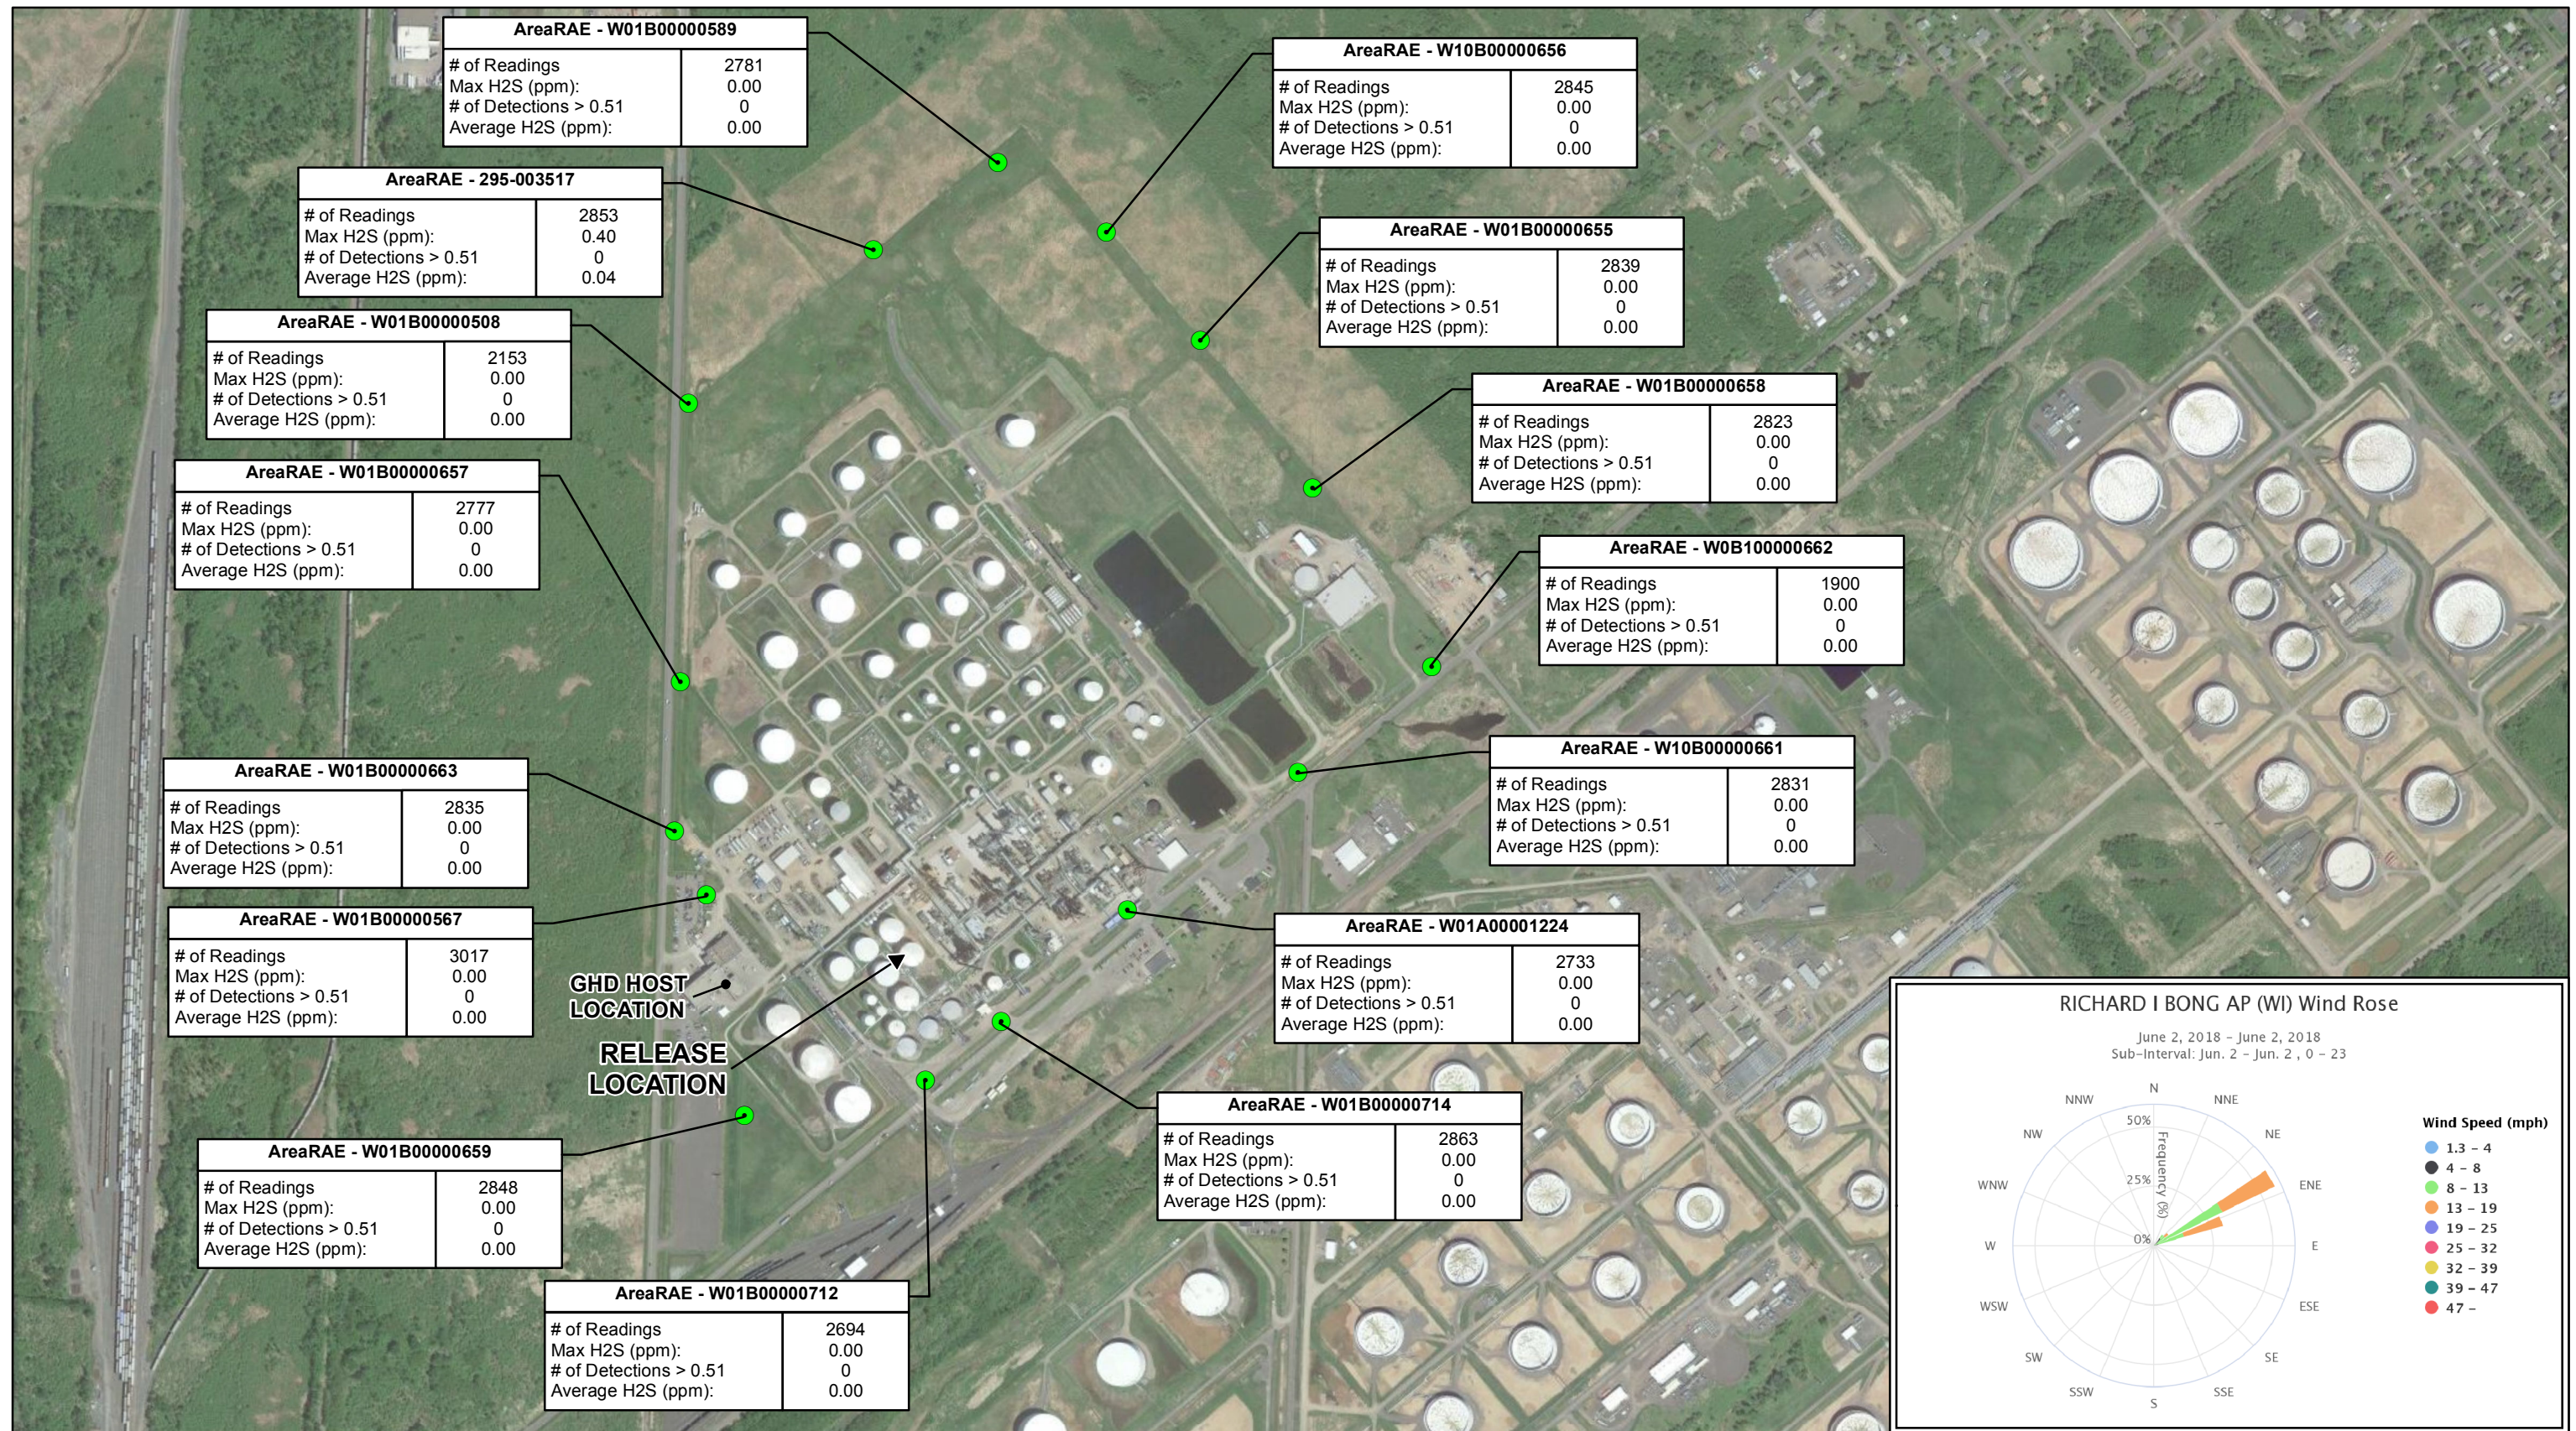
FIGURE 3

PERIMETER ZONE AIR MONITORING RESULTS - H2S (PPM)
JUNE 2, 2018 - 00:00 TO 23:59

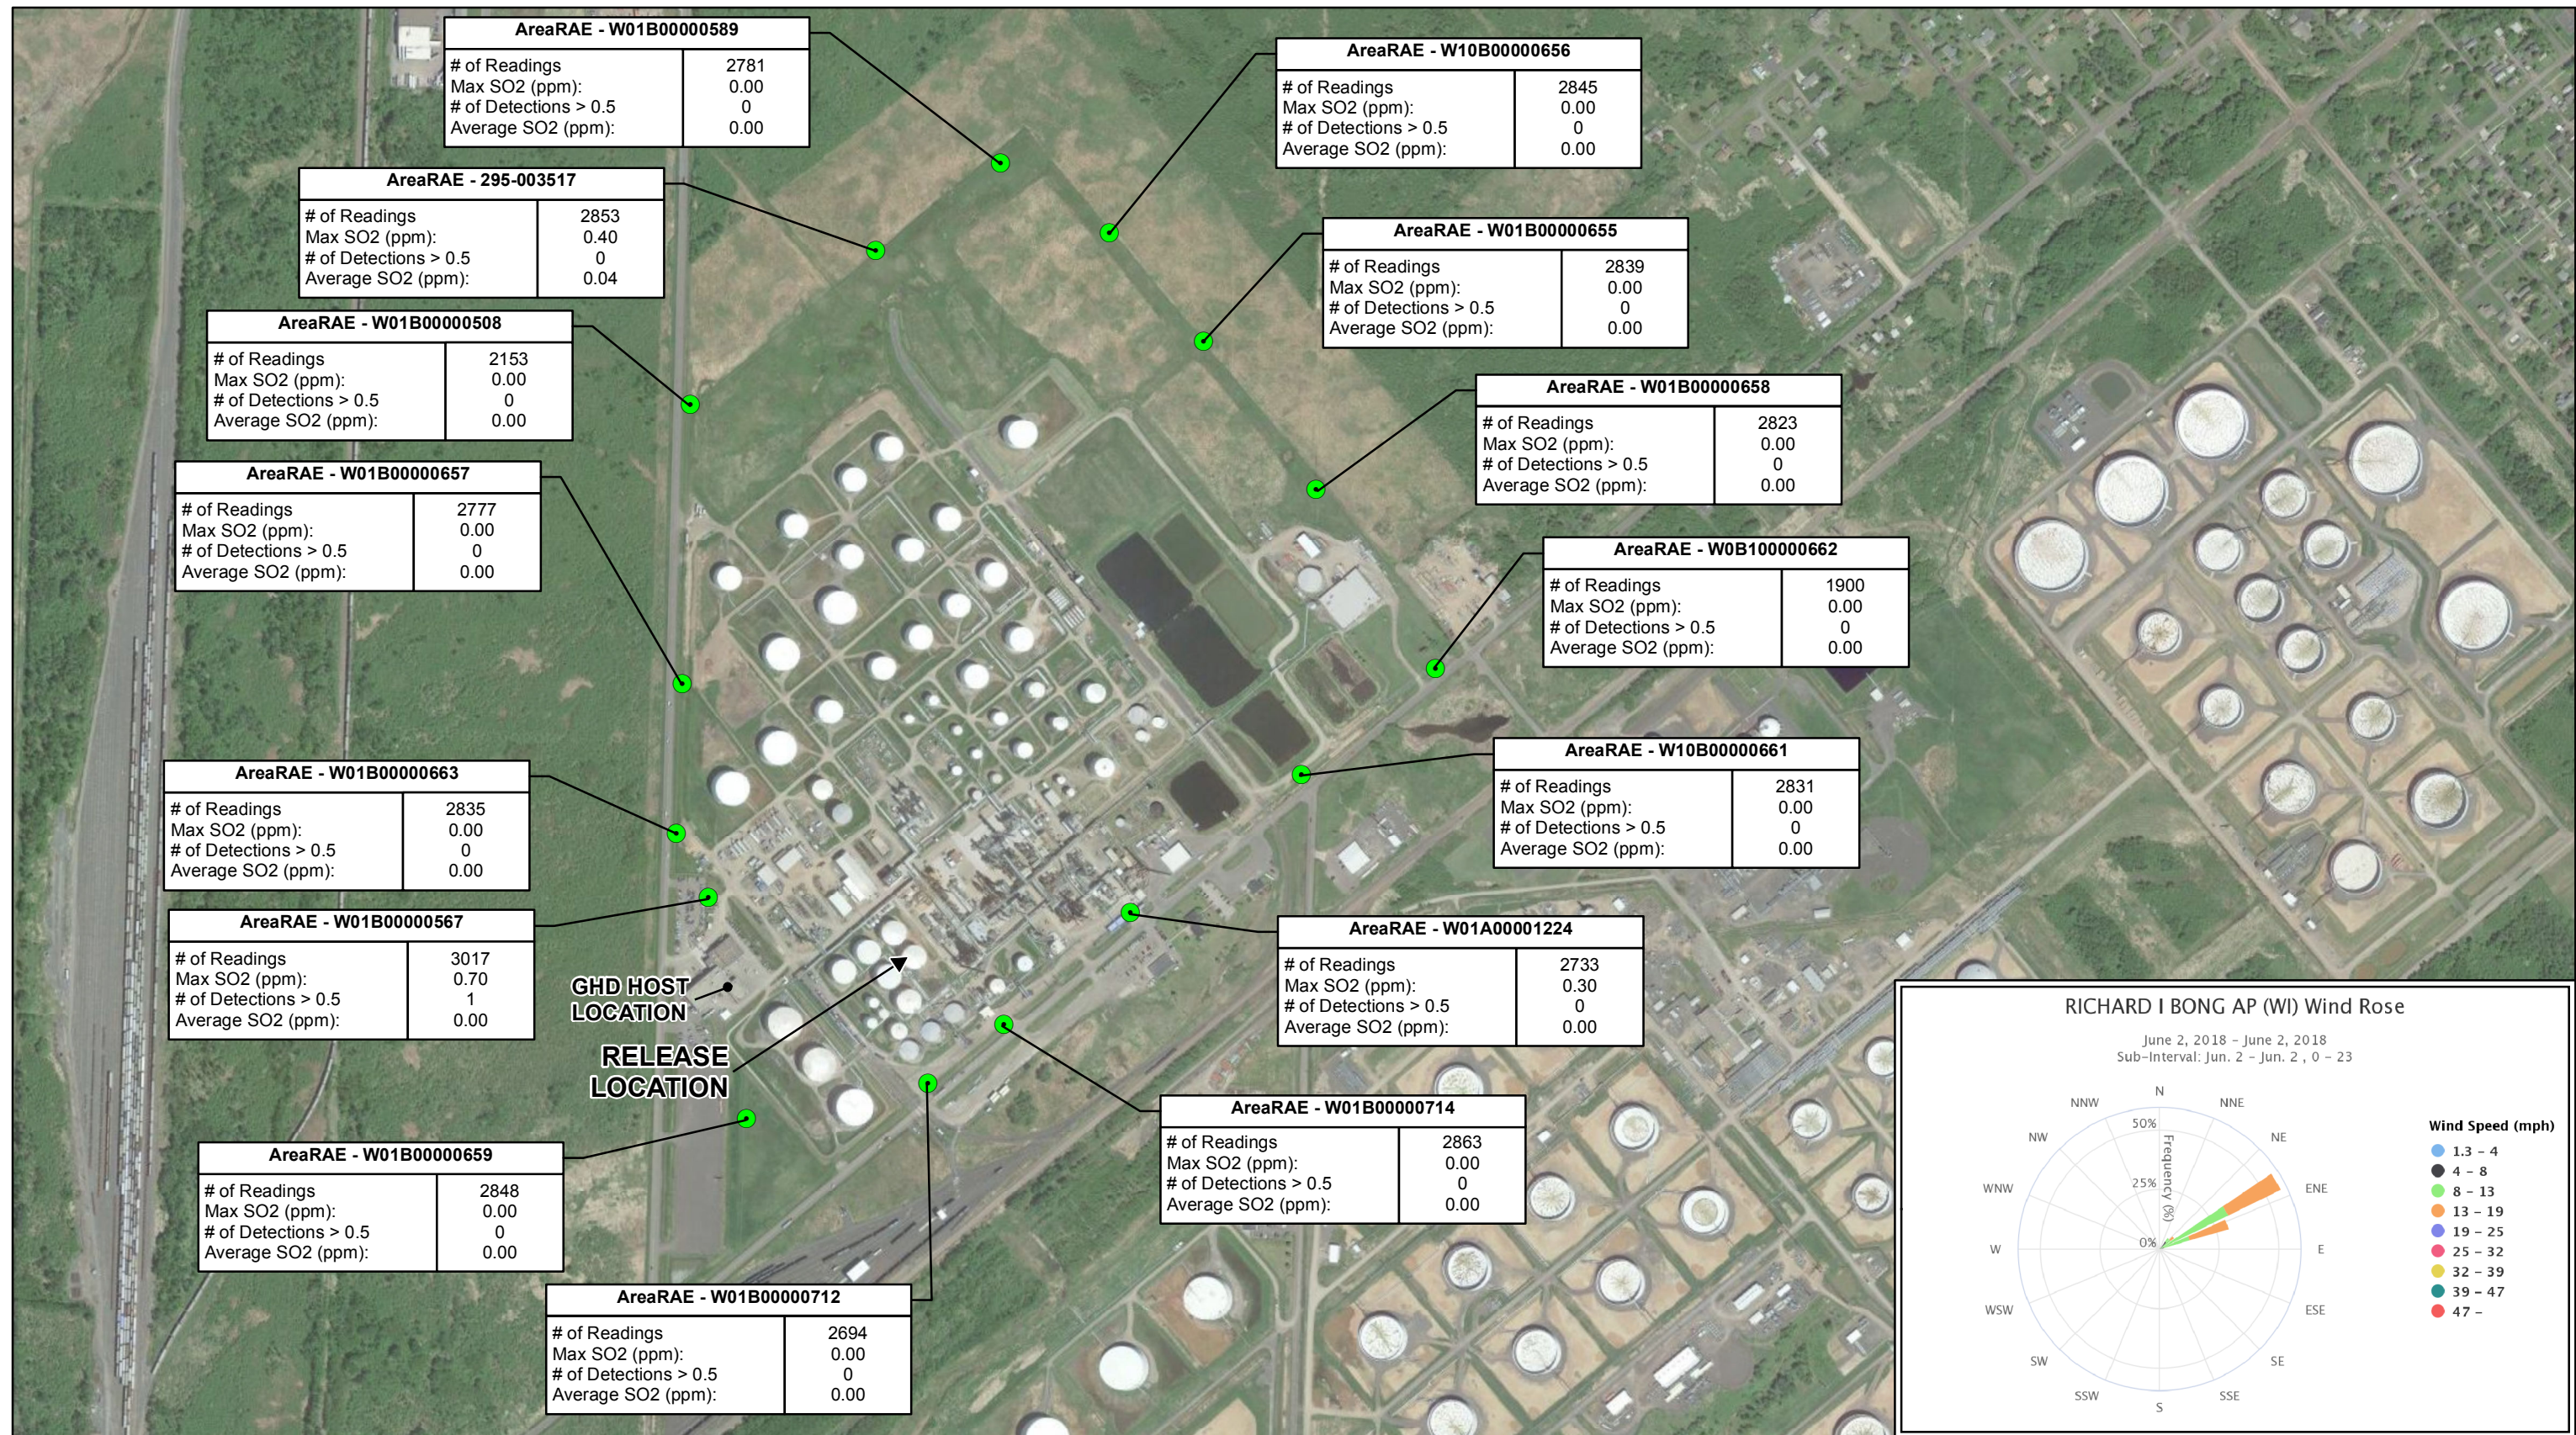
FIGURE 4

An SO₂ detection was logged above the community action level at one monitor on June 2, 2018. The detection was not sustained above the community action level. Therefore, the detection does not constitute as an exceedance of community action levels.

PERIMETER ZONE AIR MONITORING RESULTS - SO2 (PPM)
 JUNE 2, 2018 - 00:00 TO 23:59
