SUBJECT: Materials Management Plan Completion – BRRTS # 02-41-582725

SUBJECT: Cover Maintenance Plan – BRRTS # 02-41-582725

**Building 522
Soils Cover Plan**

Activity (Site) Name B522 Renovation Material Management Plan	BRRTS No. 02-41-582725
---	----------------------------------

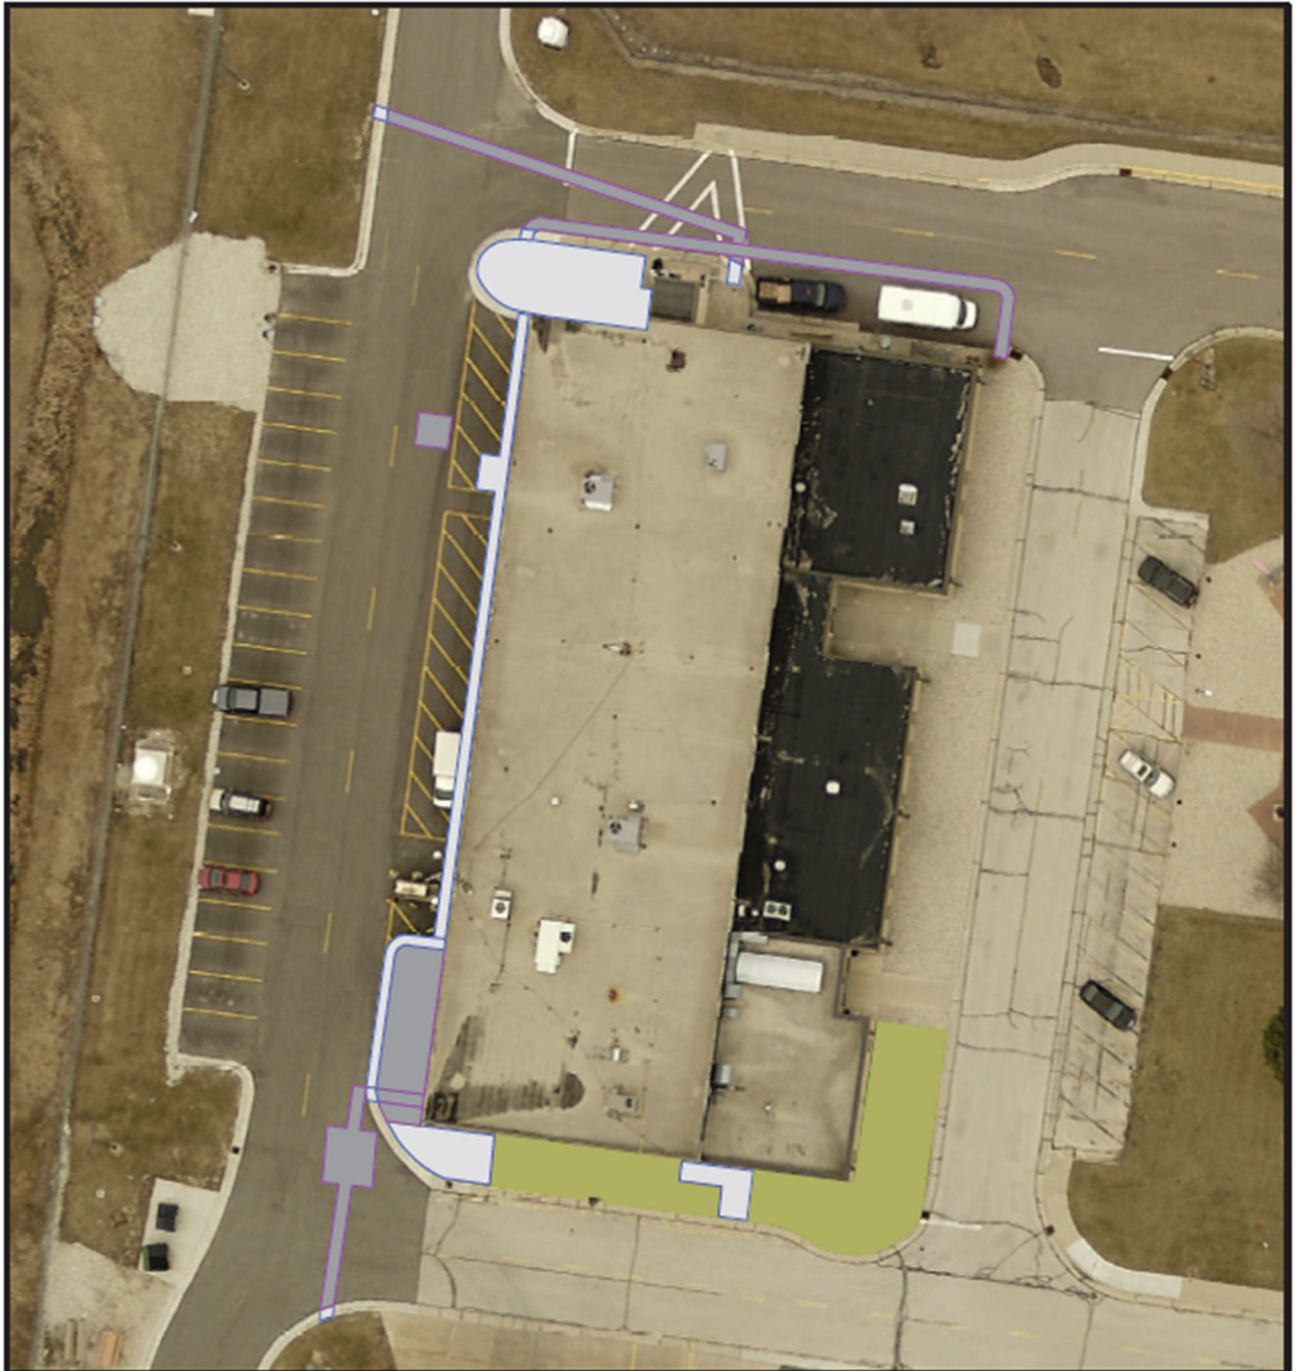
3. **Description of Cover to be Maintained** – Soil from construction activities will fall into two types of cover to be maintained. See attached map for cover locations.

- Contaminated soils will be placed under an impervious surface. Impervious surface would either be asphalt pavement system consisting typically of four inches of asphalt with a twelve inch compacted gravel base or a eight inch concrete pavement with a nine inch compacted gravel base.
- Contaminated soils will be placed back in the original excavation. Contaminated soils will be covered by minimum of one foot of clean soils, weed barrier, and covered with stone..

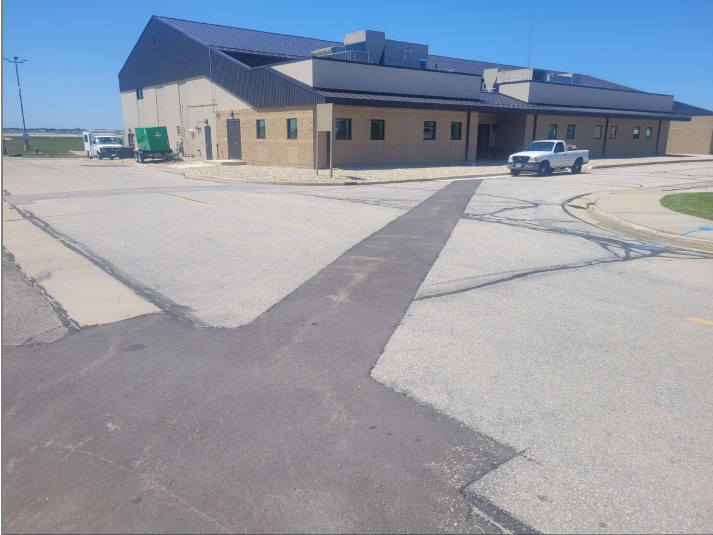
Title: Southeast Corner Building 522

Inspection Date	Inspector Name	Item	Describe the condition of the item that is being inspected	Recommendations for repair or maintenance	Previous recommendations implemented?	Photographs taken and attached?
05/25/2023	Brian Schrader	<input type="checkbox"/> monitoring well <input type="checkbox"/> cover/barrier for soil <input checked="" type="checkbox"/> sediment cap <input type="checkbox"/> other:	Impervious Surfaces around building 522	None	<input type="radio"/> Y <input checked="" type="radio"/> N	<input checked="" type="radio"/> Y <input type="radio"/> N
05/25/2023	Brian Schrader	<input type="checkbox"/> monitoring well <input type="checkbox"/> cover/barrier for soil <input checked="" type="checkbox"/> sediment cap <input type="checkbox"/> other:	Pervious Surfaces on South West Corner of building 522	None	<input type="radio"/> Y <input checked="" type="radio"/> N	<input checked="" type="radio"/> Y <input type="radio"/> N
