Spill Notification for WRR Environmental Services Co., Inc.

EPA ID# WID990829475 FID# 618026530 Spill ID# 16595

ID 20210609WC18-1 - Paint

Spill Notification for WRR Environmental Services Co - Paint container spill 06092021

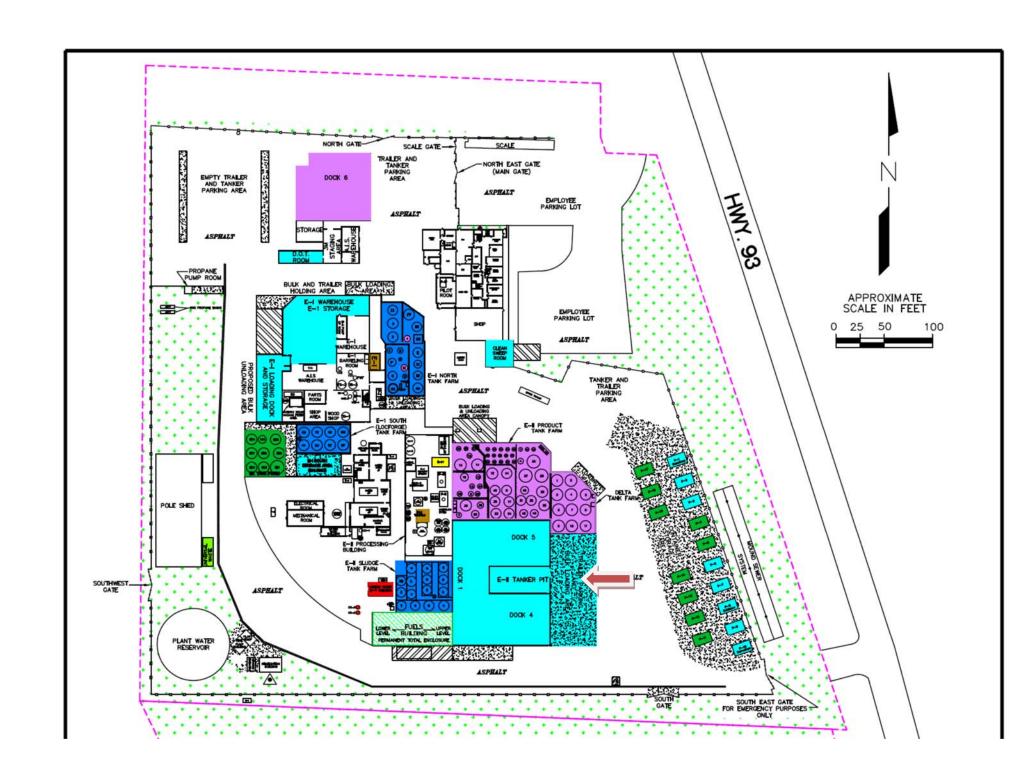
## 20210609WC18-1 JF AHERN CO.

As WRR personnel were unloading a trailer of waste that had arrived at WRR, the bottom of a drum of waste paint related material blew off due to a pressure build up in the drum.

The release was contained to the concrete area. No material impacted soil or contaminated the WRR stormwater collection area.

Included with this report is a facility map with the release location marked with a red arrow.

Shovels, brooms, clay absorbent and pads were used to pick up the bulk of the release; both inside the trailer and on the surrounding ground.
