Phase I Environmental Site Assessment

104 South Railroad Street, Campbellsport, Wisconsin

Wisconsin Department of Natural Resources

Project reference: WCS-124 Under Cooperative Agreement BF00E02369 Project number: 60692014

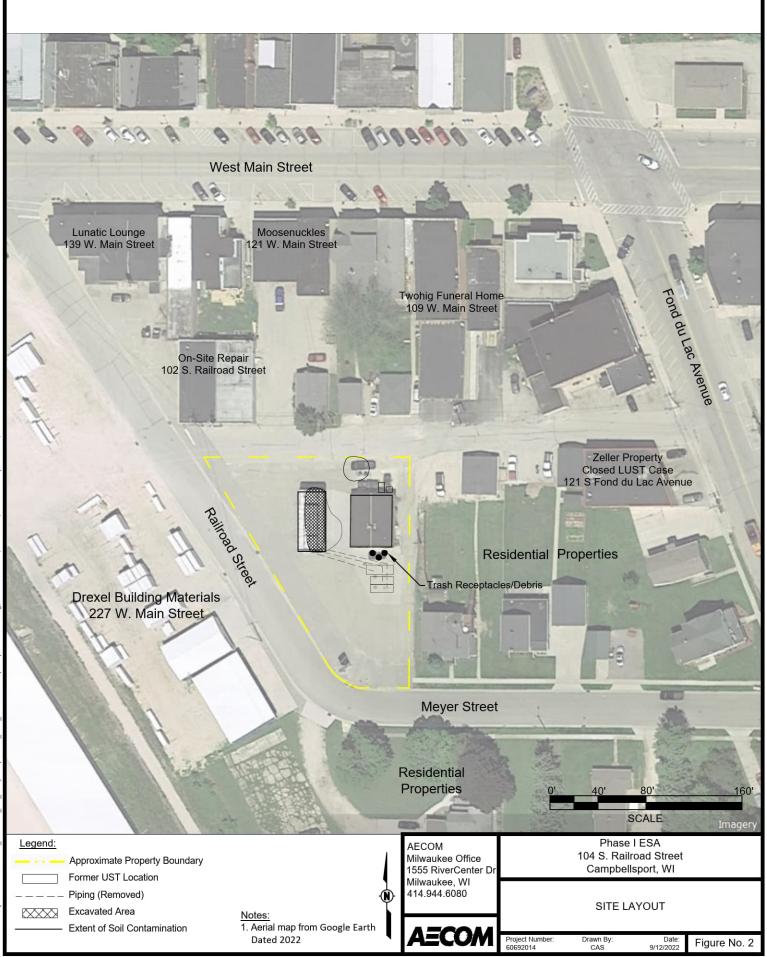
- Figure 1. Site Location
- Figure 2. Map Site Layout

During the site visit, no visual evidence of potable water wells, monitoring wells, dry wells, clarifiers, septic tanks, or leach fields was identified on the subject property. No visual evidence of discolored soil, water, or unusual vegetative conditions or odors was identified during the site visit. In addition, no visual evidence of significant corrosion was identified on the floors or walls of the subject property building or on the exterior of the subject property. The general layout of the subject property is illustrated on Figure 2 - Site Plan and representative site photographs are provided in Appendix A.

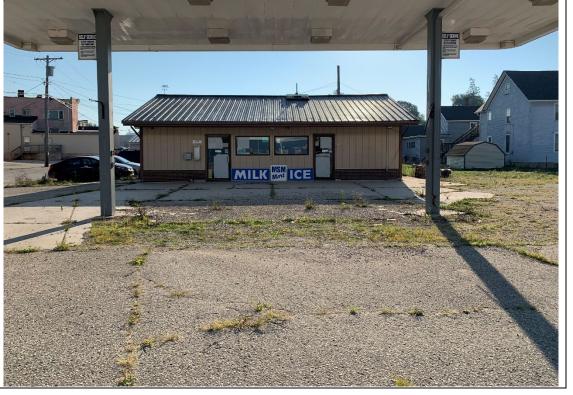
Photo No.Date:89/8/22Direction PhotoTaken:

Front of convenience store building. Gravel area under canopy is former fuel dispenser and piping excavation area.

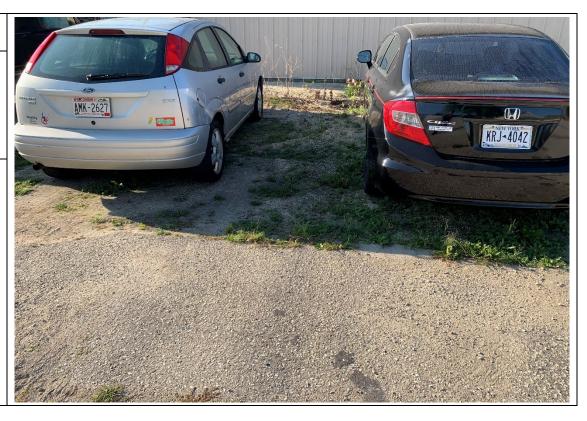
Kerosene and diesel UST and dispensing excavation area, located north of the convenience store building.

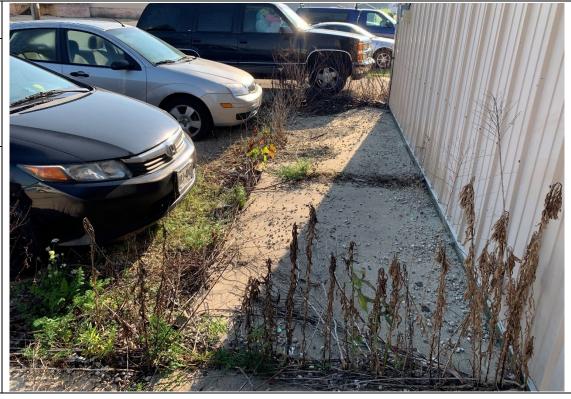
Photo No.Date:149/8/22Direction PhotoTaken:

Kerosene and diesel UST and dispensing excavation area, located north of the convenience store building.
