Re: **Revised Construction Completion Report**  
**Portions of Parcels 06-806-00739-05 and 06-806-00739-00**  
**2929 Halvor Lane**  
**Superior, Wisconsin**  
**BRRTS#: 07-16-583046**  
**BBJ Group Project No. R2112496.0**

# CONSTRUCTION COMPLETION REPORT

**FedEx Facility  
2929 Halvor Lane  
Superior, Wisconsin  
BRRTS#: 07-16-583046**

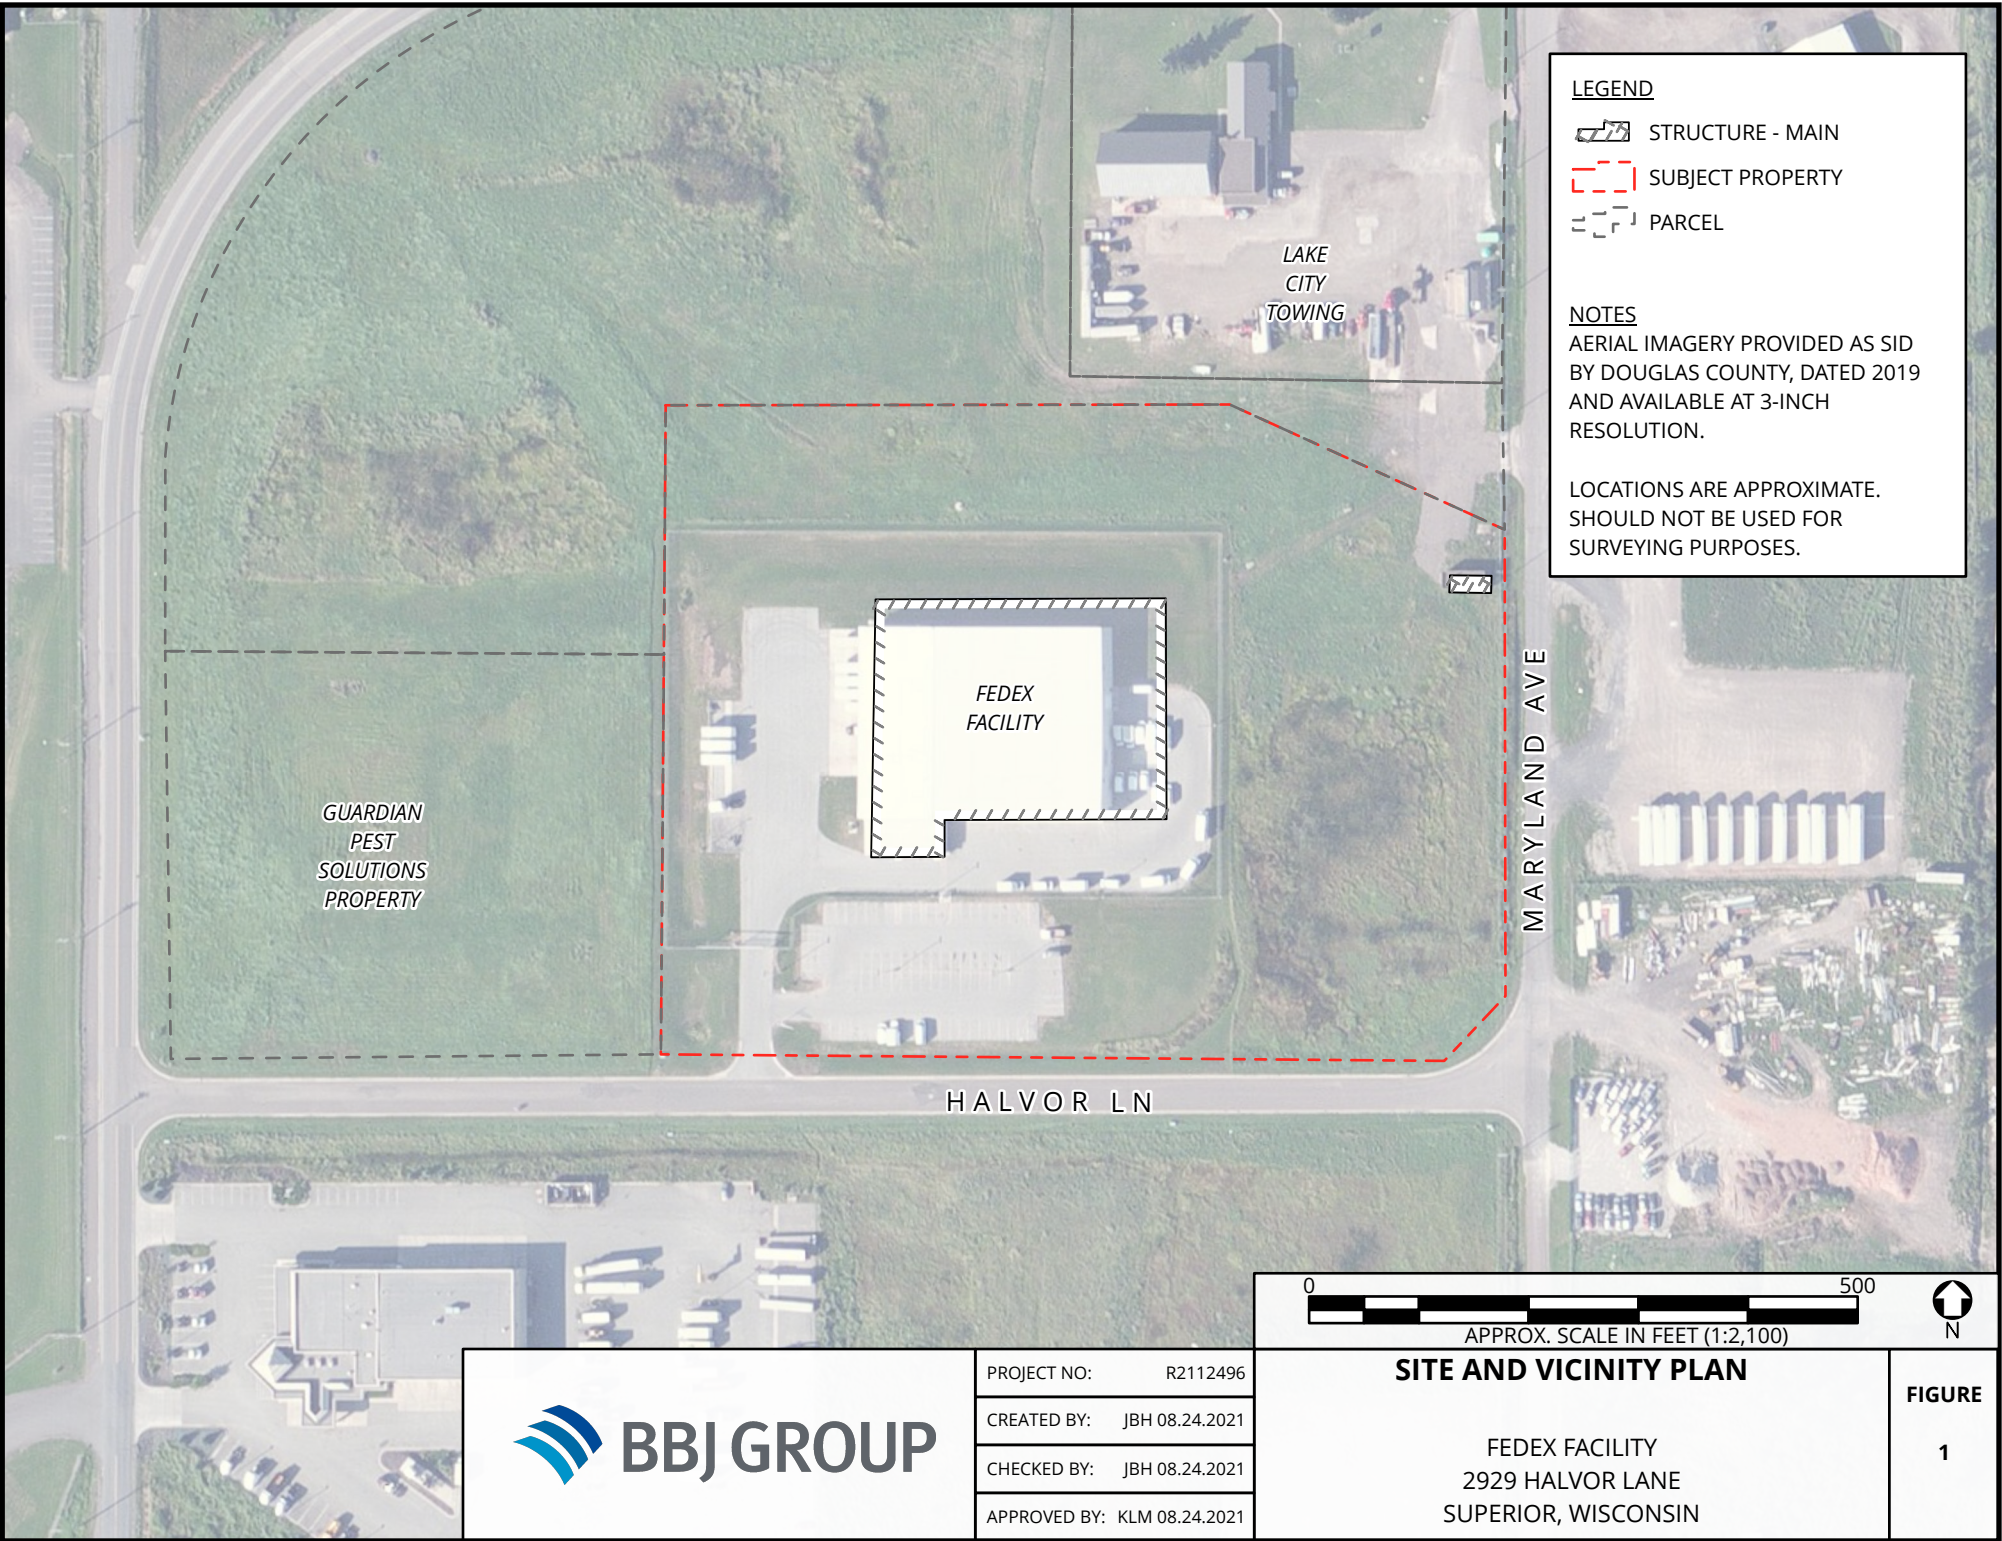
**SITE AND VICINITY PLAN**

BBJ Group, LLC (BBJ Group), on behalf of HCI Limited Partnership (HCI), prepared this Construction Completion Report (Report) to document activities completed as part of the parking lot expansion project for the FedEx facility located at 2929 Halvor Lane, Superior, Douglas County, Wisconsin (Subject Property). The Subject Property is depicted on Figure 1.

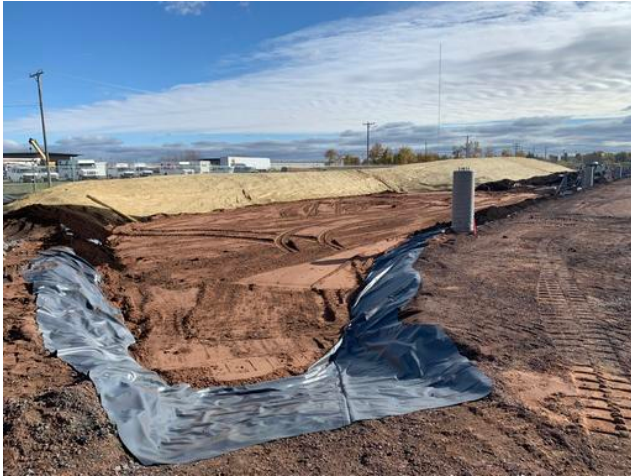
Liner & Sand in Pond

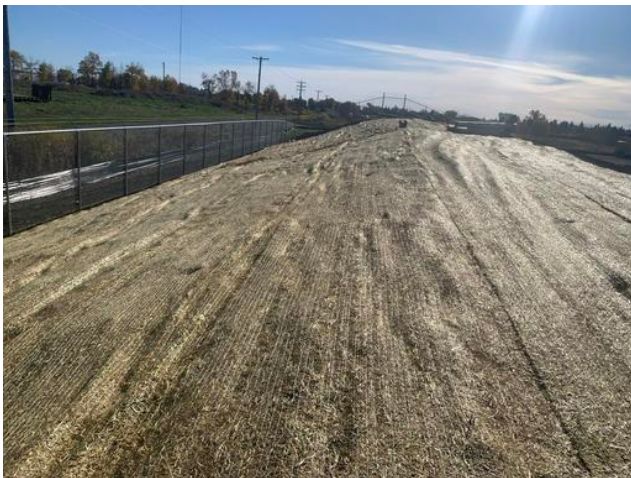
E-Mat and Fencing on Berm

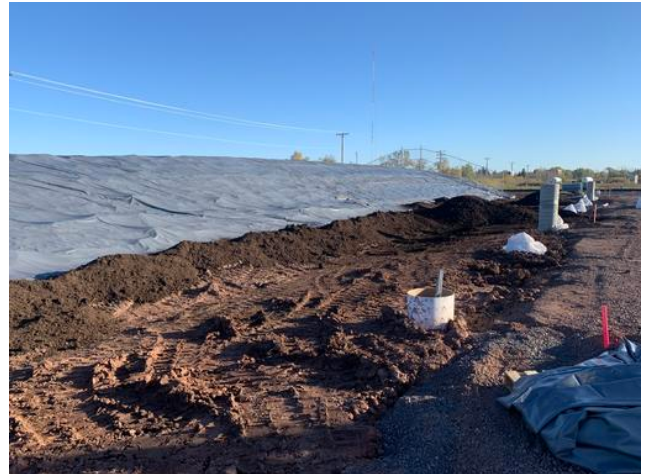
Berm PVC Liner

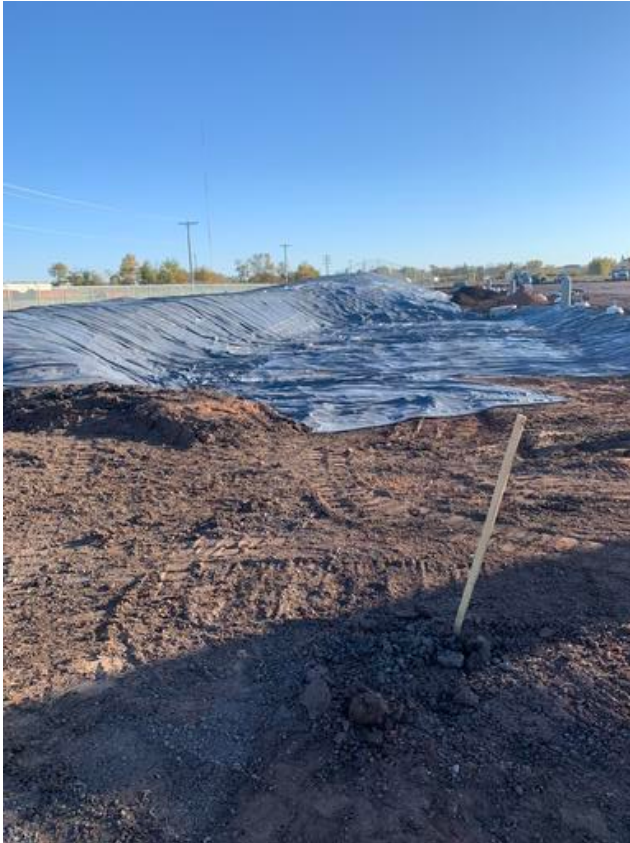
Pond & Berm PVC Liner

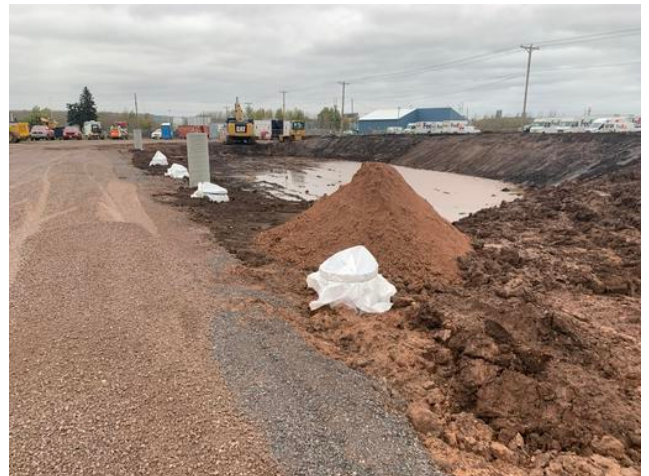
Pond and Berm

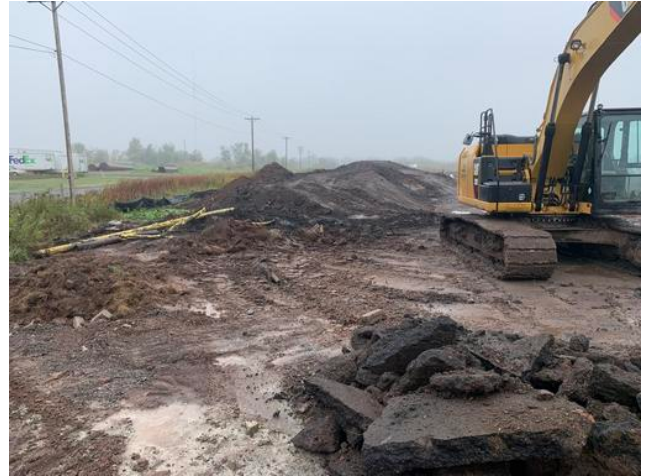
Pond berm & debris

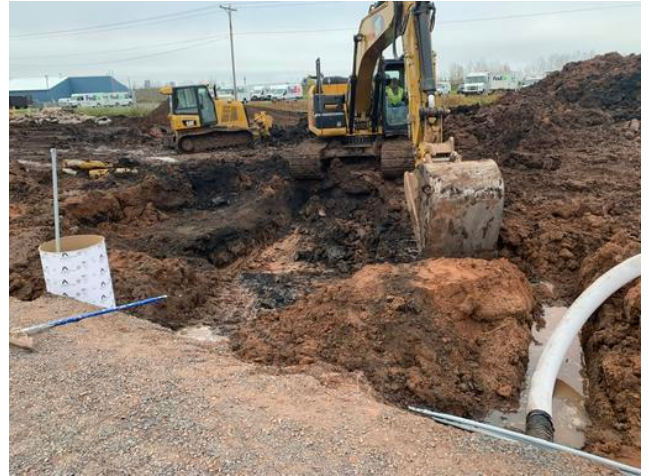
Excavating pond and removing debris  
**Scott Luostari**  
Oct 5, 2021 4:10 PM

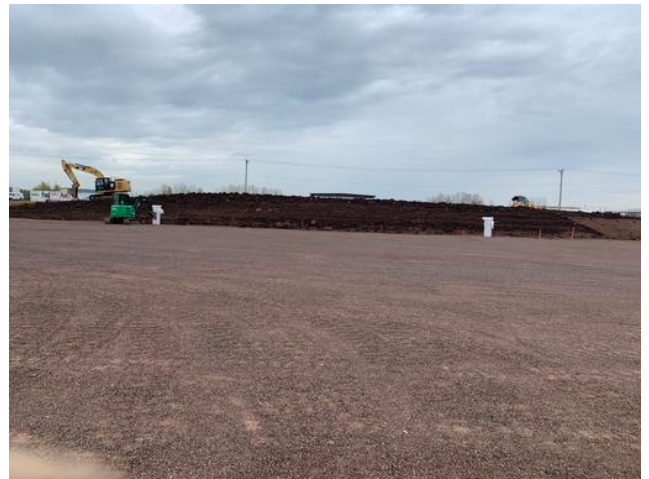
Light Pole Foundations & Berm Shaping

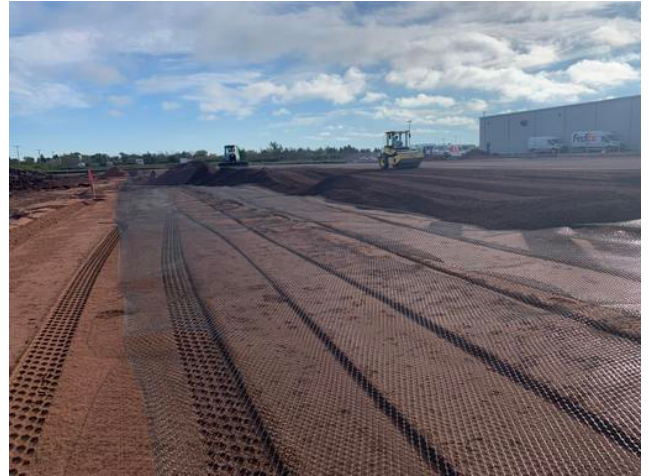
Geogrid and Gravel Placement on Van Lot

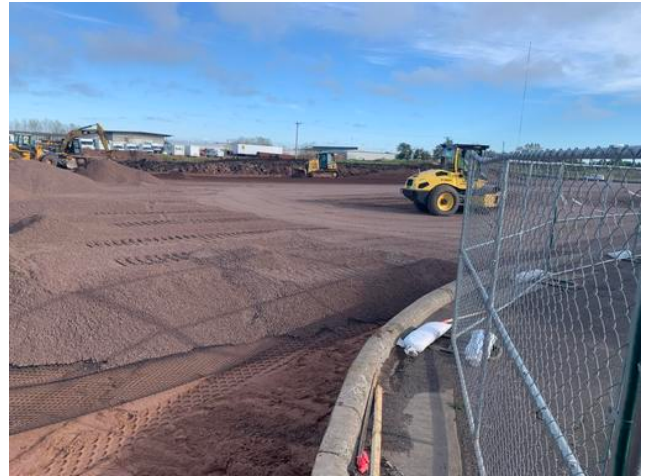
GeoGrid, Gravel and Compaction at NE Corner of Lot
