Re: **Revised Construction Completion Report**  
**Portions of Parcels 06-806-00739-05 and 06-806-00739-00**  
**2929 Halvor Lane**  
**Superior, Wisconsin**  
**BRRTS#: 07-16-583046**  
**BBJ Group Project No. R2112496.0**

# CONSTRUCTION COMPLETION REPORT

**FedEx Facility  
2929 Halvor Lane  
Superior, Wisconsin  
BRRTS#: 07-16-583046**

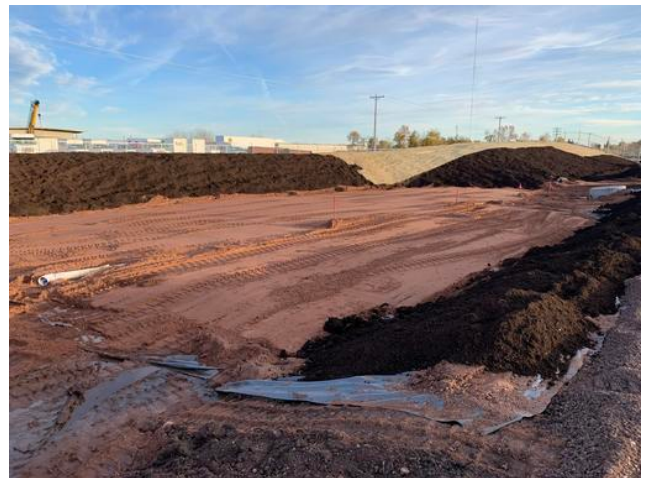
Topsoil, Draitile and Sand for Pond

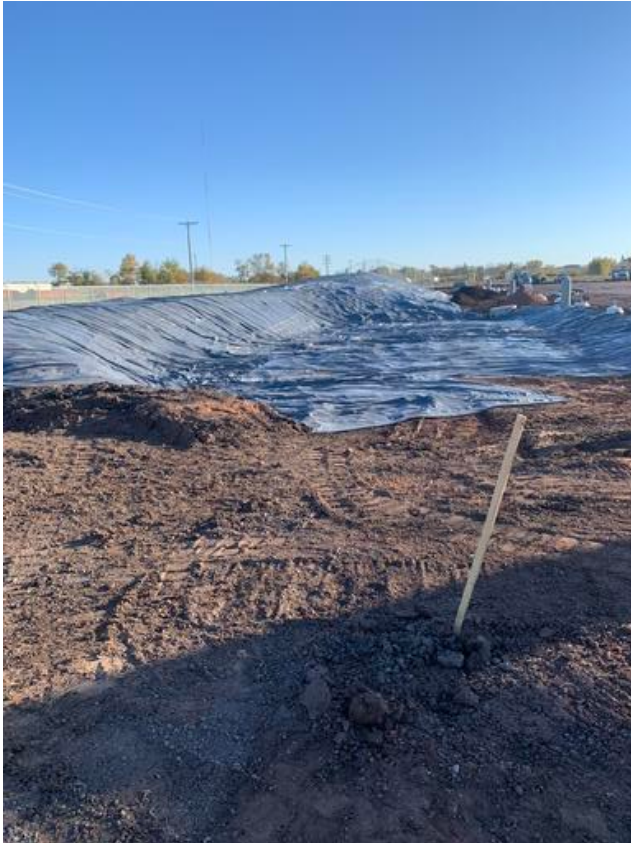
Pond & Berm PVC Liner

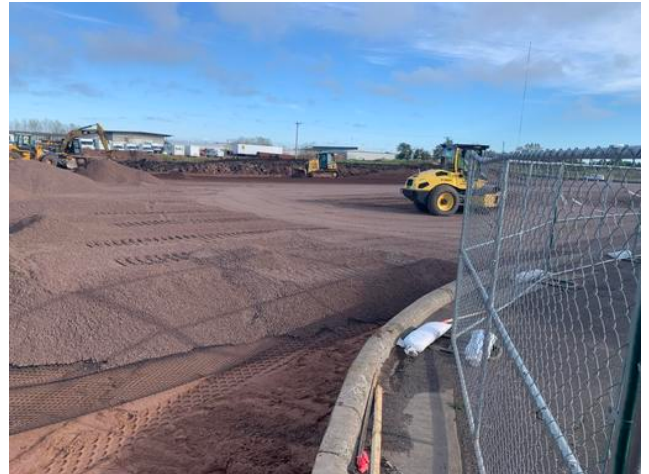
Geogrid, Gravel and Compaction at NE Corner of Lot

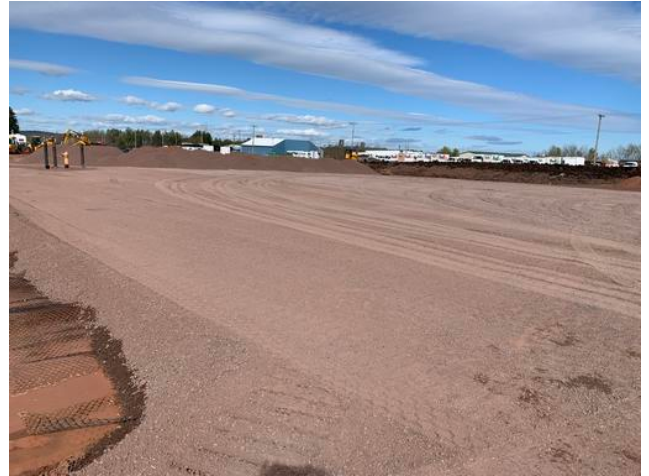
GeoGrid and Gravel on Van Lot

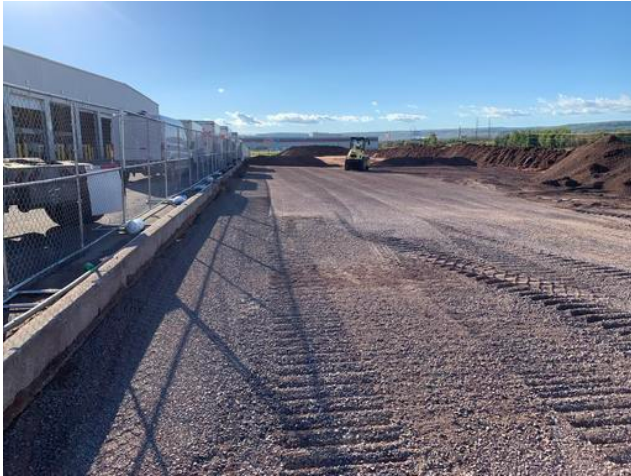
GeoGrid and Gravel on Trailer Lot

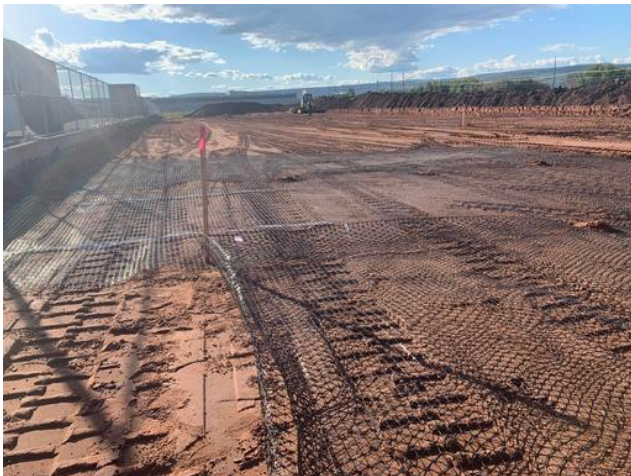
GeoGrid on Trailer Lot

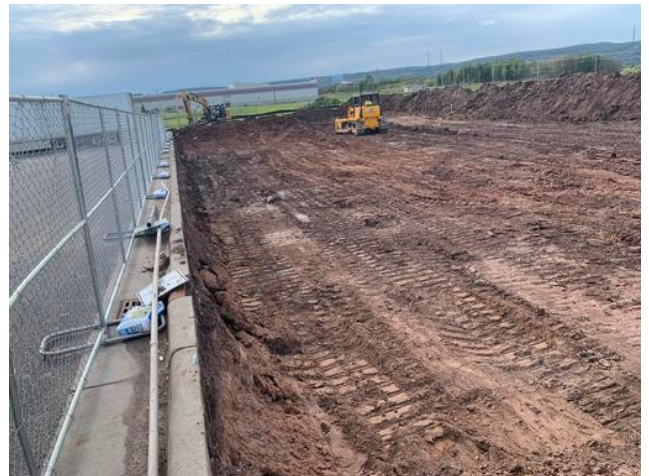
Sub-Cutting Trailer Lot

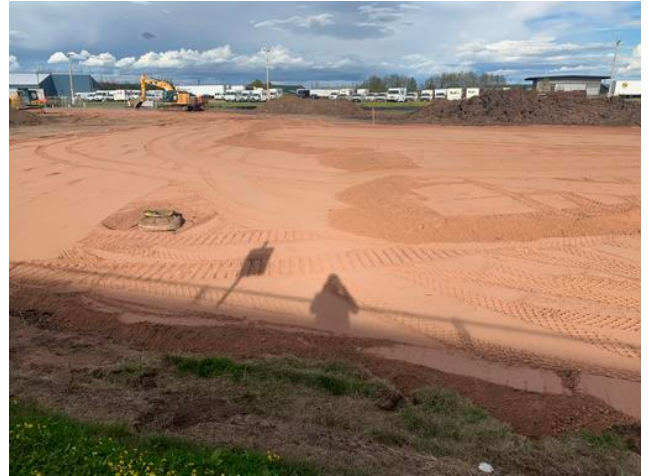
Place and compact sand on van lot
