From: LiJane Ballard <lhbballard@mmm.com>
Sent: Thursday, September 26, 2024 4:16 PM
To: Schrank, Jayson S - DNR
Cc: Bradley Luedtke
Subject: SERTS ID: 20240926WC17-1
Attachments: WettedPerimeter92624FireLoopRelease.JPG; IMG_0312.jpg; IMG_0314.jpg; IMG_0318.jpg; IMG_0320.jpg

Please see the approximate wetted perimeter of the above ground soils following discovery of the leak in our fire suppression system external loop in the image attached. As I mentioned during our conversation, this is approximately 5400 sqft. I've also attached some photos of the location/event for your reference.

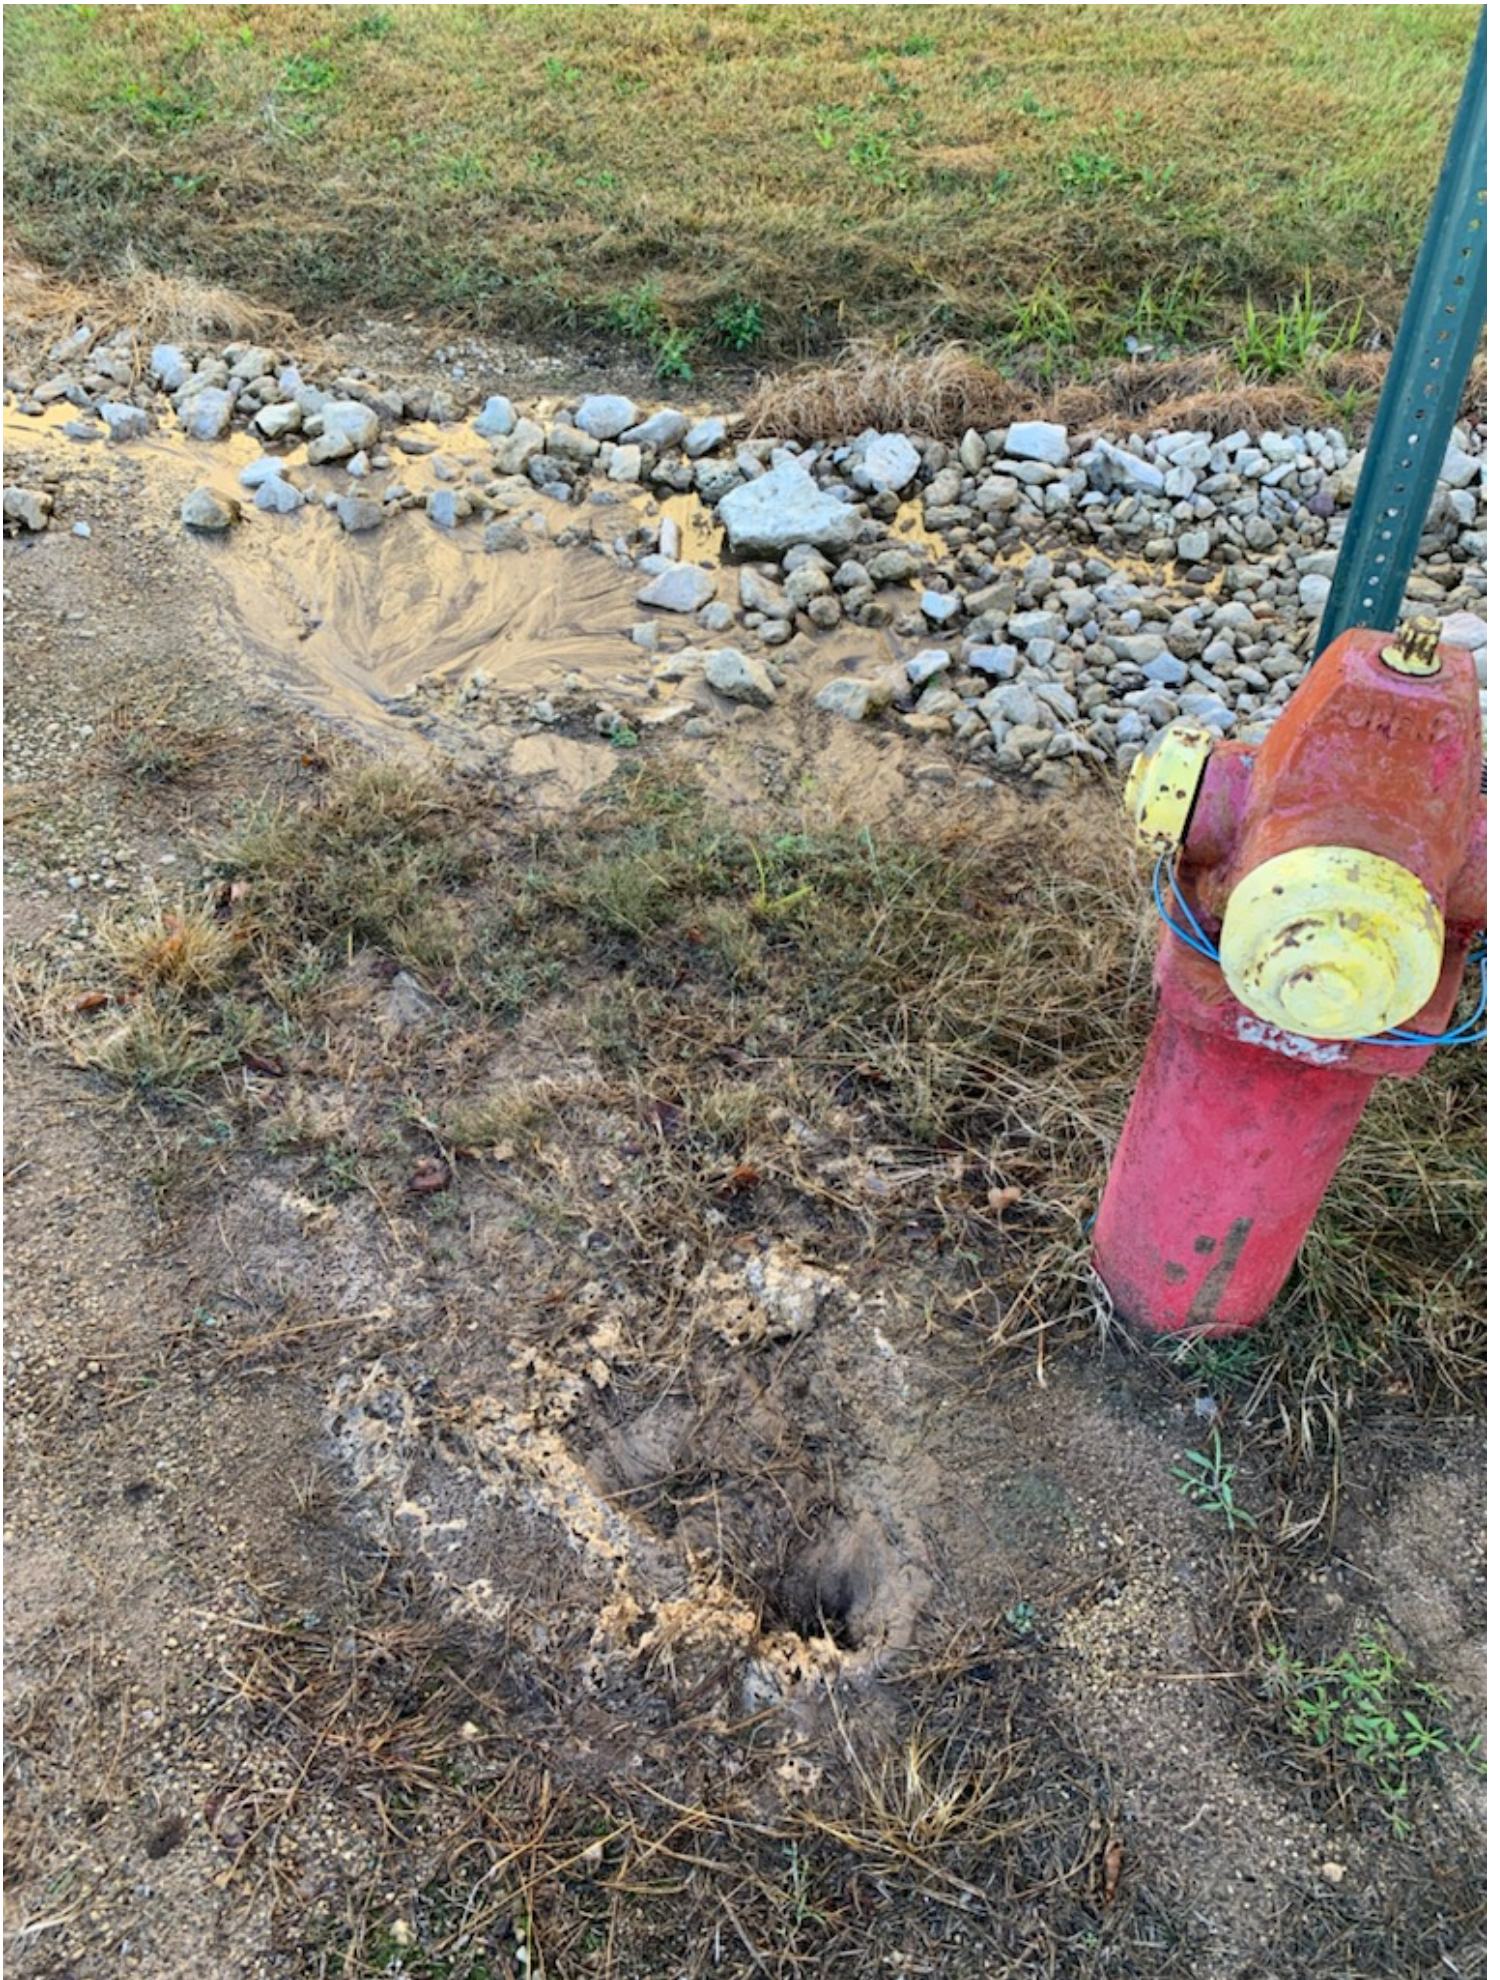
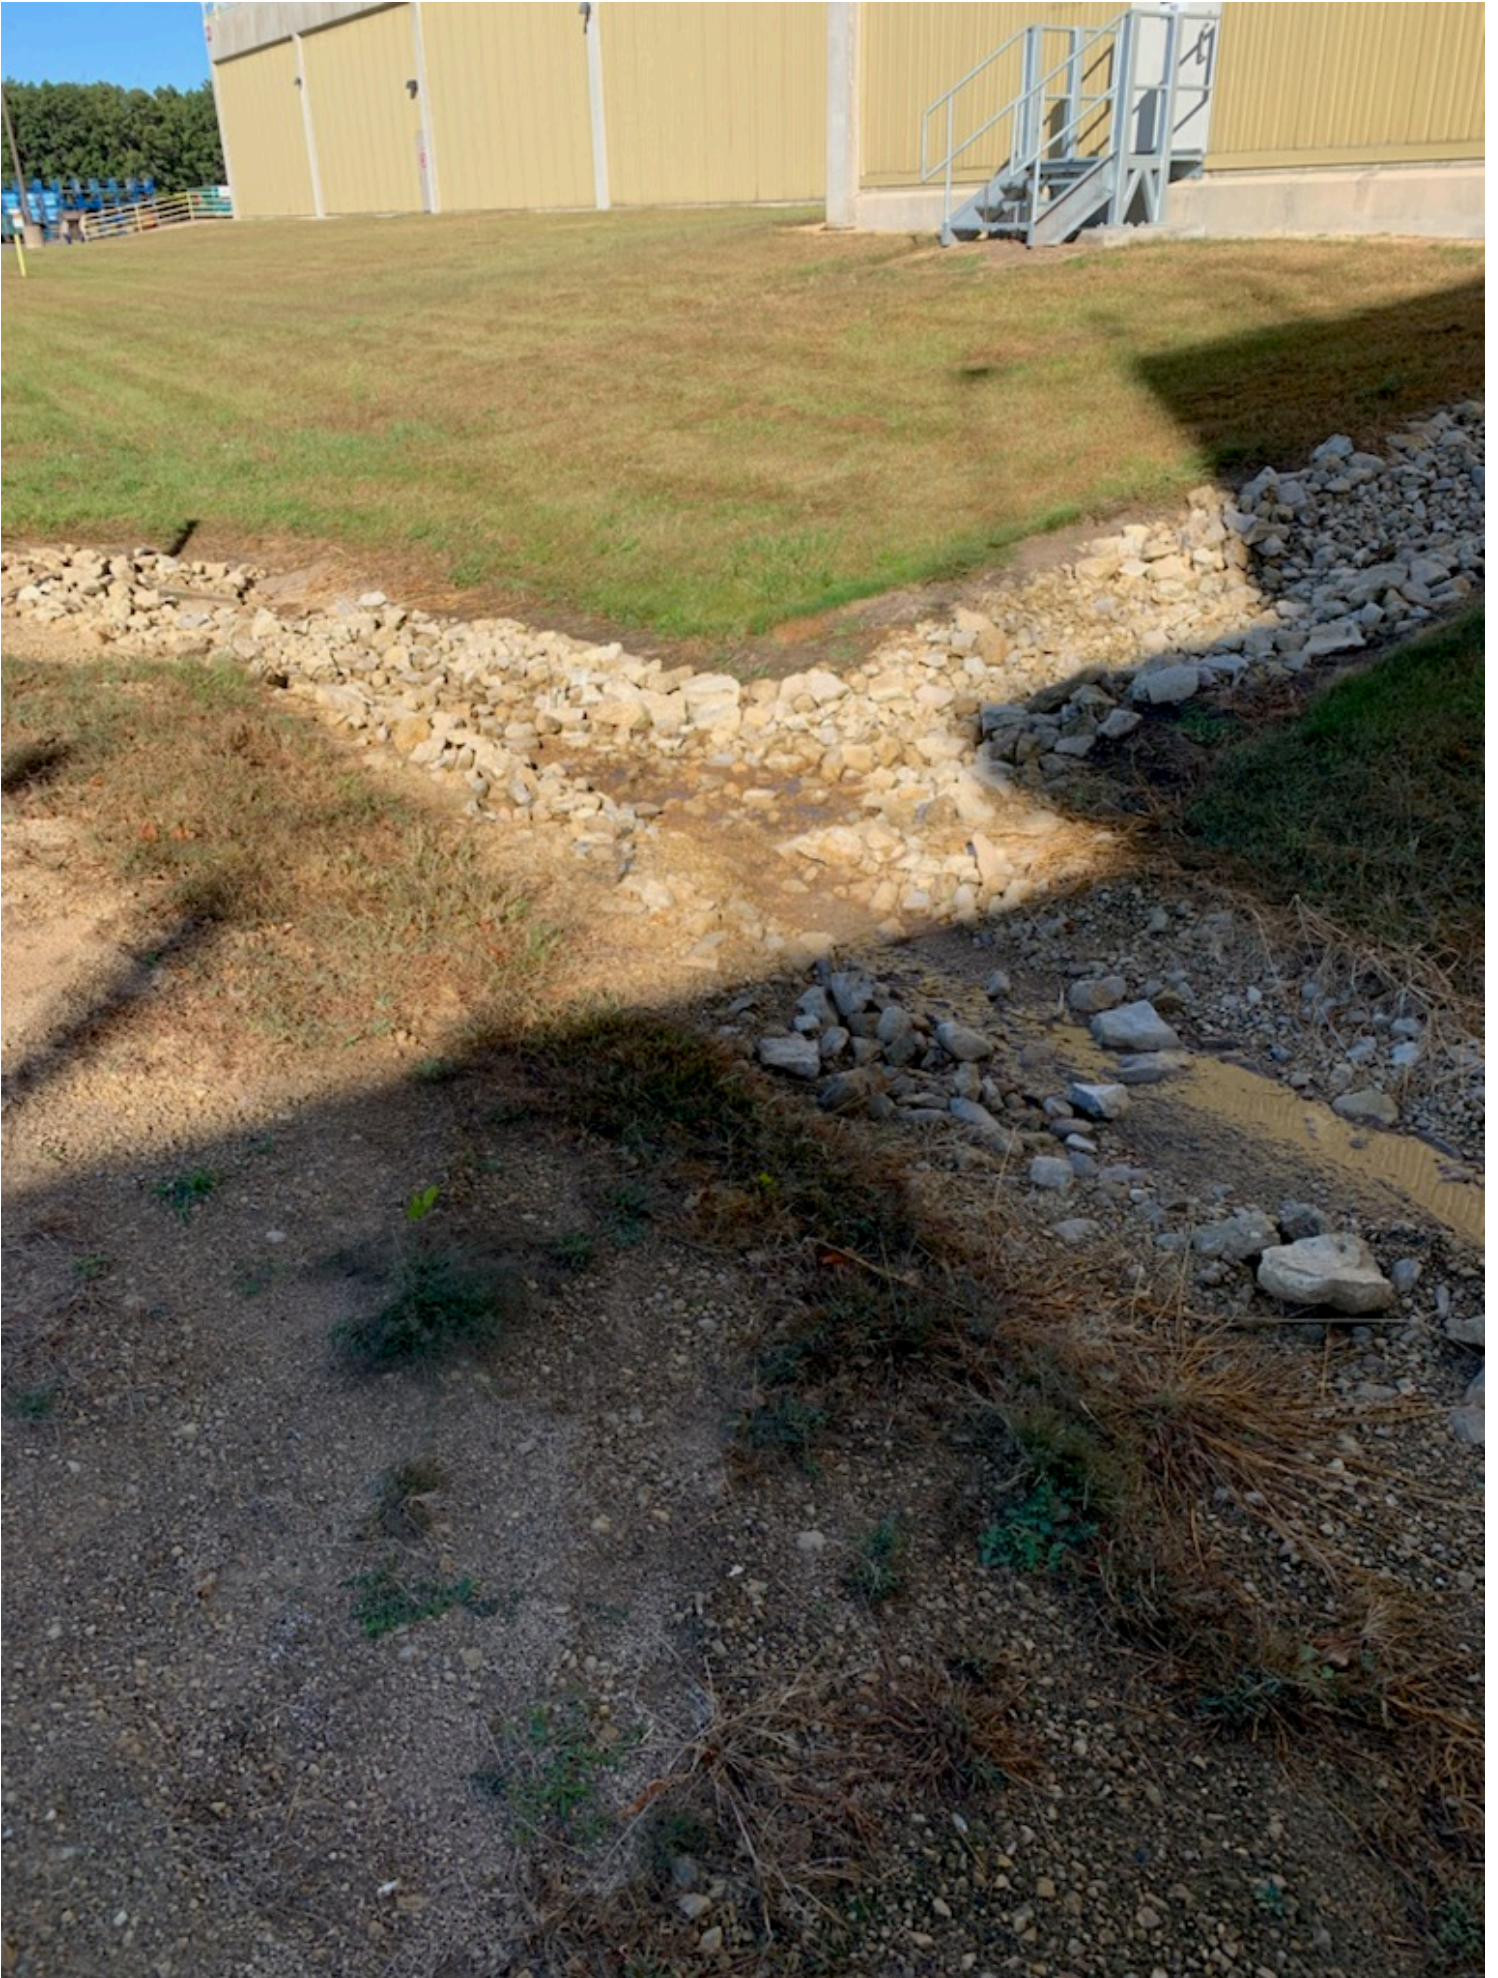
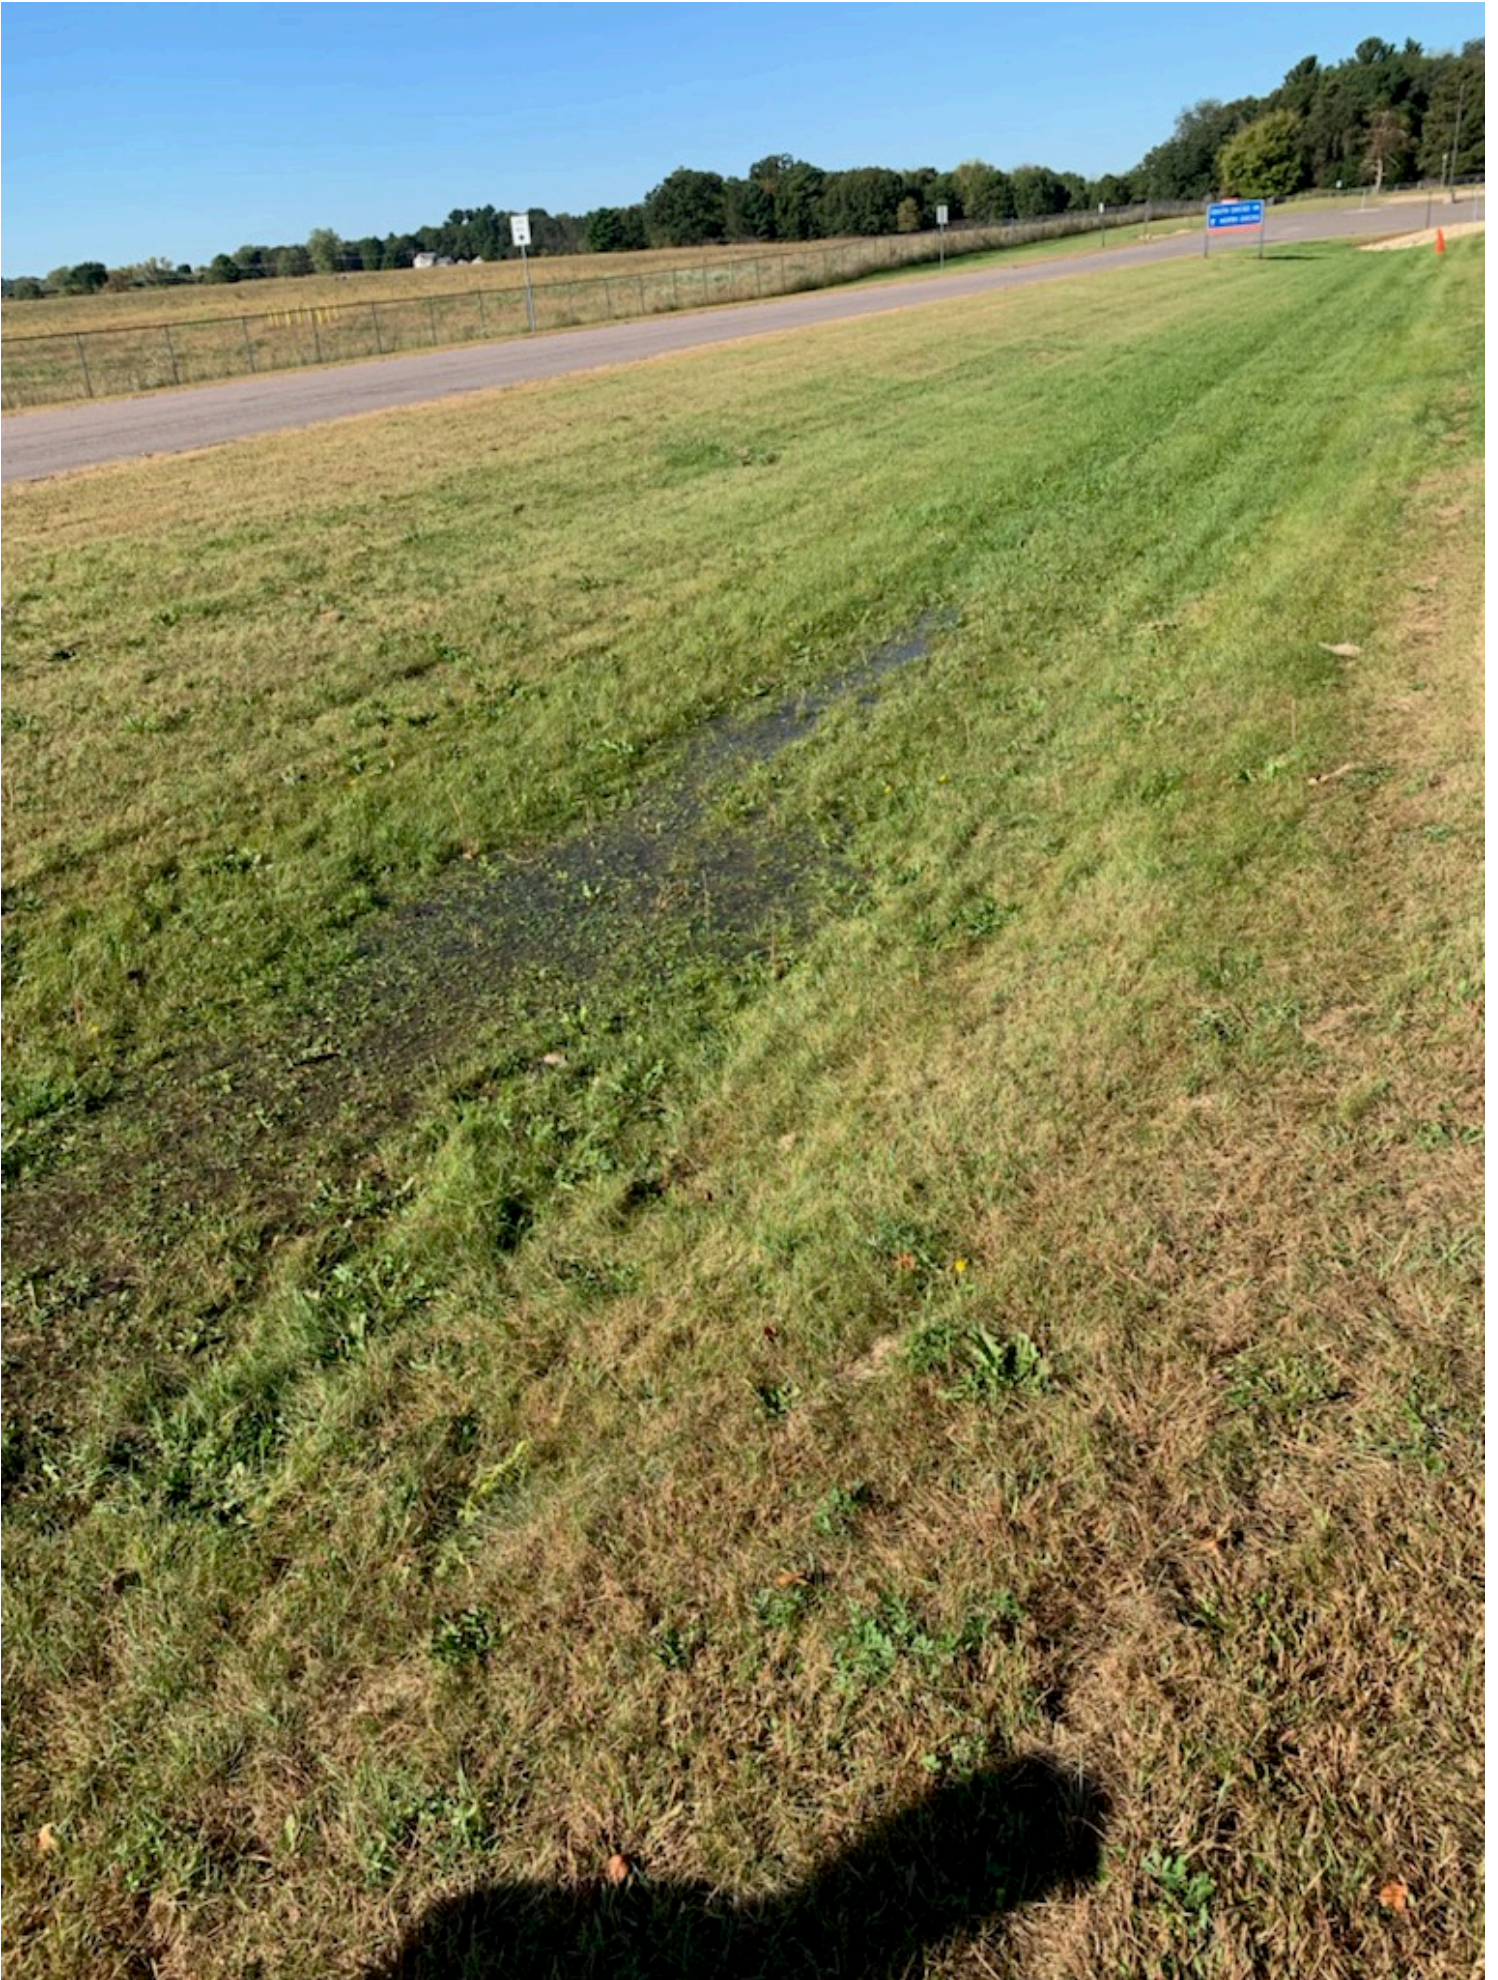
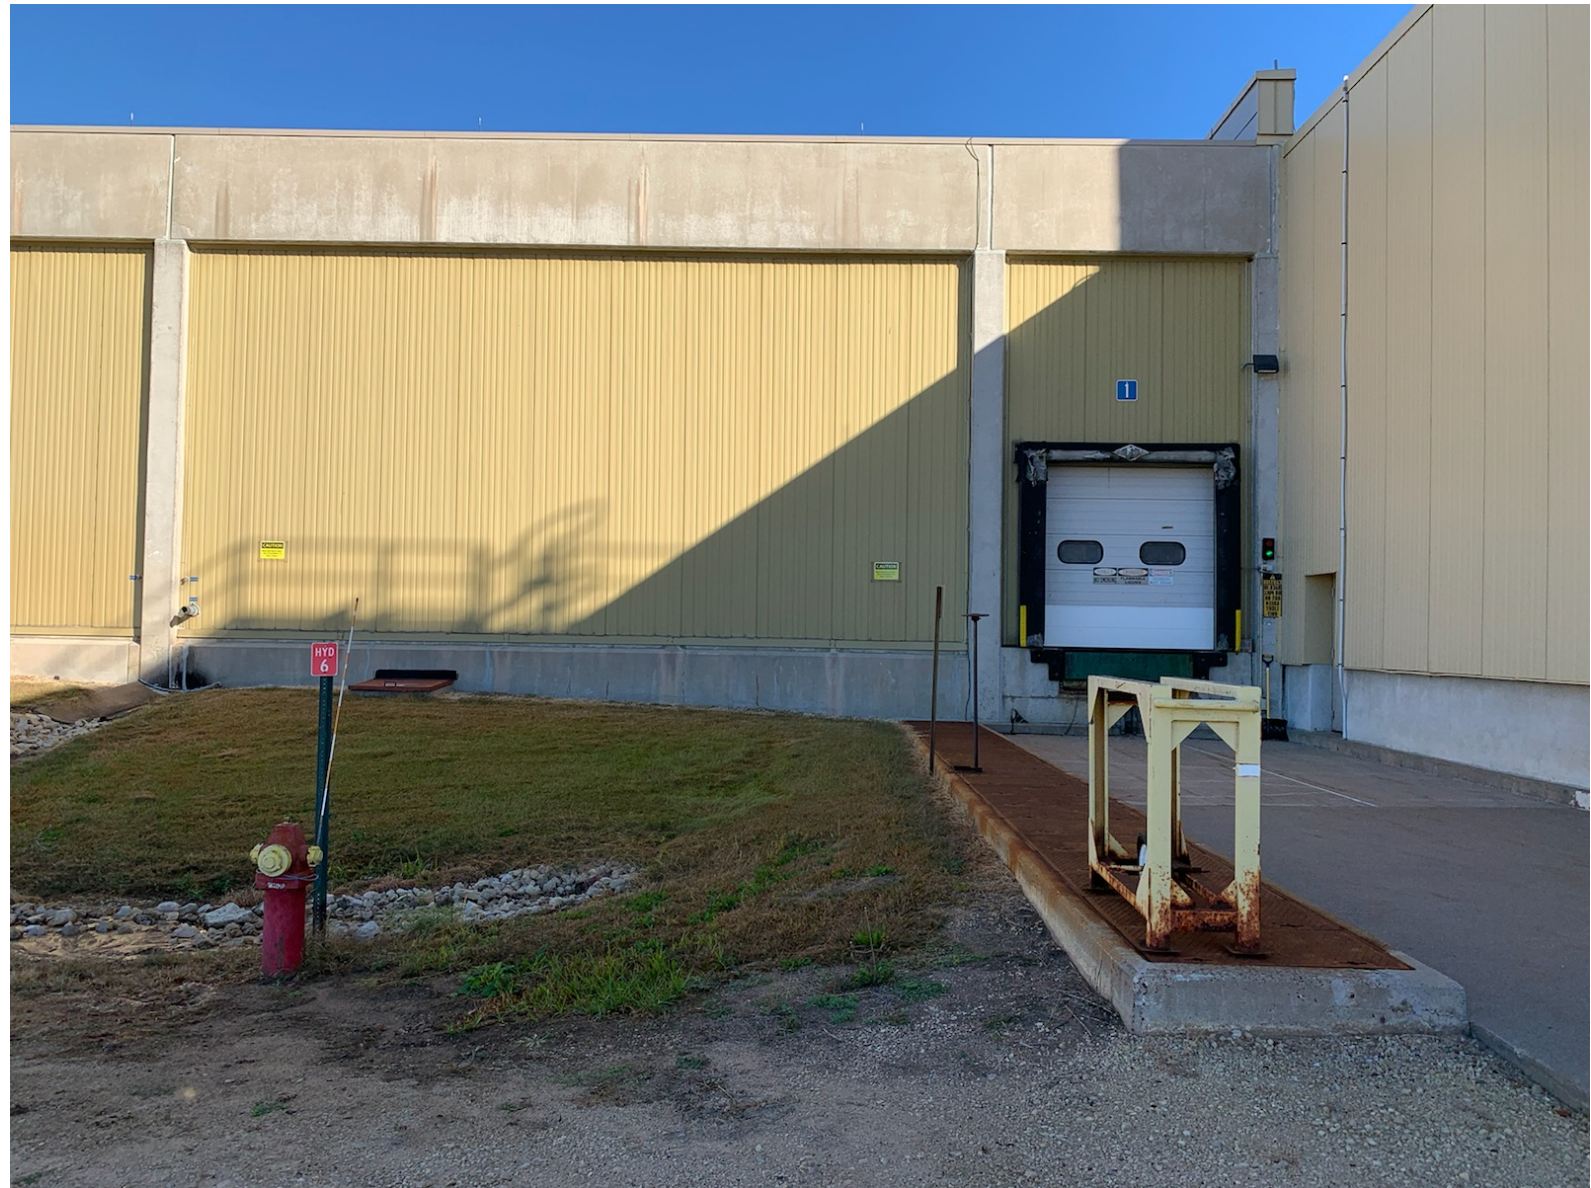
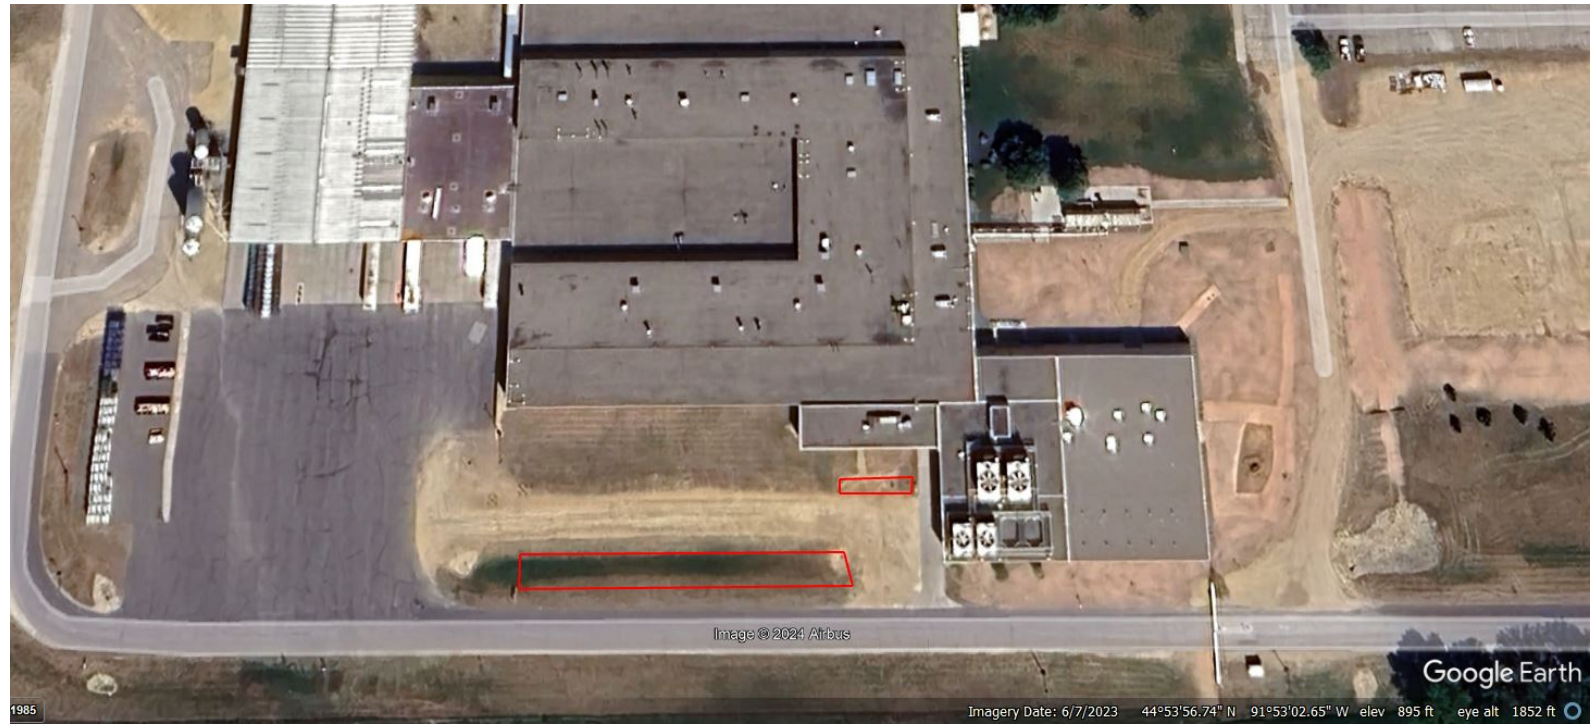
This release is fire suppression water with low/residual concentrations of PFAS materials due to an historic AFFF system release into the main fire water loop. We believe that a pipe or our hydrant developed a crack/leak in the recent past, but do not have any way to estimate the volume released at this time.

There is an active remediation action on-going in the same area of our facility and we would like to move forward with including this area and associated activities under that work umbrella. Could you please let us know what the timeframe for that might be?

Hi LiJane – sorry for the delayed response. At this time, I would recommend you continue with the investigation and attempt to define the degree and extent of this particular release. You had mentioned that some water and soil samples were collected – if that’s the case I will likely keep the spill file open until we get the results from those samples, and any immediate action that you perform and subsequent report (i.e. excavation, sampling, photos) that would coincide with those actions (NR708).
