**Re: EW1 Shutdown Pilot Study Addendum
Wausau Water Supply Superfund Site
Wausau, Wisconsin**

WAUSAU WATER SUPPLY NPL SITE
 WAUSAU, WISCONSIN
 EWI SHUT-DOWN PILOT STUDY ADDENDUM

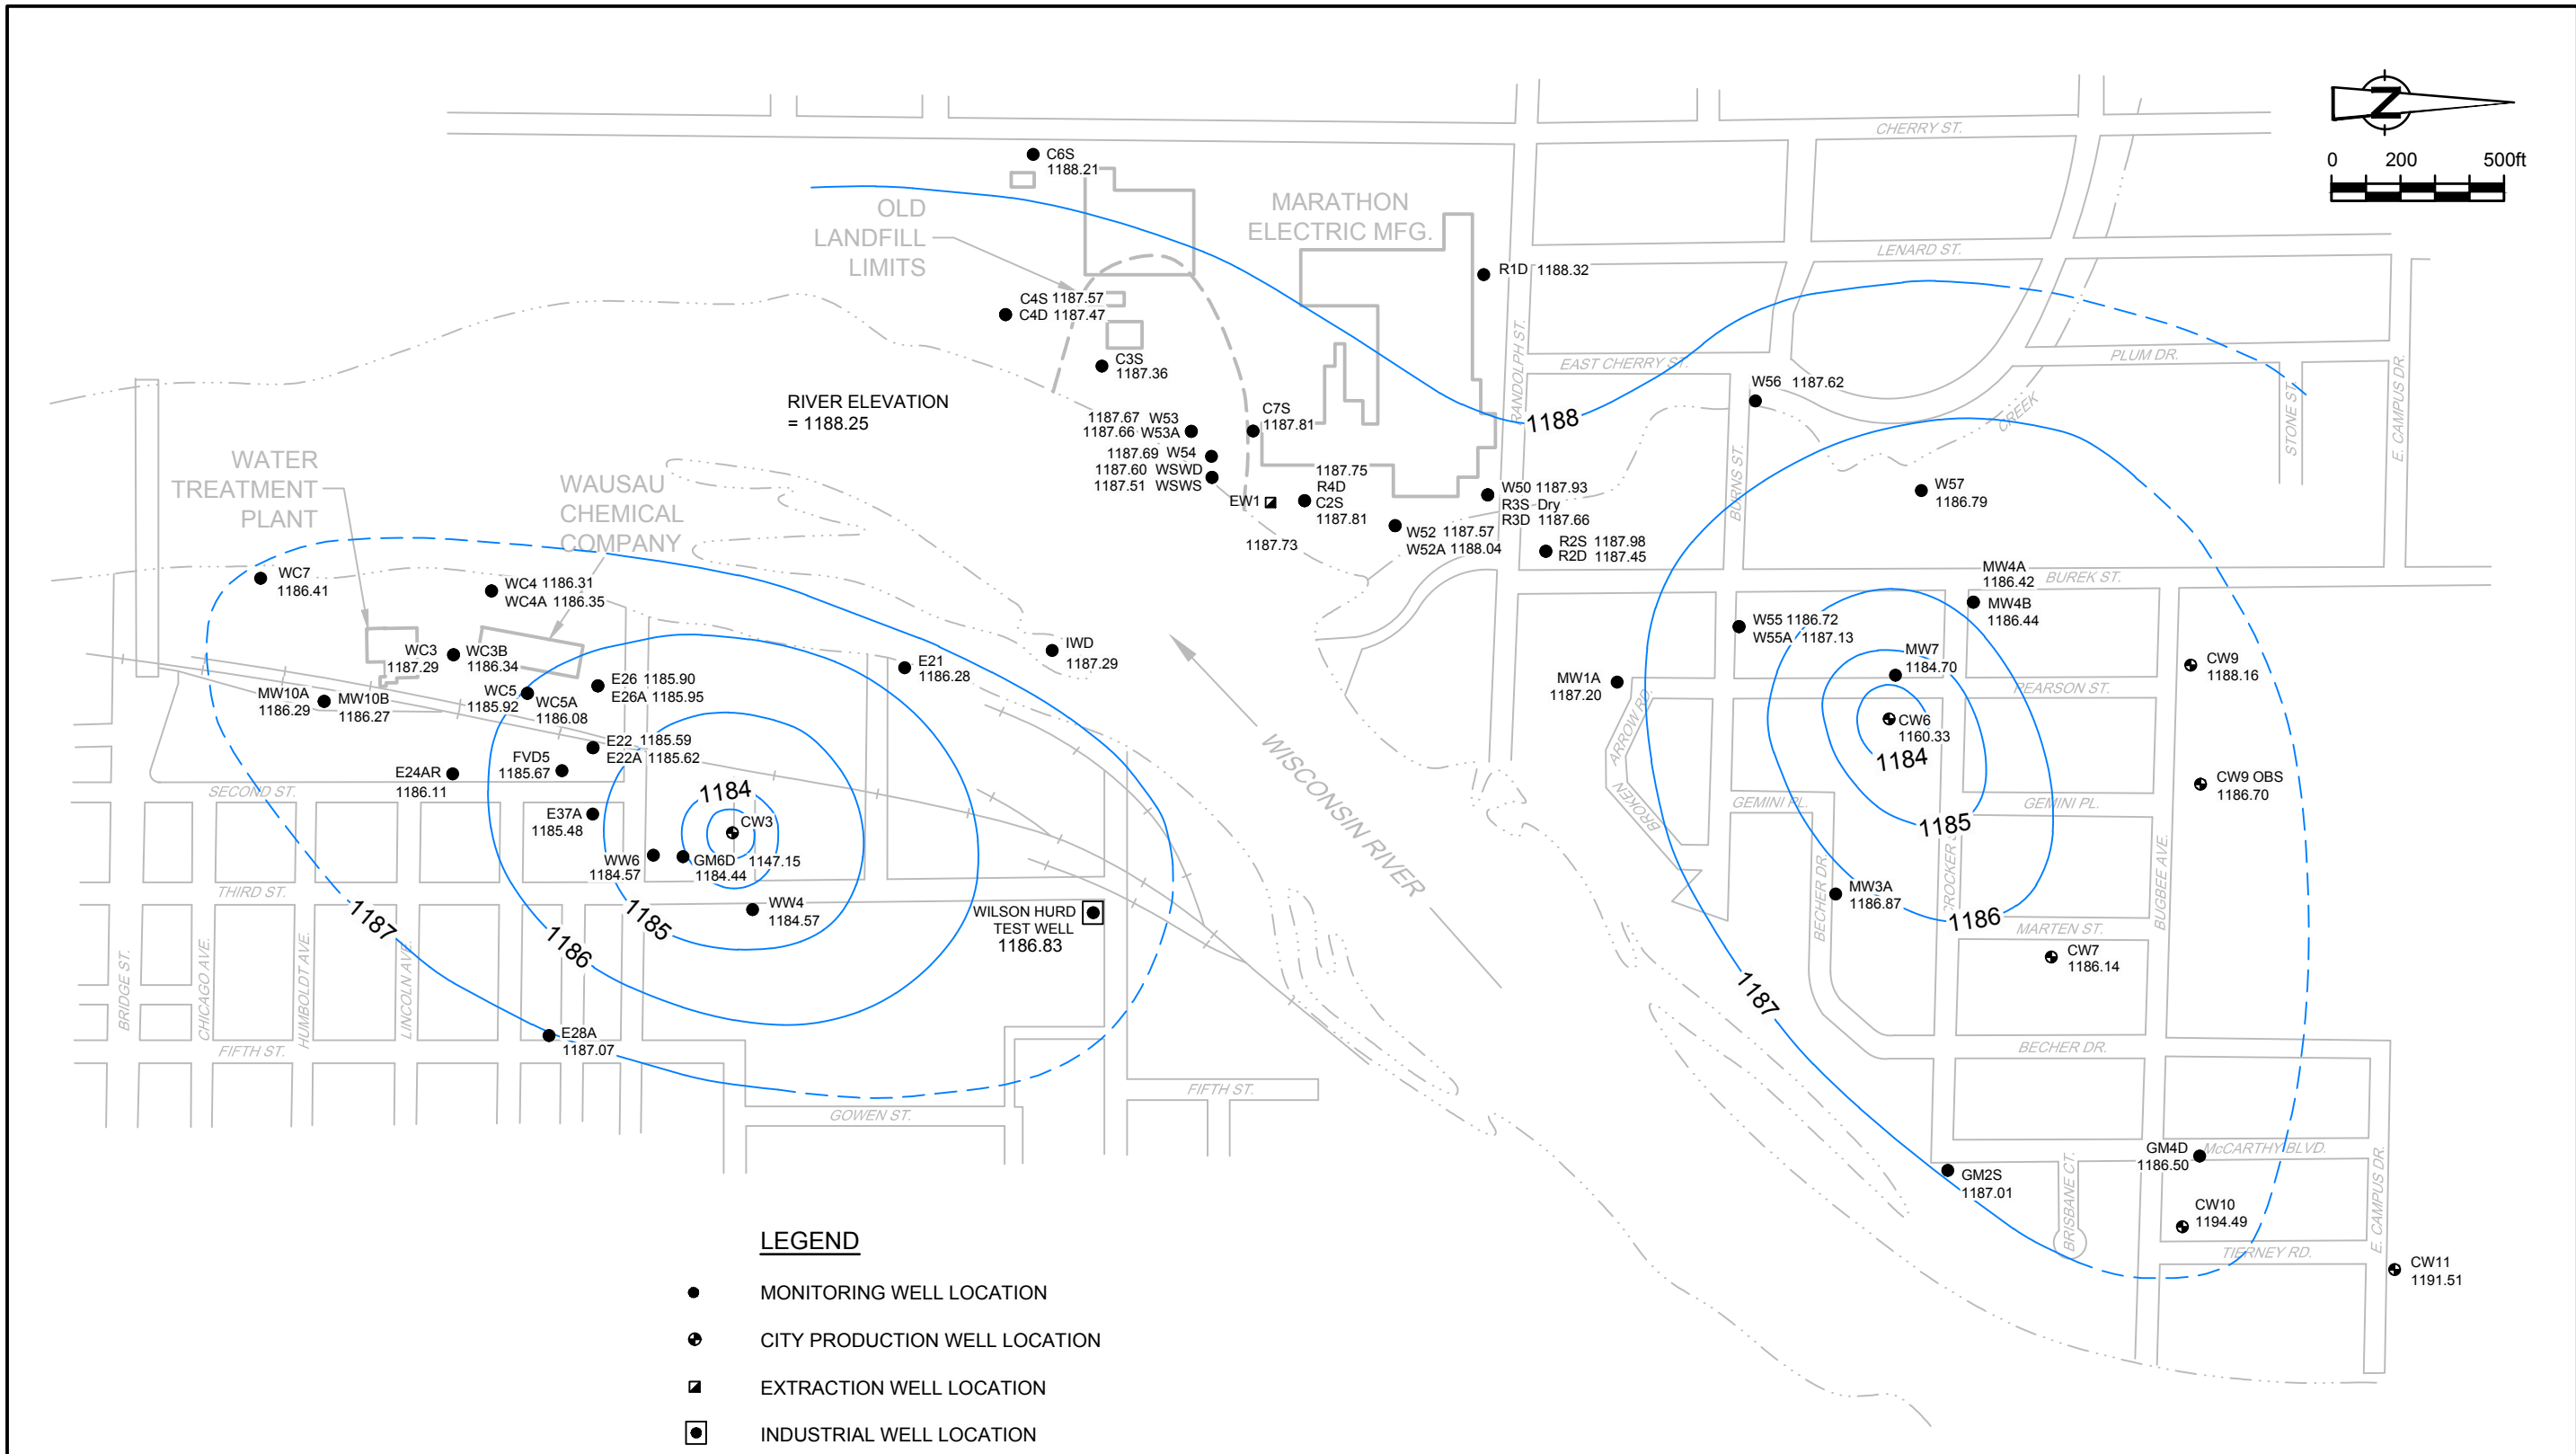
figure 2.1
 GROUNDWATER ELEVATIONS
 NOVEMBER 3, 4, 2014
 WAUSAU WATER SUPPLY NPL SITE
 Wausau, Wisconsin
