MEMORANDUM

DATE : April 2, 2023,
TO : Shane LaFave/ CWC Development
FROM : Pratap Singh and Robert Reineke PE / KSingh
SUBJECT : GC Testing for Community Within the Corridor – East Block
March 31 to April 1, 2023
COPY TO : Project #40441B

PROJECT TITLE: COMMUNITY WITHIN THE CORRIDOR

TCE CONCENTRATIONS 3RD FLOOR

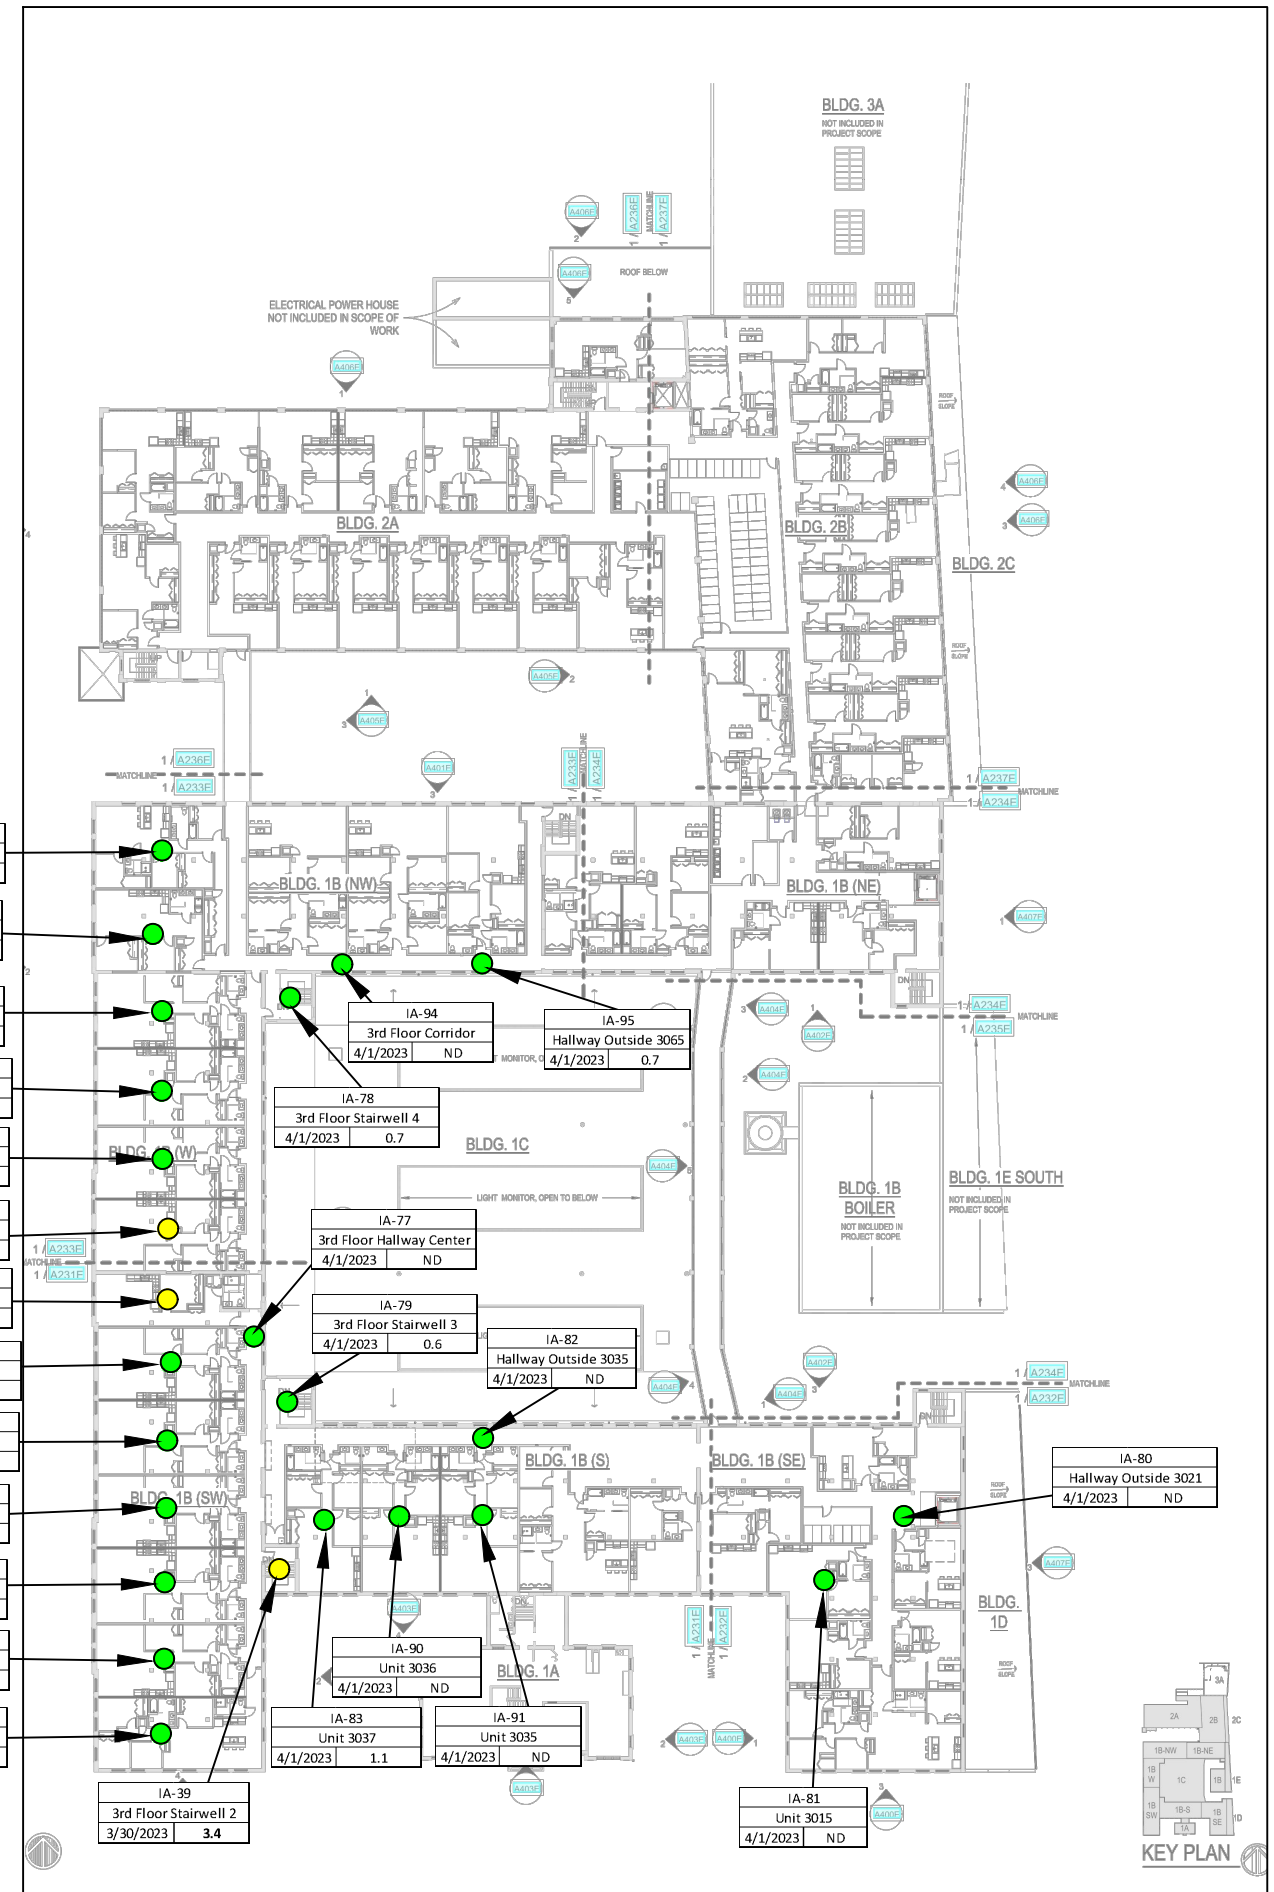
FIGURE 3

- The second floor and third floor also exhibit low levels. However, the levels of TCE on 2nd and 3rd floor appear to be related to 1st floor units 1045 and 1050 respectively.

1. CIRCLES REPRESENT APPROXIMATE LOCATION OF TCE SAMPLE POINT

IA-93 Unit 3062 4/1/2023	ND
IA-92 Unit 3061 4/1/2023	ND
IA-88 Unit 3059 4/1/2023	ND
IA-76 Unit 3058 4/1/2023	ND
IA-63 Unit 3057 3/31/2023	ND
IA-62 Unit 3056 3/31/2023	9.6
IA-61 Unit 3045 3/31/2023	6.6
IA-60 Unit 3044 3/31/2023	ND
IA-87 Unit 3043 4/1/2023	ND
IA-86 Unit 3042 4/1/2023	ND
IA-85 Unit 3041 4/1/2023	ND
IA-84 Unit 3040 4/1/2023	ND
IA-89 Unit 3039 4/1/2023	ND
IA-39 3rd Floor Stairwell 2 3/30/2023	3.4
IA-83 Unit 3037 4/1/2023	1.1
IA-90 Unit 3036 4/1/2023	ND
IA-91 Unit 3035 4/1/2023	ND
IA-81 Unit 3015 4/1/2023	ND
IA-94 3rd Floor Corridor 4/1/2023	ND
IA-95 Hallway Outside 3065 4/1/2023	0.7
IA-78 3rd Floor Stairwell 4 4/1/2023	0.7
IA-77 3rd Floor Hallway Center 4/1/2023	ND
IA-79 3rd Floor Stairwell 3 4/1/2023	0.6
IA-82 Hallway Outside 3035 4/1/2023	ND
IA-80 Hallway Outside 3021 4/1/2023	ND
