A LAKE PROTECTION PLAN FOR SCHOOL SECTION LAKE

**COMMUNITY ASSISTANCE PLANNING REPORT
NUMBER 319**

**A LAKE PROTECTION PLAN FOR SCHOOL SECTION LAKE
WAUKESHA COUNTY, WISCONSIN**

December 2014

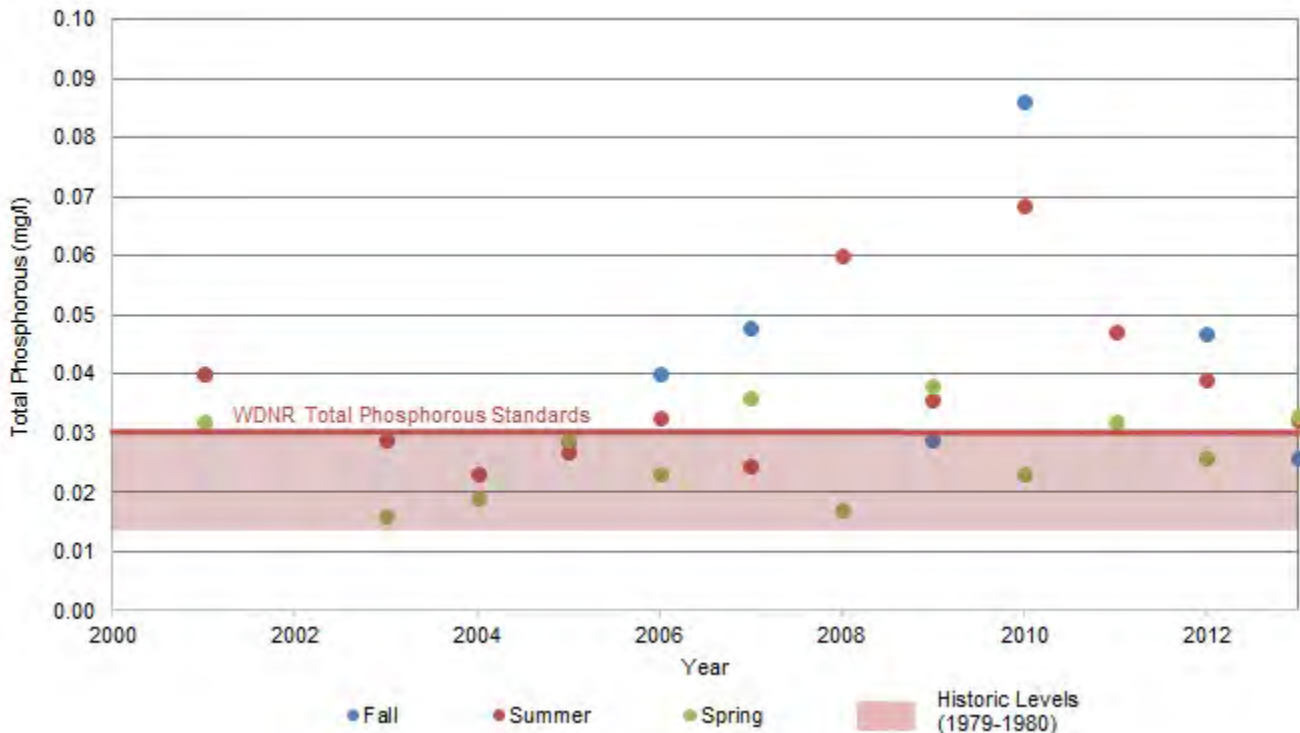
SEASONAL TOTAL PHOSPHORUS CONCENTRATIONS IN SCHOOL SECTION LAKE:
2000-2013 vs. HISTORIC LEVELS
