EQUIPMENT RECORDING SONAR MAPPED MAY 1970

Source: Wisconsin Department of Natural Resources 608-266-2621
Oak Creek Parkway Pond – Milwaukee County, Wisconsin DNR Lake Map
Date – May 1970 - Historical Lake Map - Not for Navigation
A Public Document - Please Identify the Source when using it.

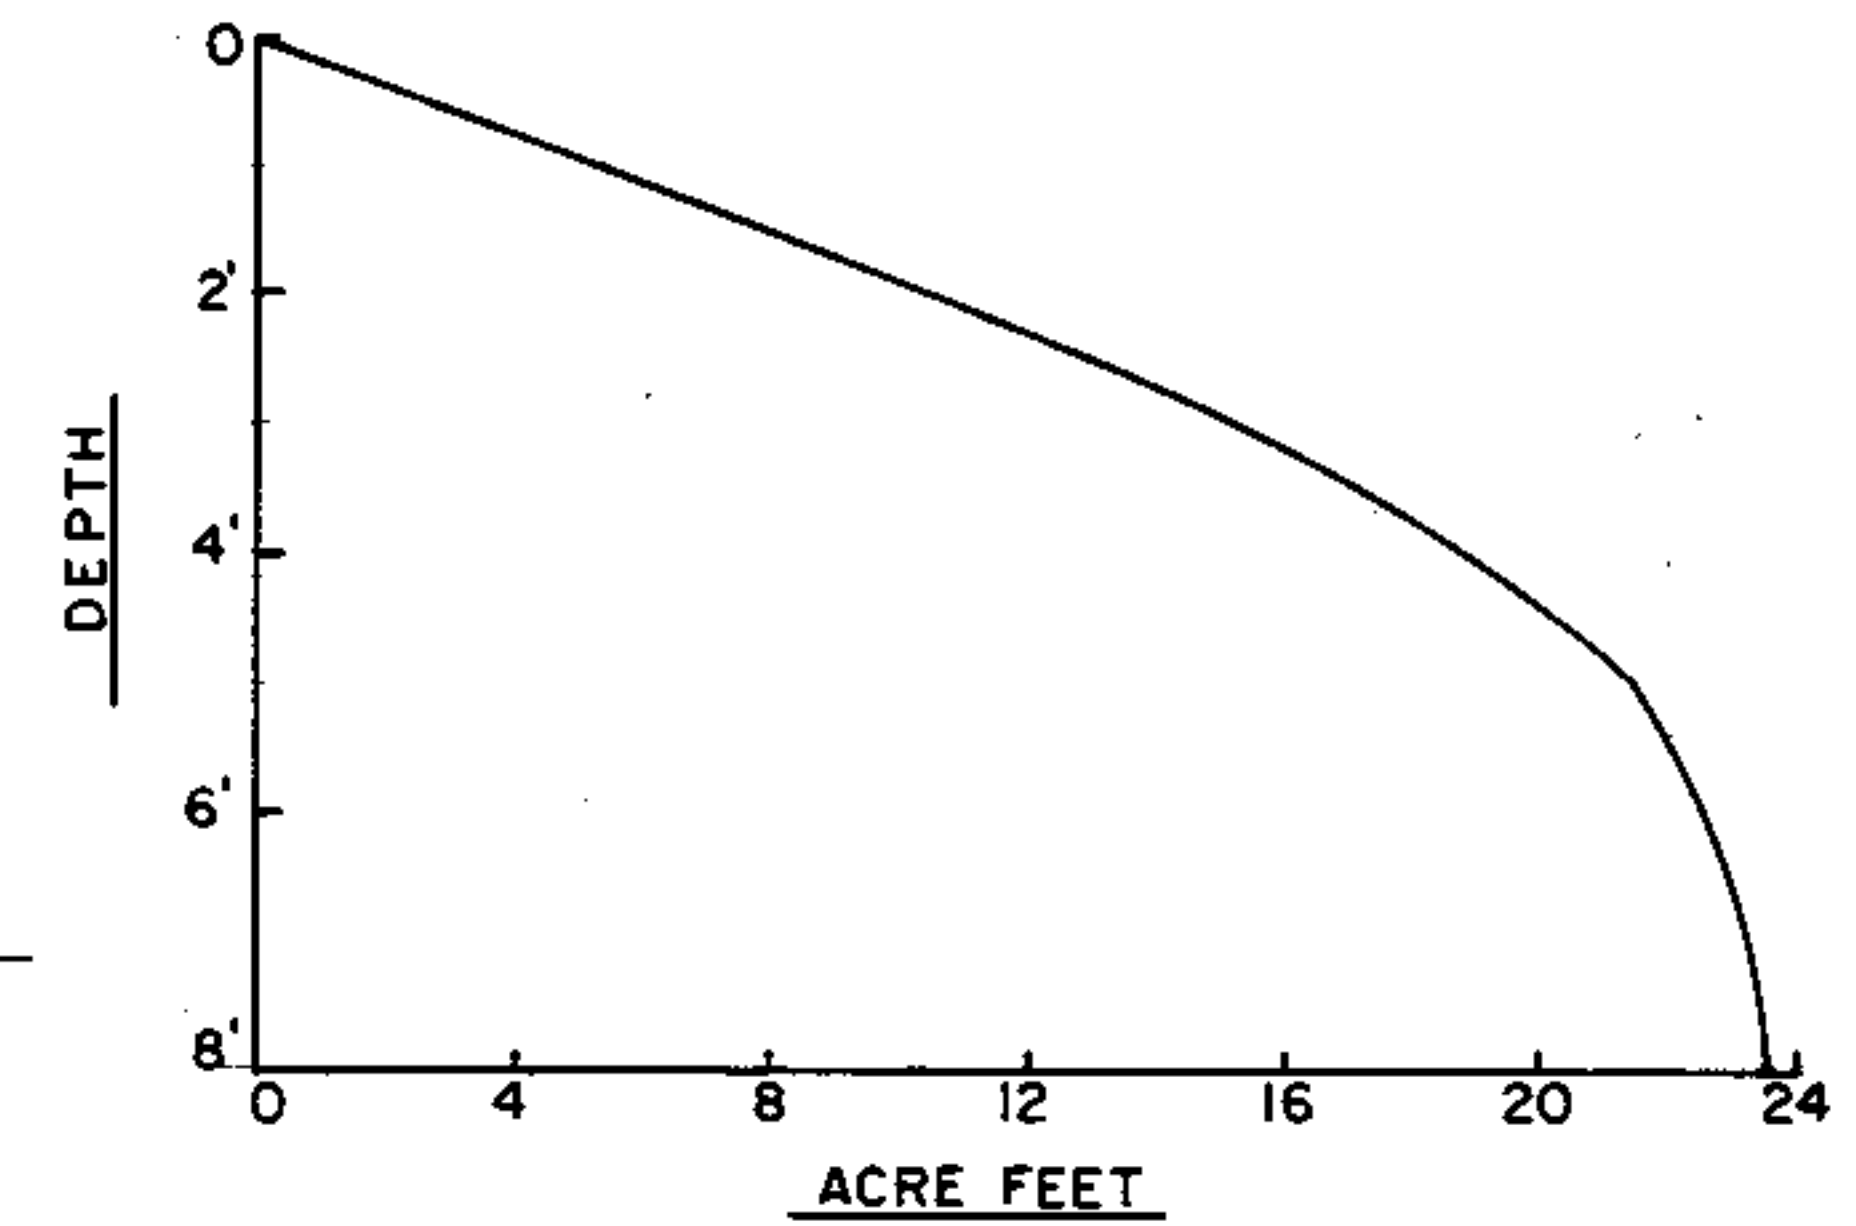
Department of Natural Resources Bench Mark.
Eastern-most edge of boat dock (concrete footing)
Assumed Elevation 100.00'
Water Elevation 98.25' (May 1970)

WATER AREA 5.4 ACRES
 UNDER 3 FT. 13 %
 OVER 20 FT. 0 %
 MAX. DEPTH 8 FEET.
 TOTAL ALK. 264 P.P.M.
 VOLUME 23.6 ACRE FT.
 SHORELINE 0.57 MILES
 0.47 MILES OF SHORELINE
 EXCLUDING ISLAND
