Field work by: H. Schmude Drawn by: E.Ecton <u>JUNE 1963</u> LAKE MAPPED___ SOURCE OF INFORMATION W. C.D. SONAR SOUNDINGS____ TOTAL ALK. 145 P.P.M.

Source: Wisconsin Department of Natural Resources 608-266-2621 Shoe Lake – Manitowoc County, Wisconsin DNR Lake Map Date – Jun 1963 - Historical Lake Map - Not for Navigation A Public Document - Please Identify the Source when using it.

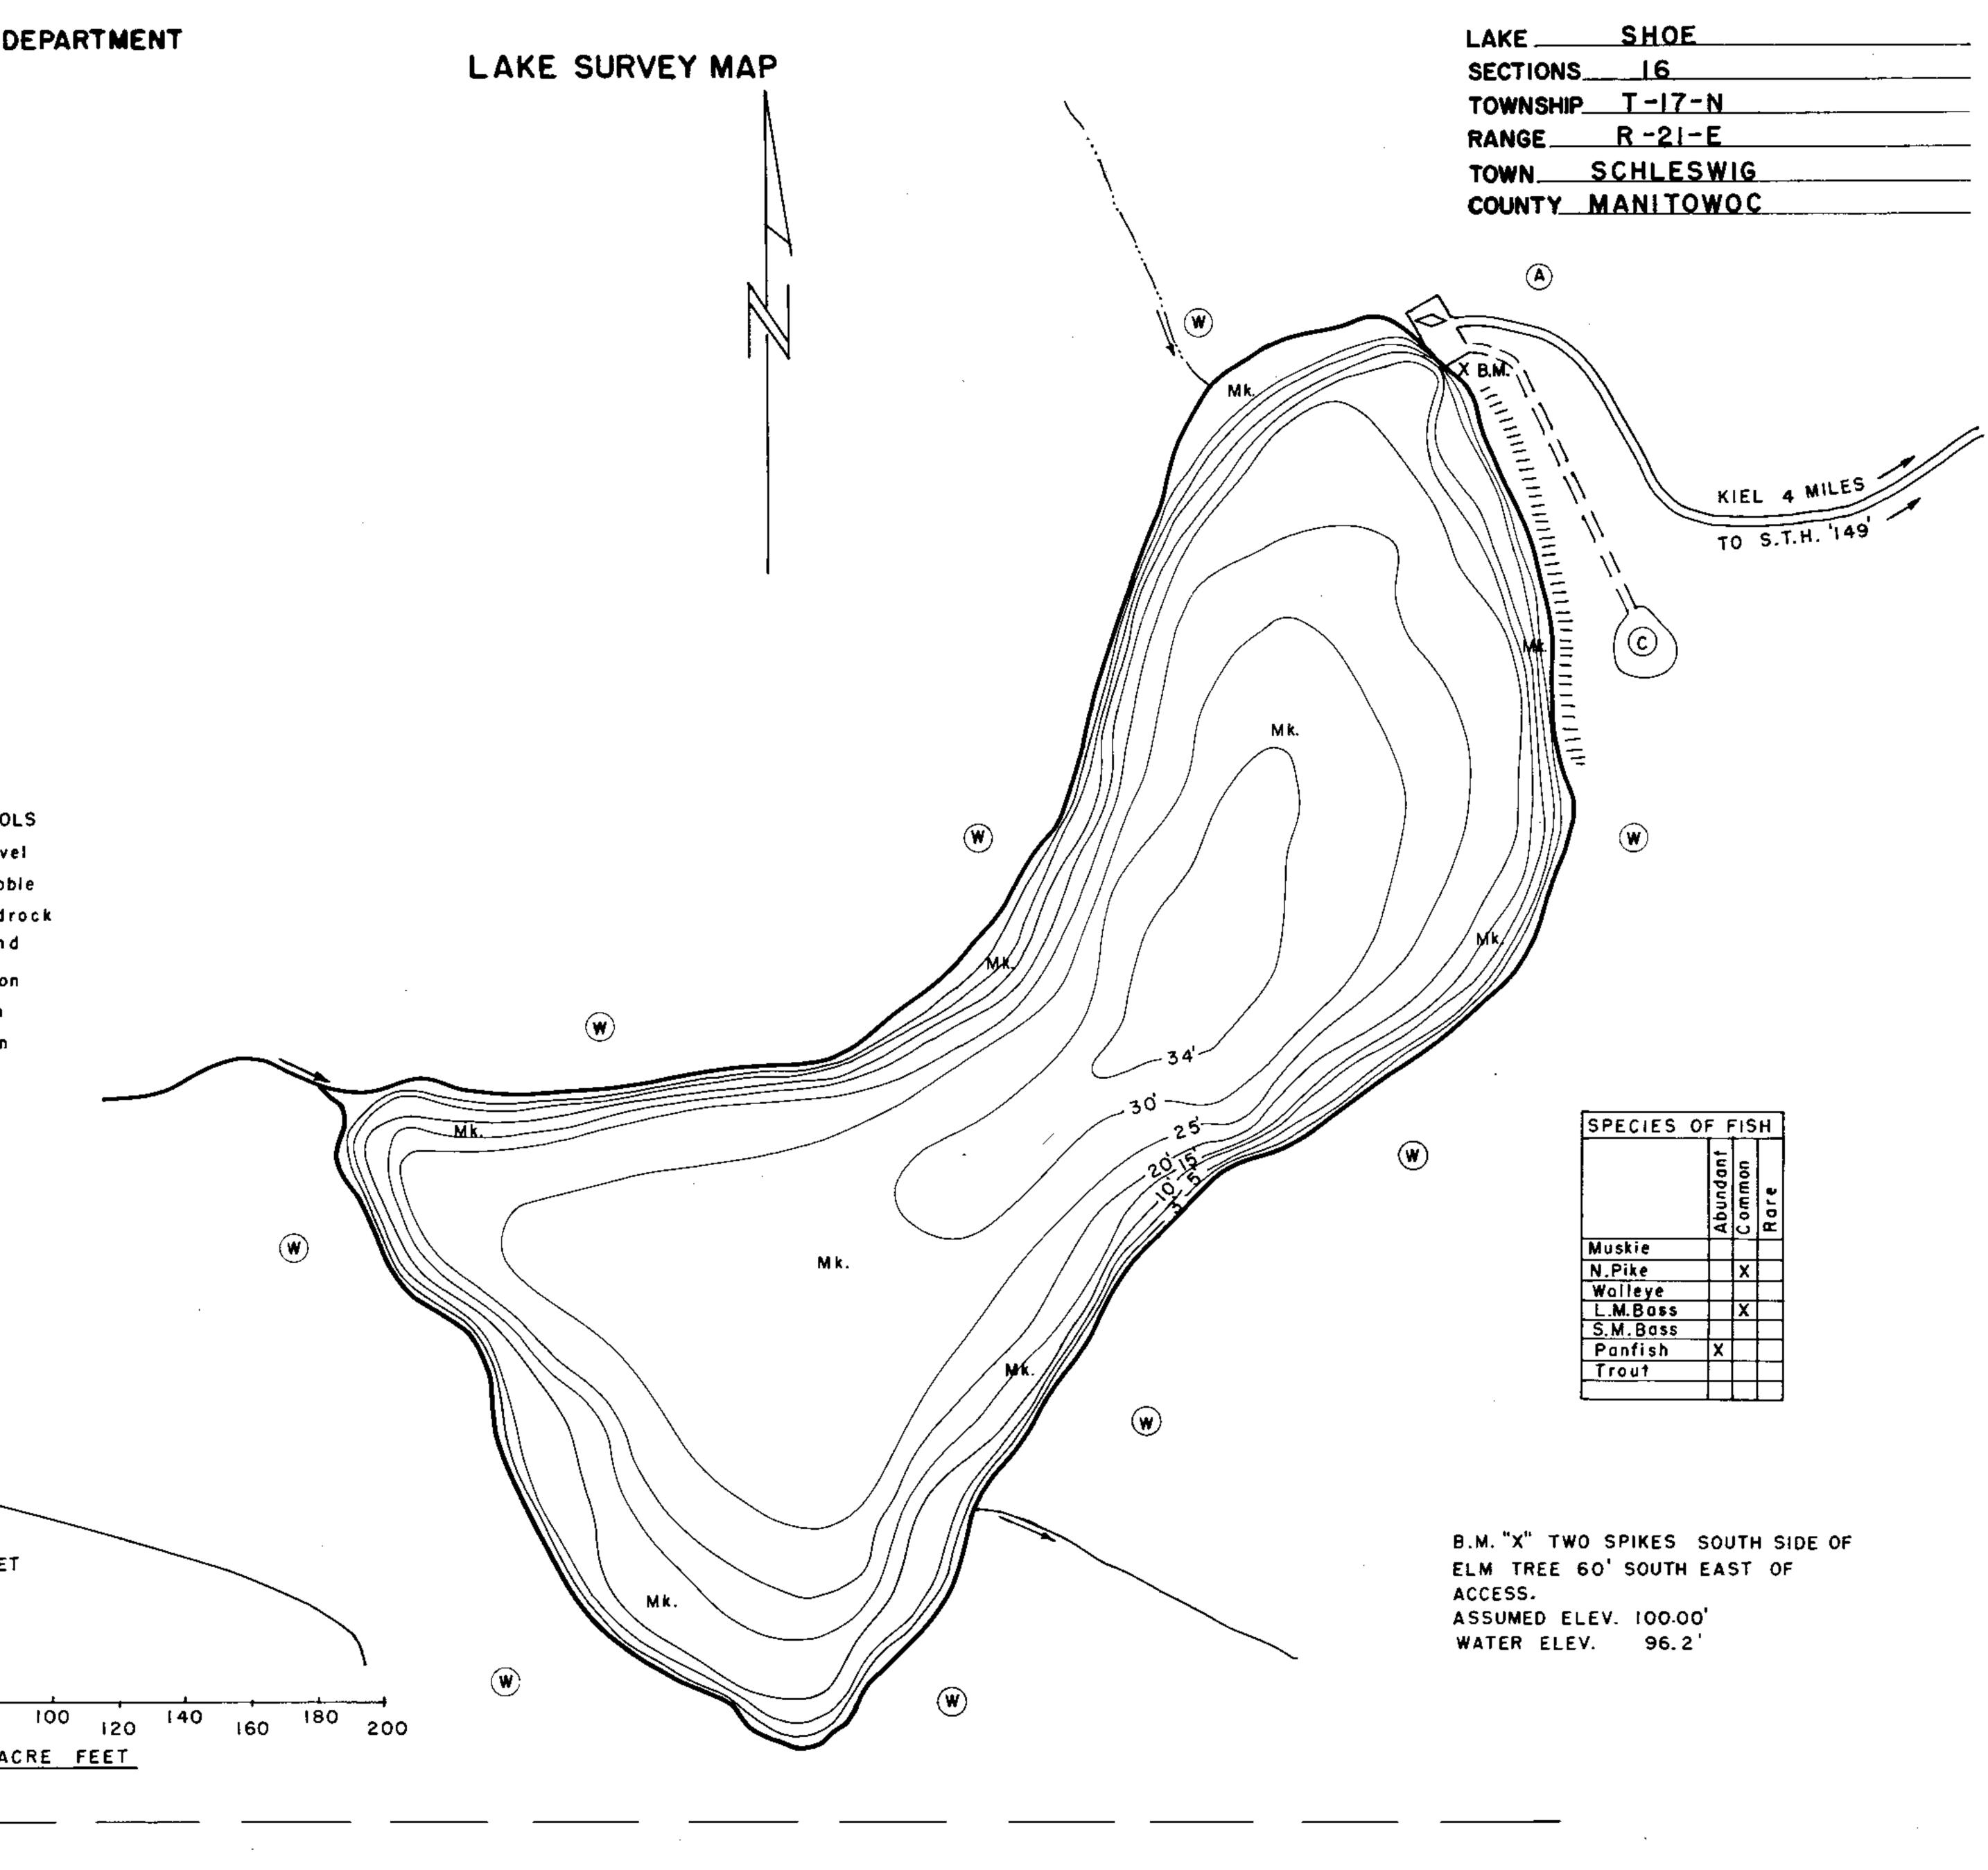
AREA_ TOTAL SHORELINE. MAX. DEPTH UNDER 3'6%

9.2	ACRES
.58	MILES
34	FEET
OVER	20' 64 %
