AREA 272.7 ACRES  
 UNDER 3FT. 14.2 %  
 OVER 20FT. 0 %  
 VOLUME 1,548.1 ACRE FT.  
 TOTAL ALK. 147 P.P.M.  
 SHORELINE 3.4 MILES  
 MAX. DEPTH 10 FEET

Source: Wisconsin Department of Natural Resources 608-266-2621  
Europe Lake - Door County, Wisconsin DNR Lake Map  
Date – Jun 1967 - Historical Lake Map - Not for Navigation  
A Public Document - Please Identify the Source when using it.

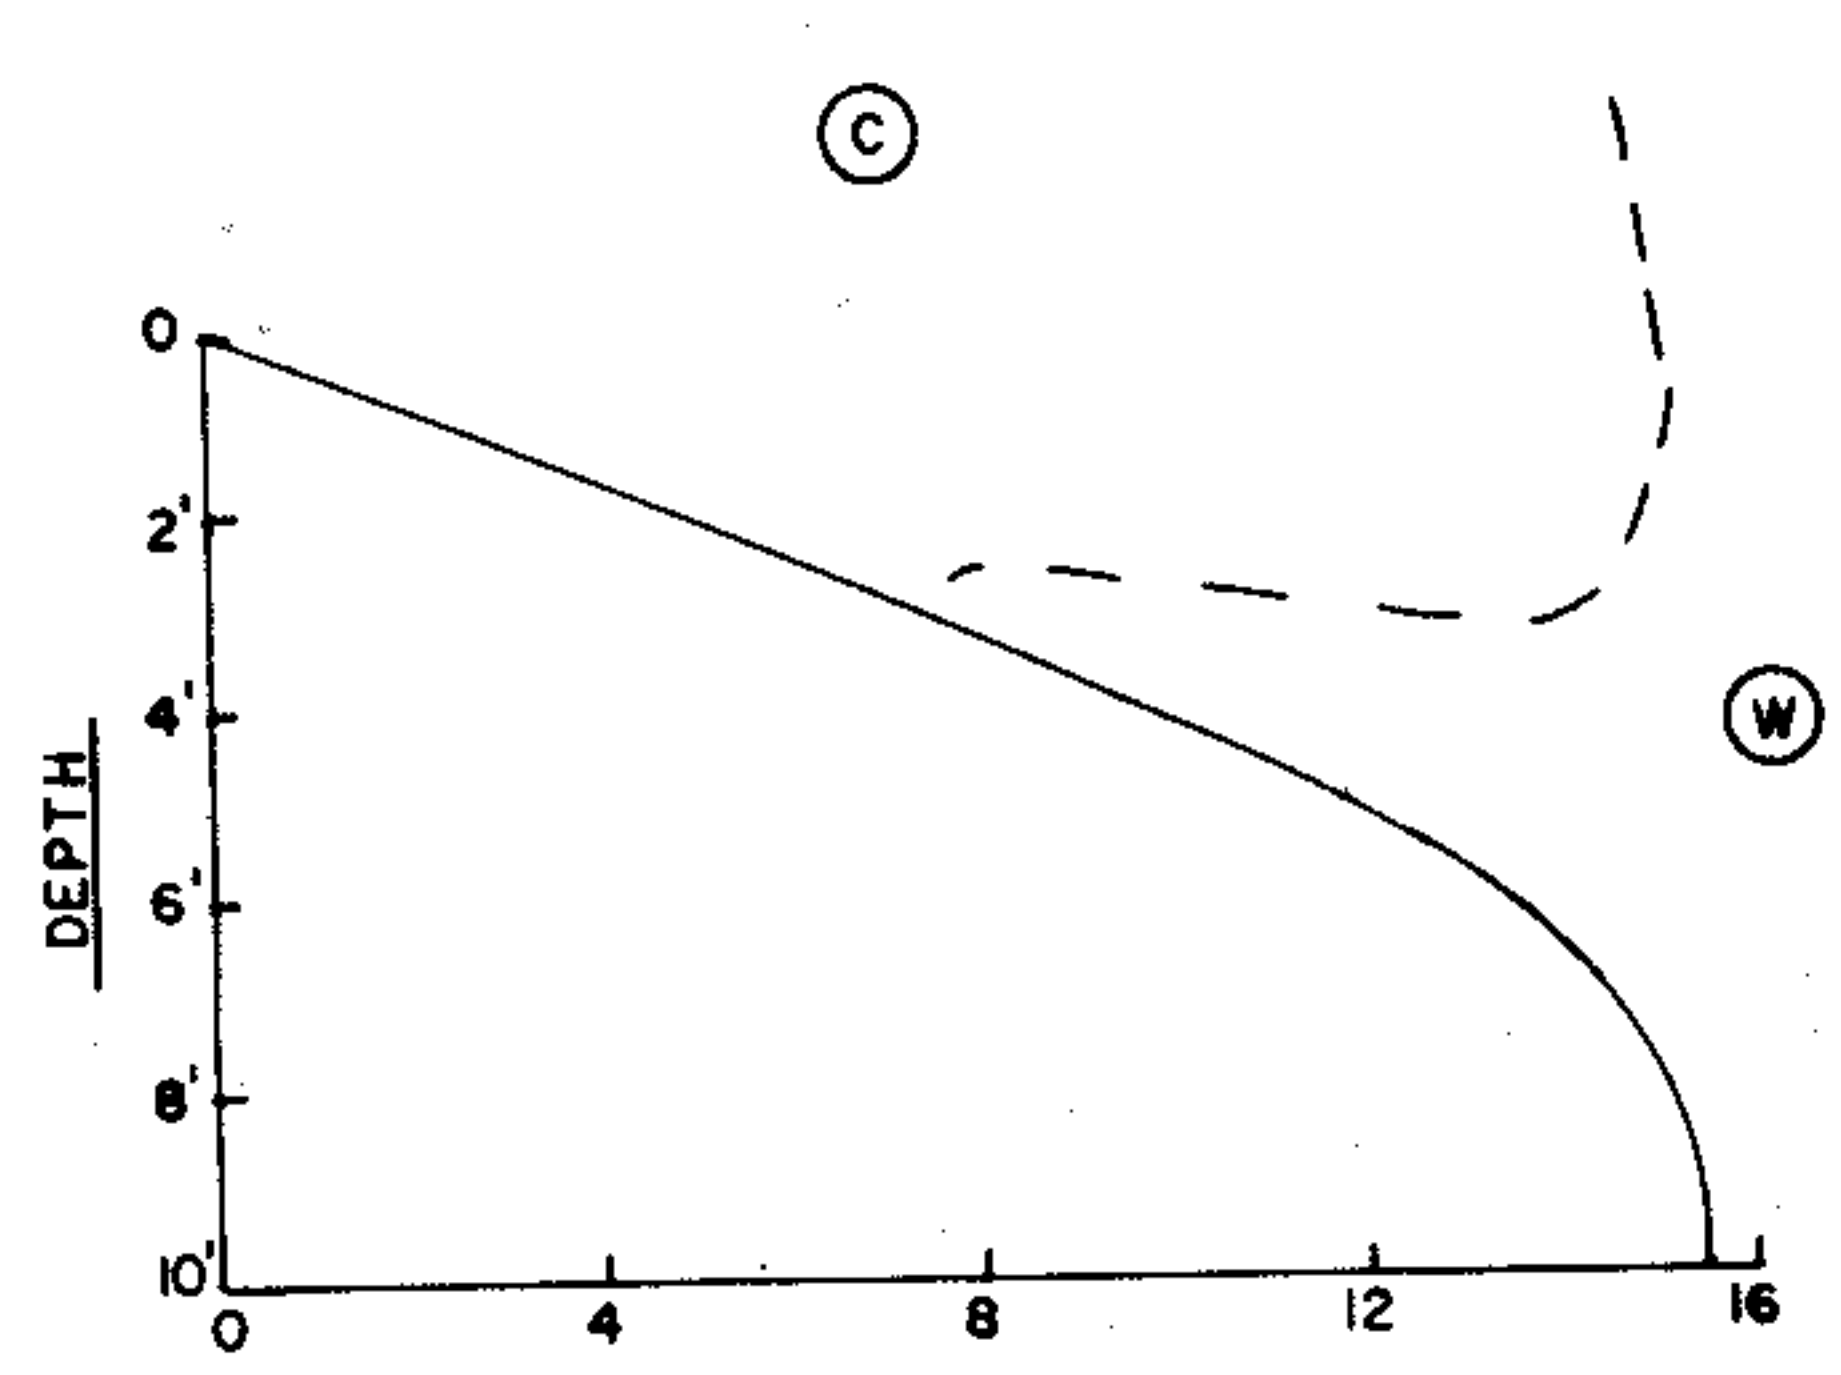
DEPTH  
 0  
2  
4  
6  
8  
10  
 0 4 8 12 16  
 ACRE FEET IN HUNDREDS

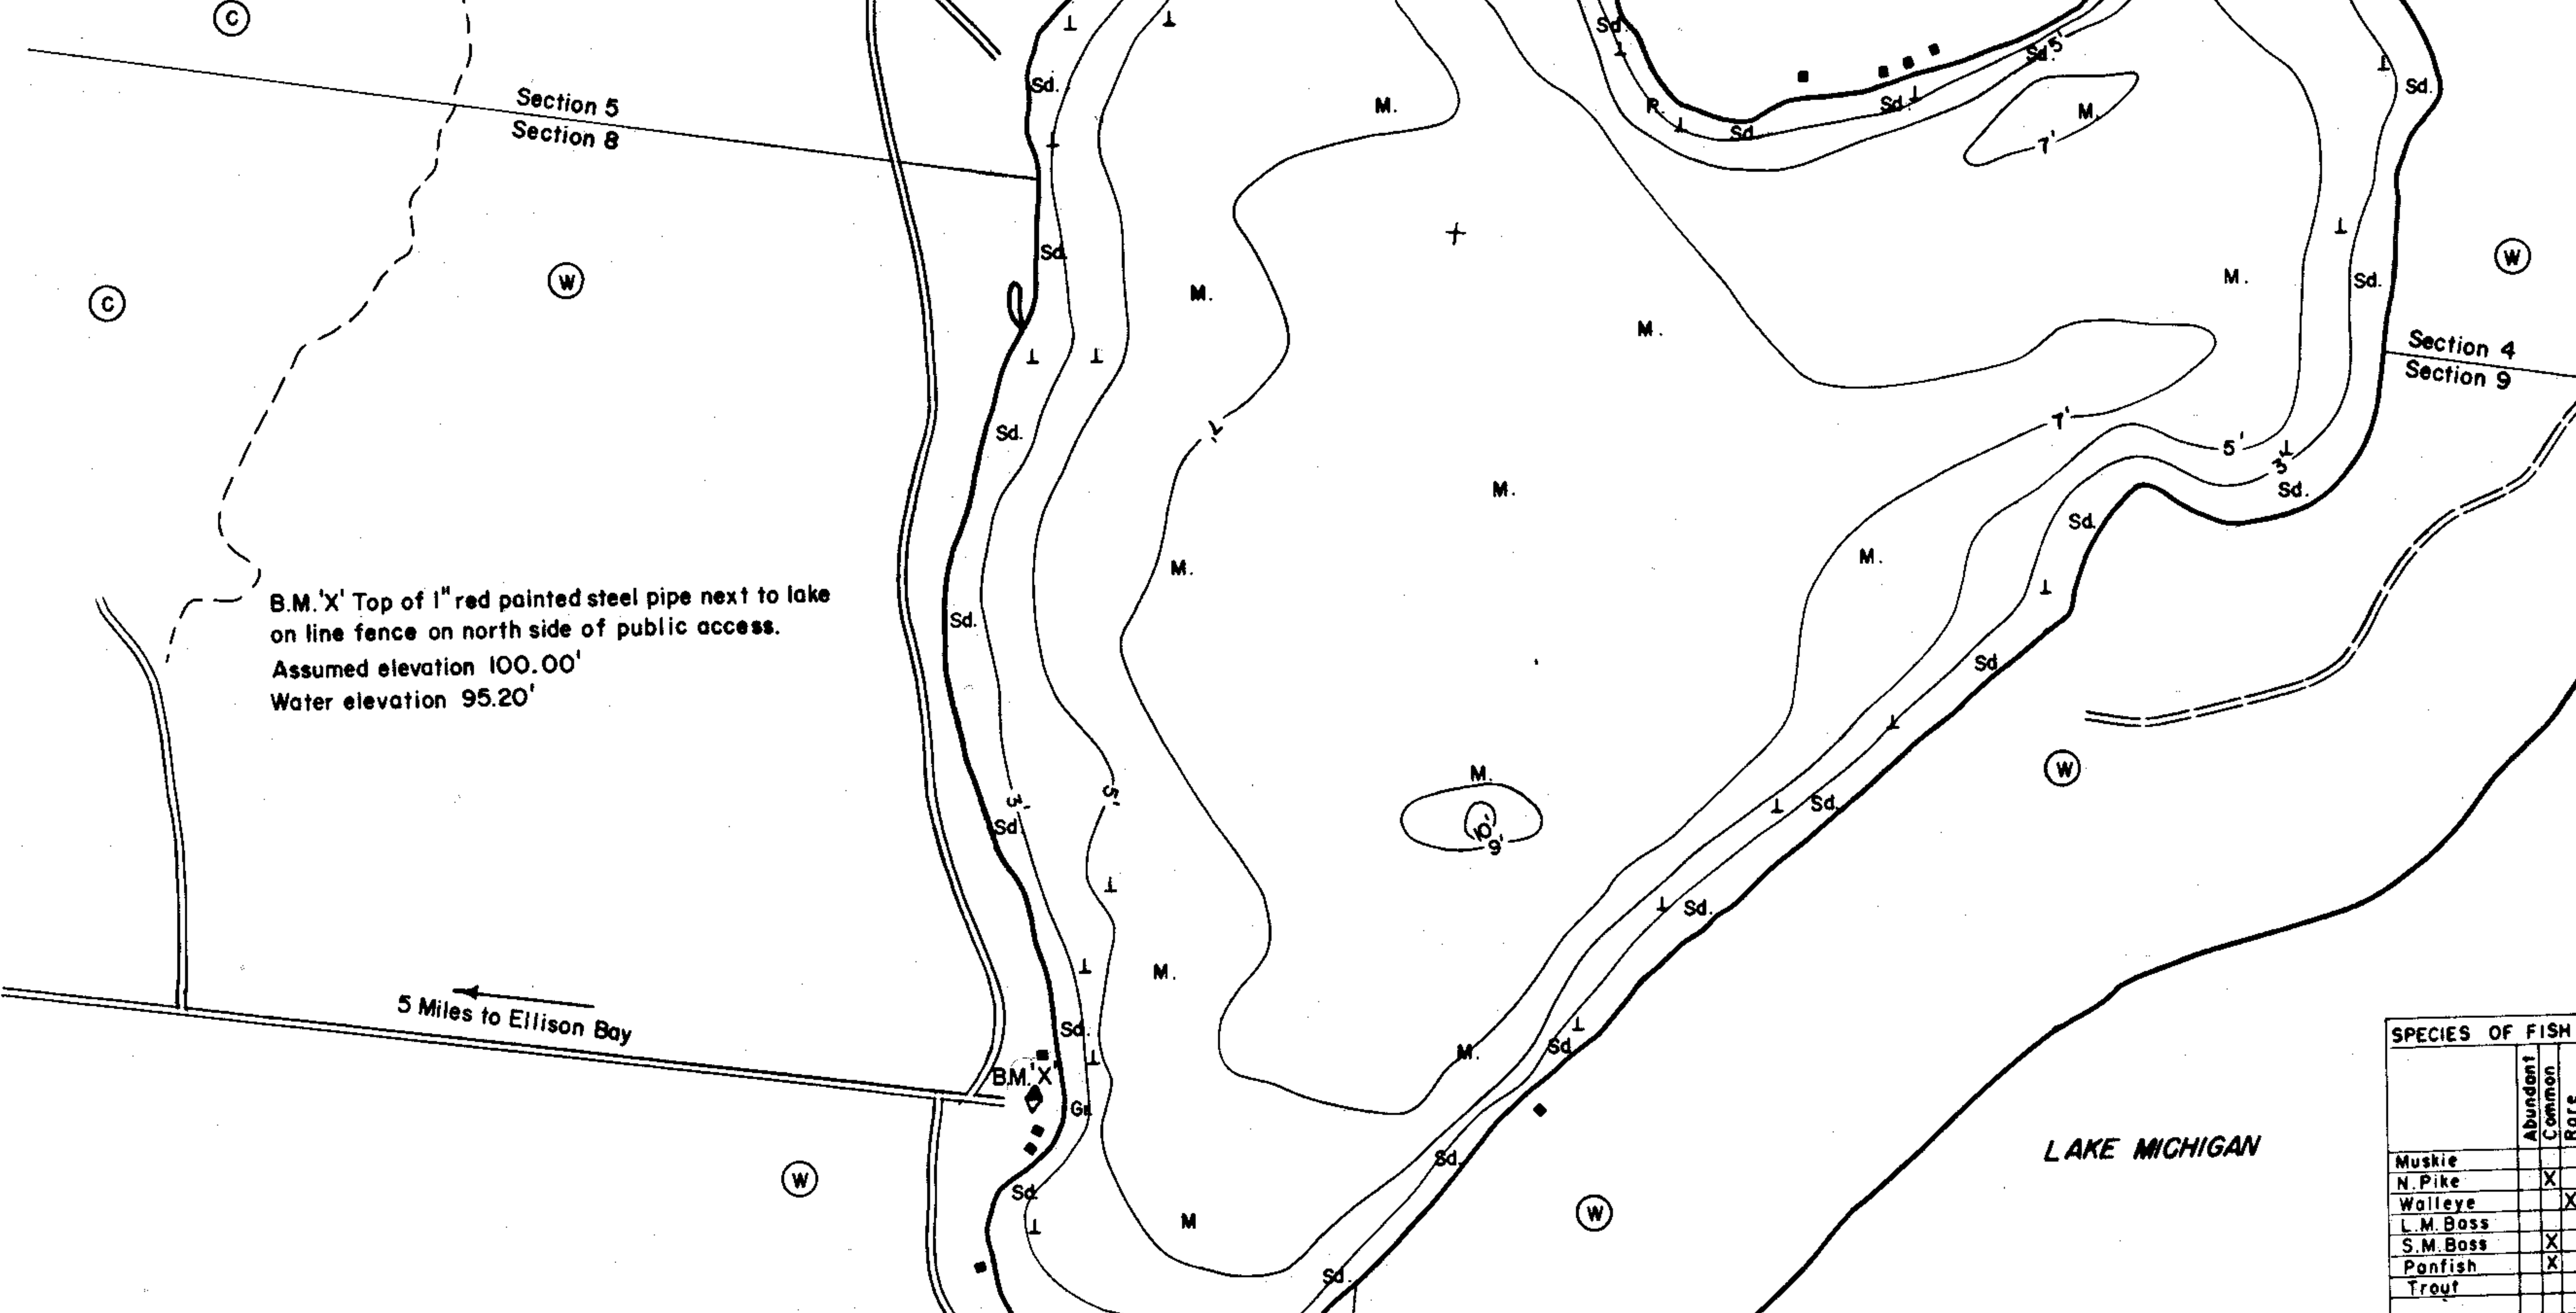
B.M. 'X' Top of 1" red painted steel pipe next to lake on line fence on north side of public access.  
 Assumed elevation 100.00'  
 Water elevation 95.20'

EQUIPMENT RECORDING SONAR MAPPED JUNE 1967  
 MO. YR.  
 WATER ELEV. 95.20'
