AREA 27.52 ACRES
UNDER 3FT. 57 %
OVER 20FT. 0 %
VOLUME 85.21 ACRE FT.
TOTAL ALK. 320 P.P.M.
SHORELINE 2.62 MILES
MAX. DEPTH 8 FEET

Source: Wisconsin Department of Natural Resources 608-266-2621
Monterey Millpond – Waukesha County, Wisconsin DNR Lake Map
Date – Oct 1965 - Historical Lake Map - Not for Navigation
A Public Document - Please Identify the Source when using it.

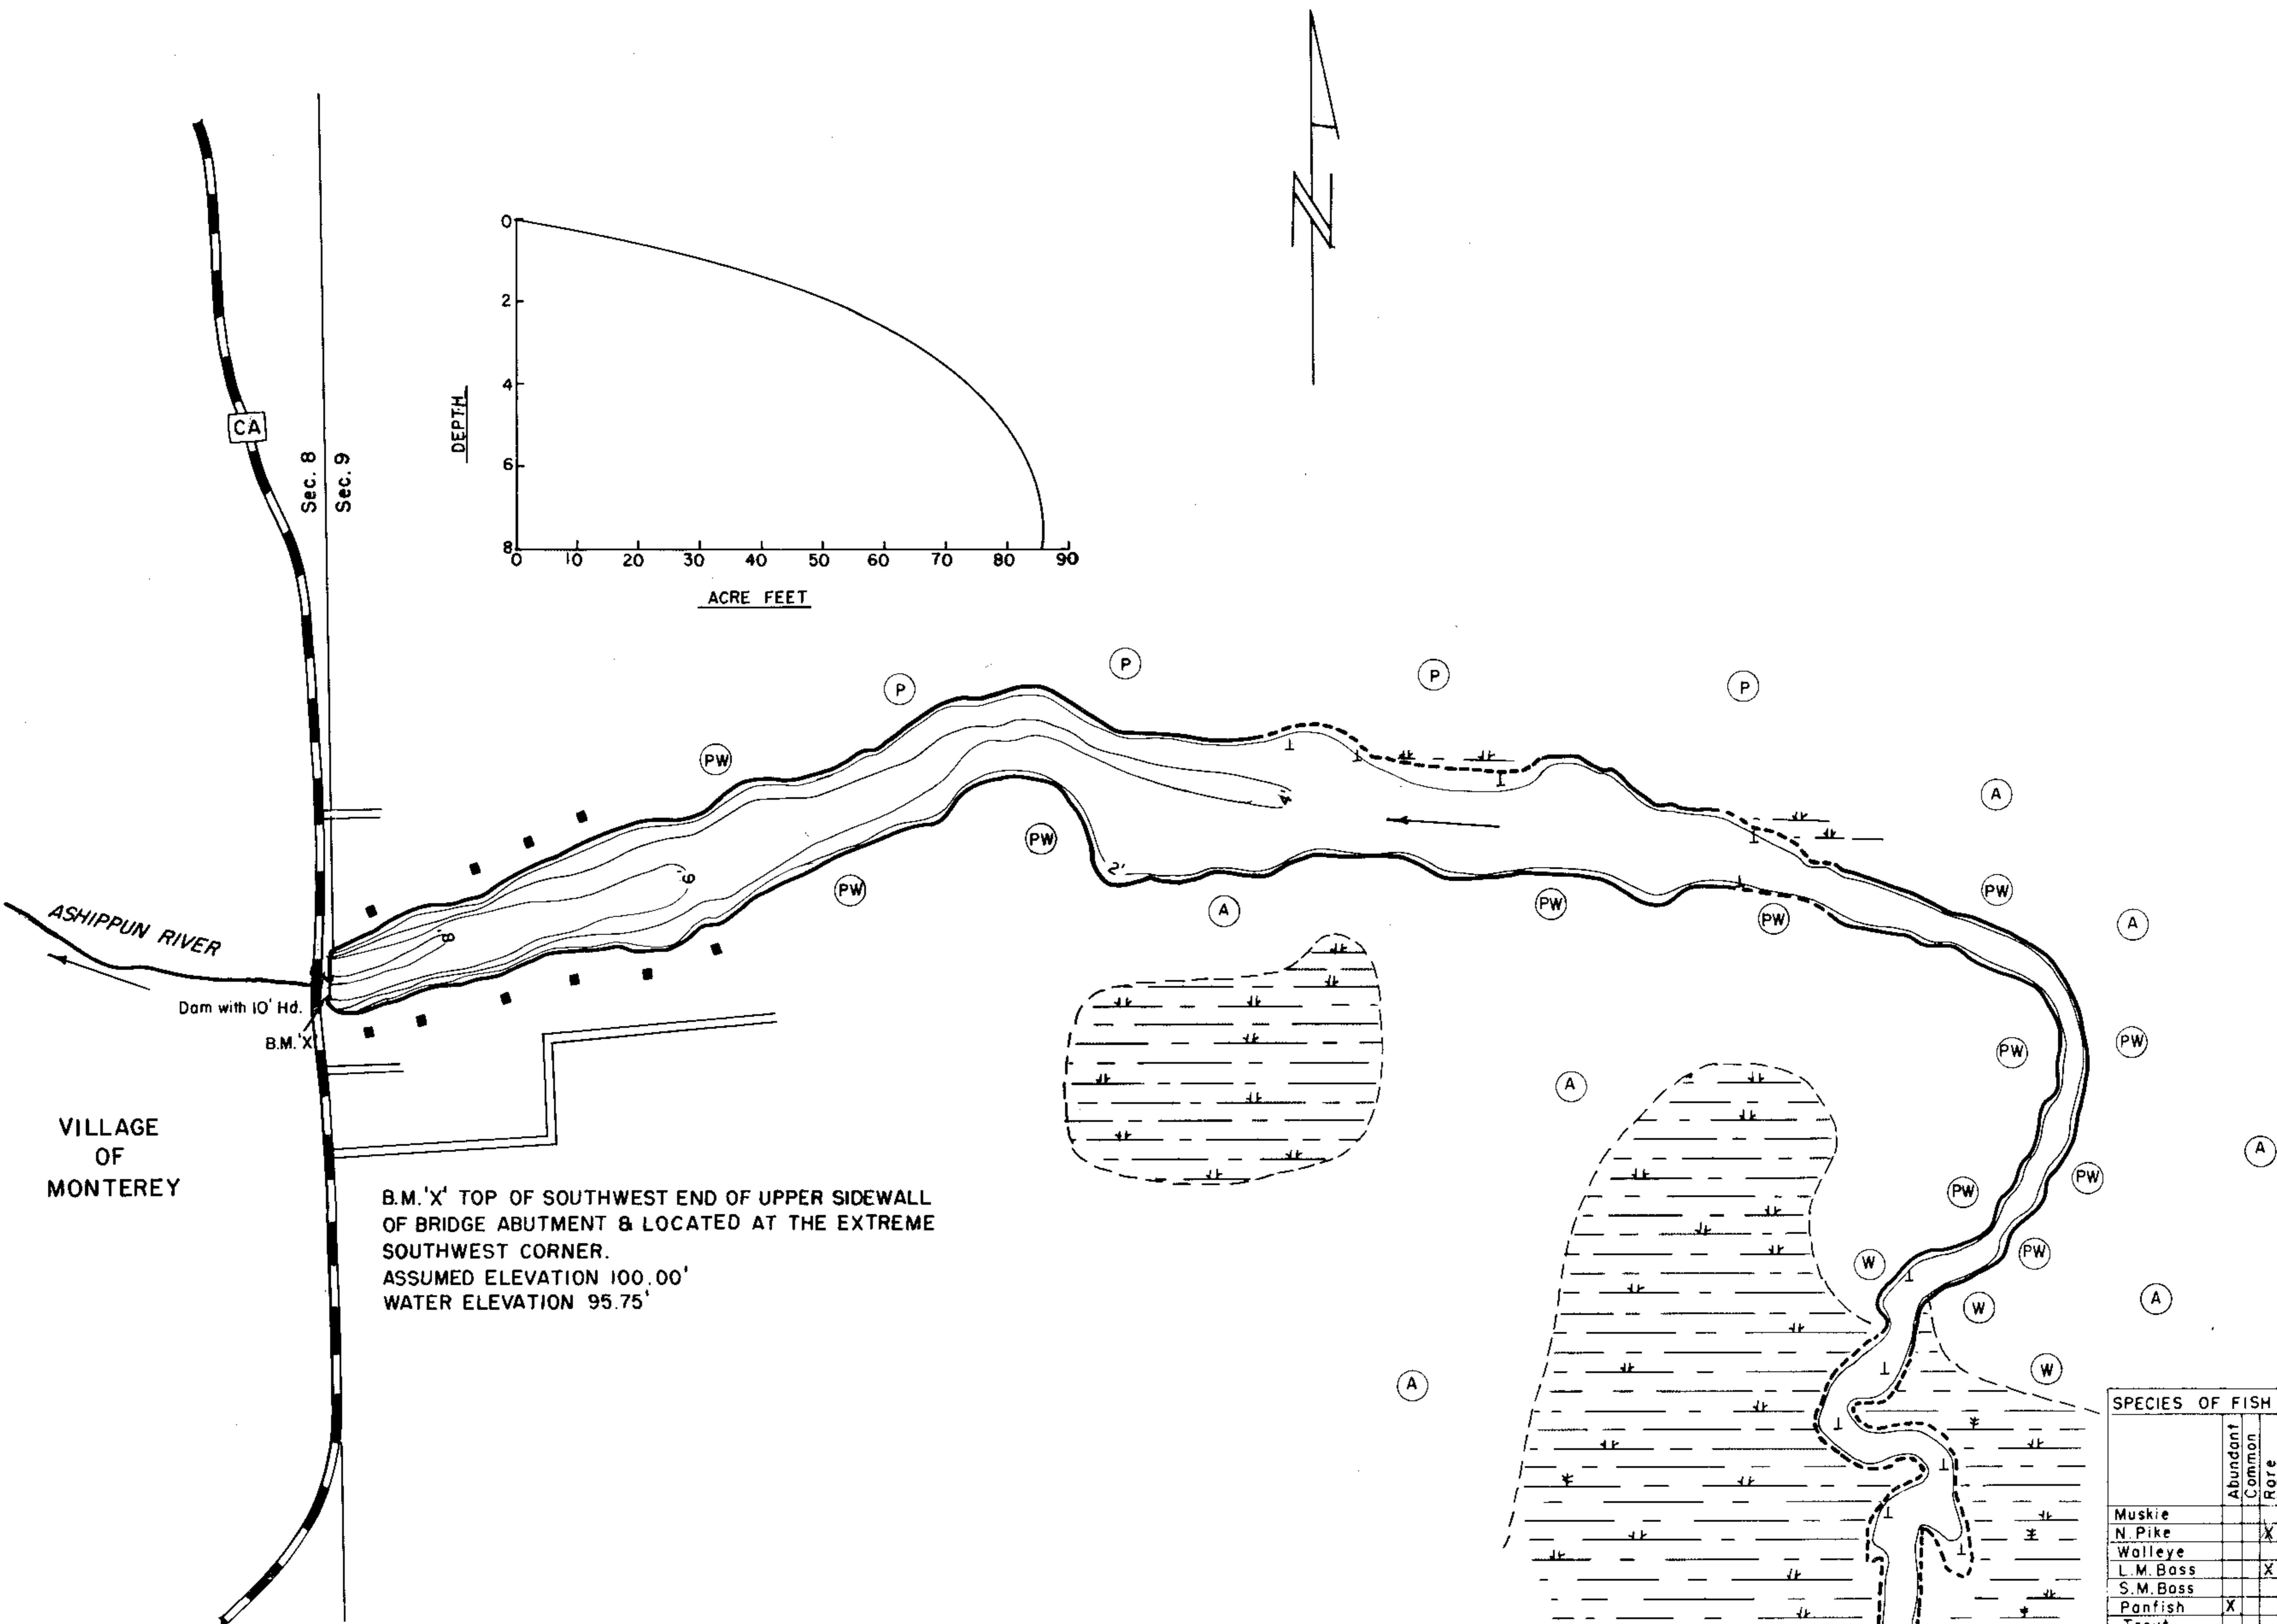
B.M. 'X' TOP OF SOUTHWEST END OF UPPER SIDEWALL OF BRIDGE ABUTMENT & LOCATED AT THE EXTREME SOUTHWEST CORNER.
ASSUMED ELEVATION 100.00'
WATER ELEVATION 95.75'

EQUIPMENT RECORDING SONAR MAPPED OCT. 1965
MO. YR.
