EQUIPMENT RECORDING SONAR MAPPED AUG 1970

Source: Wisconsin Department of Natural Resources 608-266-2621
Leland Pond – Sauk County, Wisconsin DNR Lake Map
Date – Aug 1970 - Historical Lake Maps - Not for Navigation
A Public Document - Please Identify the Source when using it.

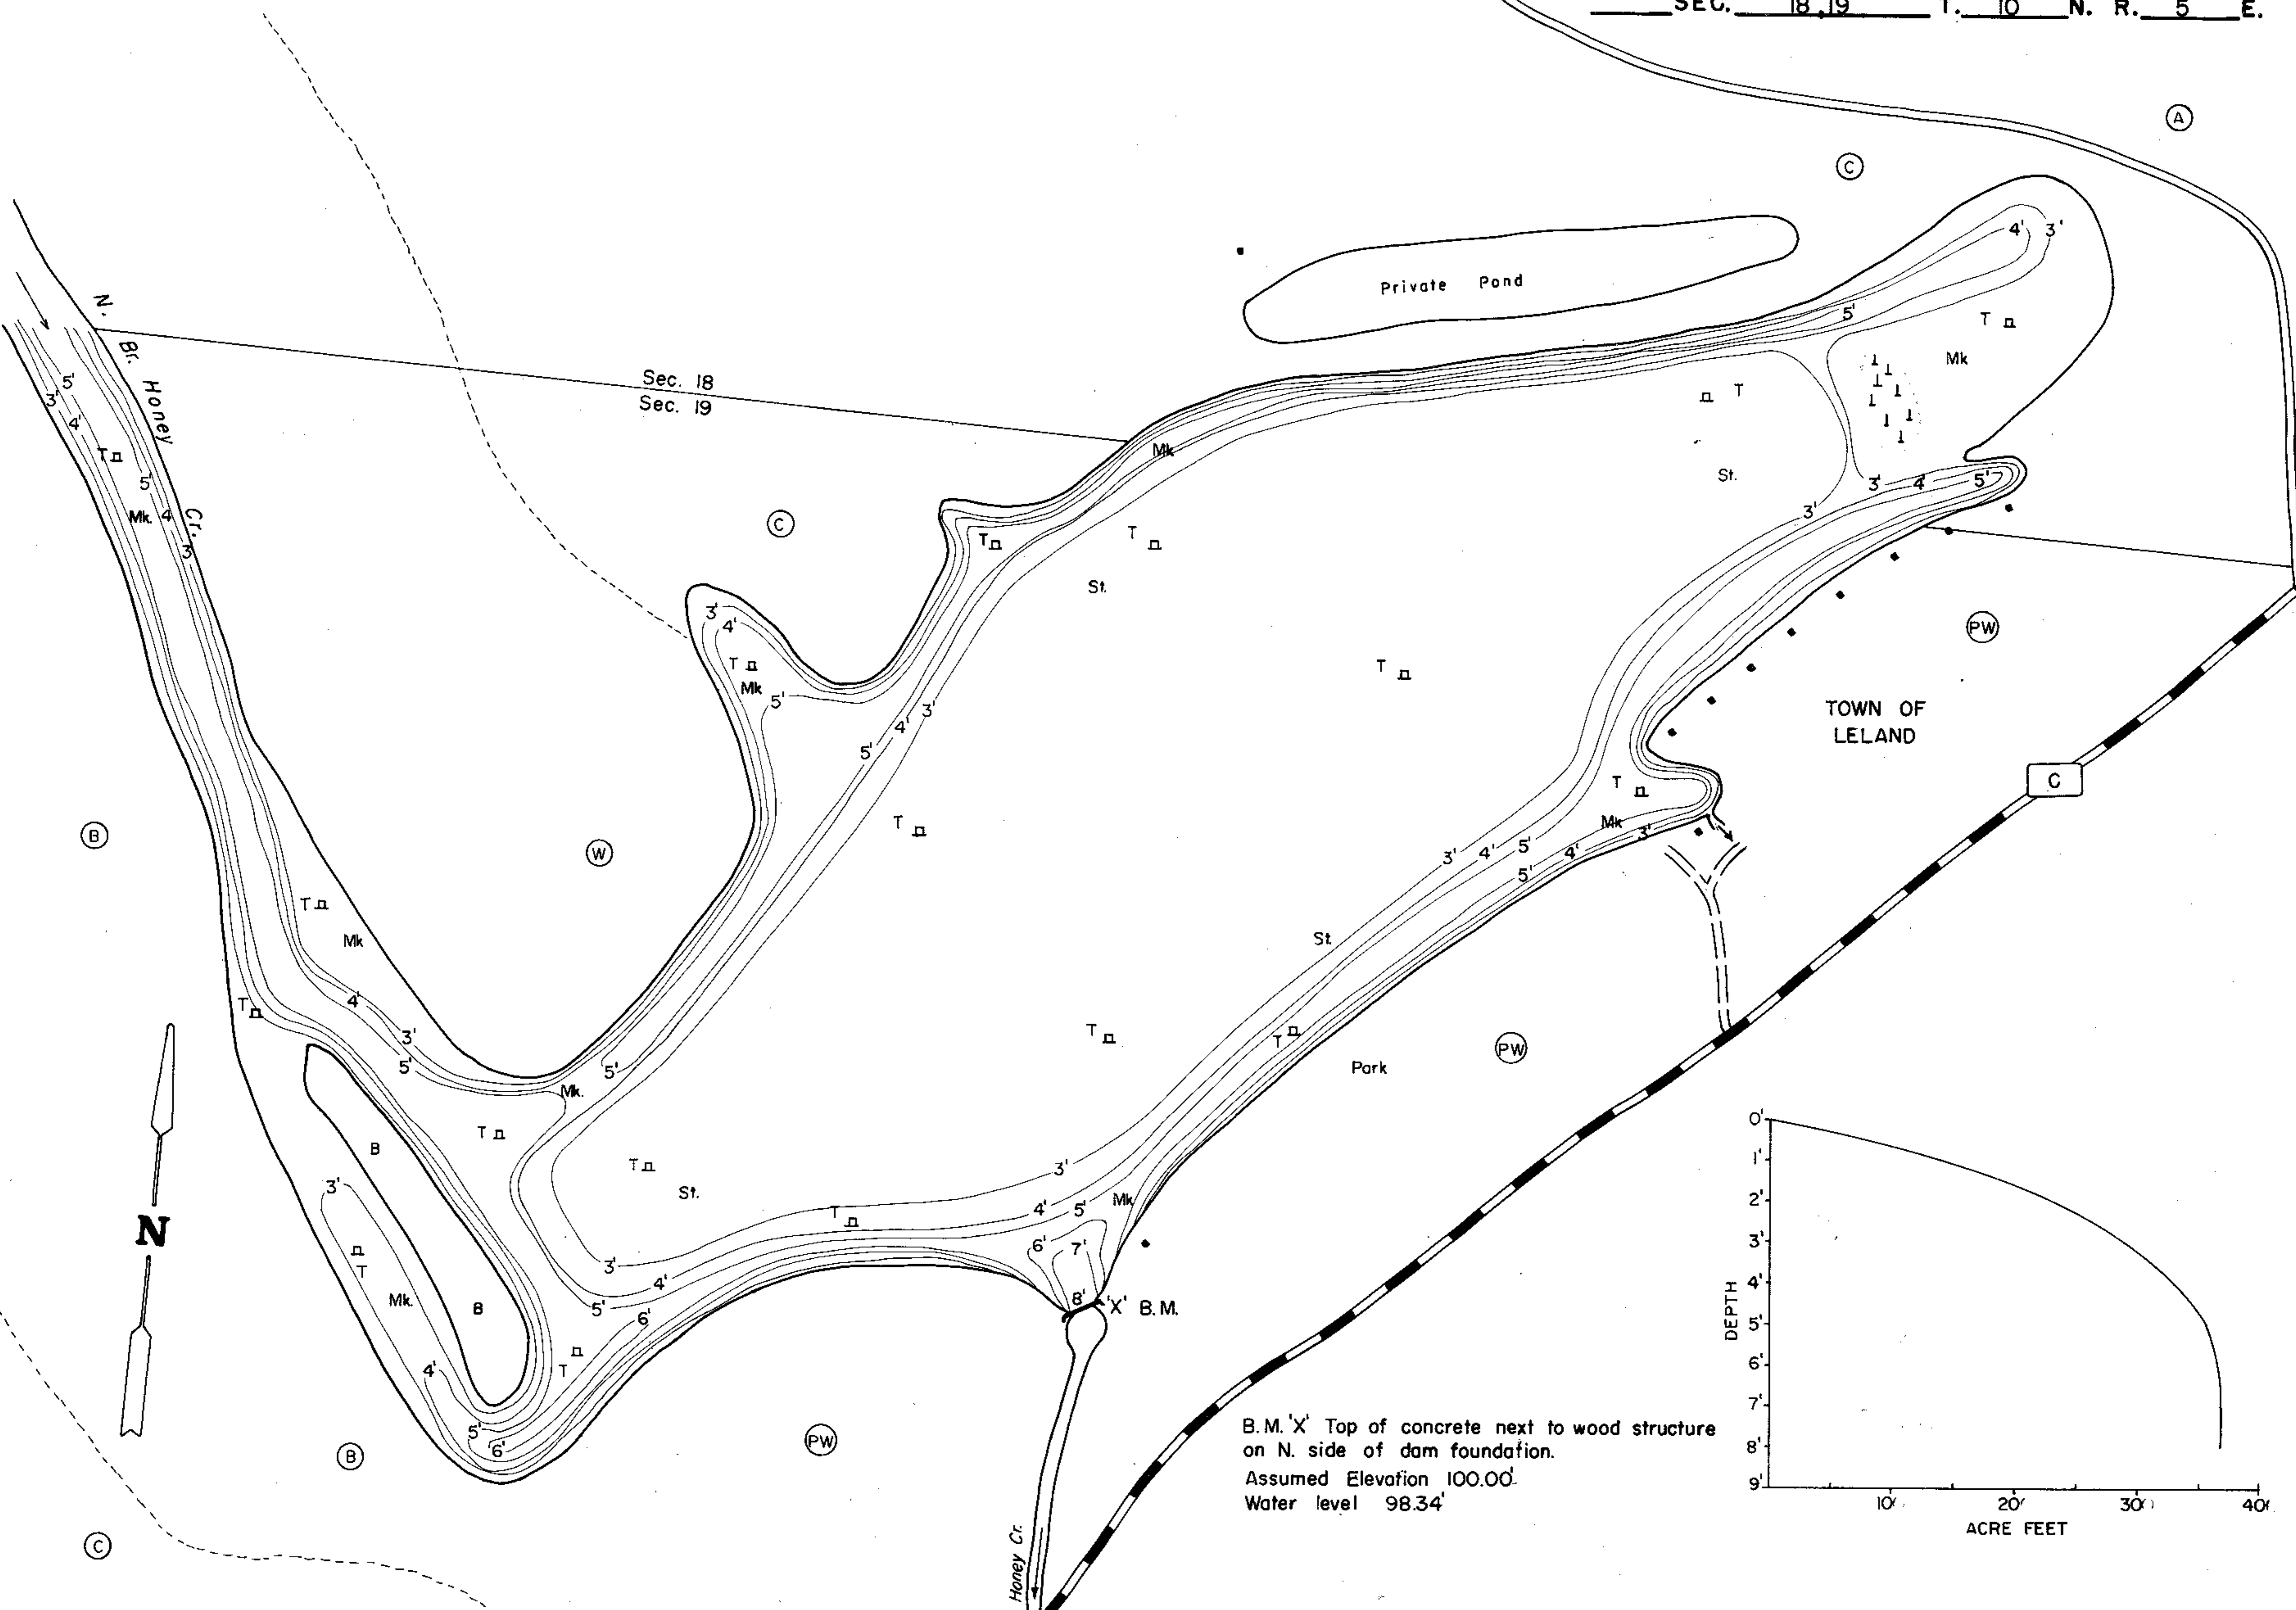
B.M. 'X' Top of concrete next to wood structure on N. side of dam foundation.
Assumed Elevation 100.00'
Water level 98.34'

WATER AREA 14.3 ACRES
 UNDER 3 FT. 65 %
 OVER 20 FT. 0 %
 MAX. DEPTH 8 FEET.
 TOTAL ALK. 172 P.P.M.
 VOLUME 366 ACRE FT.
 SHORELINE 1.07 MILES
 SHORELINE 1.21 MILES WITH IS.
