EQUIPMENT SONAR & POLE MAPPED MAY 1968
MO. YR.

Source: Wisconsin Department of Natural Resources 608-266-2621
Monroe County Flowage – Monroe County, Wisconsin DNR Lake Map
Date – May 1968 - Historical Lake Map - Not for Navigation
A Public Document - Please Identify the Source when using it.

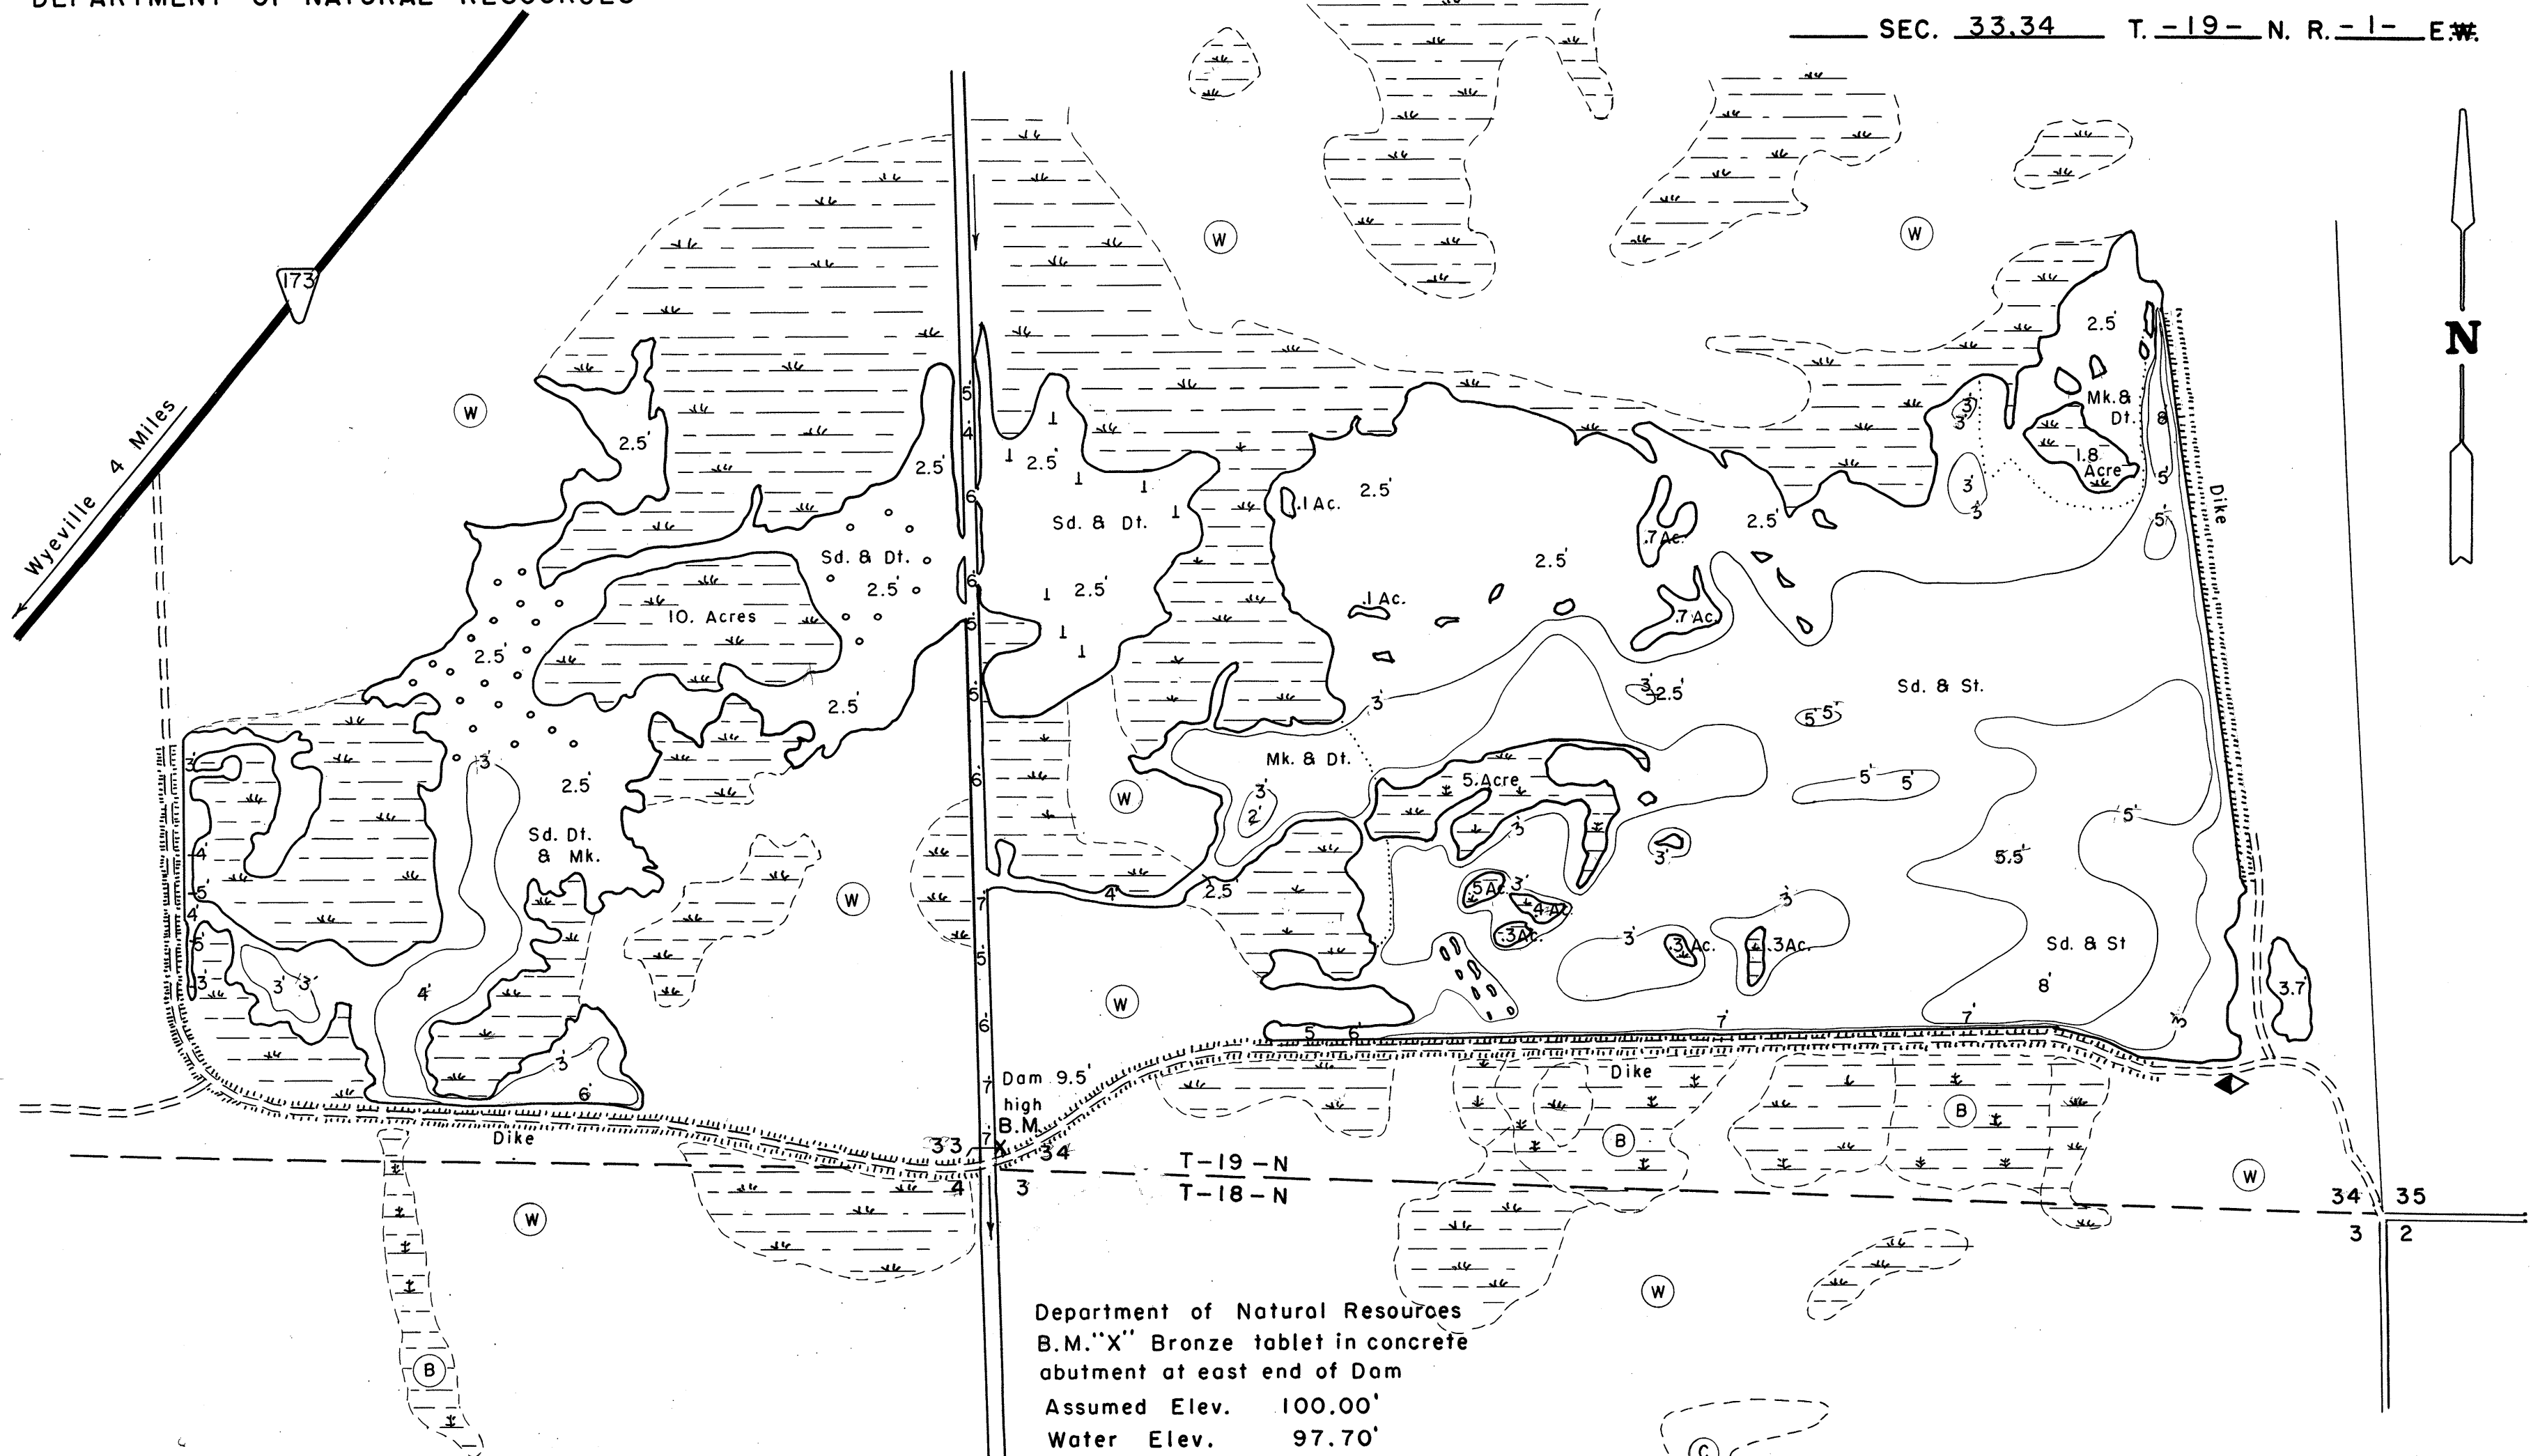
Department of Natural Resources
B.M. "X" Bronze tablet in concrete
abutment at east end of Dam
Assumed Elev. 100.00'
Water Elev. 97.70'

AREA 263 ACRES
UNDER 3FT. 60 %
OVER 20FT. 0 %
VOLUME 712 ACRE FT.
TOTAL ALK. 6 P.P.M.
SHORELINE 12 MILES
MAX. DEPTH 8 FEET
