Dam has 5' Head. Concrete Spillway with Stoplogs. Water diversion for Cranberry Bog

Source: Wisconsin Department of Natural Resources 608-266-2621
Bass Lake – Rusk County, Wisconsin DNR Lake Map
Date – Jul 1965 - Historical Lake Map - Not for Navigation
A Public Document - Please Identify the Source when using it.

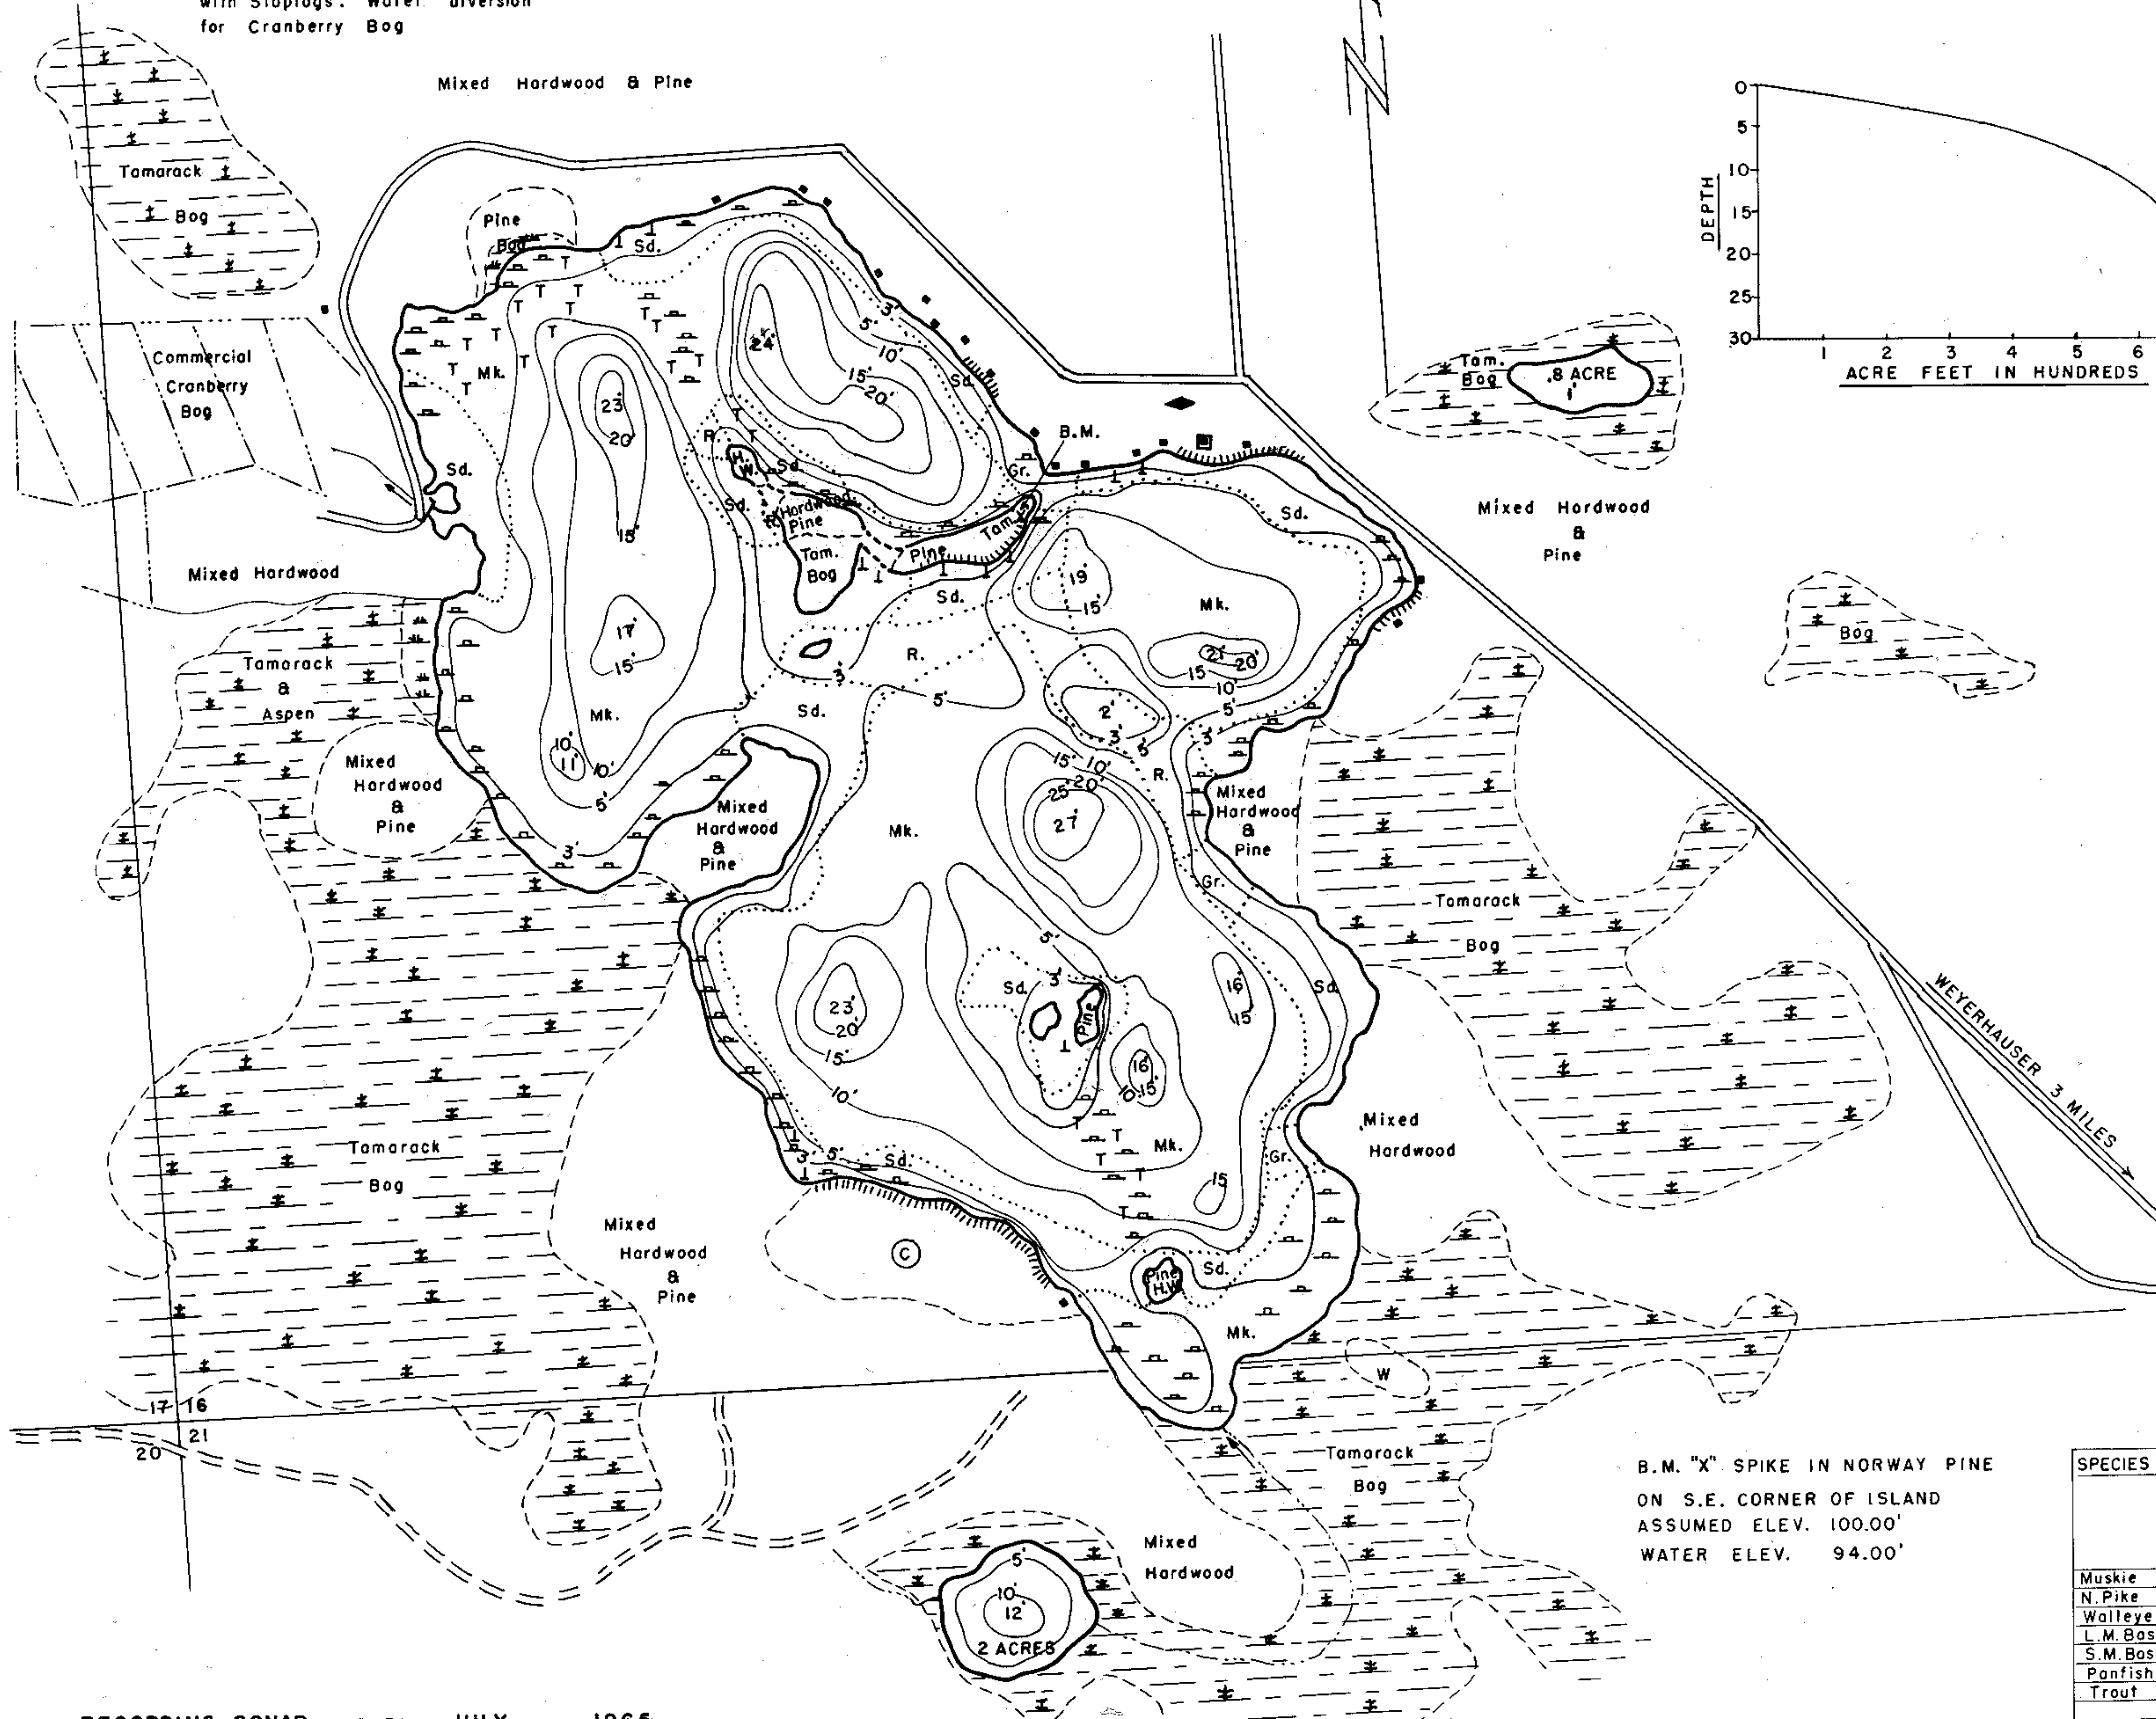
- LAKE BOTTOM SYMBOLS
- P. Peat
 - Mk. Muck
 - C. Clay
 - M. Marl
 - Sd. Sand
 - St. Silt
 - Gr. Gravel
 - R. Rubble
 - Br. Bedrock
 - T Submergent vegetation
 - ↓ Emergent vegetation
 - △ Floating vegetation

B.M. "X" SPIKE IN NORWAY PINE ON S.E. CORNER OF ISLAND ASSUMED ELEV. 100.00' WATER ELEV. 94.00'

90.2 WITH ISLANDS
AREA 87.8 ACRES
UNDER 3FT. 19 %
OVER 20FT. 3 %
VOLUME 682.5 ACRE FT.
TOTAL ALK. 10 P.P.M.
SHORELINE 2.7 MILES
MAX. DEPTH 27 FEET
