EQUIPMENT SONAR MAPPED MONTH YEAR
JULY 1972

Source: Wisconsin Department of Natural Resources 608-266-2621
Riverdale Flowage – St. Croix County, Wisconsin DNR Lake Map
Date – Jul 1972 - Historical Lake Map - Not for Navigation
A Public Document - Please Identify the Source when using it.

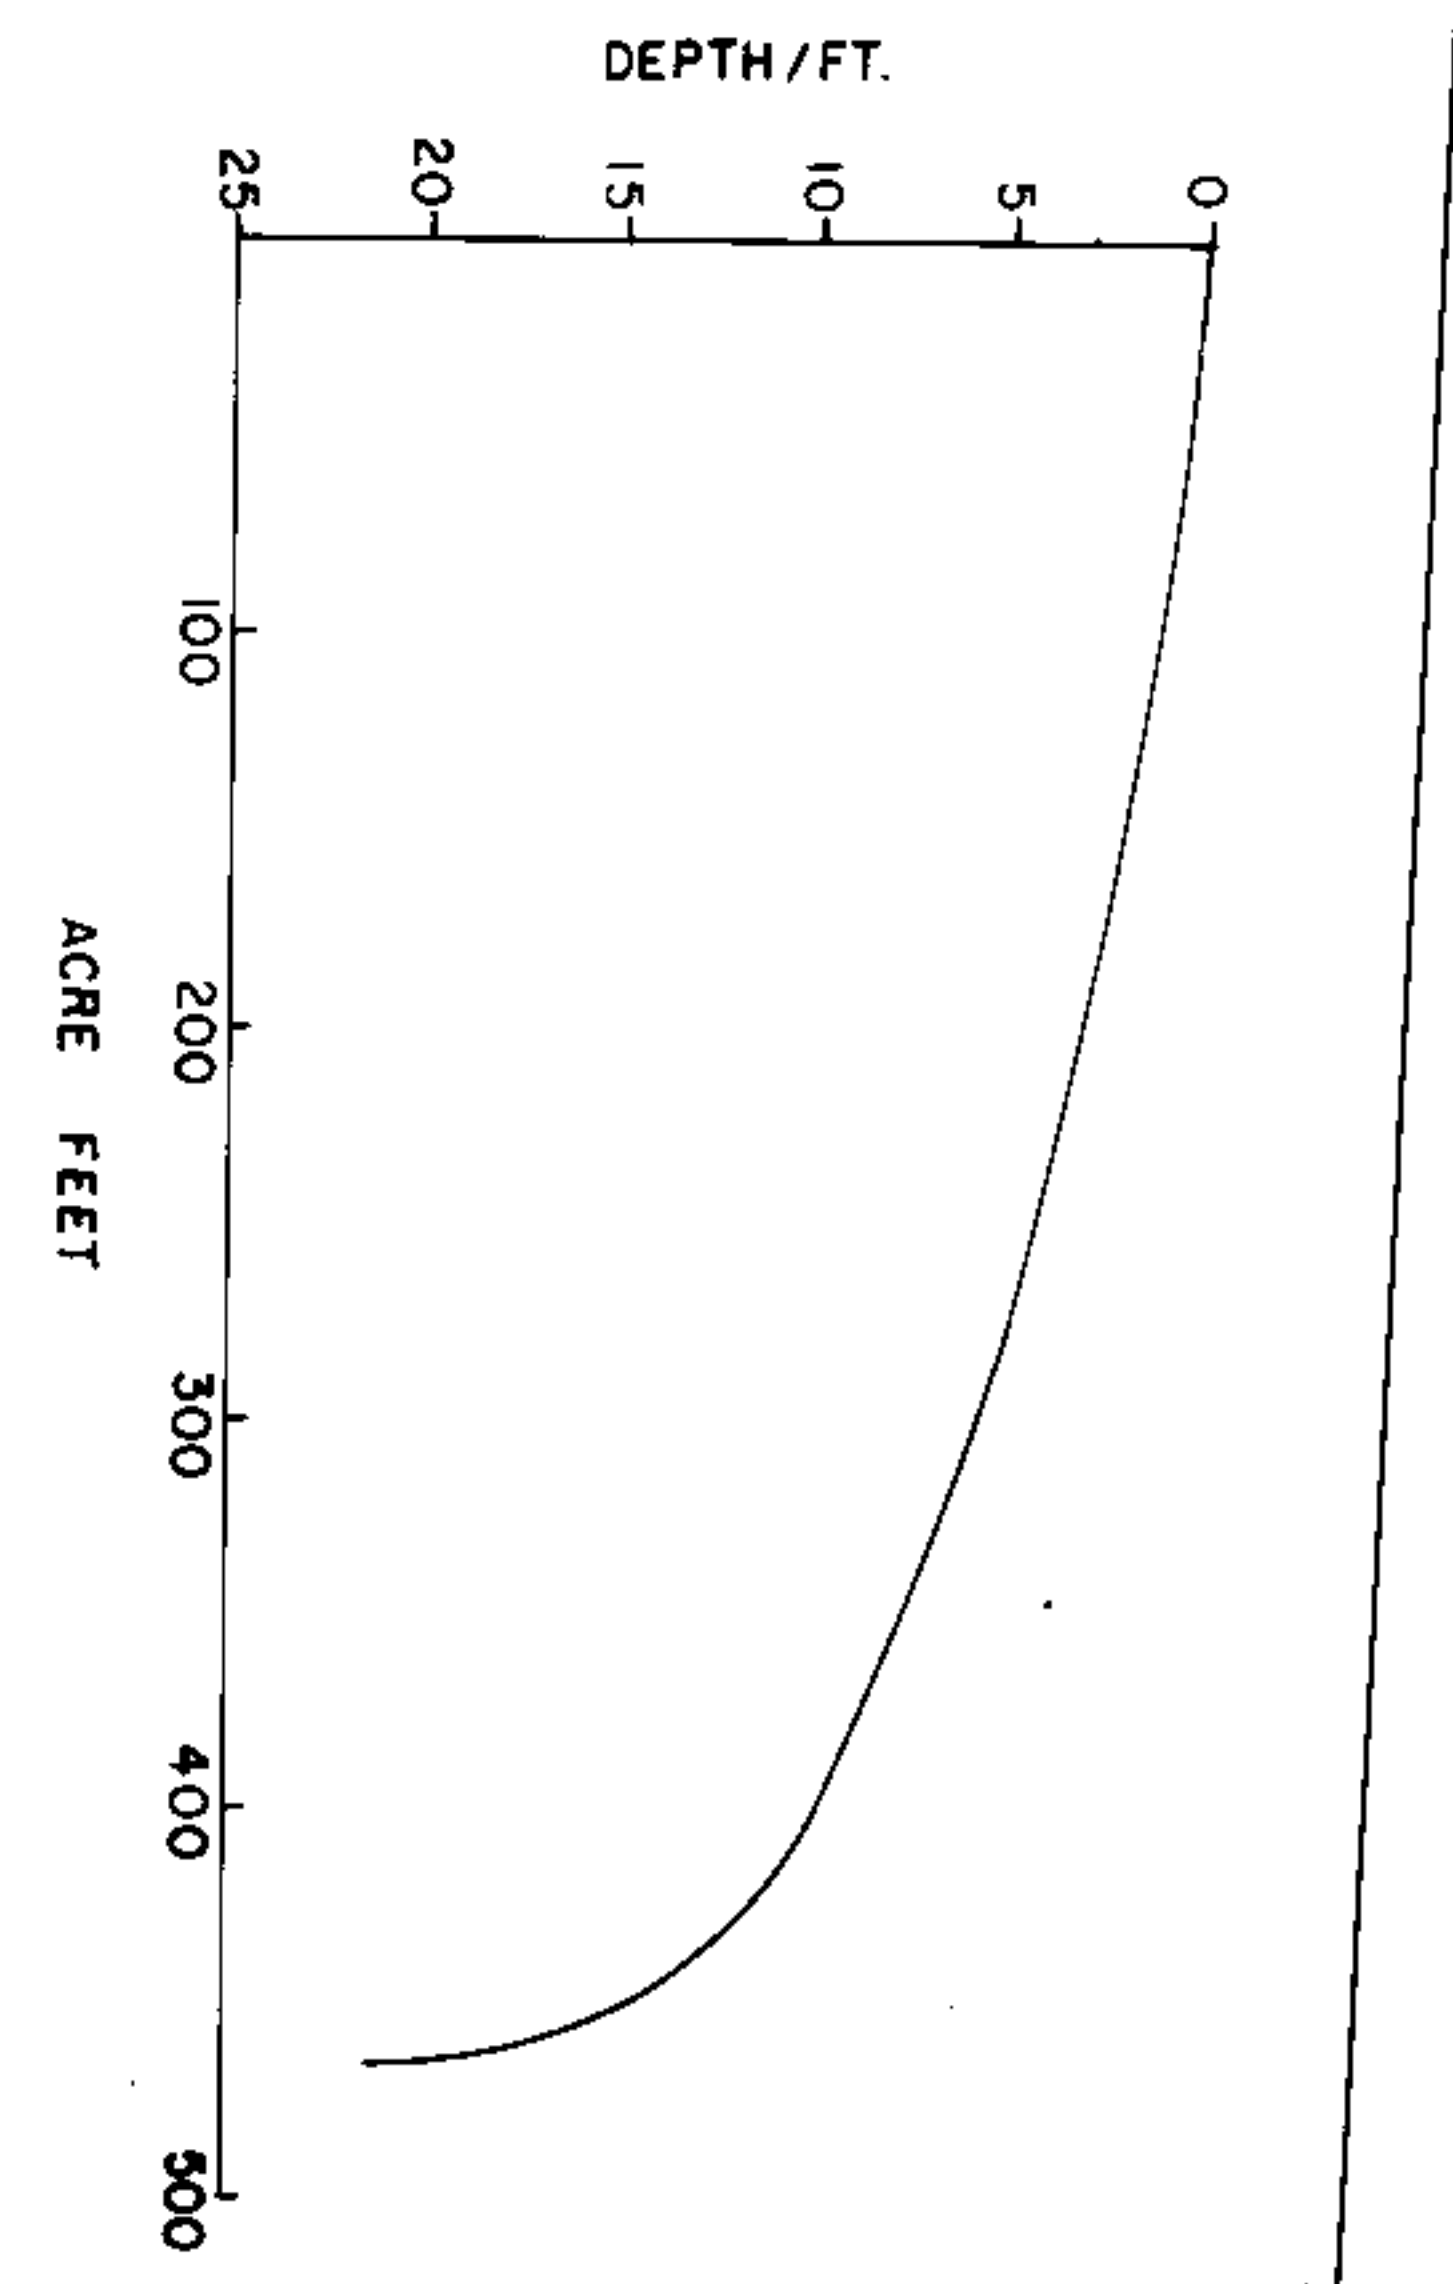
B.M. 1, Railroad Commission of Wis.
Water Power bench mark. Located
at extreme southwest end of dam,
10.5' from northwest edge.
Assumed Elevation 100'
Water Level 96.43'

WATER AREA 75.2 ACRES
 UNDER 3 FT. 29.7 %
 OVER 20 FT. 0 %
 MAX. DEPTH 20.0 FEET.
 TOTAL ALK. 12.5 P.P.M.
 VOLUME 467.8 ACRE FT.
 MAIN SHORELINE 3.2 MI.
 ISLAND SHORELINE .2 MI.
