EQUIPMENT RECORDING SONAR MAPPED MAY 1968

Source: Wisconsin Department of Natural Resources 608-266-2621  
English Lake – Ashland County, Wisconsin DNR Lake Map  
Date – May 1968 - Historical Lake Map - Not for Navigation  
A Public Document - Please Identify the Source when using it.

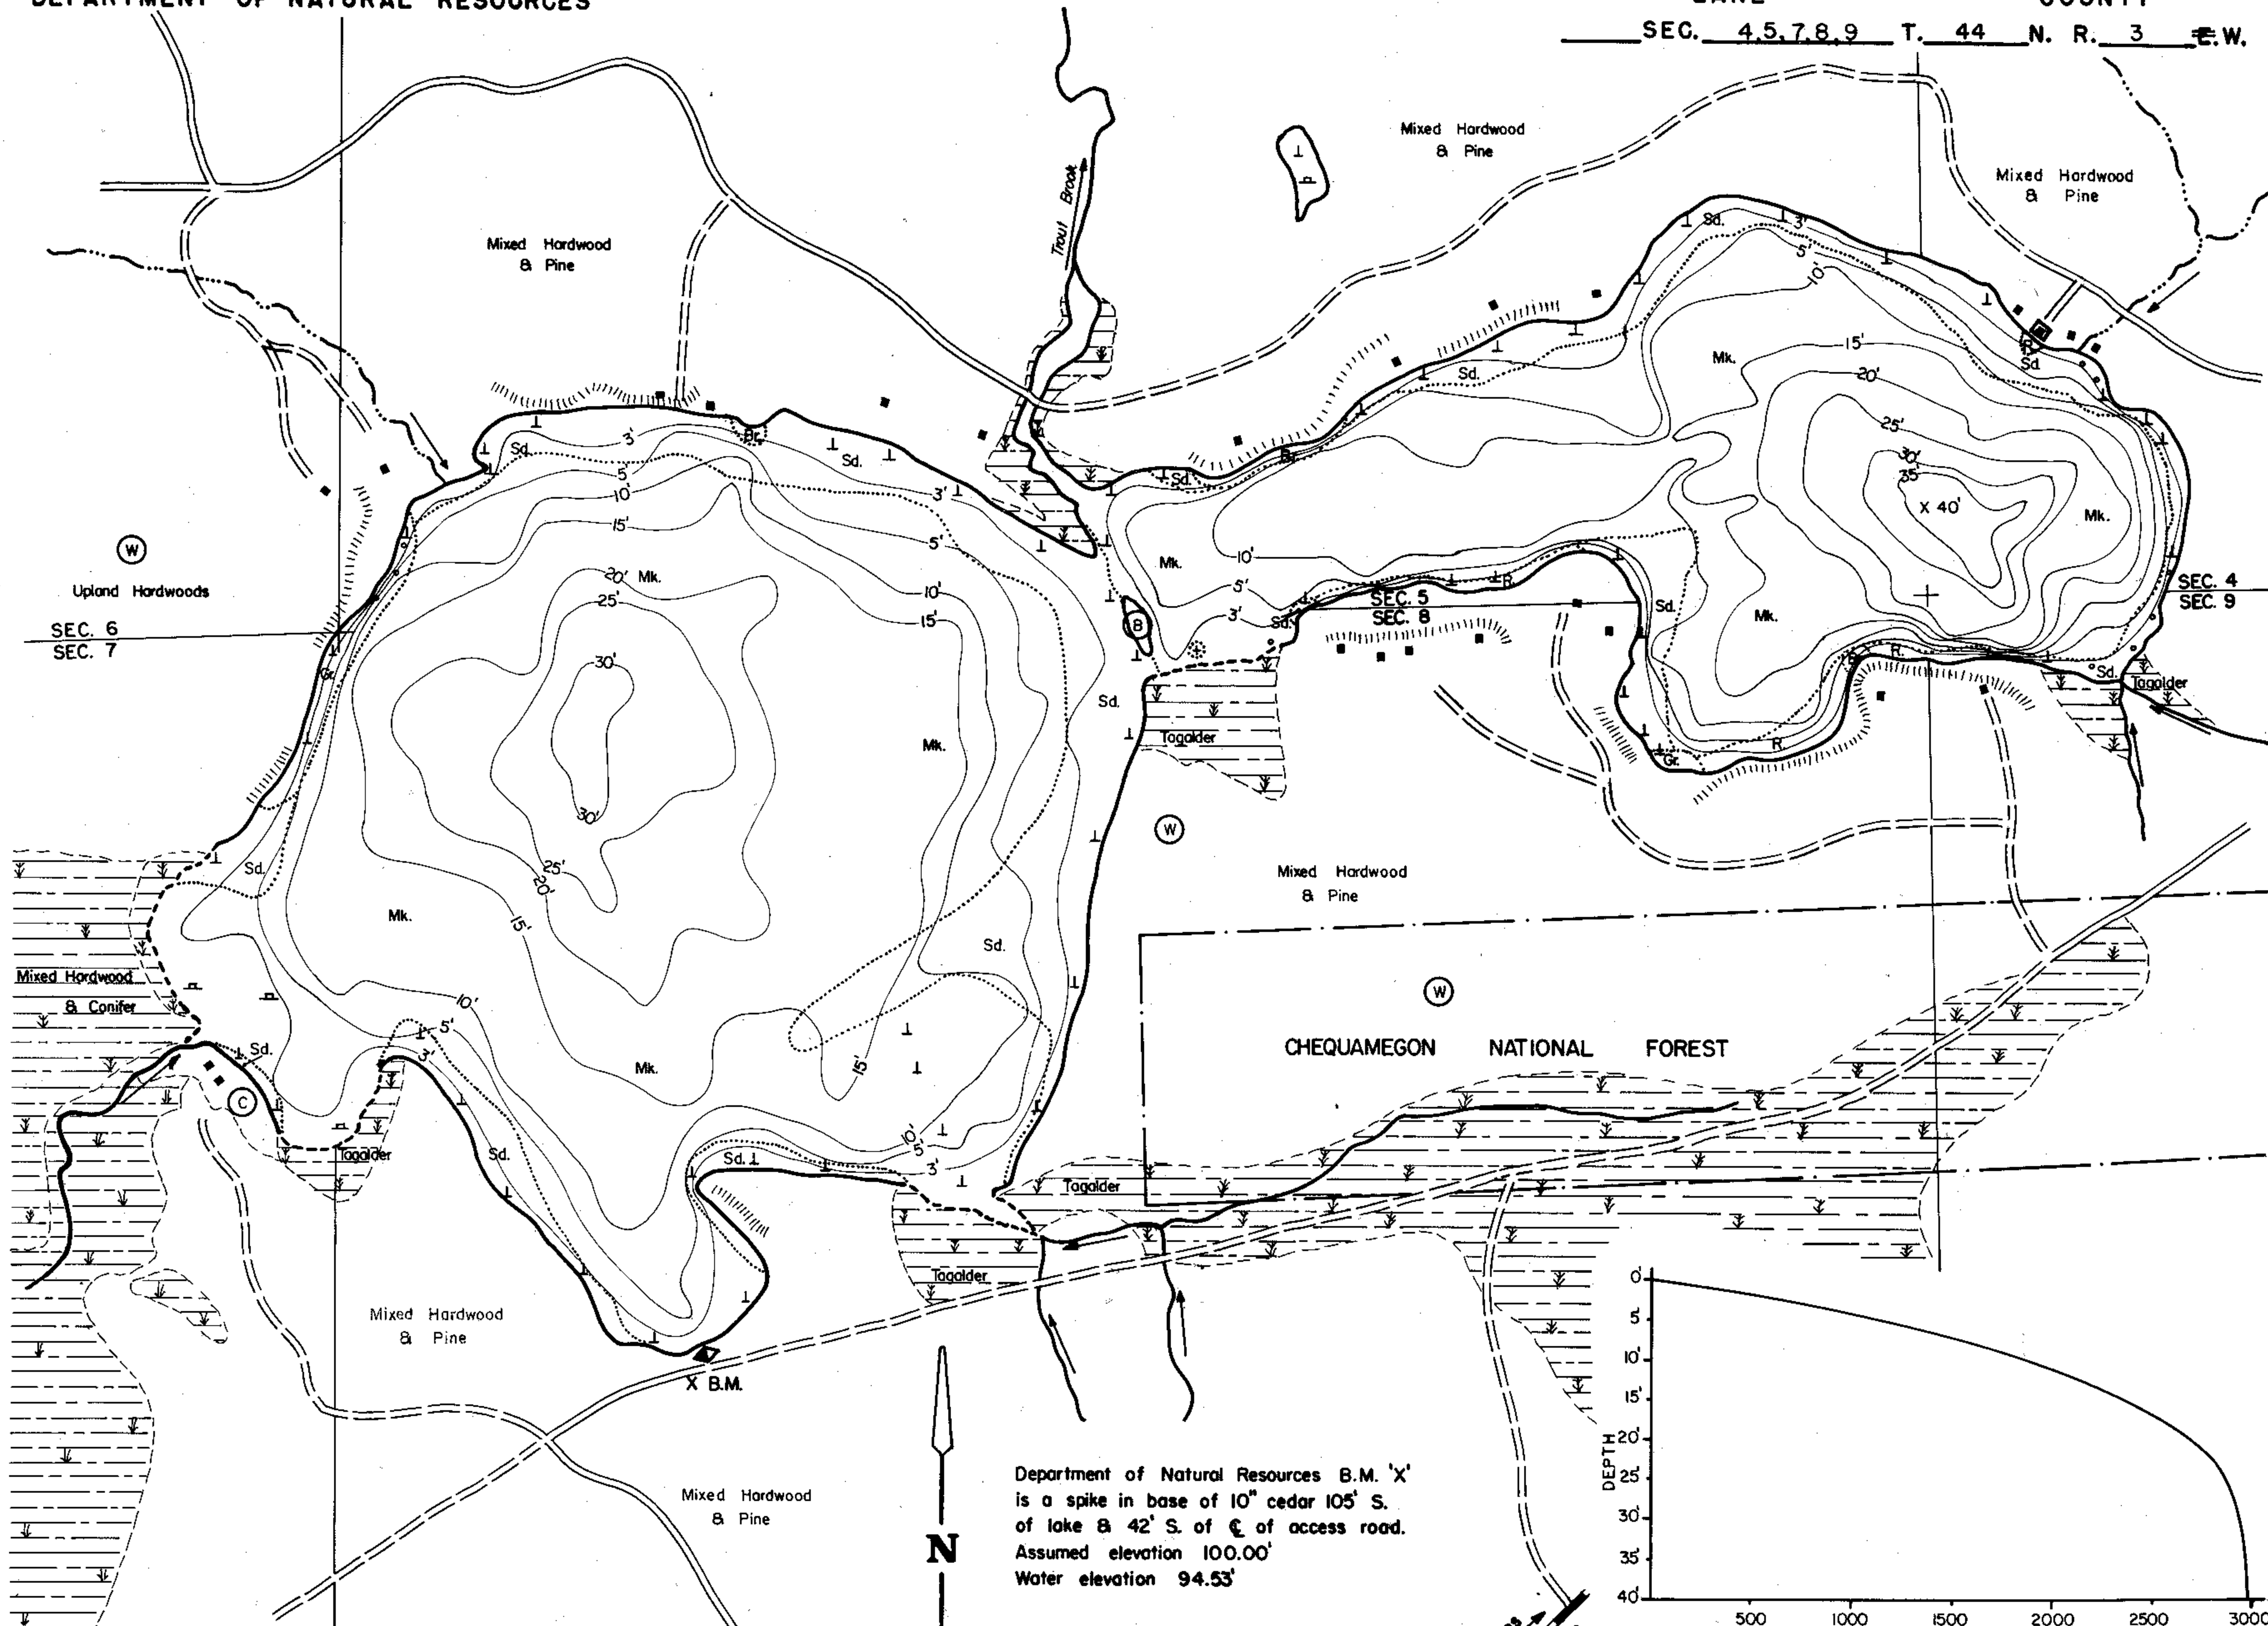
Department of Natural Resources B.M. 'X' is a spike in base of 10" cedar 105' S. of lake & 42' S. of E. of access road. Assumed elevation 100.00' Water elevation 94.53'

TOPOGRAPHIC SYMBOLS		LAKE BOTTOM SYMBOLS	
(B) Brush	Steep slope	P. Peat	B Boulders
(PW) Partially wooded	----- Indefinite shoreline	Mk. Muck	o Stumps & Snags
(W) Wooded	----- Marsh	C. Clay	o Rock danger to navigation
(C) Cleared	o Spring	M. Marl	T Submergent vegetation
(P) Pastured	----- Intermittent stream	Sd. Sand	l Emergent vegetation
(A) Agricultural	----- Permanent inlet	Sl. Silt	l Floating vegetation
B.M. Bench Mark	----- Permanent outlet	Gr. Gravel	o Brush shelters
■ Dwelling	o Dam	R. Rubble	
□ Resort	D.N.R. State owned land	Br. Bedrock	
□ Camp

WATER AREA	244.2	ACRES
UNDER 3 FT.	14.9	%
OVER 20 FT.	16.9	%
MAX. DEPTH	40	FEET.
TOTAL ALK.	22	P.P.M.
VOLUME	2992.1	ACRE FT.
SHORELINE	4.05	MILES
WITHOUT ISLAND	3.97	MILES
