Aquatic Plant Management Plan

Beecher Lake

Chuck Druckrey
Marinette County Land Information Department
Land & Water Conservation Division
January 2009

Beecher Lake Aquatic Plant Management Plan

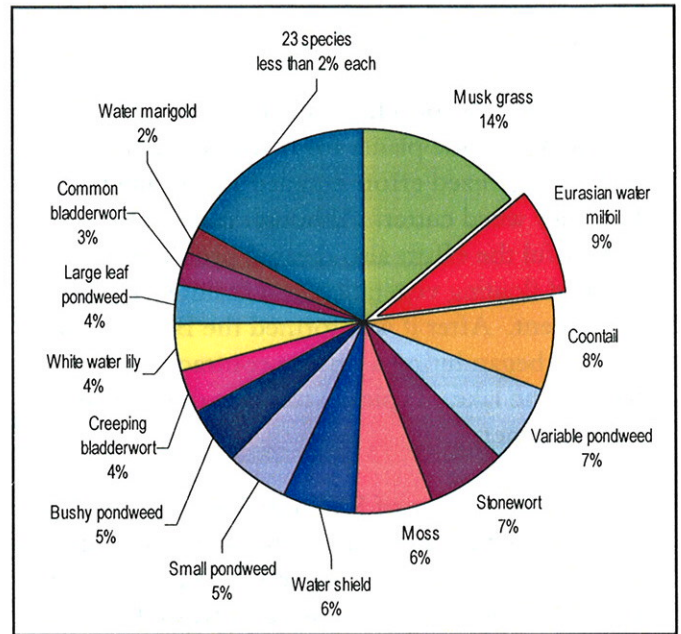
Figure 4. Relative abundance of aquatic plants in Beecher Lake.

Beecher Lake supports an abundant and diverse aquatic plant population with 31 native species identified during the survey along with the exotic Eurasian watermilfoil. Since the EWM infestation is relatively new, it does not yet dominate the aquatic plant community. Indeed, no one plant can be said to dominate in Beecher Lake. The thirteen most abundant species in the lake account for more than 80% of the population but no one species accounts for more than 14% by itself (figure 4). The following aquatic plants were found at more than 10% of vegetated sites and could be considered the dominant plants in Beecher Lake. Descriptions are taken from *Through the Looking Glass, a Field Guide to Aquatic Plants* (Boreman 1997), a publication of the Wisconsin Lakes Partnership. Distribution maps for each species can be found in Appendix A.

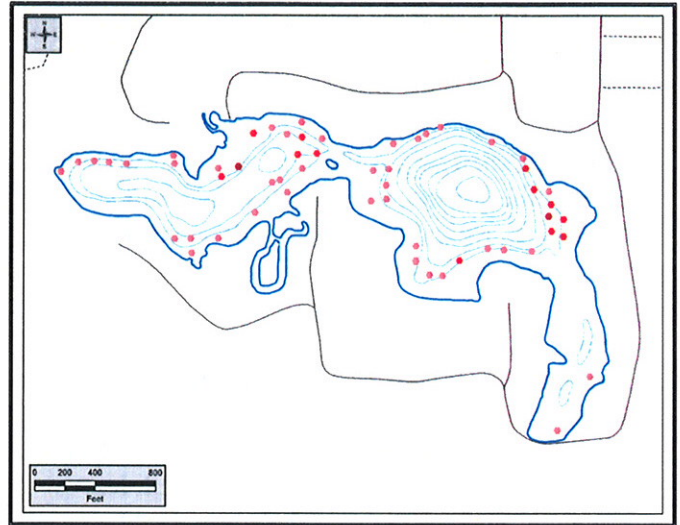
Figure 5. EWM distribution in Beecher Lake.

EWM shows a slight preference for water between five and eight feet of depth. It also shows a preference for muck sediment. The survey showed that although EWM can be found throughout the lake its density was greatest in the Beecher Lake basin on the east end and in a narrow band along the north shore. In the Upper Lake basin EWM was most dense between the boat landing and the channel.

The distribution of EWM in the lakes appears to be expanding. When the plant was first discovered in 2007 it was uncommon in the Upper Lake basin and along the south shore of Beecher. Since then it has spread and can be easily found in all areas of the lake. The EWM map developed from the point/intercept survey (figure 5) does not accurately illustrate the true spread of EWM. This is most evident in the shallow arm of the lake near the dam. Here the

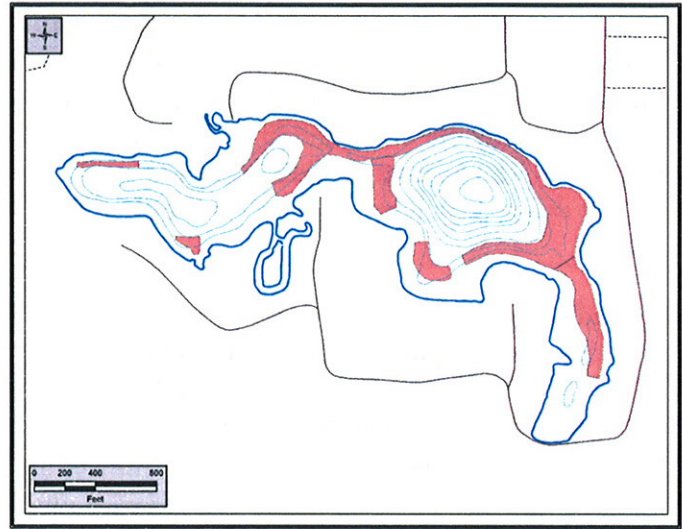
Figure 10. Proposed 2009 EWM herbicide treatment area.

Since the EWM invasion of Beecher Lake is still in an early stage and the native plant community is still in relatively good condition it makes sense to aggressively attack the EWM as soon as possible to prevent it from taking over. At the same time, the District needs to explore all
